HISTORIC THEATRES

STATEWIDE SURVEY AND PHYSICAL NEEDS ASSESSMENT

This report commissioned by the Washington state Department of Archaeology and Historic Preservation.

Published June 30, 2008

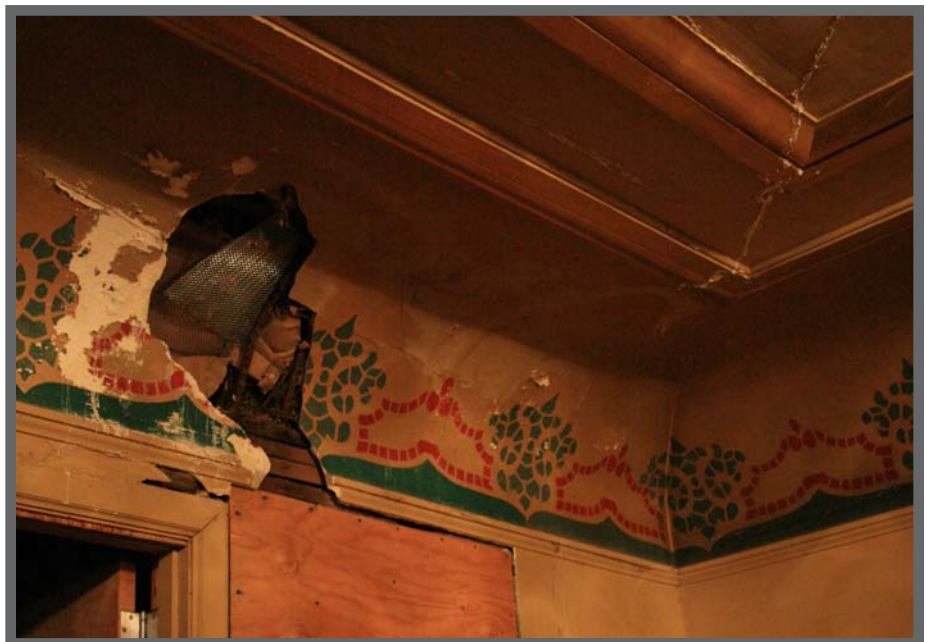
Interior plaster walls and ceilings often show localized water damage, usually from a past roof leak.
Source: Artifacts Consulting, Inc. 2008.
