CURRAN HOUSE HISTORIC STRUCTURE REPORT

Published May, 2010

Charles and Mary Louise Curran Residence

4009 Curran Lane

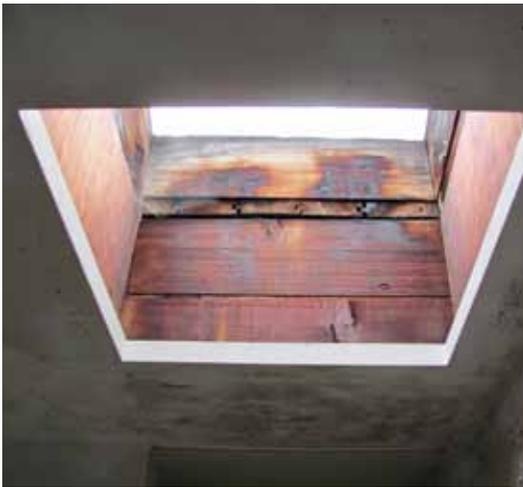
Detail of unfinished interior light well of skylight and mold on ceiling, bathroom #1. Source: Artifacts Consulting, Inc. 2010

- Redesign the roof plan in order to improve drainage and eliminate standing water.
- Replace homemade skylights with factory manufactured versions of a similar size and profile in order to eliminate water infiltration to the bathroom interiors. Proper joint sealant also

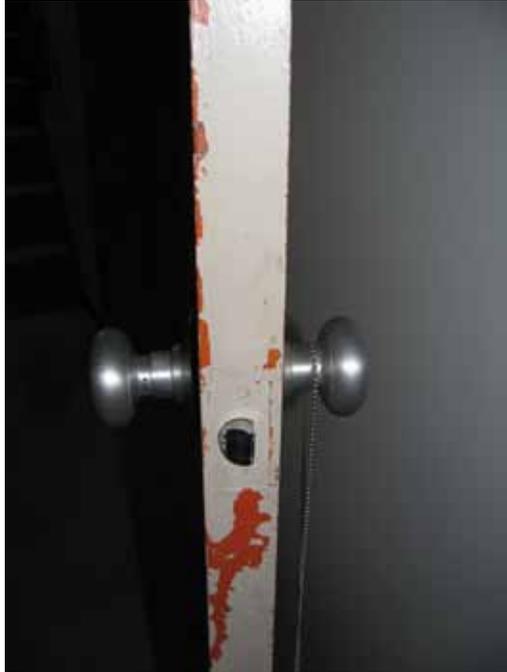
Basement bedroom door, showing added paint layer over original orange layer. Source: Artifacts Consulting, Inc. 2010

- Added paint layers over the original color palette. Examination of original paint layers in order to determine their character and condition would be beneficial as it might be possible to remove paint coatings and restore original finishes.
- Water infiltration at failing connections, including in bedroom #2's northeast wall and the bathroom skylights.
- Holes in the walls and doors, along with broken closet doors, should be repaired as funding allows.
- Interior features remain overall in good condition. The extent of previous alterations on the basement level has removed the majority of the interior original materials, with the exception of the fireplace in the family room. The stairwell railing and banister have been replaced and interior guardrails added to the window walls on both floors.

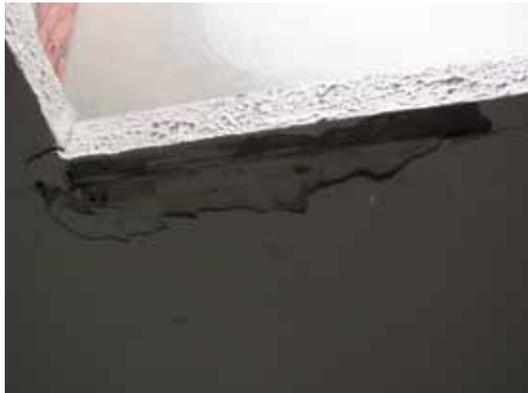
Detail of water damage at ceiling-light well junction in bathroom #2. Source: Artifacts Consulting, Inc. 2010

reduces water and air infiltration to interior spaces, improving energy performance.

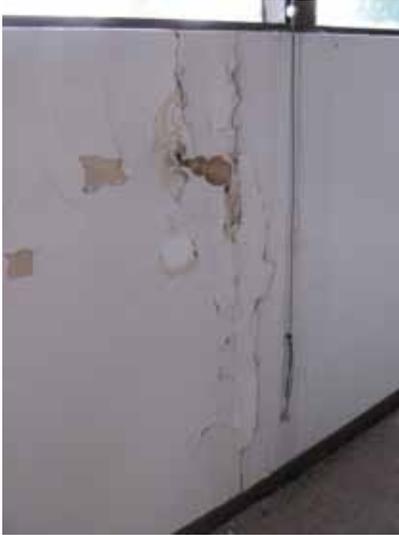
Detail of water damaged wall below northeast window, bedroom #2. Source: Artifacts Consulting, Inc. 2010

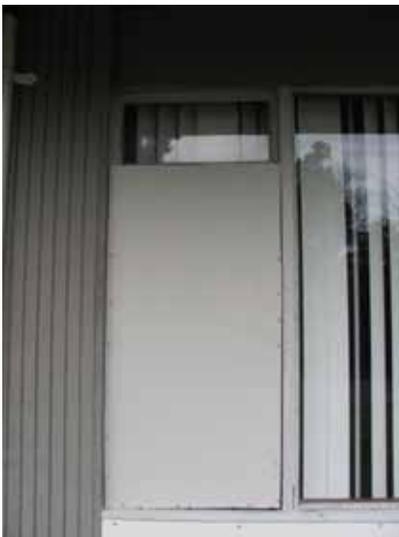
Broken casement type window in bedroom #3. Source: Artifacts Consulting, Inc. 2010

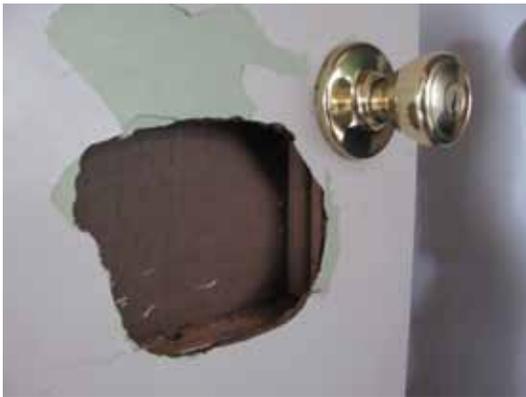
Detail of hole in door, bedroom #3. Source: Artifacts Consulting, Inc. 2010

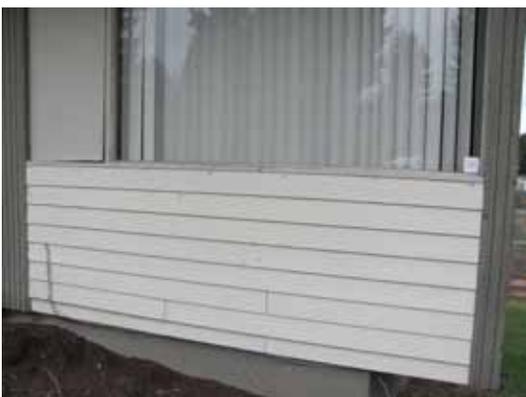
New horizontal veneer cladding beneath window of bedroom #3. Source: Artifacts Consulting, Inc. 2010

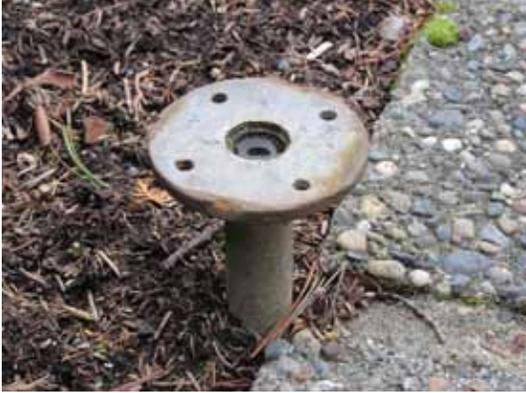
Detail of post support, indicating where a breeze-way wooden screen once stood. Source: Artifacts Consulting, Inc. 2010
