DOWNTOWN EVERETT HISTORIC BUILDINGS
ASSESSMENT & TOOLKIT

Prepared for:
The City of Everett

BOLA Architecture + Planning

July 21, 2017

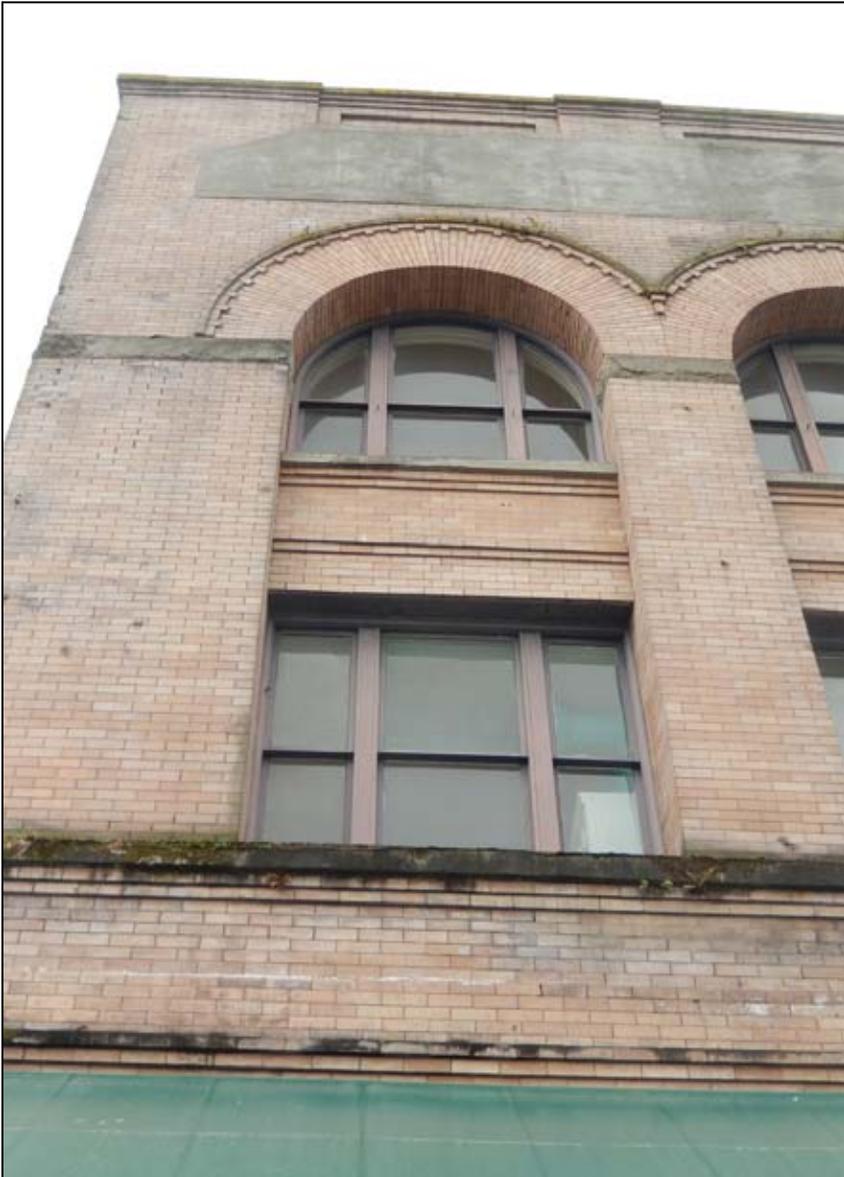
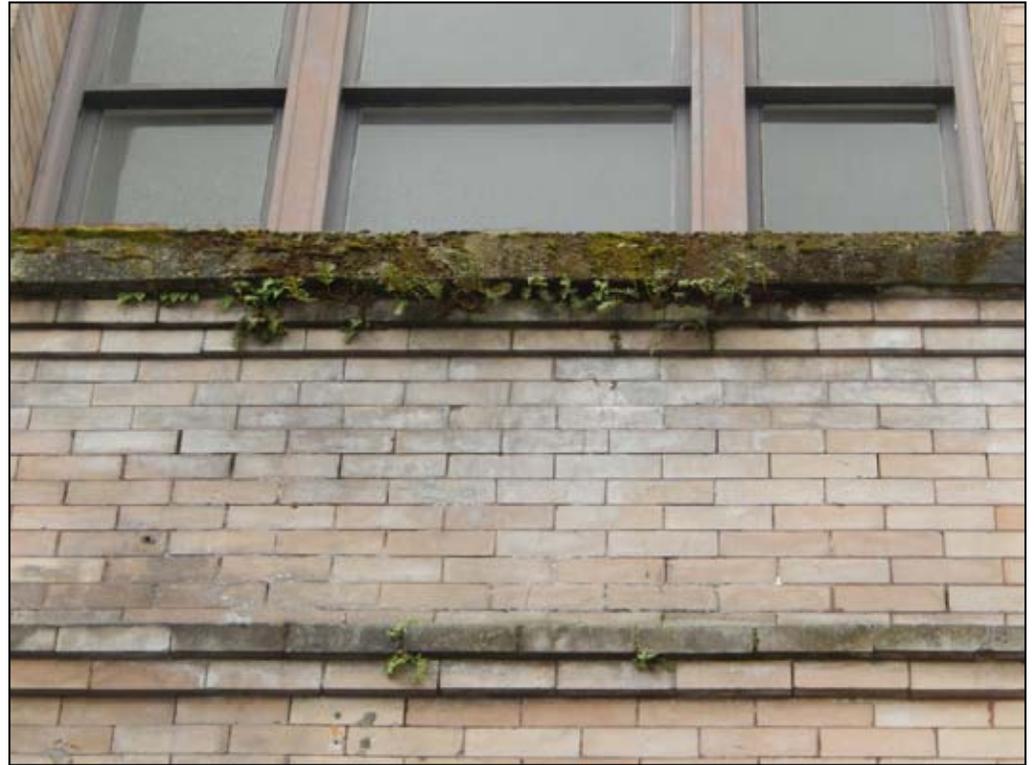
Stone trim and details introduce another color and texture to a building façade. Stone is often used as a window sill or lintel, string course, or cornice. The examples pictured here are showing problems resulting from water damage.

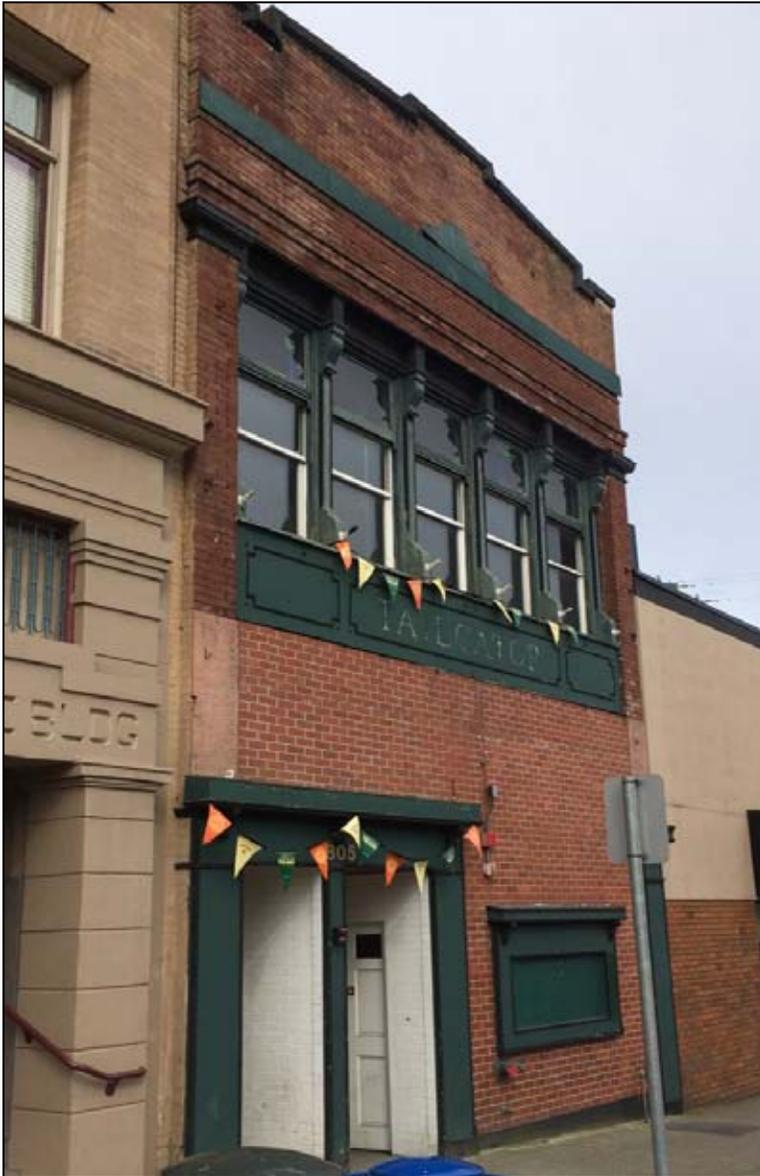
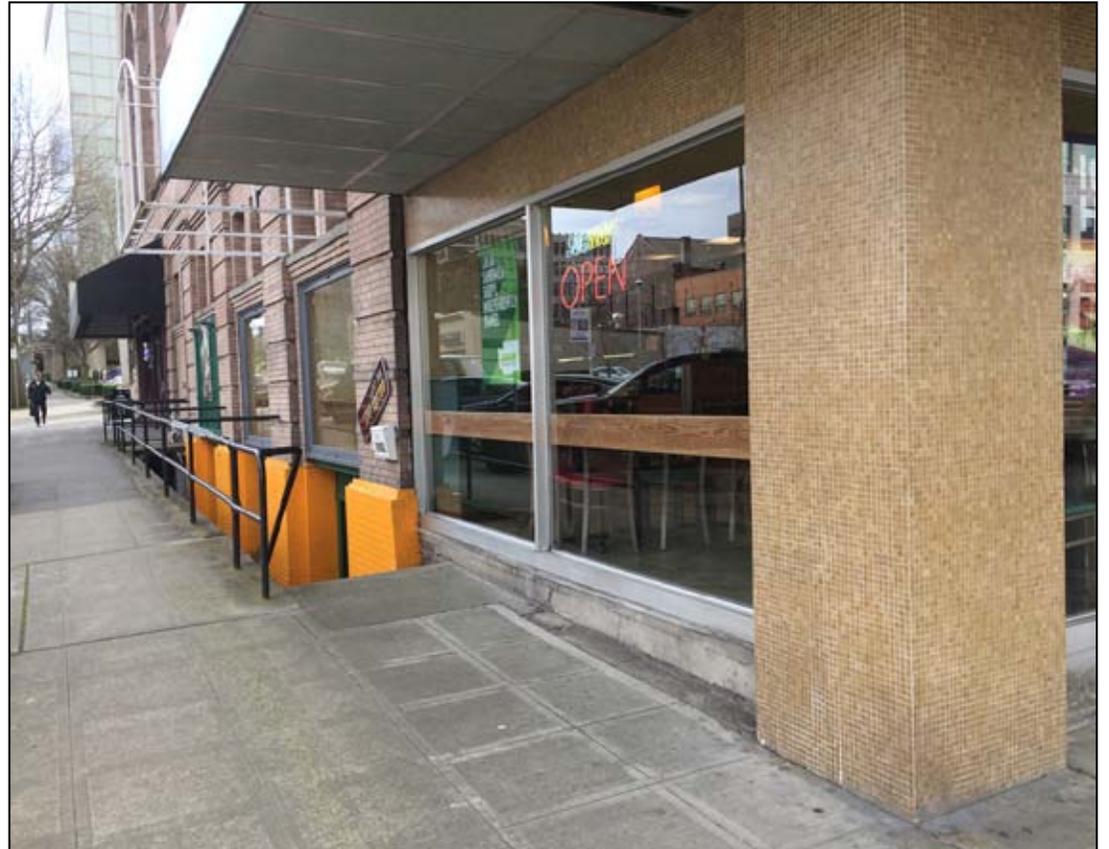
In each of these three examples, the original storefront assembly was replaced with a contemporary version that is not harmonious with the building's historic character. The proportions and materials are out of place. The alterations to the Horseshoe Saloon also resulted in a loss of visual transparency.

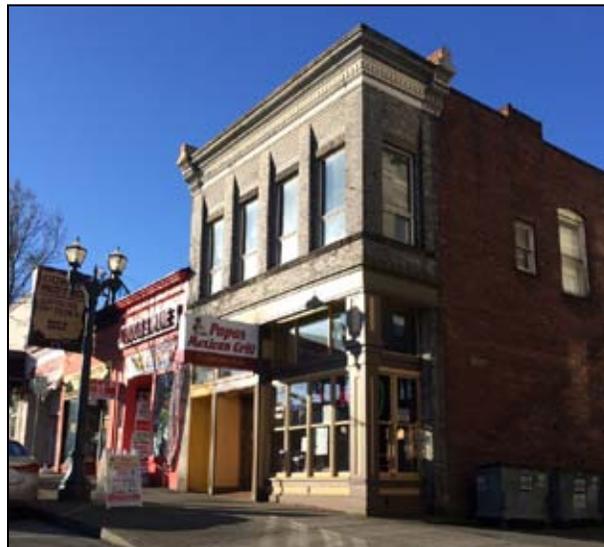
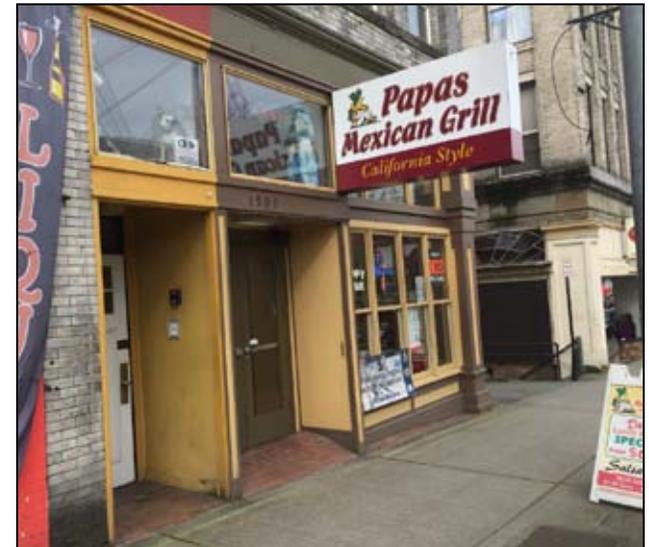
- Face brick is generally in good condition, although at the sign band level there are holes in the brick, likely from signage installed and removed over time. There are some areas of missing mortar/open joints in the brickwork. Brick, along with stone details, should be inspected by a qualified mason, cleaned, repaired and repointed where needed.
- Consider replacing non-original second-floor windows with single-hung wood windows that better match the originals, visible in the historic photo.
- The sheet metal cornice should be inspected to verify condition and confirm that it is properly attached to the building. Based on a cursory view from the sidewalk, it appears there are areas of missing paint. At a minimum, the cornice should be cleaned, properly prepared, and repainted.

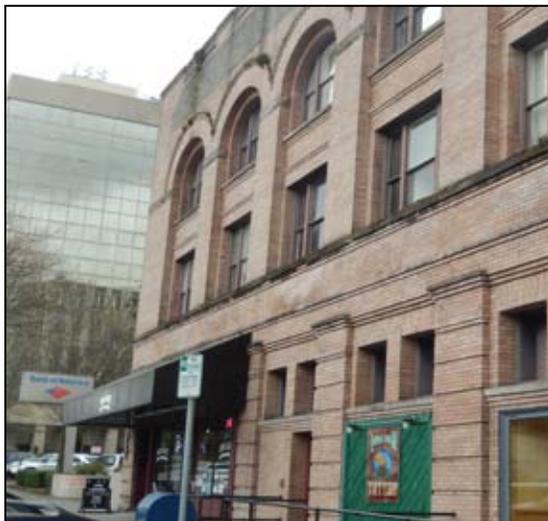
- There is evidence of extensive water infiltration, indicated by staining and plant growth.
- Sandstone trim is in poor condition, with spalling, cracks, and biological growth.
- Face brick is generally in good condition, although at the sign band level there are numerous holes in the brick from signage installed and removed over time. There are some areas of missing mortar/open joints in the brickwork. Brick should be inspected by a qualified mason, cleaned, repaired and repointed where needed.
- Second- and third-story original wood windows appear from the sidewalk to be in fairly good condition, although the sills were not visible and may be deteriorated.
- Consider reconstructing the original projecting cornice, which has been removed. Brace the tall parapet.
- Storefronts have been remodeled, most extensively on the north and northeast corner.

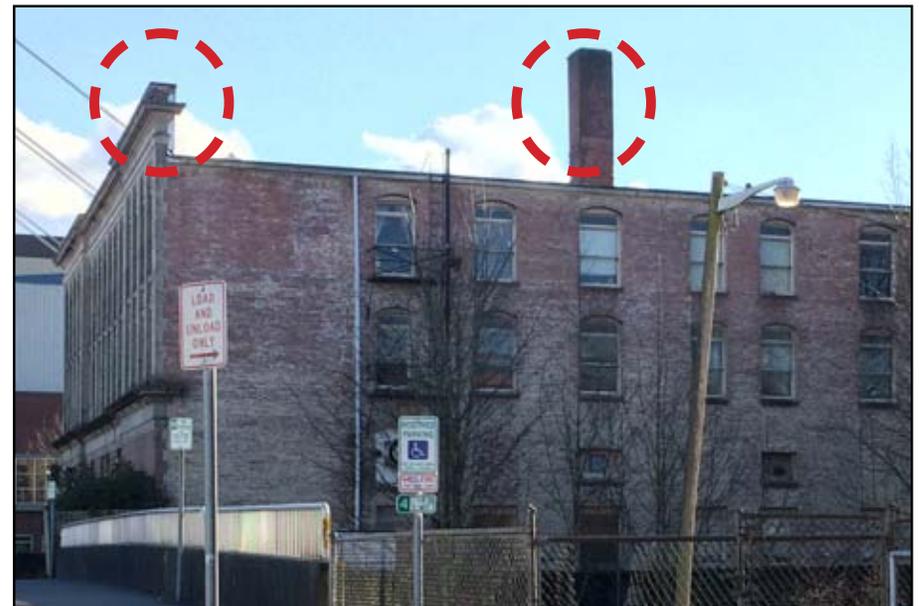
This building has very good integrity but suffers from some significant deterioration. Water infiltration is evident, indicated by staining and areas of moisture, particularly on the sandstone, and extensive biological growth.

- Sandstone trim is in very poor condition in some areas, and the projecting cornice and intermediate cornice (below the second floor line) may be a safety hazard. It should be immediately inspected by a stonemason for further steps.
- The face brick and terra cotta trim appear to be in relatively good condition but should be inspected by a qualified mason. Brick should be cleaned and repointed where needed.
- The tall brick chimney should be repointed as needed and braced.
- The building has a tall parapet, which should be braced.
- The metal awning/marquee over the central south entrance should be inspected, cleaned, and repaired as necessary.
- Scrape, prime, and repaint wood storefronts, bulkheads, and doors.

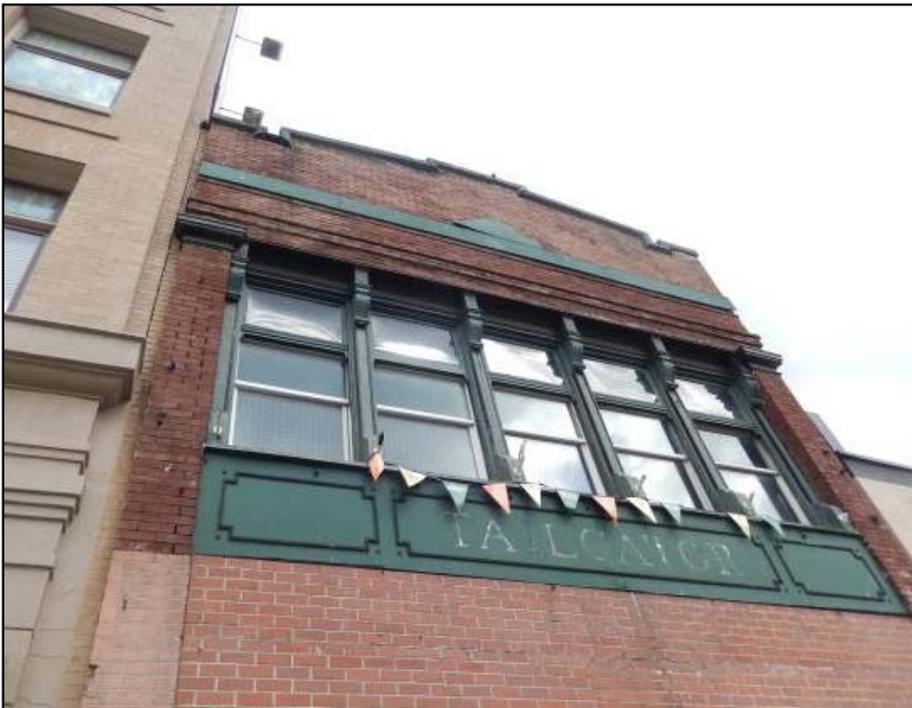
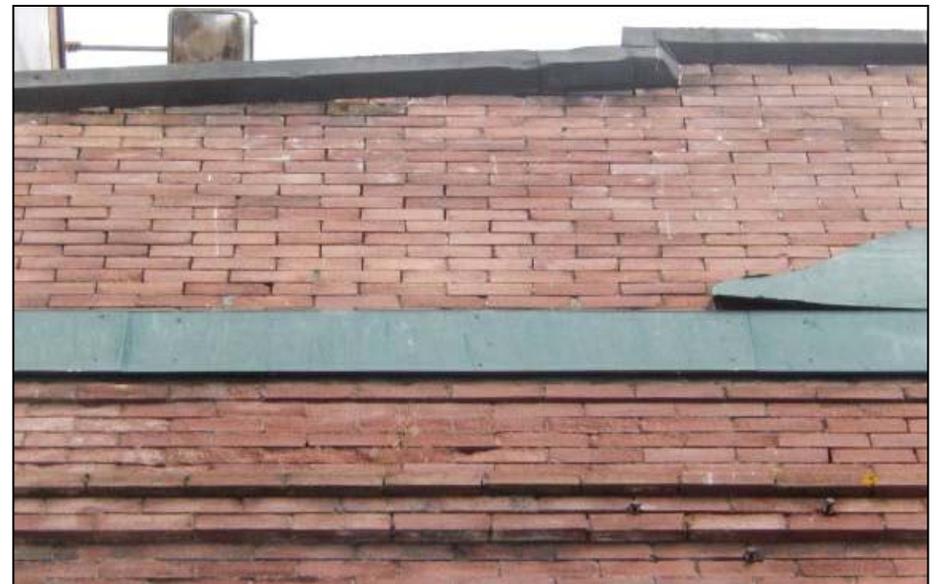
- Some of the original brick appears to be deteriorating. The brick should be inspected by a qualified mason, cleaned, repaired and repointed where needed.
- Scrape, prime, and repaint wood trim.
- Consider replacing non-original second-floor windows with single-hung wood windows that better match the originals, visible in historic photos.
- Consider reversing the extensive alterations at the first story and restoring a historically appropriate storefront.
- Consider reconstructing the projecting cornice to provide physical water repellency for surfaces below.

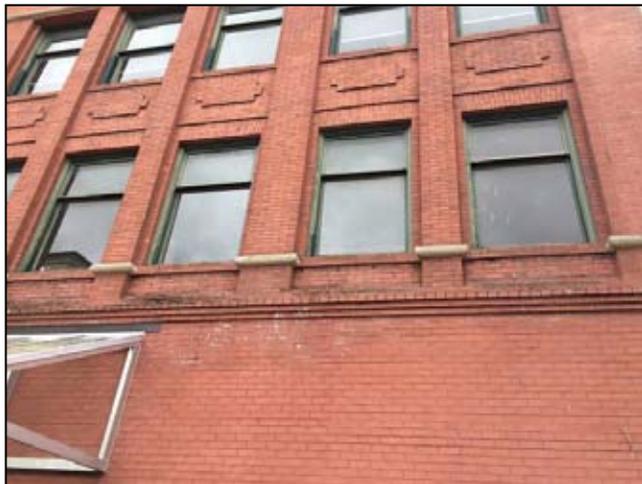
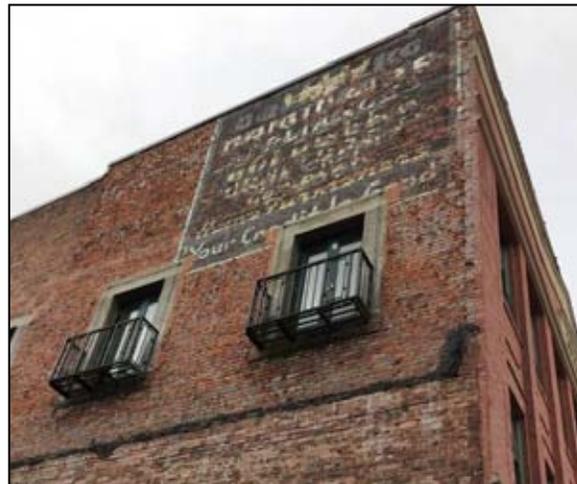
- Reconstruct the projecting cornice.
- Remove the non-original glass awning, which is incompatible with the historic character of the building. Consider an awning more sensitive to the building. Consider restoring the storefront to the original, taller height.
- The original wood windows appear to be deteriorating. Undertake a window survey to determine their condition and necessary repairs; repair the windows.
- The brick should be inspected by a qualified mason, cleaned, repaired and repointed where needed.

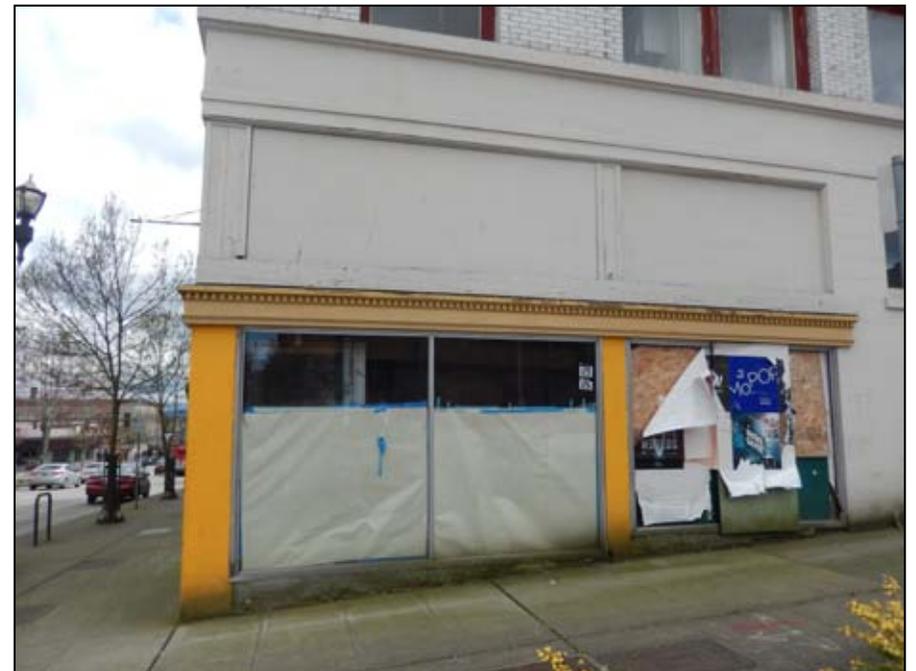
- The face brick is stained in many areas. The brick should be inspected by a qualified mason, cleaned, repaired and repointed where needed.
- Scrape, prime, and repaint wood trim.
- The sheet metal cornice should be inspected to verify condition and confirm that it is properly attached to the building. Based on a cursory view from the sidewalk, it appears there are extensive areas of missing paint and some rust. At a minimum, the cornice should be cleaned, properly prepared, and repainted.
- Consider reversing the alterations at the first story and restoring a historically appropriate storefront, including transom windows.

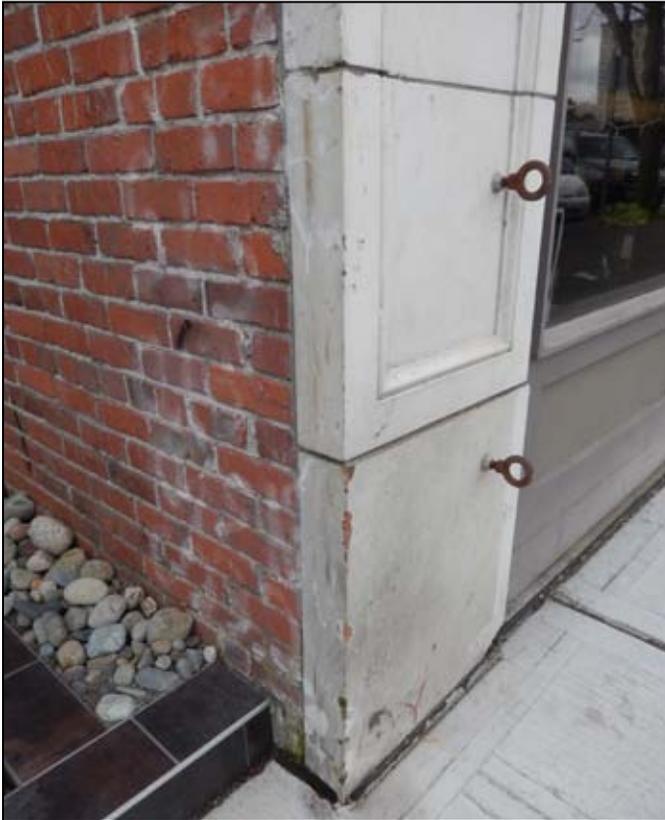
- The common red brick that is exposed on the north side of the building was likely intended to be covered by an adjacent building and not meant to be exposed as exterior brick. It has some efflorescence, as well as missing mortar and evidence of former ivy growth. The face brick on the primary west façade appears to be in good condition. The terra cotta has some spalling, some open joints, and areas that have been previously painted. The brick and terra cotta should be inspected by a qualified mason, cleaned, repaired and repointed where needed.
- Consider replacing non-original second-floor windows with wood windows that better match the original casement windows, visible in historic photos.

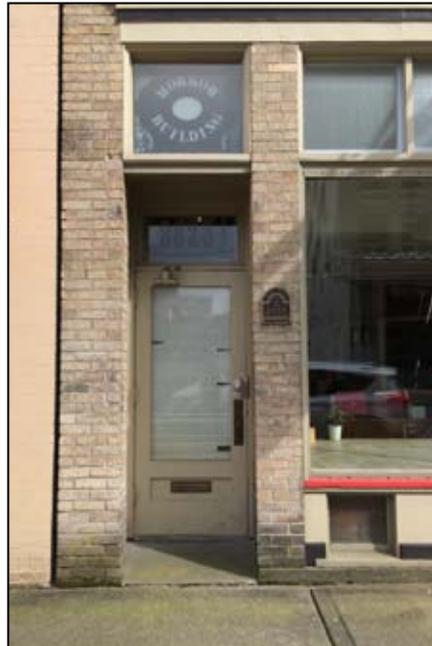
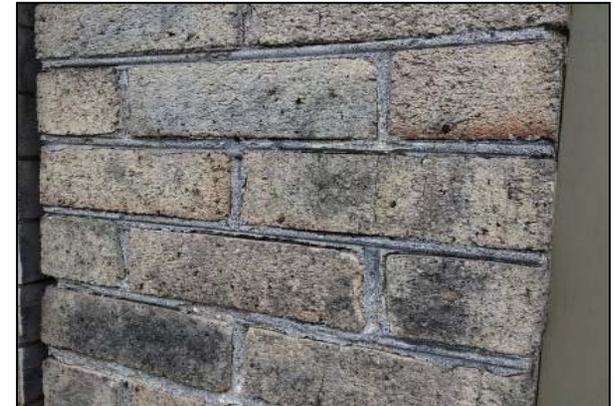
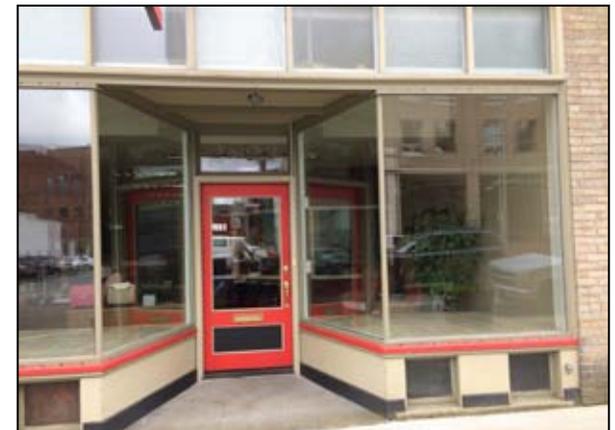
- The brick appears to have been repointed in some areas, and original mortar is showing areas of failure. The brick should be inspected by a qualified mason, cleaned, repaired and repointed where needed.
- There is some missing trim along the bottom of the display window at the storefront, resulting in exposed wood. Add trim.

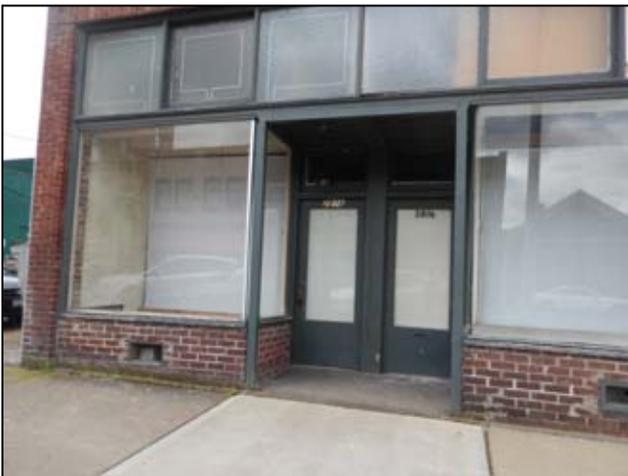
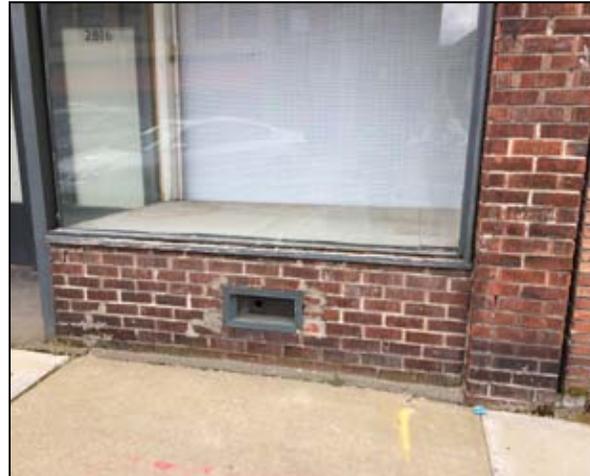
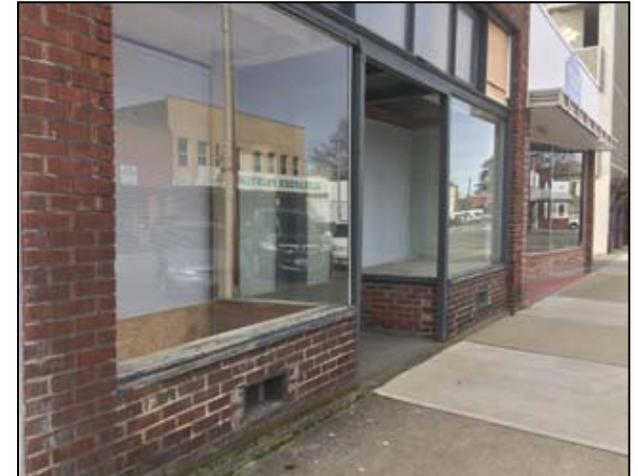
- A large crack is apparent at the upper left (south) end of the primary façade and may indicate that the south exterior wall is separating from the structure. This should be evaluated by a structural engineer.
- The brick should be inspected by a qualified mason, cleaned, repaired and repointed where needed.
- Scrape, prime, and repaint wood trim.
- Replace the missing transom light in kind.

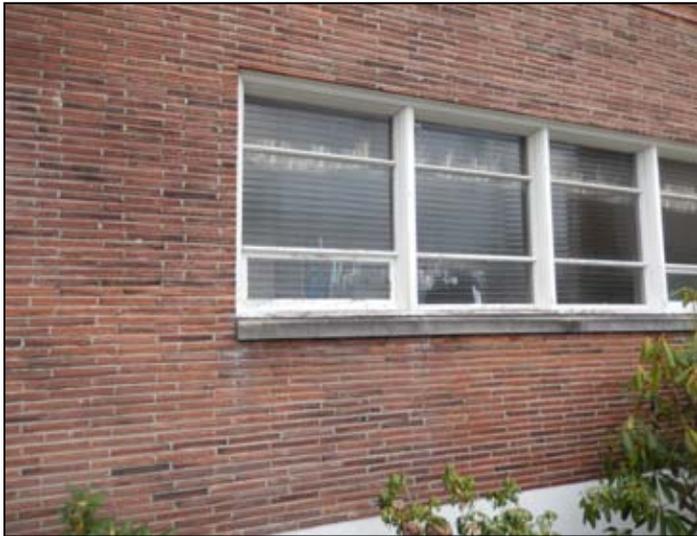
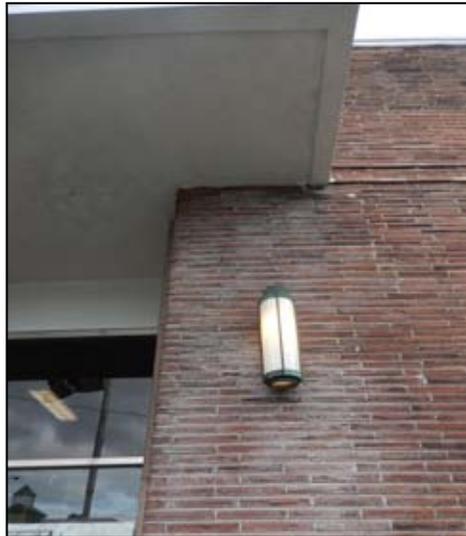
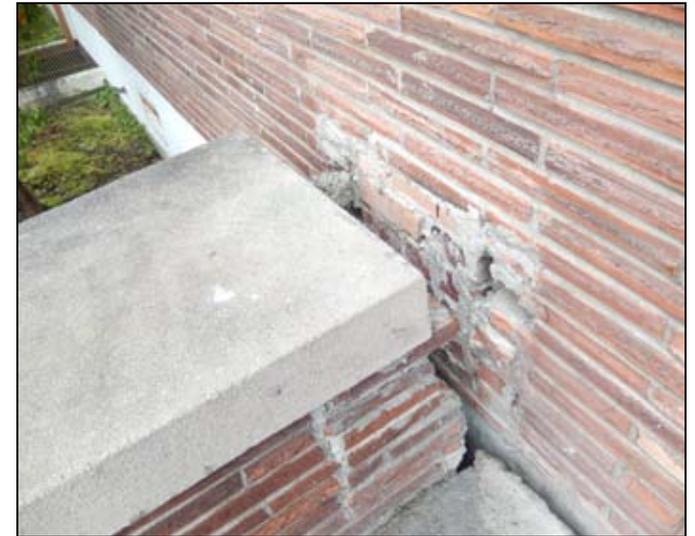
- The brick is in generally good condition but some effluorescence is evident. The brick should be inspected by a qualified mason, cleaned, repaired and repointed where needed.
- The concrete front entry ramp appears to be settling, and the two brick cheek blocks flanking the entrance are separating/pulling away from the wall.
- There is some evidence of water damage on the underside of the concrete canopy. It should be inspected and appropriate drainage verified.
- The wood windows appear to be in good condition, but they should be inspected and the wood scraped, primed and repainted.
- The wrought iron balustrade has some areas of flaking paint and rust. It should be cleaned of any rust and loose paint with a wire brush, prepared and repainted.
