WOODSTOCK FARM NATIONAL HISTORIC DISTRICT
City of Bellingham, Washington

CYRUS AND MABEL GATES HOUSE
HISTORIC STRUCTURE REPORT

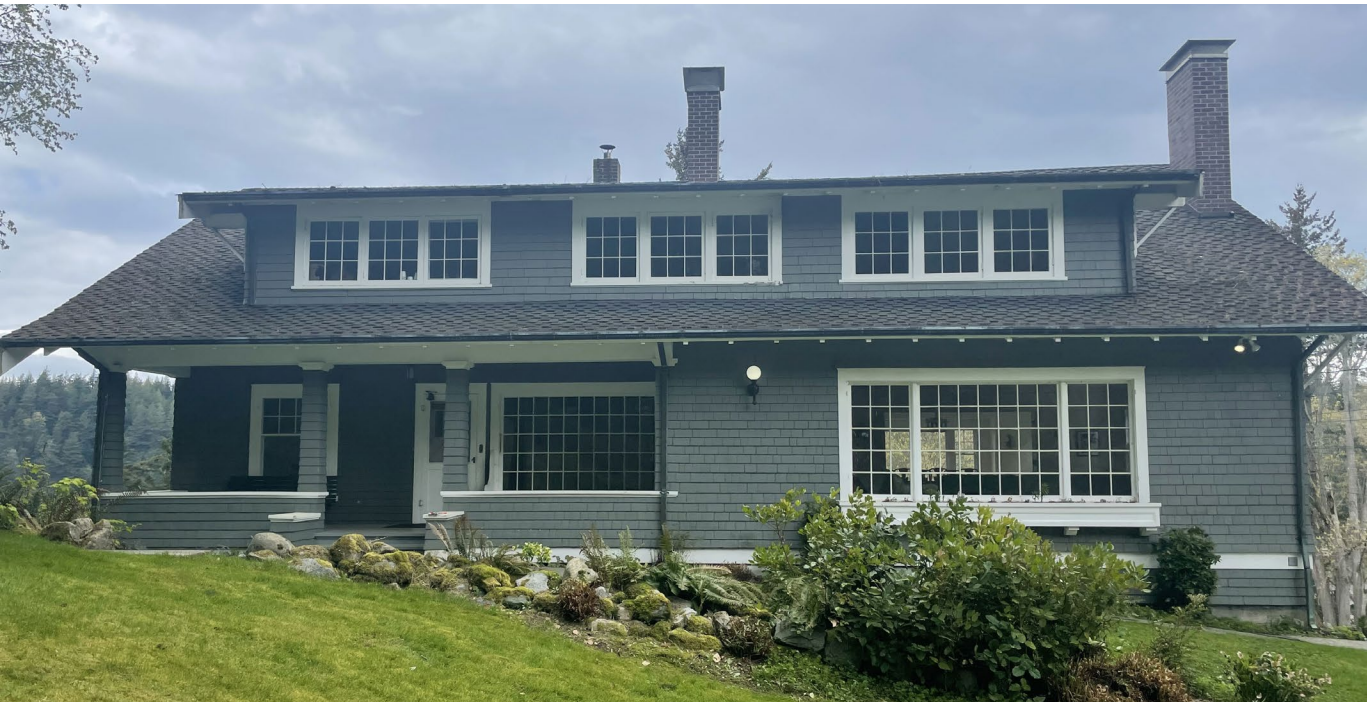
INTRODUCTION AND EXECUTIVE SUMMARY

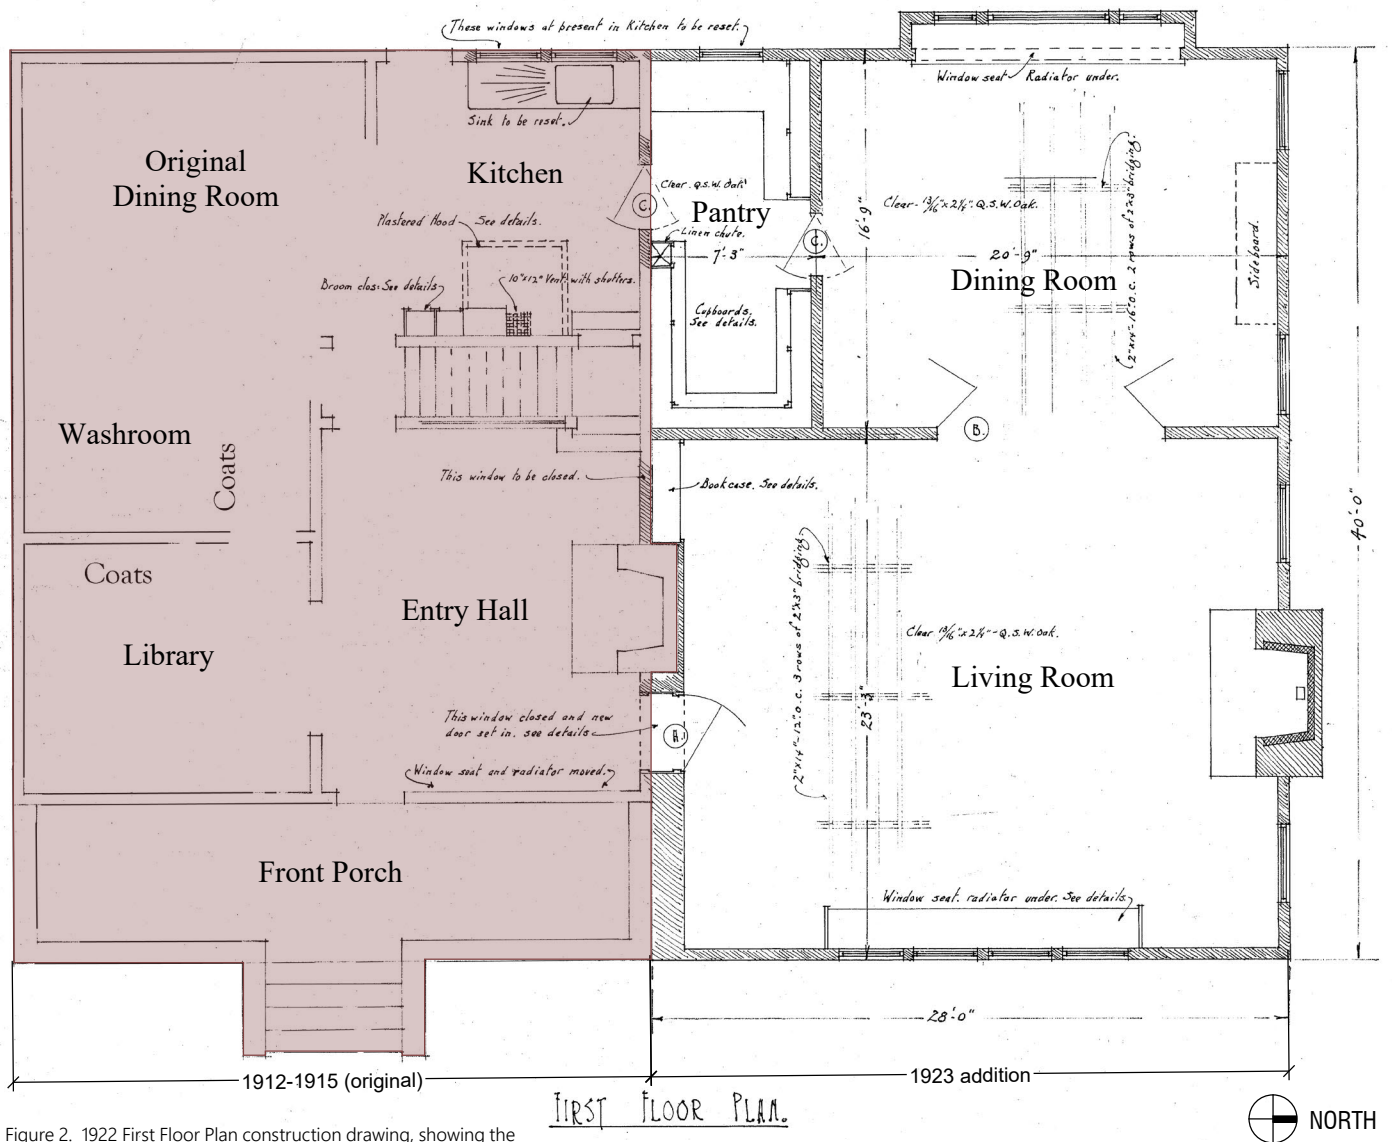
Figure 2. 1922 First Floor Plan construction drawing, showing the original house (shaded, left) and the north addition, right. Room name annotations have been added to clarify old and new space uses. (Courtesy Tim Wahl collection, citations available, with shading and room name clarifications by SHKS Architects.)

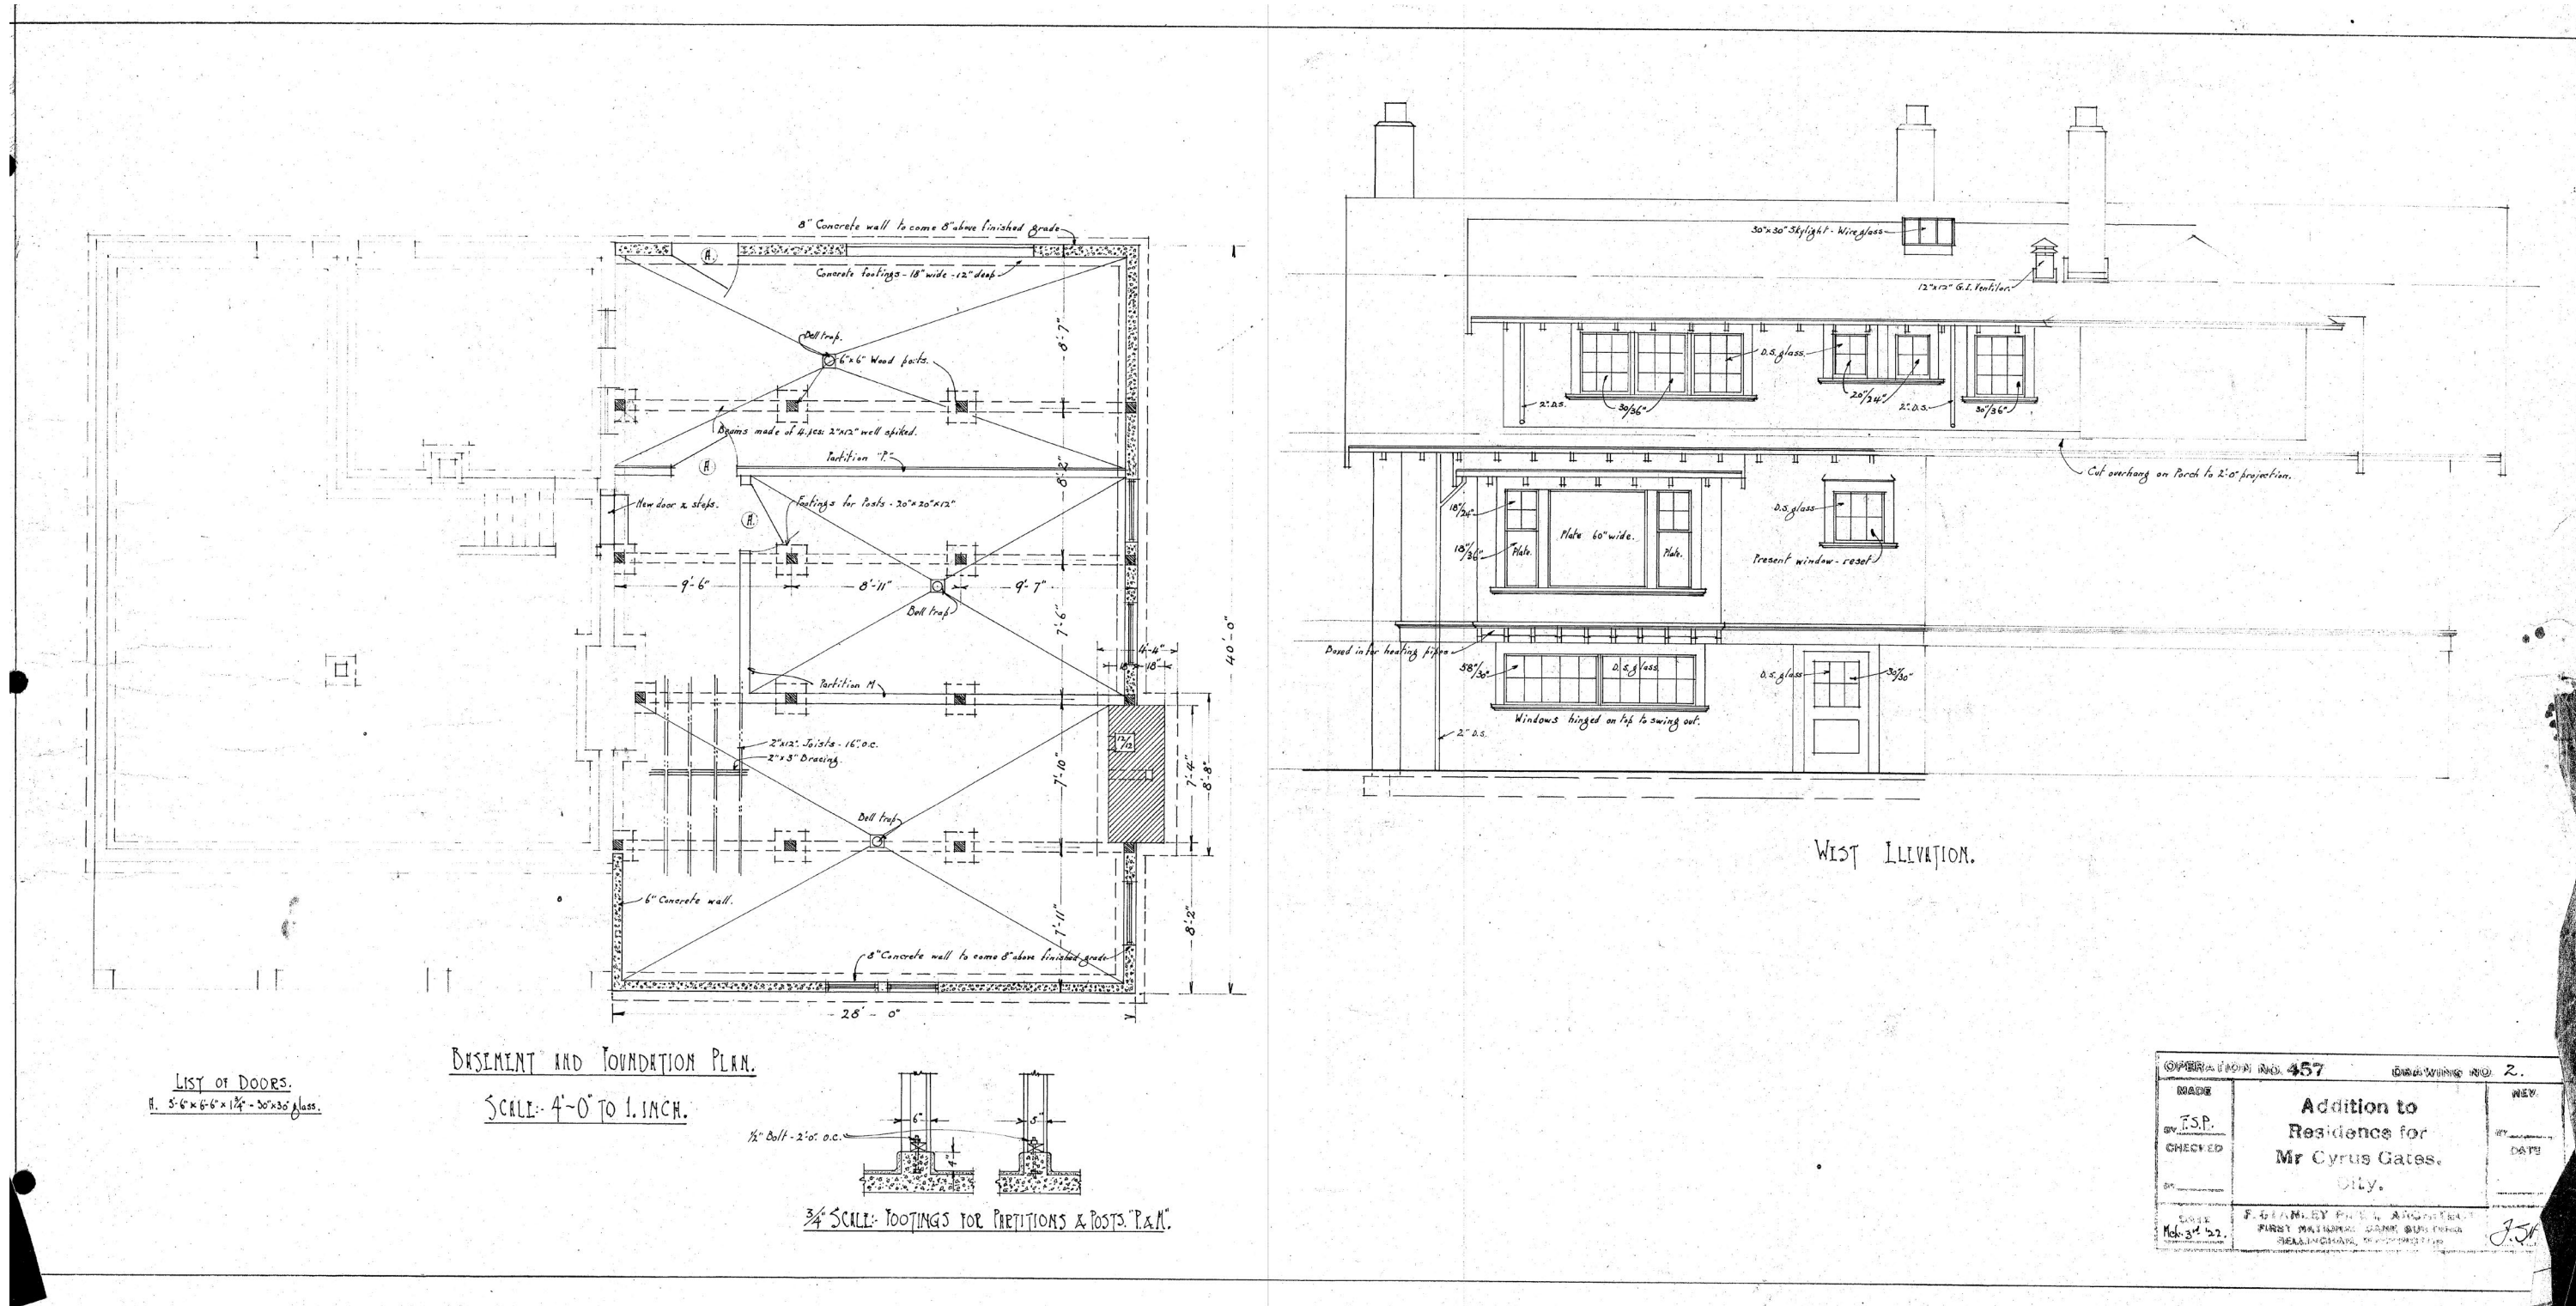
SUPERIOR PLAN NO. 457		DRAWING NO. 2.
MADE BY J.S.P.	Addition to Residence for Mr. Cyrus Gates, City.	REV.
CHECKED BY		DATE
SCALE 1/8" = 1'-0"	F. G. M. BY P. H. & A. G. S. P. L. T. FIRST PUBLISHED 1912. REPRINTED 1922.	J.S.P.

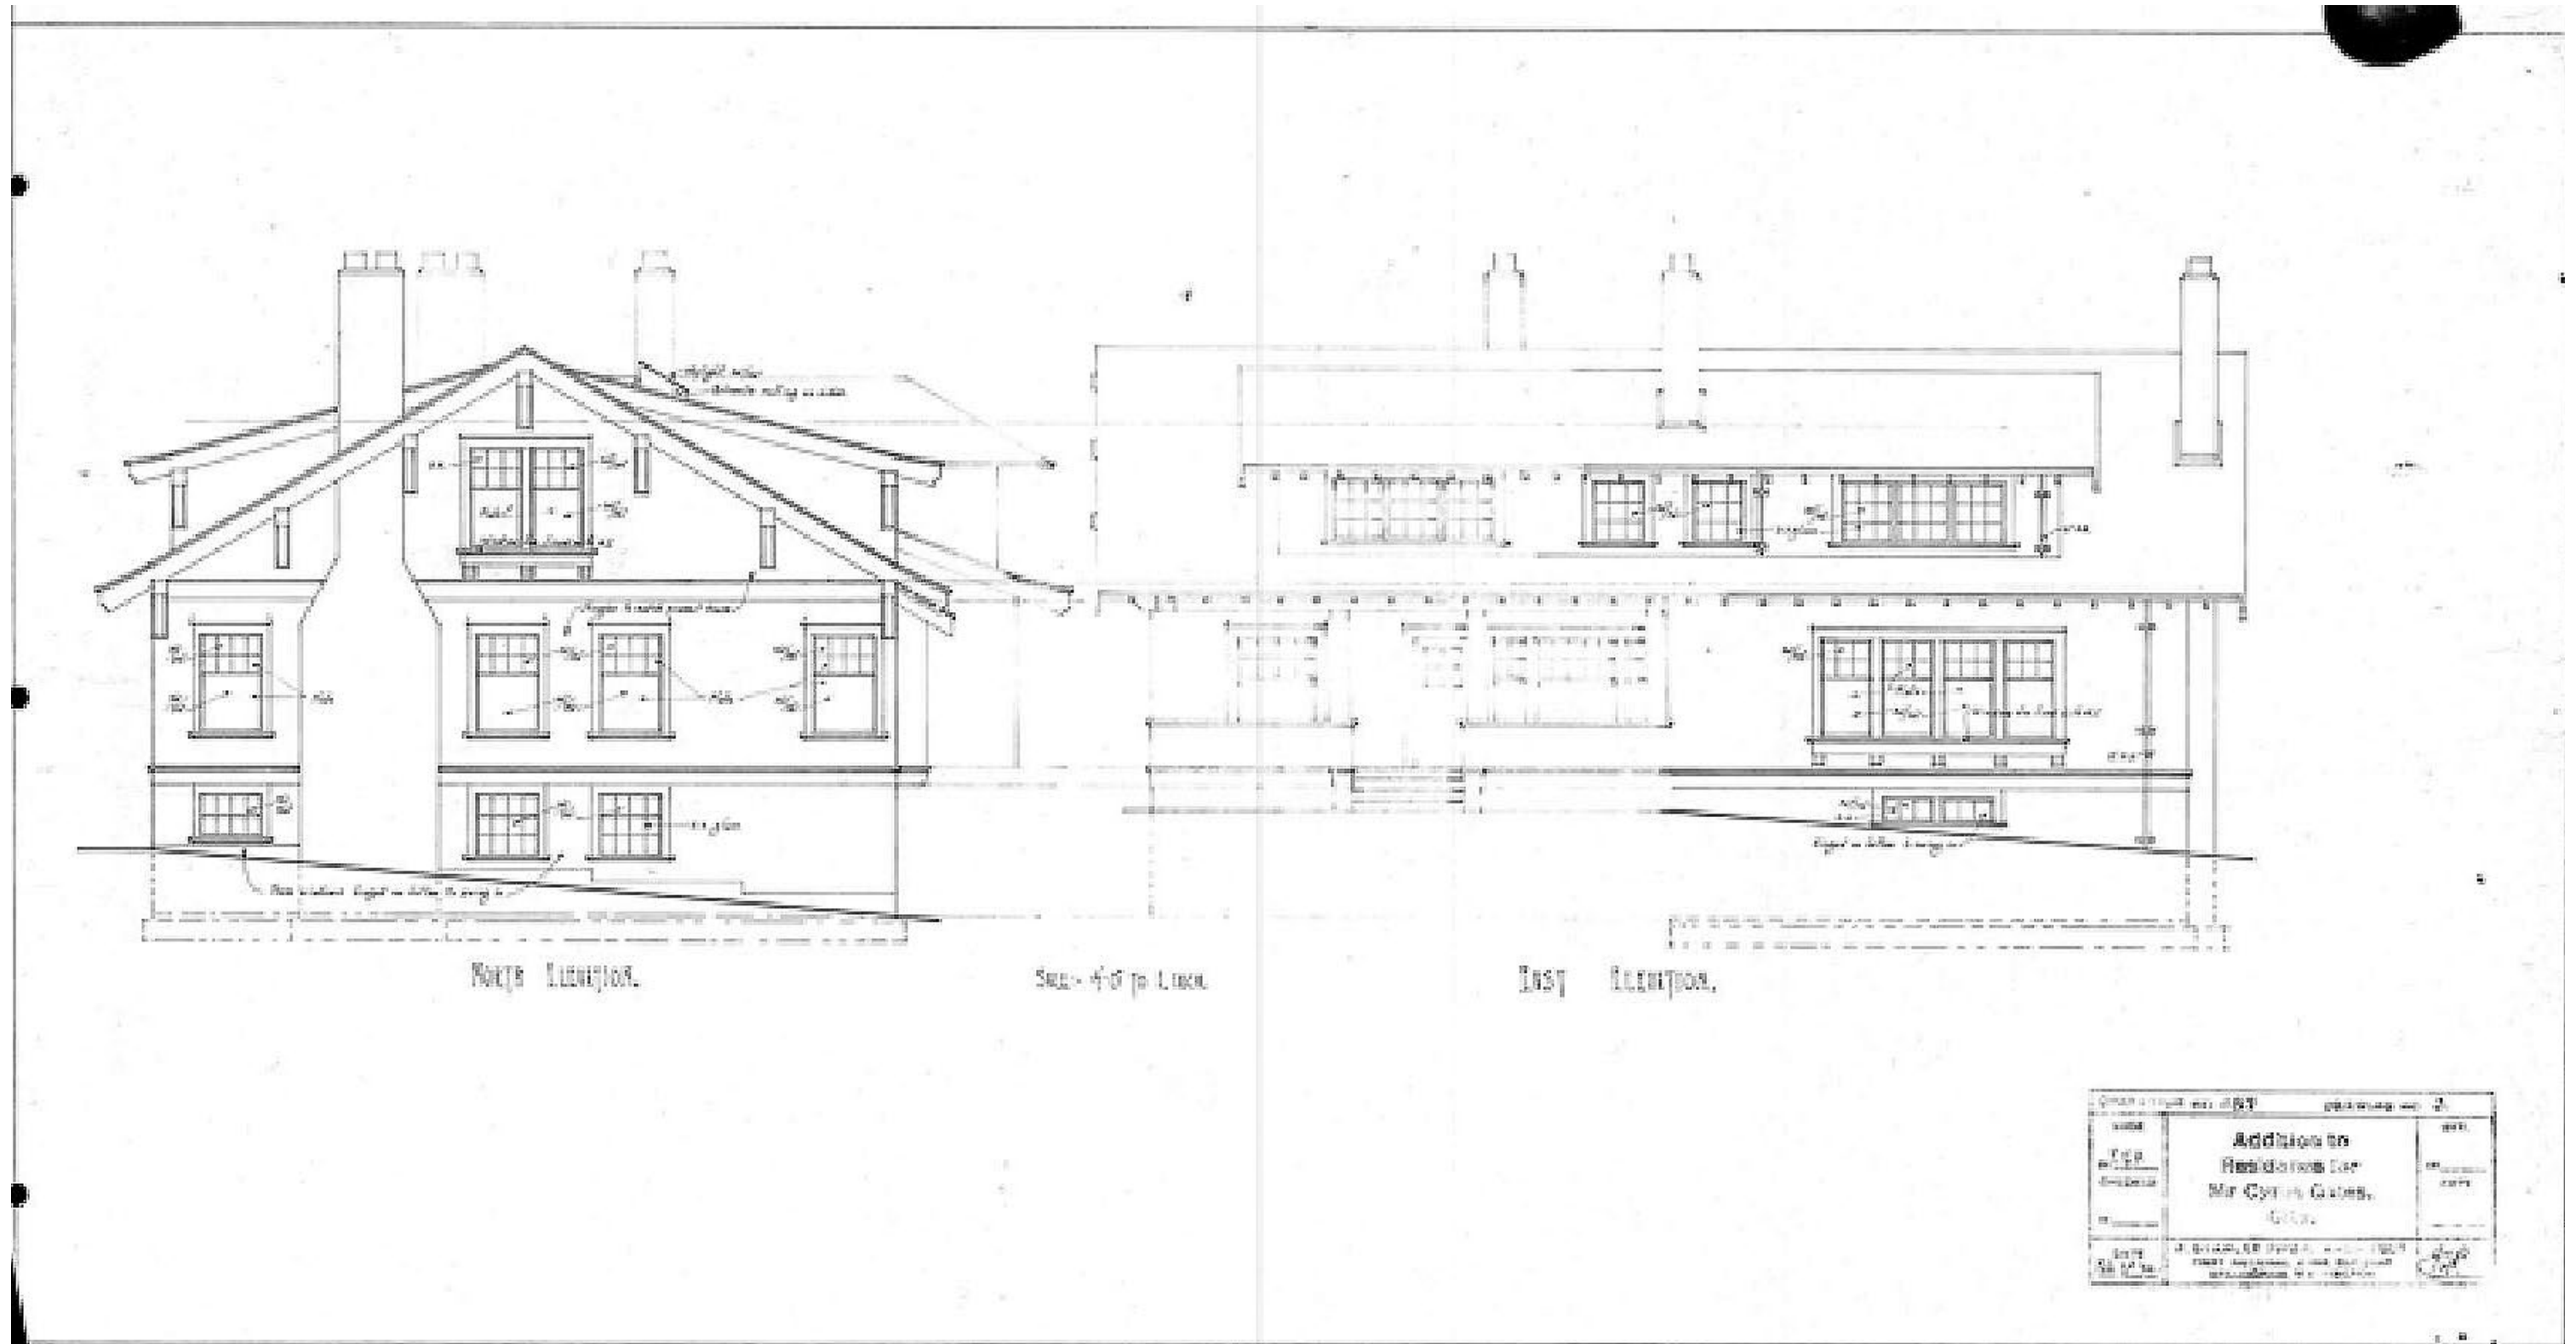
Figure 5. Drawing No. 3: North [Exterior] Elevation (left) and East [Exterior] Elevation (right), dated 3/3/1922. (Courtesy Tim Wahl collection, citations available.)

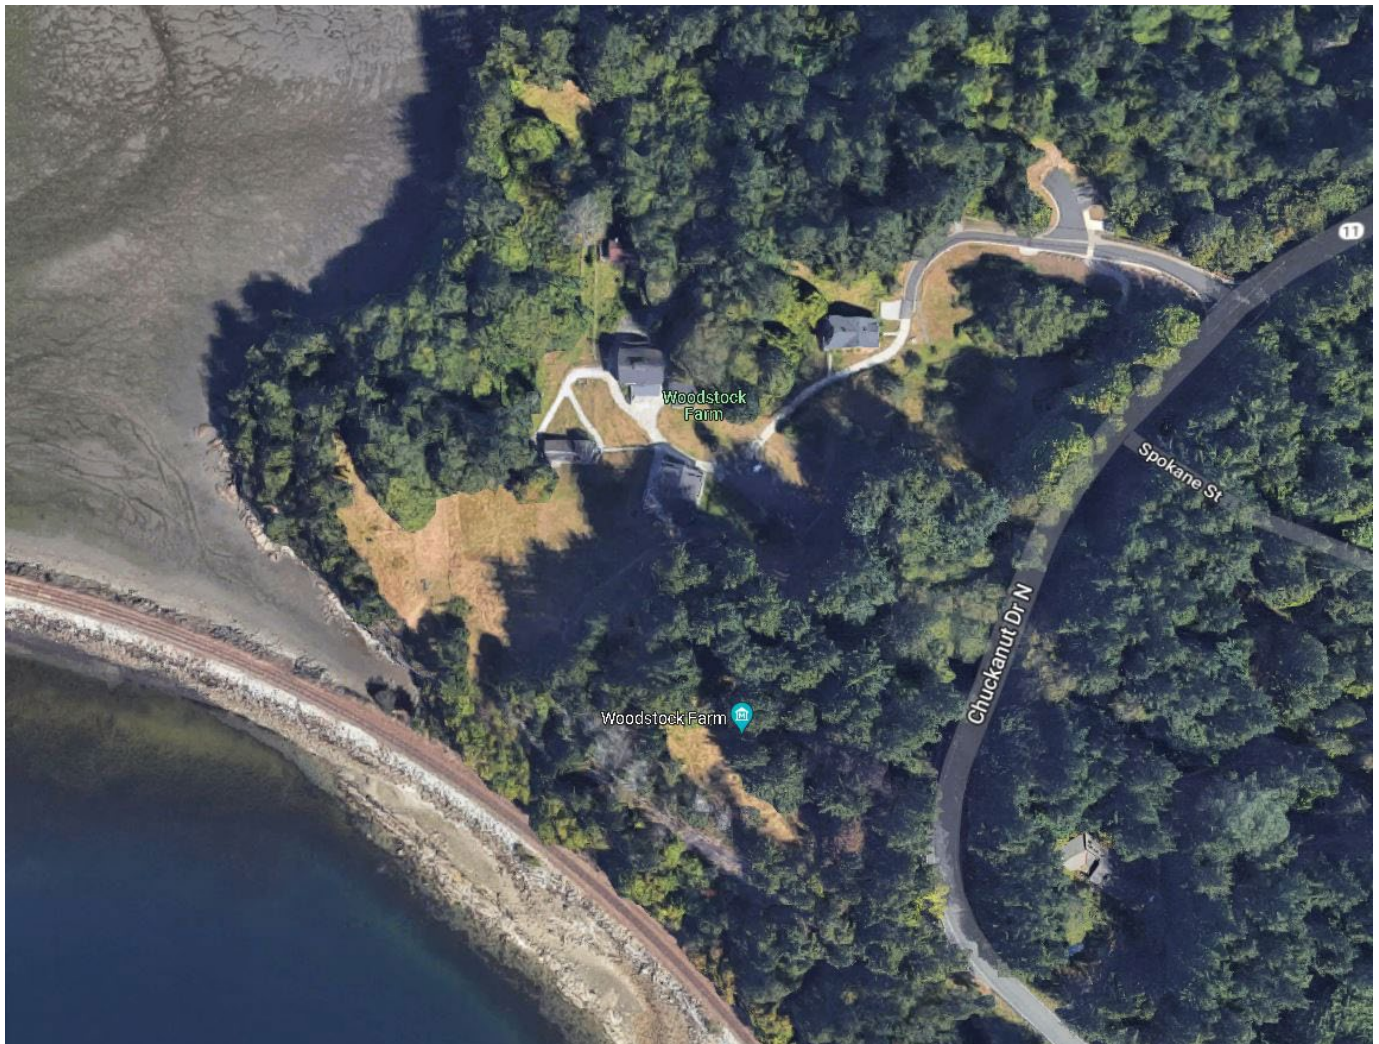
Figure 9. 2022 aerial photograph. (Courtesy Google Maps)

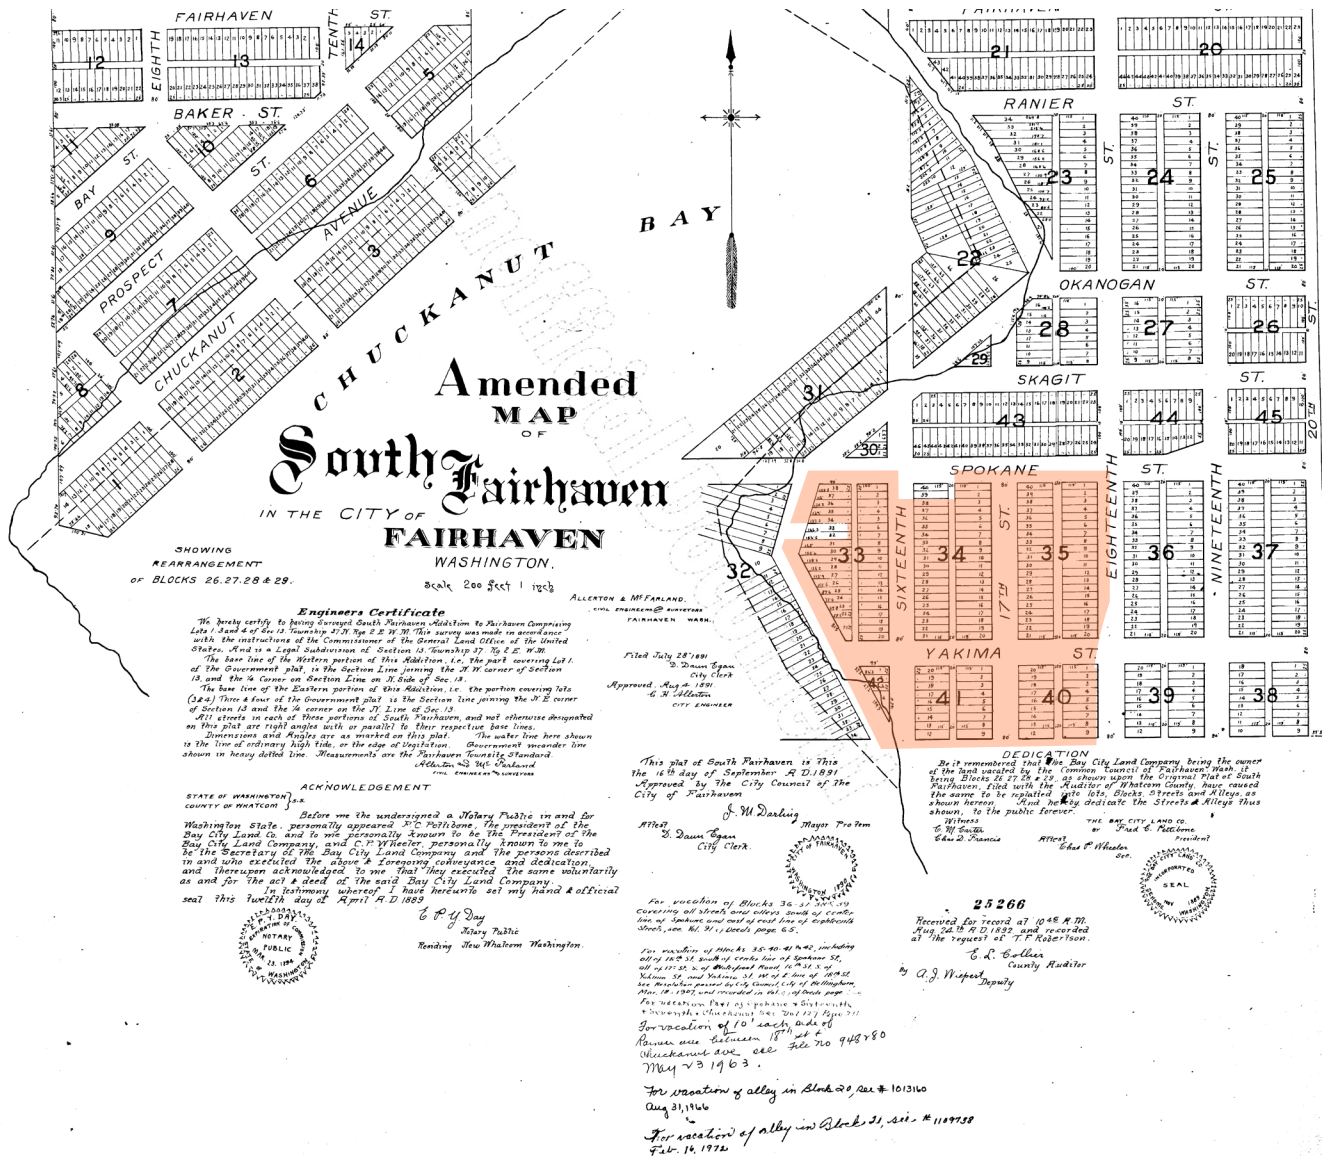
Figure 31. 1892 Bay City Land Company's Plat Map of South Fairhaven, with the Woodstock Farm property shaded. (Courtesy Whatcom County Tax Assessors Parcel Viewer)

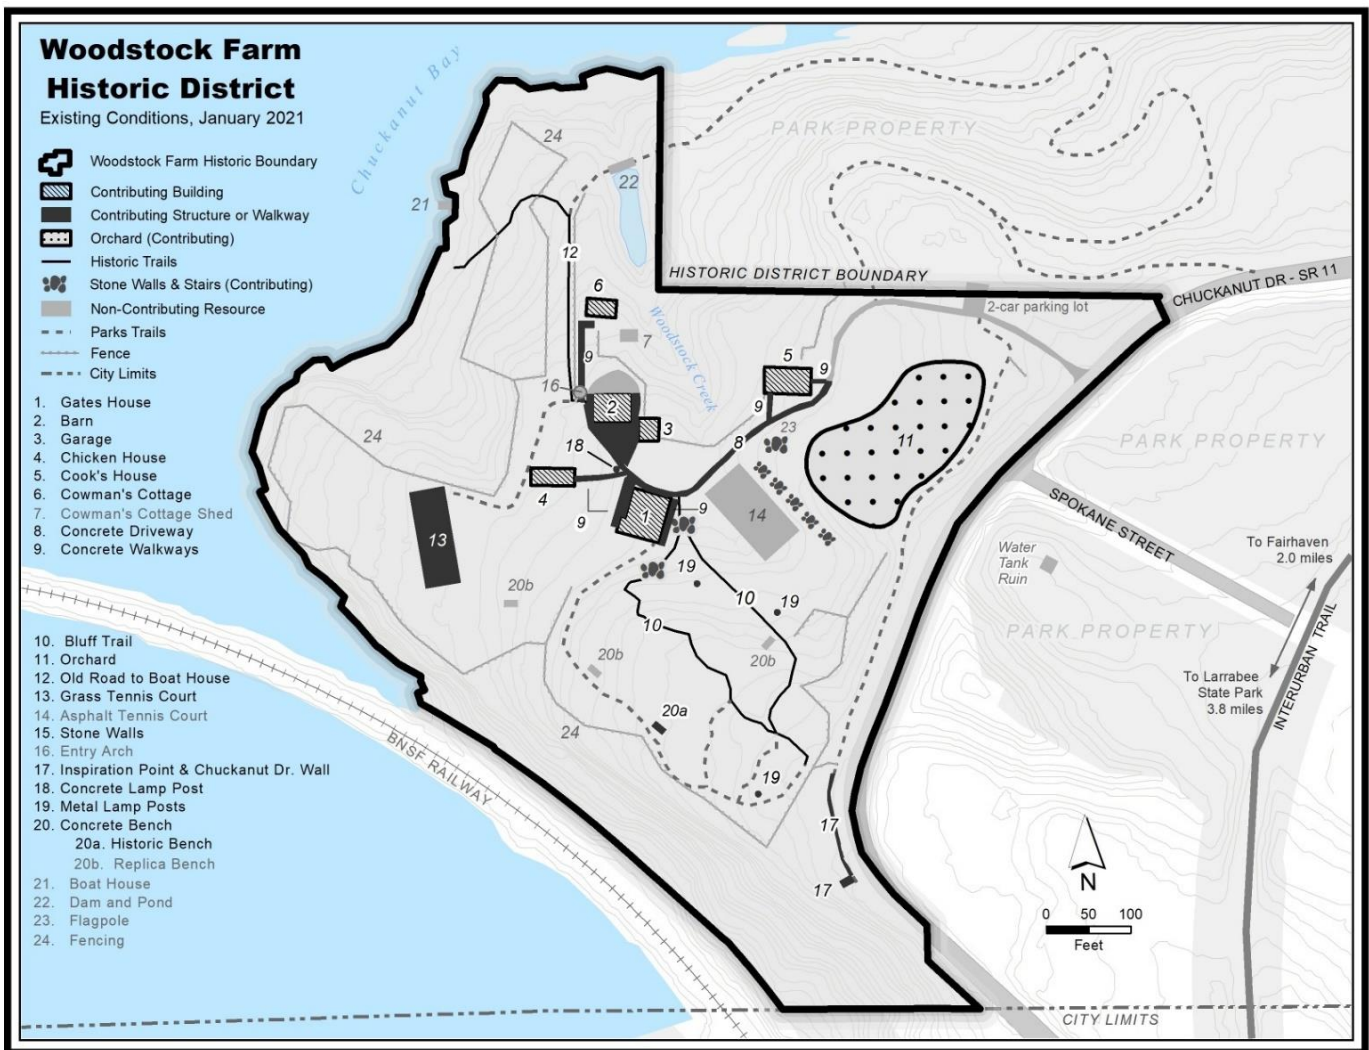
Figure 34. Woodstock Farm Historic District Boundary Map, 2021. (Excerpt from National Register Nomination)

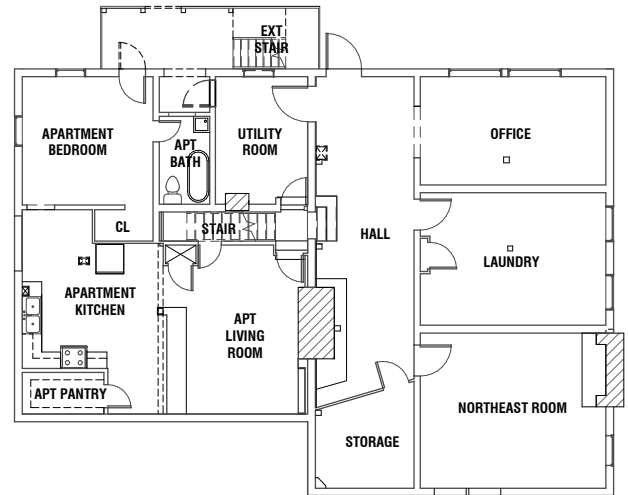
Figure 53. Basement Key Plan.

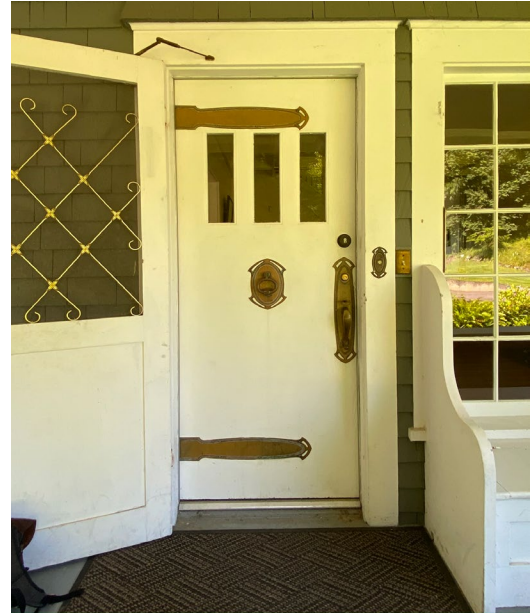
Figure 57. Detail of east entry door, with decorative hardware and grillework screen door. (Courtesy City of Bellingham, Michelle _____)

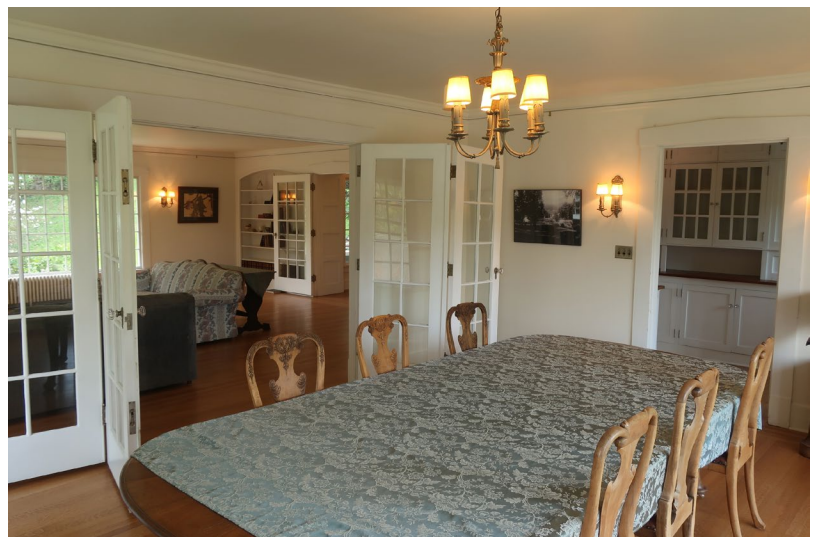
Figure 65. Spacious Dining Room open to Living Room beyond.

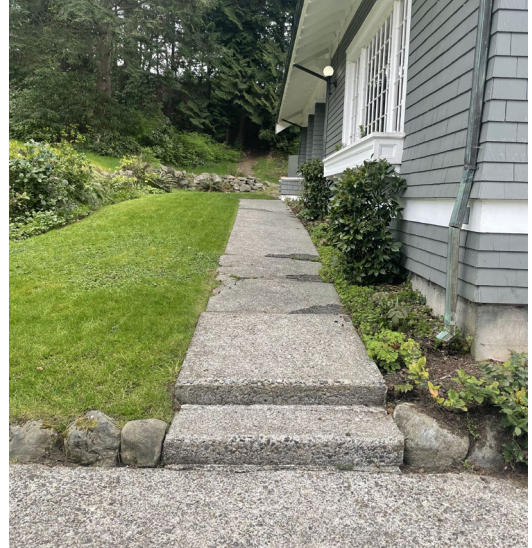
Figure 66. Concrete steps and walkway along the east side, looking south from the driveway. Repairs can be seen particularly along the west (right) edge.

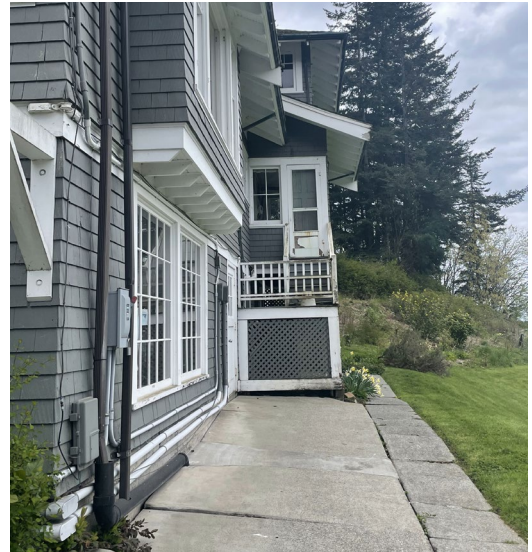
Figure 67. Concrete walkway along the west side, looking south. Exposed electrical conduit, disconnects, and other appurtenances are surface-mounted along the west wall, and extend up the northwest corner, creating visual clutter on a prominent corner.

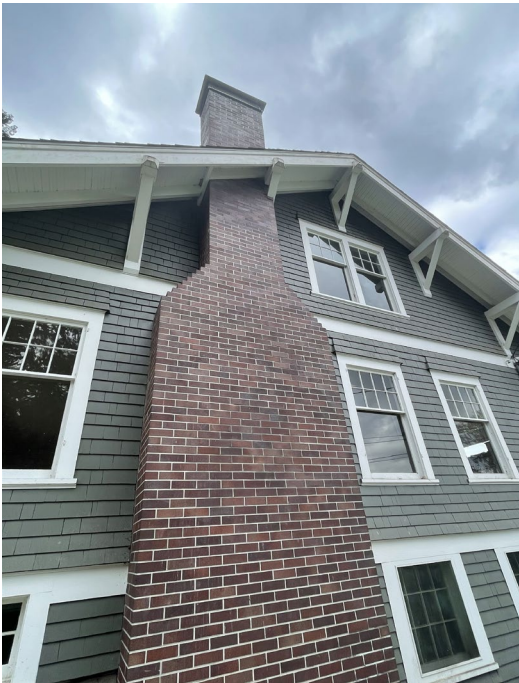
Figure 70. Detail of the north chimney. Prior crack repair was observed at the lower east corner, near the cleanout.

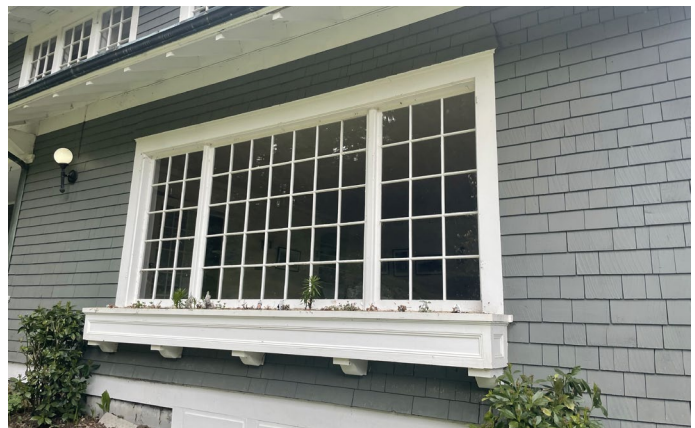
Figure 71. Detail of large east window in the Living Room. This window replaced the original 4-ganged double-hung assembly, and has been recently repaired after damage from an impact broke several panes and muntins. The flower box with brackets and exterior light fixture appear to be original.

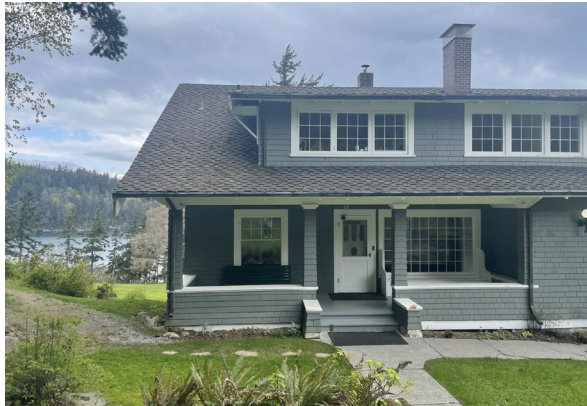
Figure 72. View of the East Entry Porch.

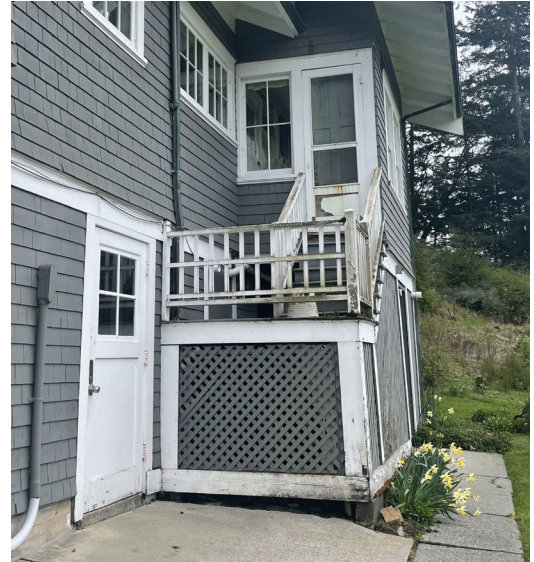
Figure 74. Detail of the west exterior stair, looking south. Paint failure and rotted wood on the decking and railings are evident.

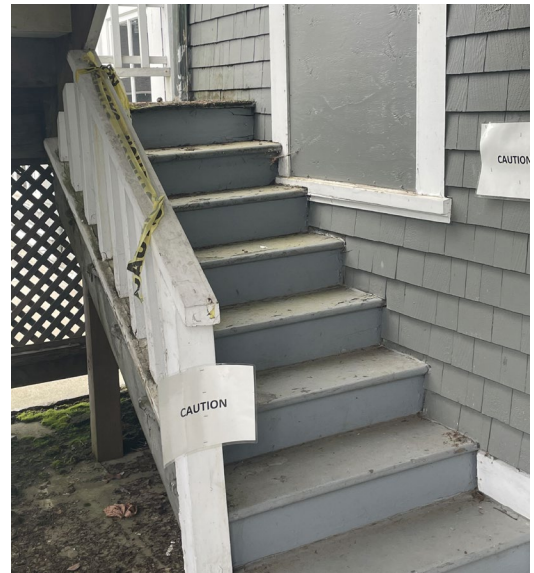
Figure 75. Detail of the west exterior stair, looking northeast. It is currently signed for no access.

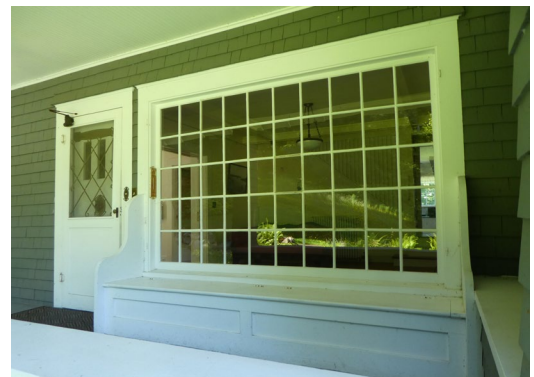
Figure 76. Detail of East Entry Porch original bench and door. The window has been replaced, but still has hardware from the earlier exterior screens. (Courtesy City of Bellingham)

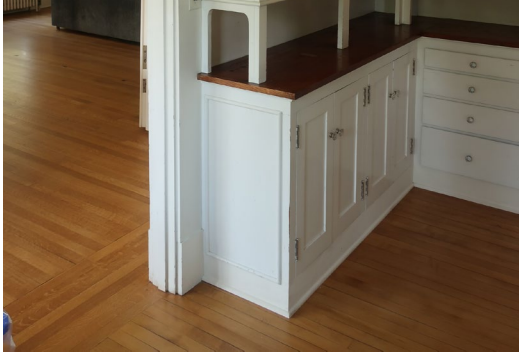
Figure 77. Oak and maple flooring in the Dining Room (left) and Pantry (right) with 6-strip border banding visible near the threshold.

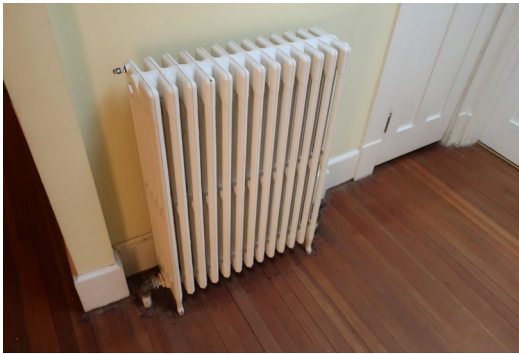
Figure 78. Fir flooring at the Second Floor Hall, with missing base shoe molding, presumably preparing for refinishing the floors.

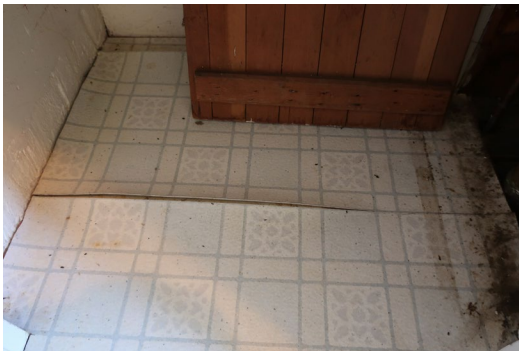
Figure 79. Sheet linoleum flooring at the Second Floor Bath 3, peeling up and heavily soiled. It is likely that most of the sheet flooring products at the restrooms are not original.

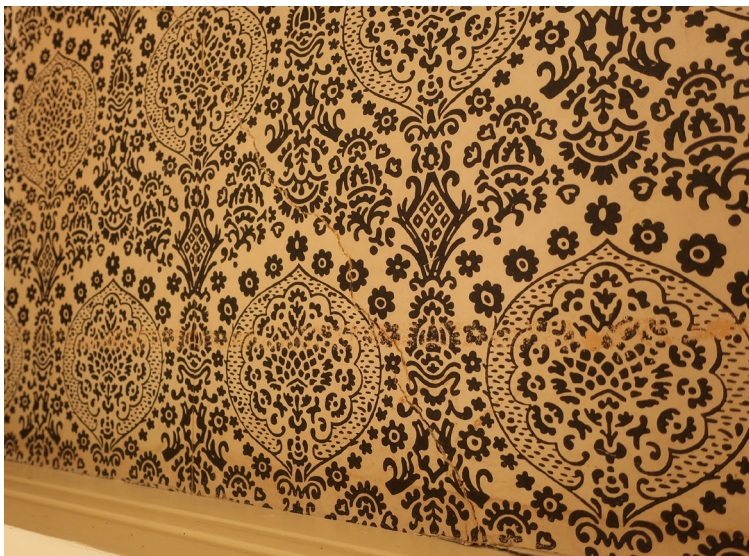
Figure 81. Wall paper in the Original Dining Room, with horizontal wear marks at the plate rail, and telegraphing cracks at the underlying plaster substrate.

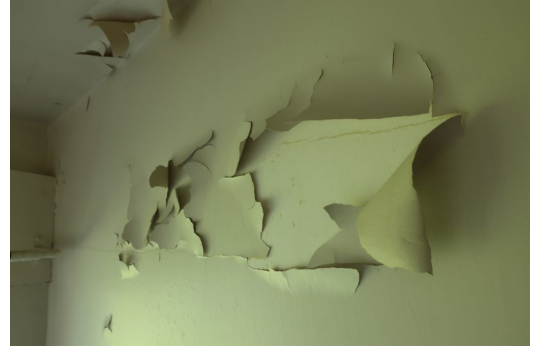
Figure 82. Paint peeling at plaster wall and ceiling in Bath 4. This is a fairly extreme example, not typical, but more prevalent in the humid restrooms where the hard enamel paint has debonded in sheets.

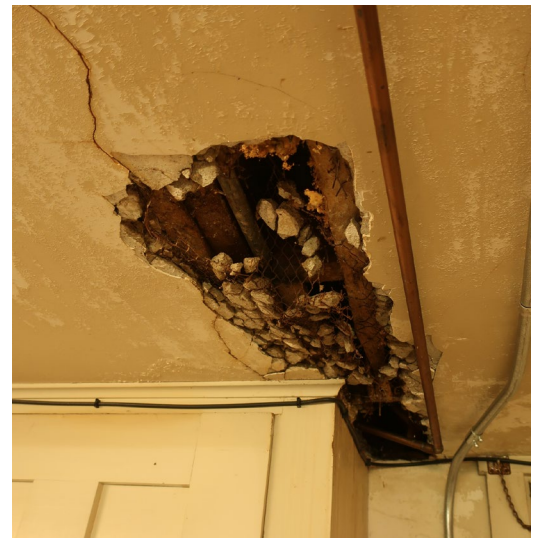
Figure 83. Plaster ceiling damage at the Basement Laundry Room, south wall, either due to water damage, movement, or intentional removal to install or access concealed utilities. Note the opening has both metal and wood lath.

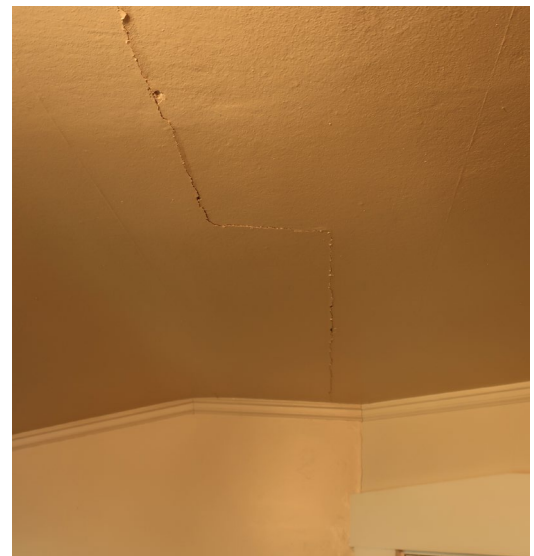
Figure 84. Plaster ceiling crack at Second Floor Room 2, likely telegraphing movement in the structure at some time.

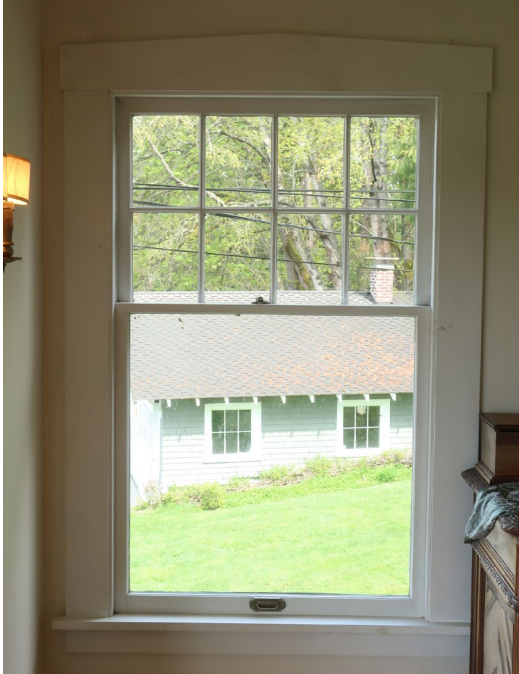
Figure 85. Typical painted wood window trim, with flatstock stool, apron, and pedimented header piece.

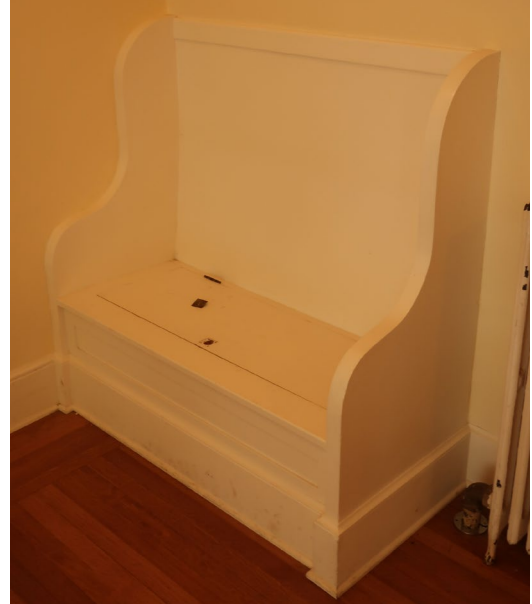
Figure 88. Built-in bench with sculptural form, in the southwest corner of the Entry Hall. This reportedly is the top of the firewood dumbwaiter, and was apparently built as part of or after the 1923 addition work, because the 1922 drawing shows the wall behind as a door to the Basement Stair landing.

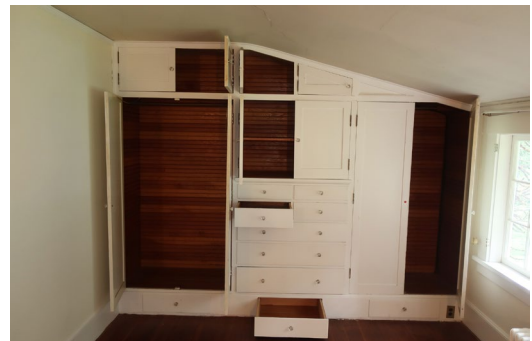
Figure 89. Built-in wardrobe, Second Floor Room 6, with painted cabinet doors, stained beadboard lining, and crystal pull hardware.

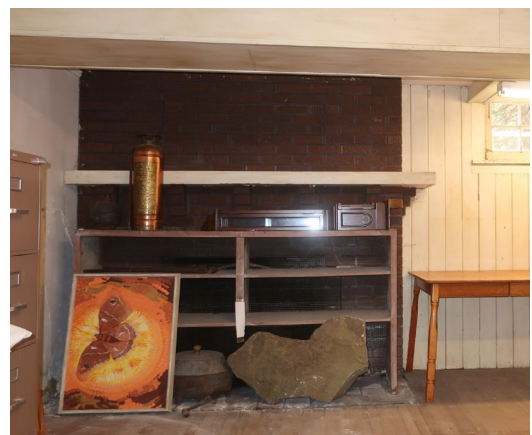
Figure 90. Detail of disused fireplace in the Northeast Room, with brick surround to the ceiling, and raised stone hearth on the raised wood floor. There is water damage on the adjacent wall to the left.

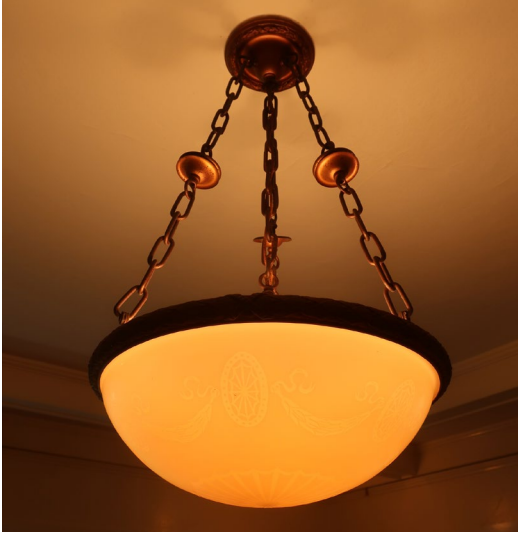
Figure 91. Pendant fixture in the center of the Entry Hall.

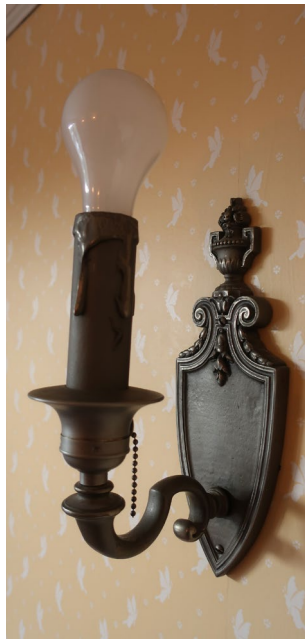
Figure 94. Wall sconce in Second Floor Room 5, missing its shade.

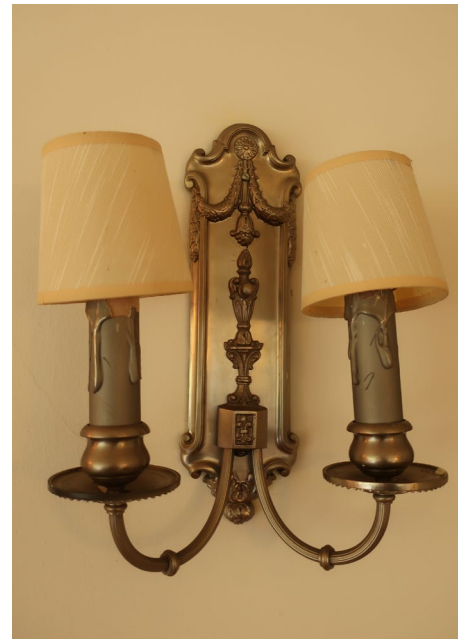
Figure 95. Wall sconce in the Living Room.

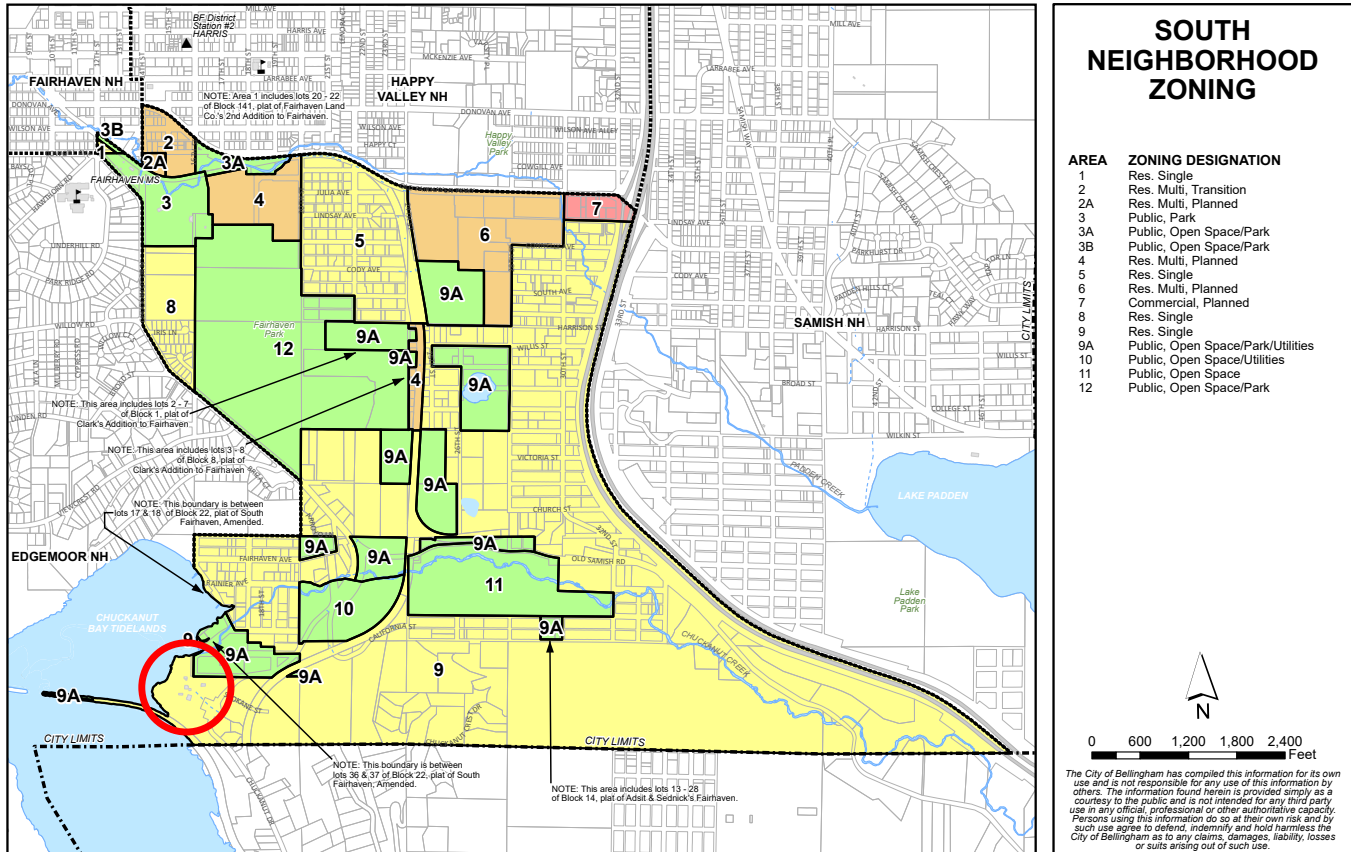
AREA	ZONING	USE QUALIFIER	DENSITY	SPECIAL CONDITIONS	PREREQUISITE CONSIDERATIONS	SPECIAL REGULATIONS
9	Residential, Single	Detached, cluster	20,000 sq. ft minimum "detached" lot size. 1 lot/20,000 sq. ft. average overall cluster density	Clearing; wetlands; flood; upgrading of water service; shoreline.	Development of sanitary sewer service	None
