WOODSTOCK FARM NATIONAL HISTORIC DISTRICT
City of Bellingham, Washington

CYRUS AND MABEL GATES HOUSE
HISTORIC STRUCTURE REPORT

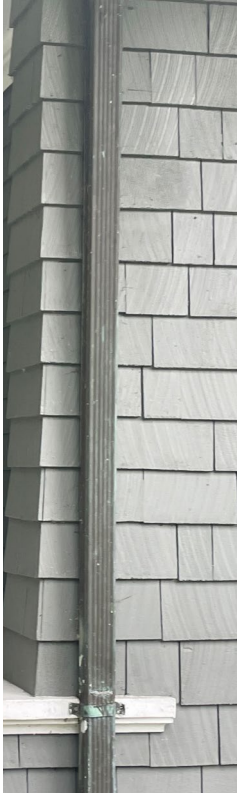
Figure 97. Cedar siding detail.

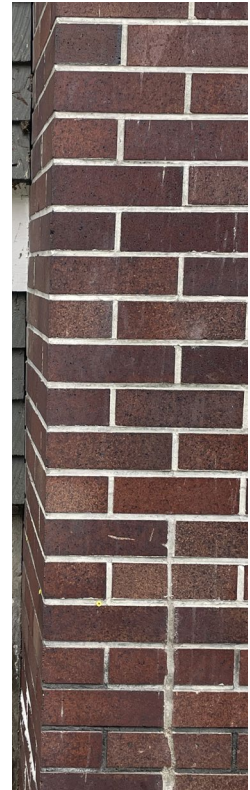
Figure 99. Brick chimney detail.

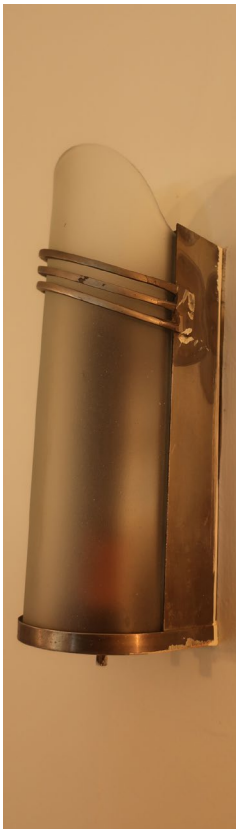
Figure 102. Original light fixture detail.

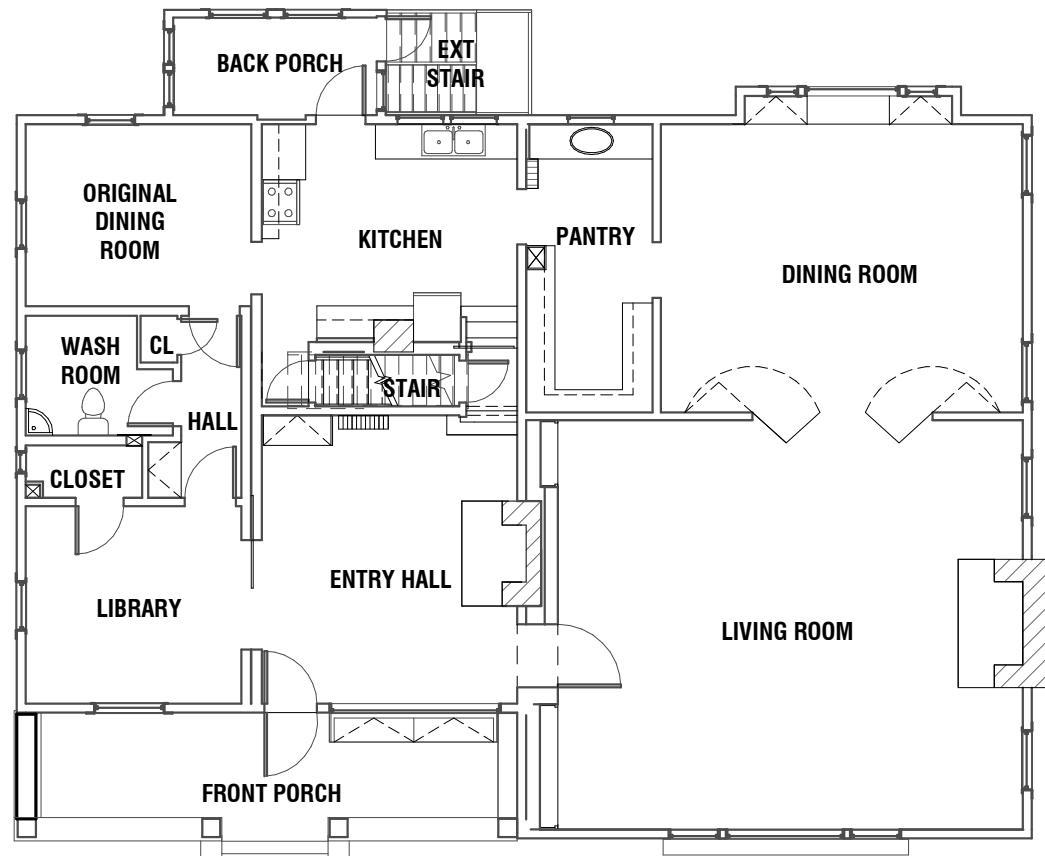
1 EXISTING FIRST FLOOR KEY PLAN
3/32" = 1'-0"

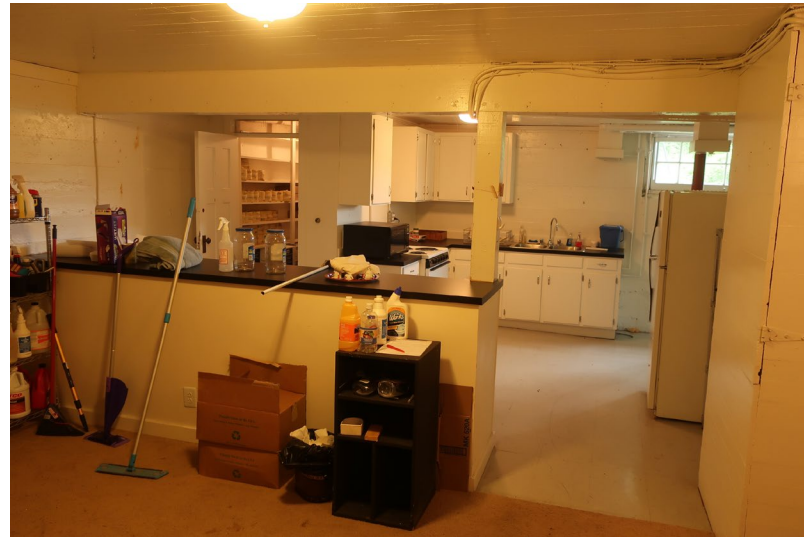
Figure 105. View looking south. The dividing counter was constructed ca. 2004.

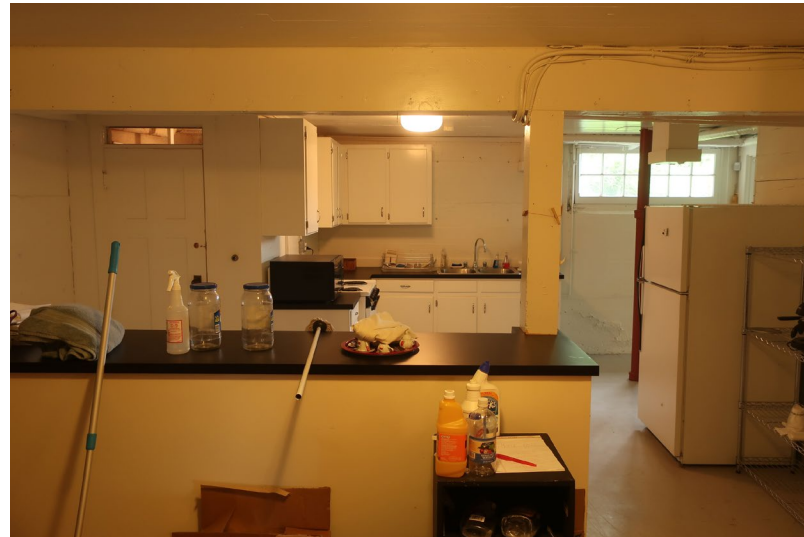
Figure 114. View looking south from the Living Room.

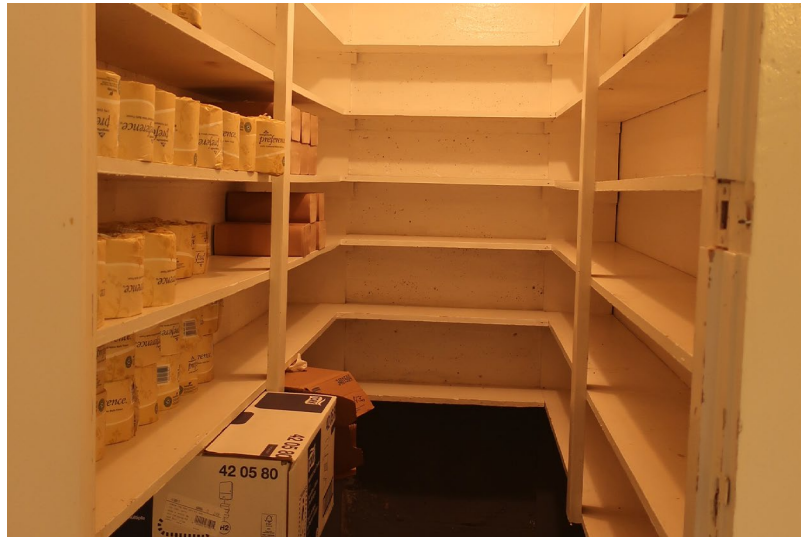
Figure 122. View looking south at the open shelving.

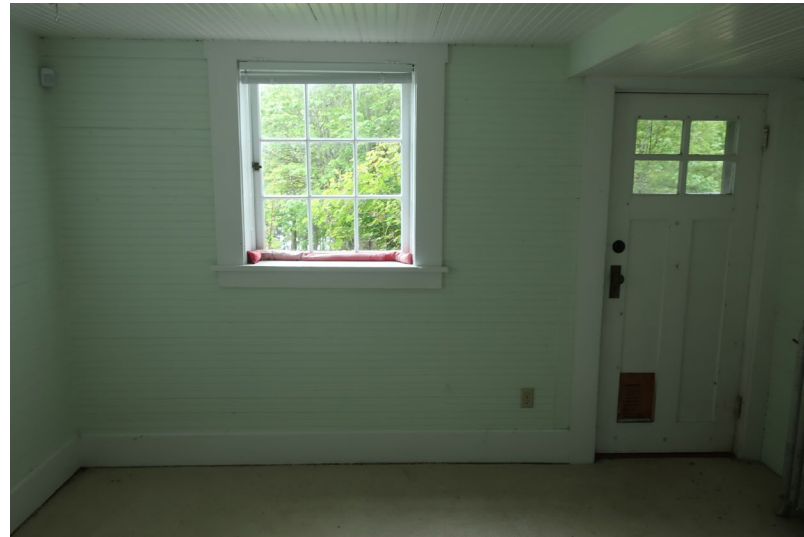
Figure 130. View looking west at window and exterior door. Walls are furred and finished with beadboard.

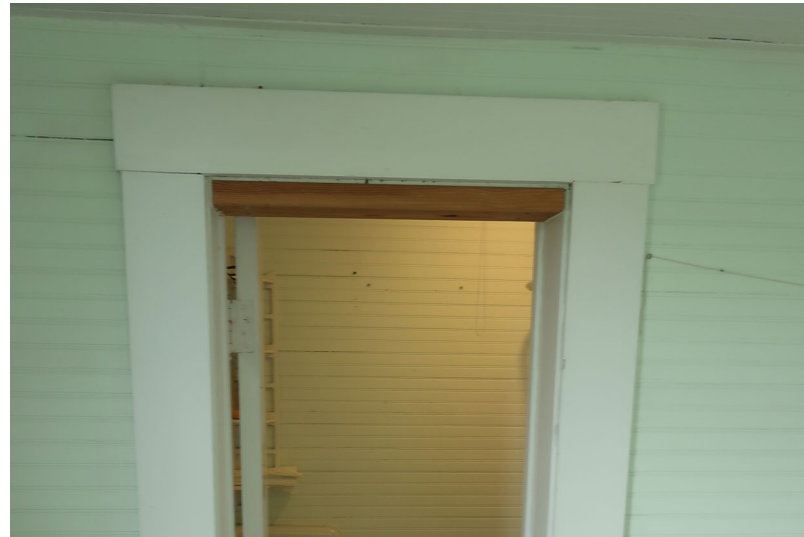
Figure 139. Detail of door head with framing repair, from Bedroom side.

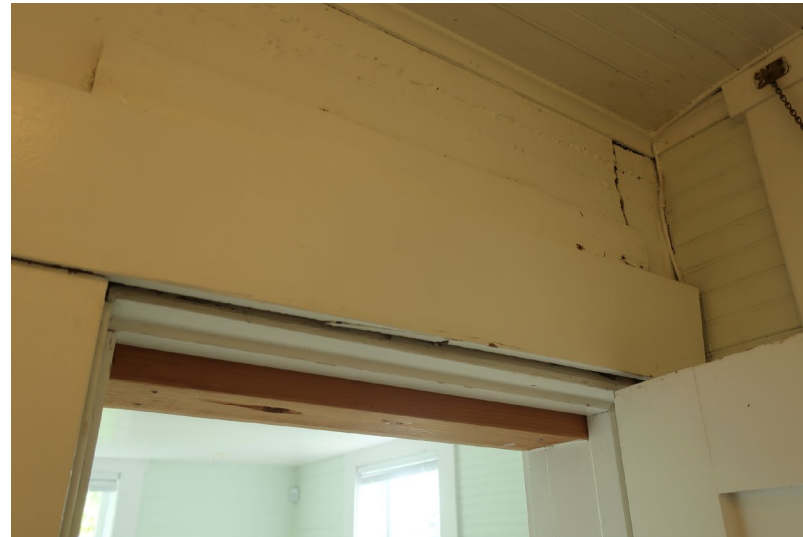
Figure 140. Detail of door head with framing repair, and concrete crack visible at upper right corner.

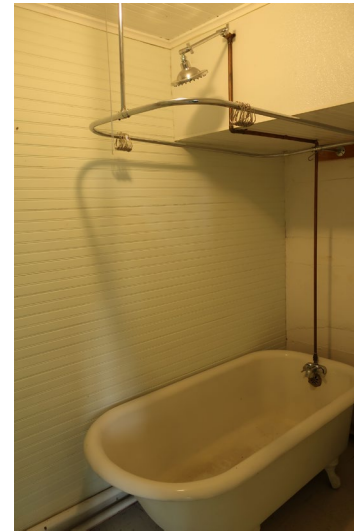
Figure 141. View looking northeast at clawfoot tub, FRP-wrapped soffit, and exposed piping.

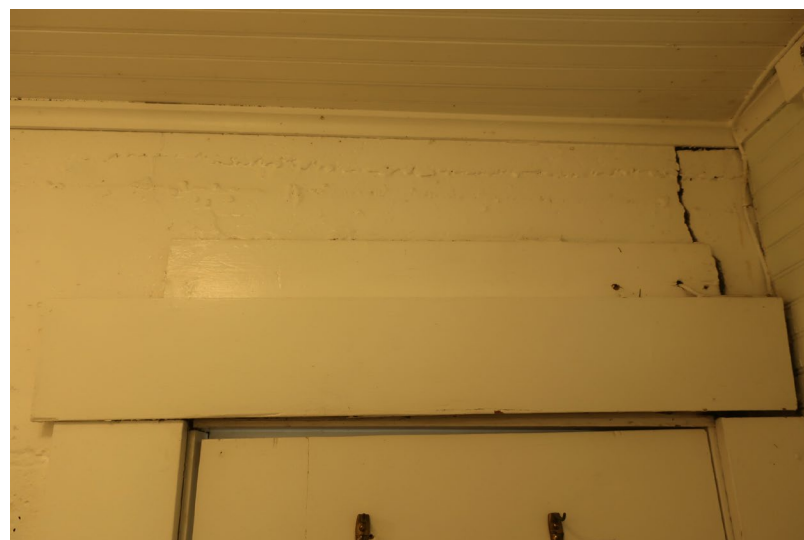
Figure 144. Detail concrete crack above door head.

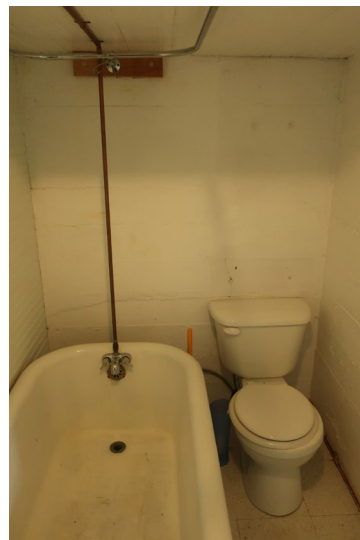
Figure 145. View looking east.

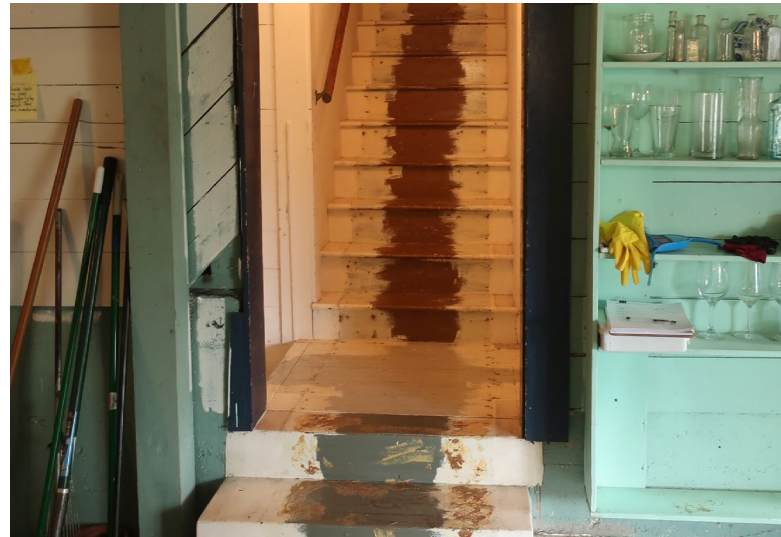
Figure 148. View looking south, door opening was cut through original exterior wall.

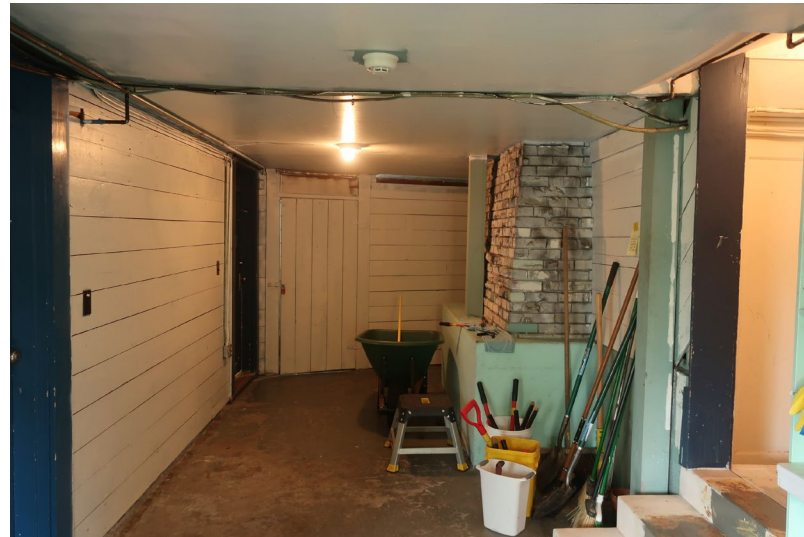
Figure 157. View looking east. Original exterior north wall is at right, with battered brick chimney.

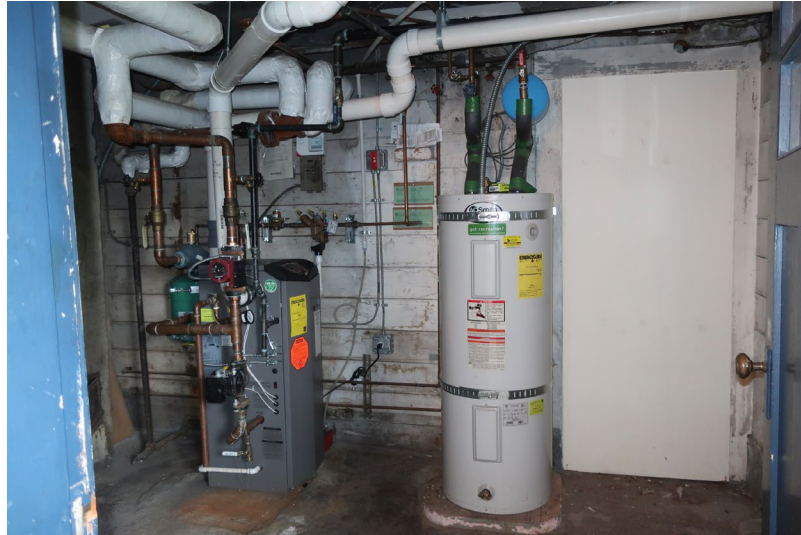
Figure 165. View looking south. Original exterior door at right has been closed up.

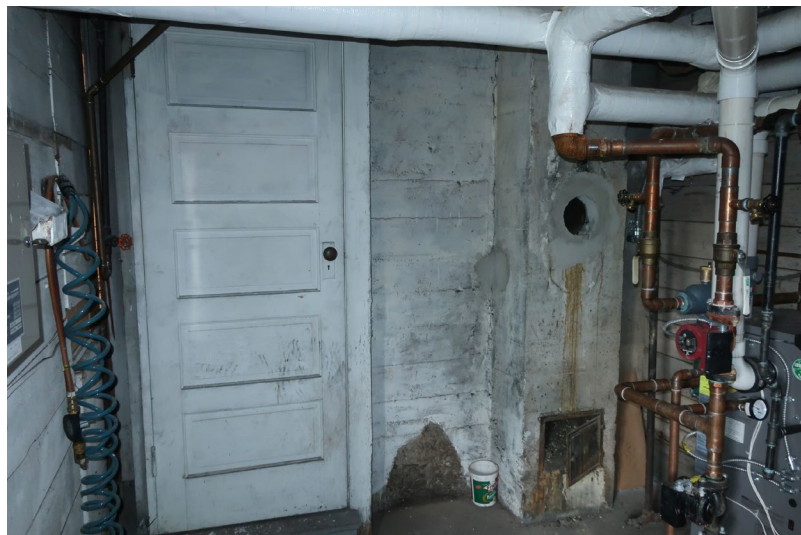
Figure 168. View looking east, at door to the Basement stair at left, and the concrete chimney base that served the original boiler and the Kitchen stove above. Note the concrete spall at the wall base.

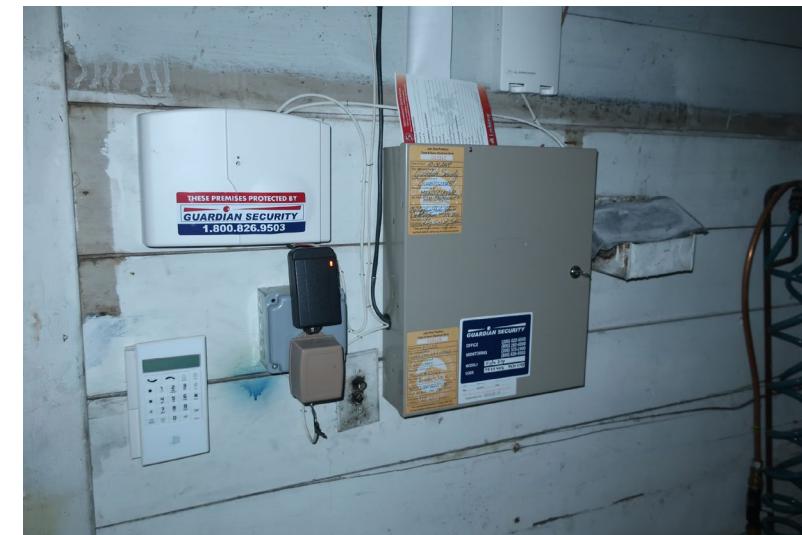
Figure 169. Detail of security system on north wall.

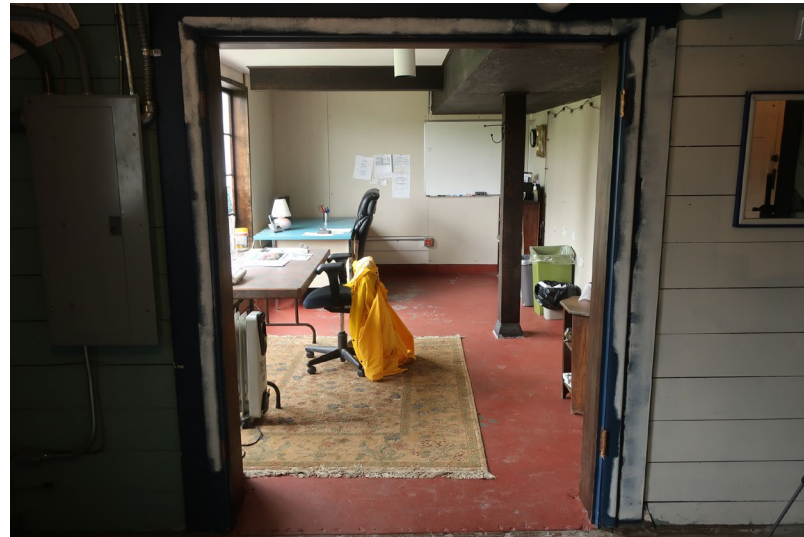
Figure 174. View looking north through double door opening.

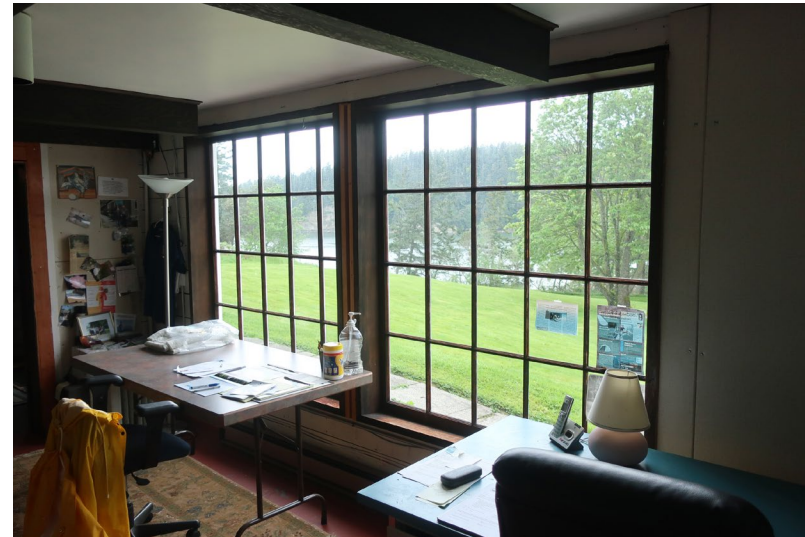
Figure 175. View looking southwest at large stained wood windows.

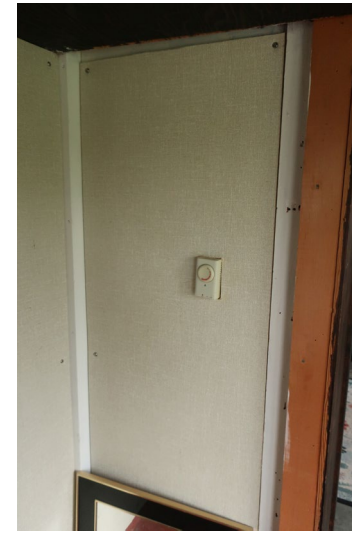
Figure 176. Detail of acoustic office furniture panelling typical of the wall surfacing.

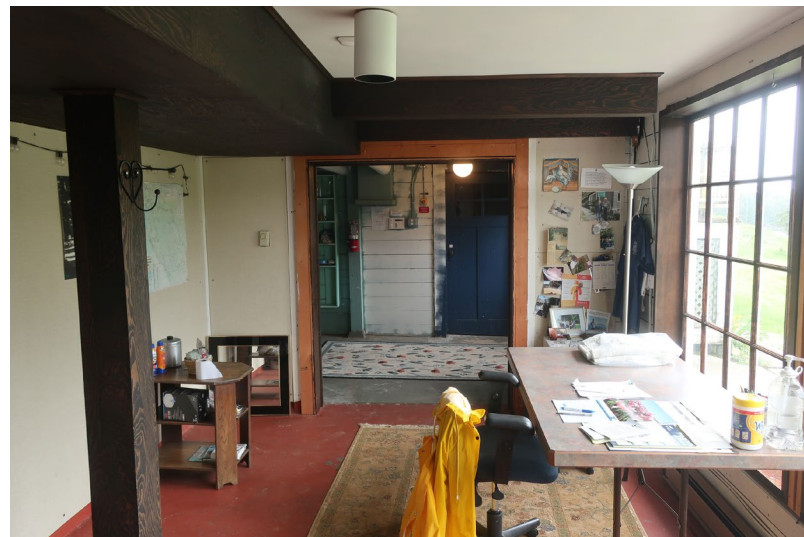
Figure 177. View looking south. Dark stained plywood soffits conceal radiator piping. There is new rough framing for a double door, without leaves.

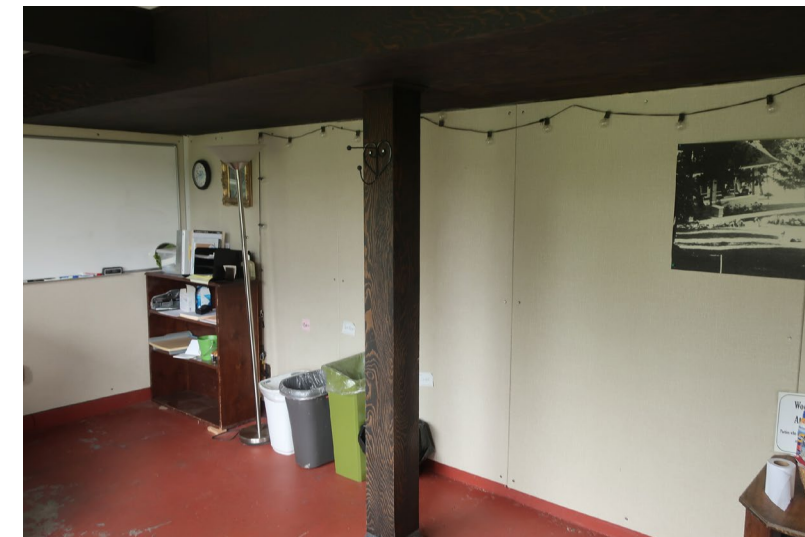
Figure 178. View looking northeast. Floor is painted concrete (ca. 2007, per Farm Records on City Website).

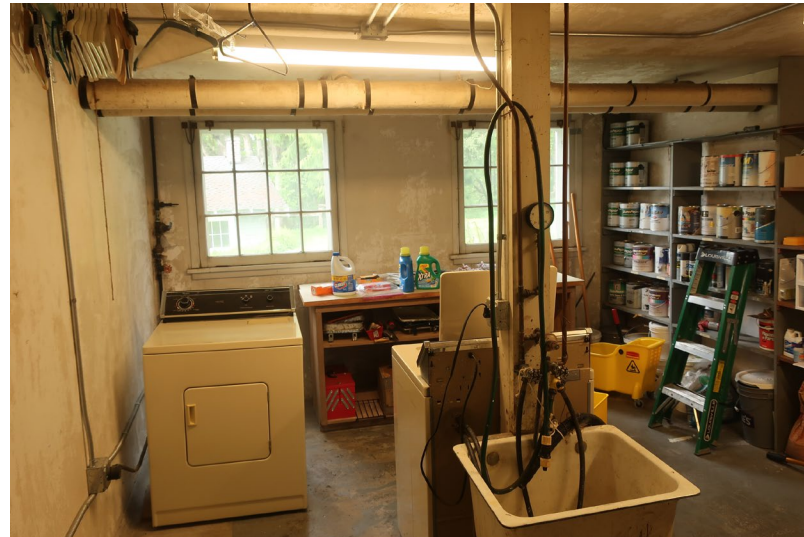
Figure 183. View looking north, with two operable windows.

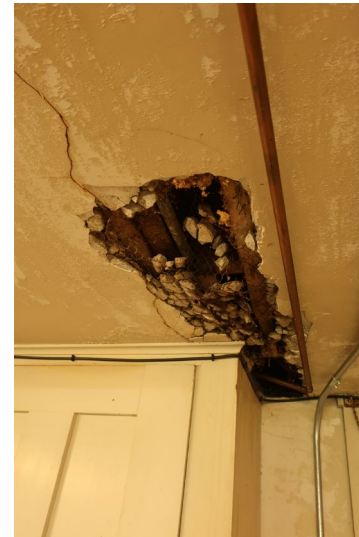
Figure 185. Detail of plaster damage, and possibly prior repair at a plumbing penetration, south end of ceiling.

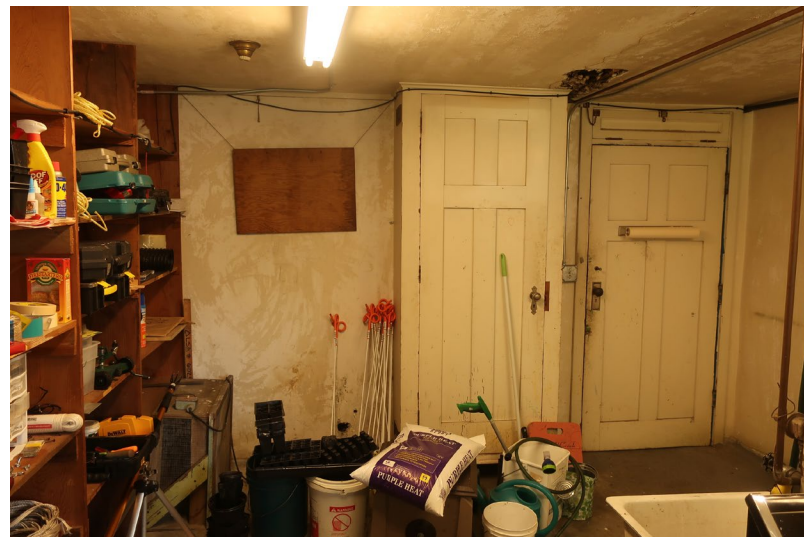
Figure 186. View looking south. A built-in cabinet is at center, and the entry door with transom is at right. An original light fixture is visible adjacent to a contemporary fluorescent strip fixture.

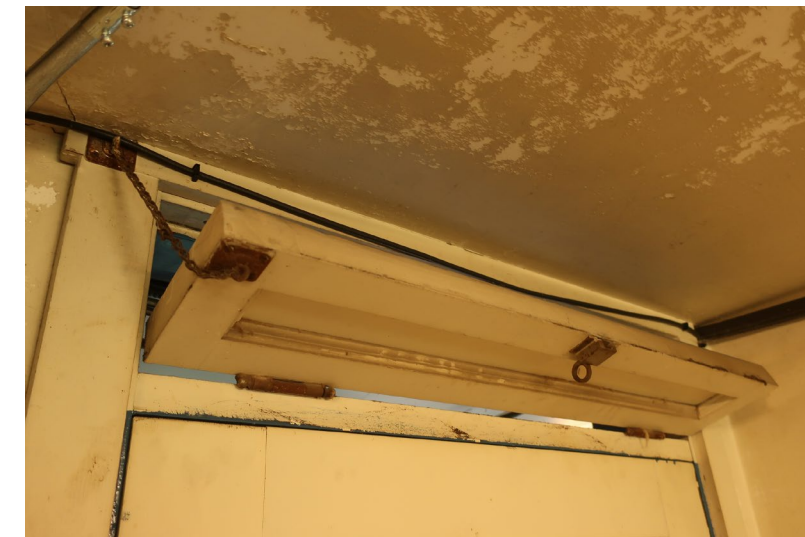
Figure 187. Detail of operable solid-panel transom over the door. Note the paint condition on the plaster, which is typical heavy flaking, due to the high humidity of the space.

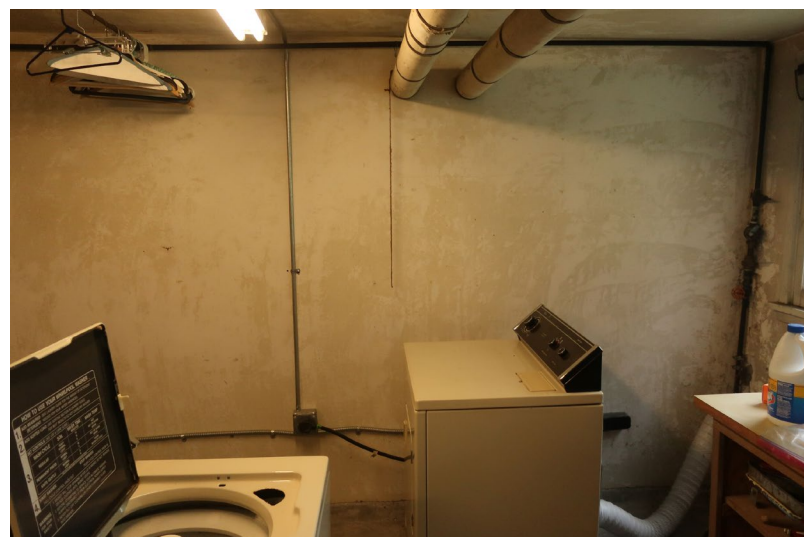
Figure 188. View looking west at north end of the wall.

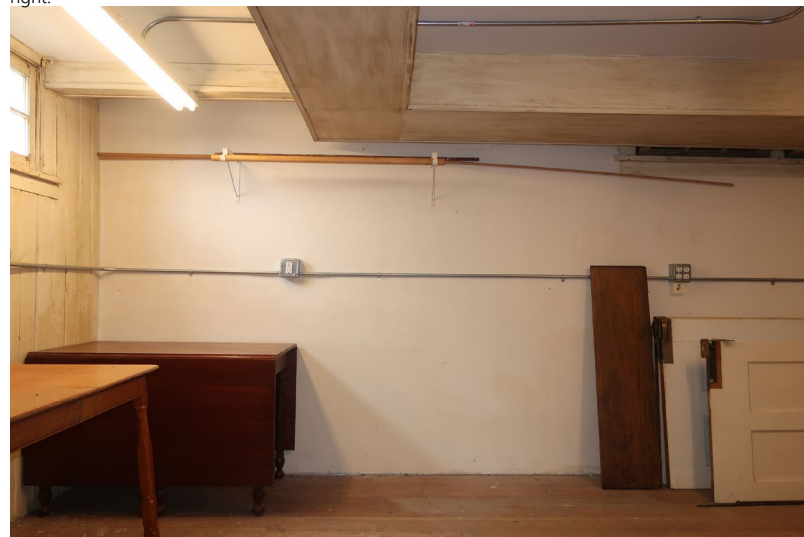
Figure 195. View looking east, with stained plywood soffits, and stored salvaged double-swinging doors from the First Floor Pantry and Kitchen.

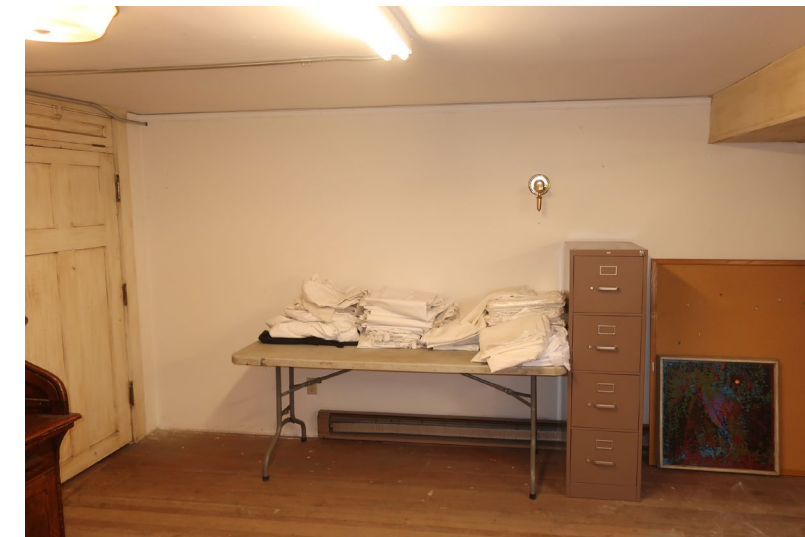
Figure 196. View looking west, with baseboard radiator visible under the table.

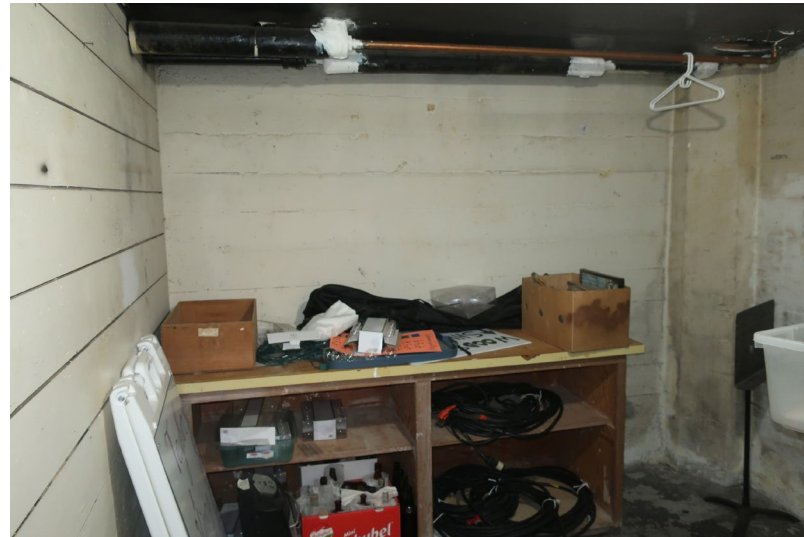
Figure 201. View looking east at the concrete foundation / retaining wall. Partially insulated copper radiator piping is visible at the ceiling.

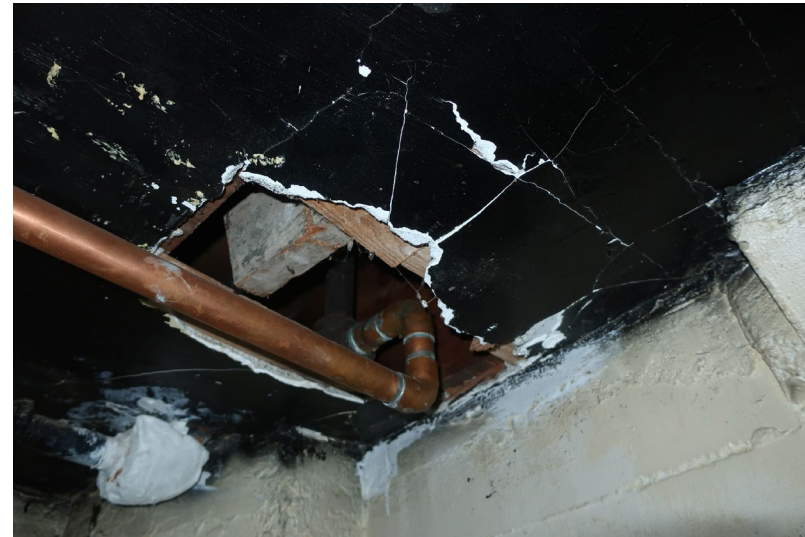
Figure 202. Detail of copper piping extending through plaster ceiling to radiator above.

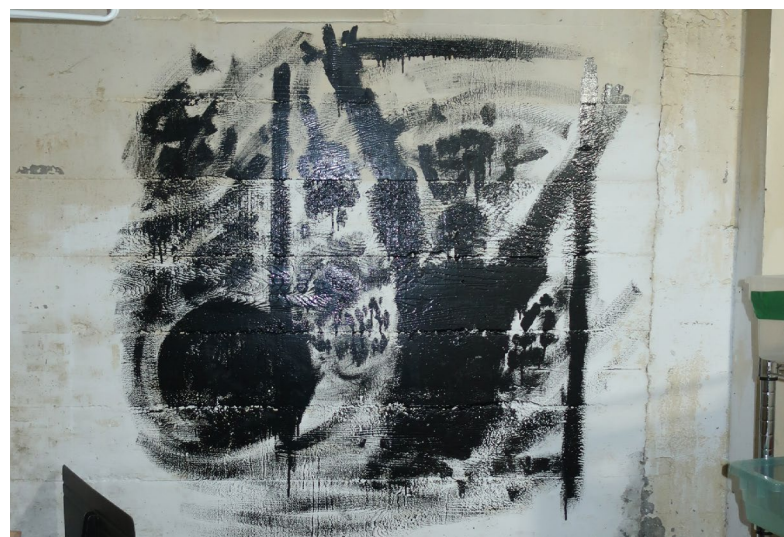
Figure 206. Detail of art on the concrete foundation wall.

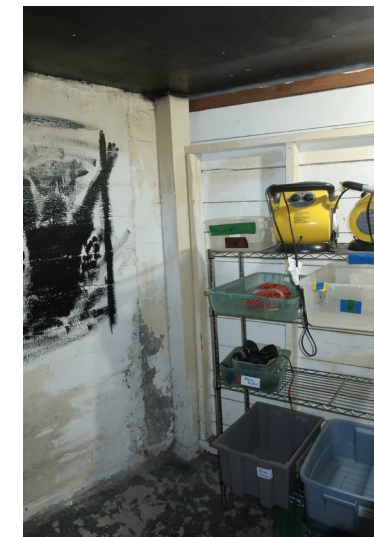
Figure 207. View looking southwest.

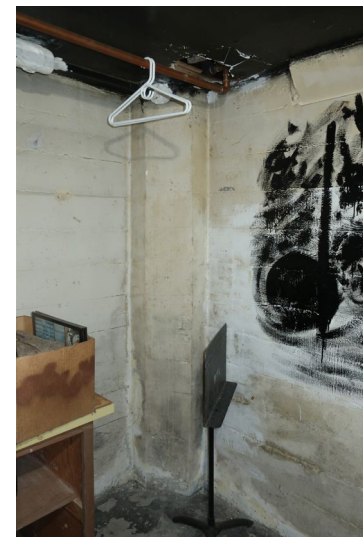
Figure 208. Detail of southeast corner projection that may have been the original porch corner foundation.

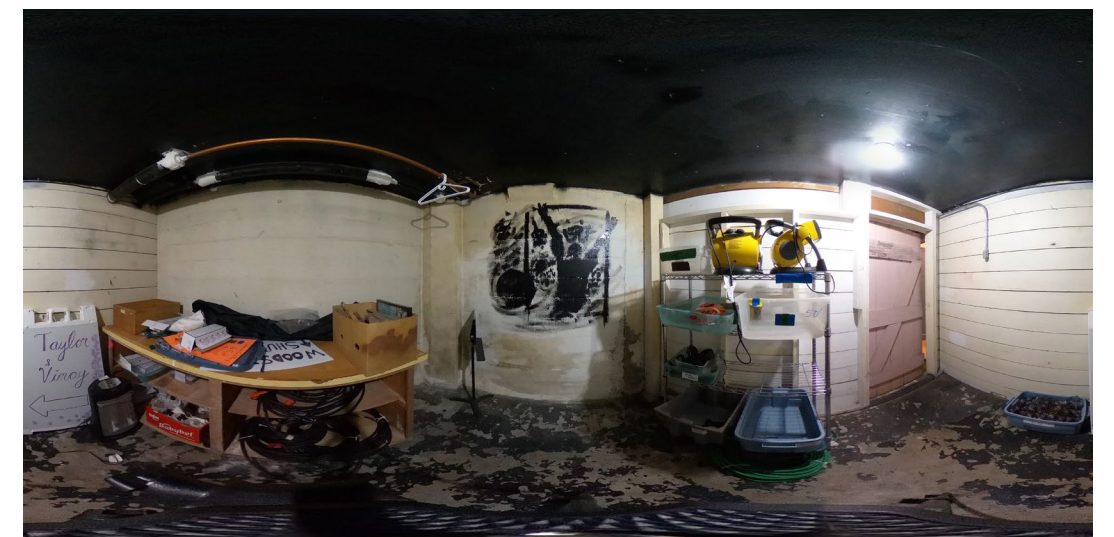
Figure 209. Fish-eye thumbnail of 360 camera image. See <https://data.cob.org/tours/planning/woodstockhistoricstructuresreport/>

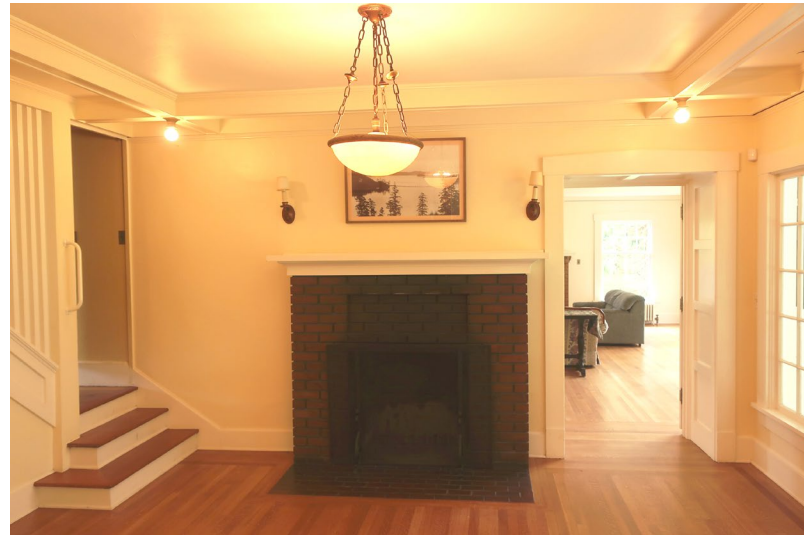
Figure 210. View looking south, with the second floor stair at left, fireplace at center, and passage to the Dining Room at right.

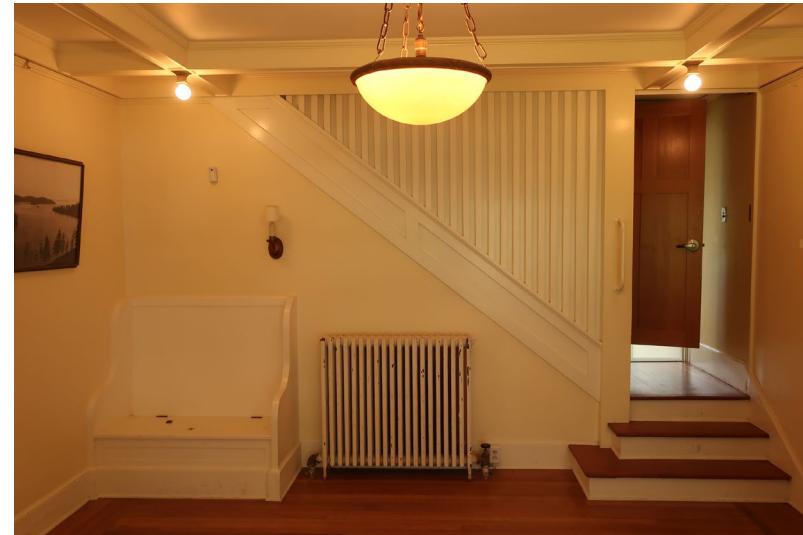
Figure 211. View looking west, showing the firewood dumbwaiter bench, radiator, and stair. The open door has been replaced, and former double-swinging door is missing. The wall behind the bench was originally an opening to the top of the basement stair.

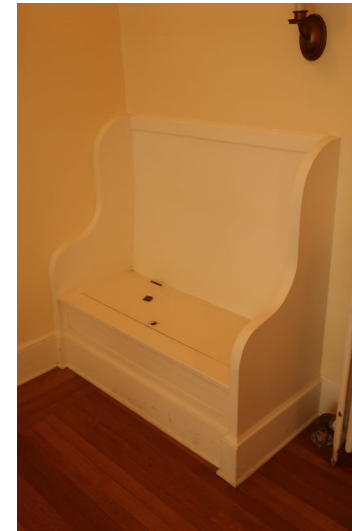
Figure 212. Detail of firewood bench.

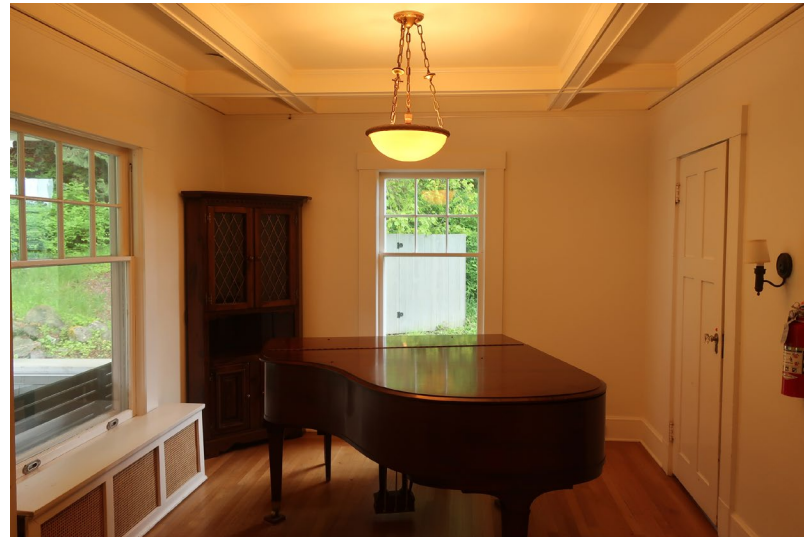
Figure 219. View looking south, with box beams and pendant light fixture.

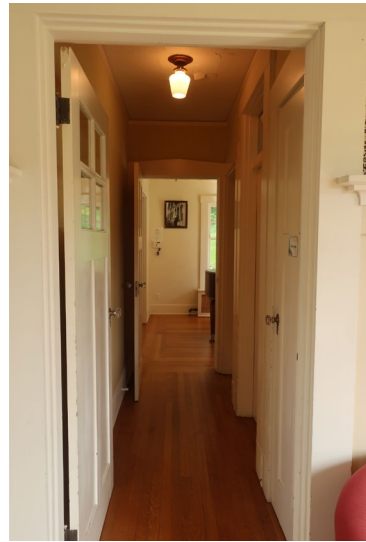
Figure 228. View looking east from Original Dining Room.

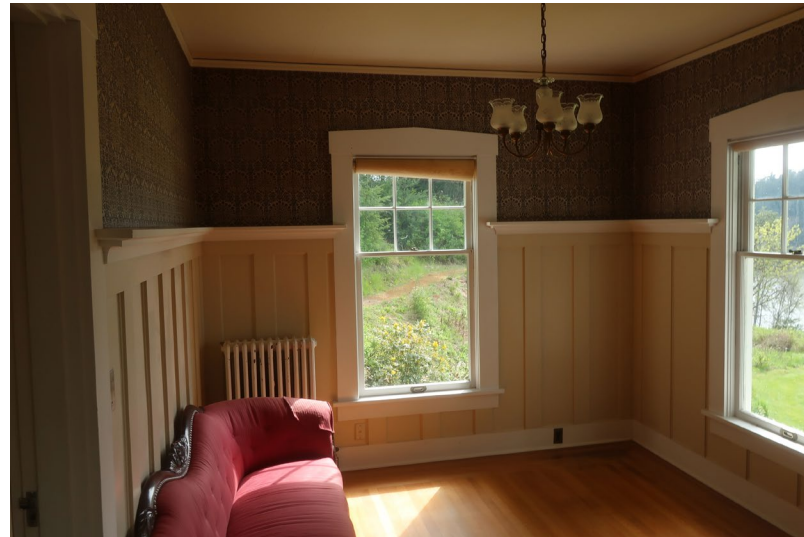
Figure 248. View looking southeast.

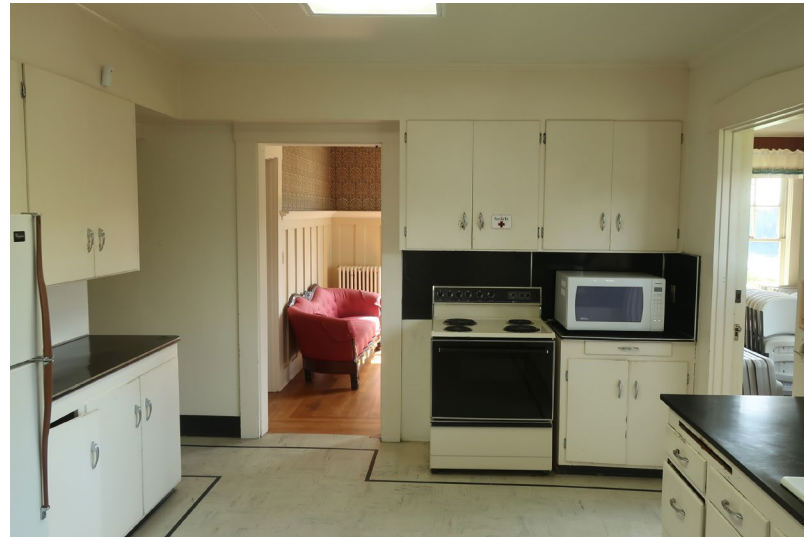
Figure 257. View looking south.

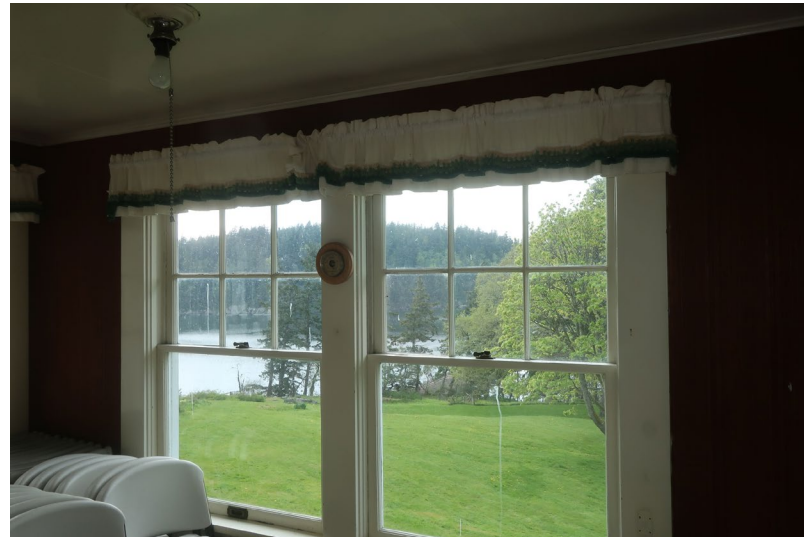
Figure 266. View looking west at double hung windows and the lawn and Chuckanut Bay beyond.

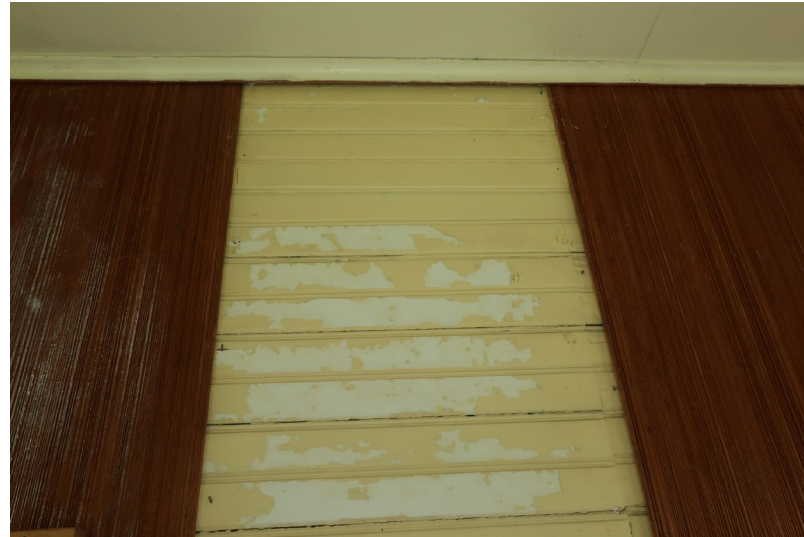
Figure 269. Detail of the rilled panelling, and what appears to be a missing panel over painted beadboard siding.

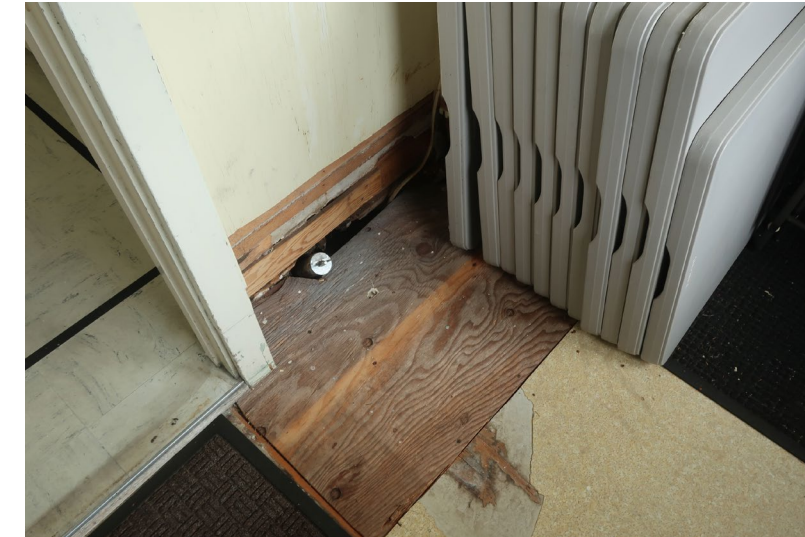
Figure 270. Detail of the lower portion of the "key door," and the various flooring - plywood, linoleum, and area mats.

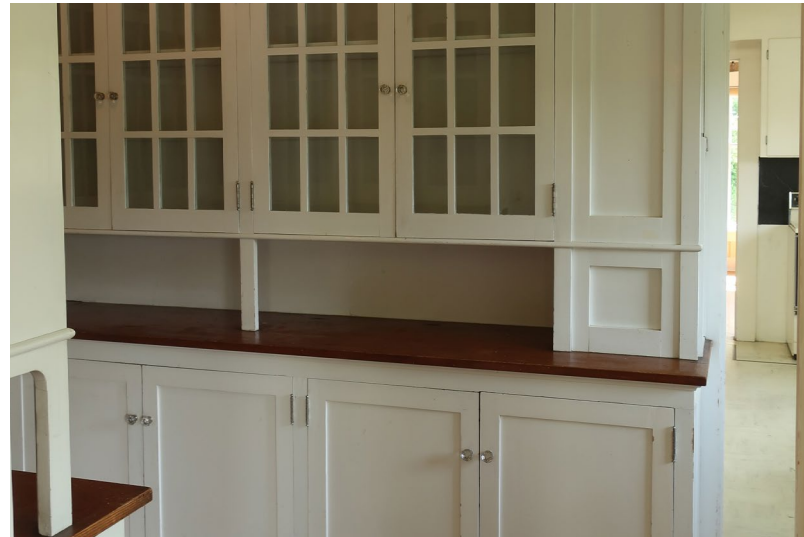
Figure 275. View looking south.

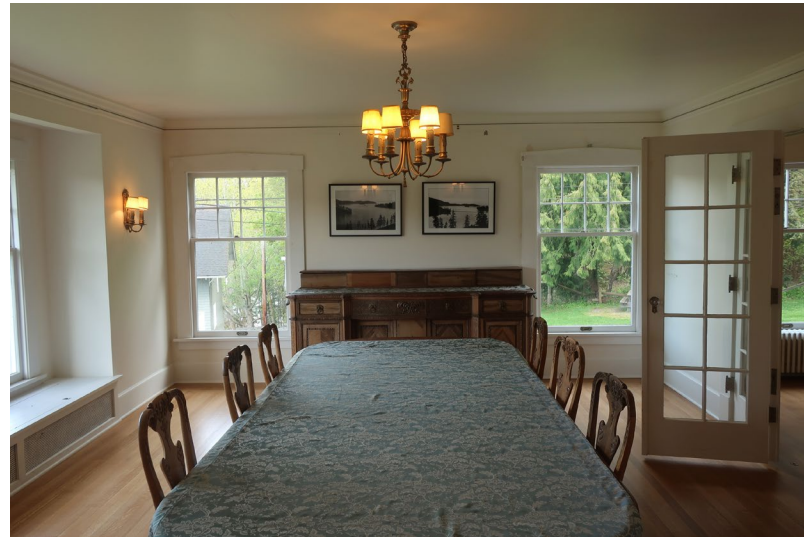
Figure 284. View looking north.

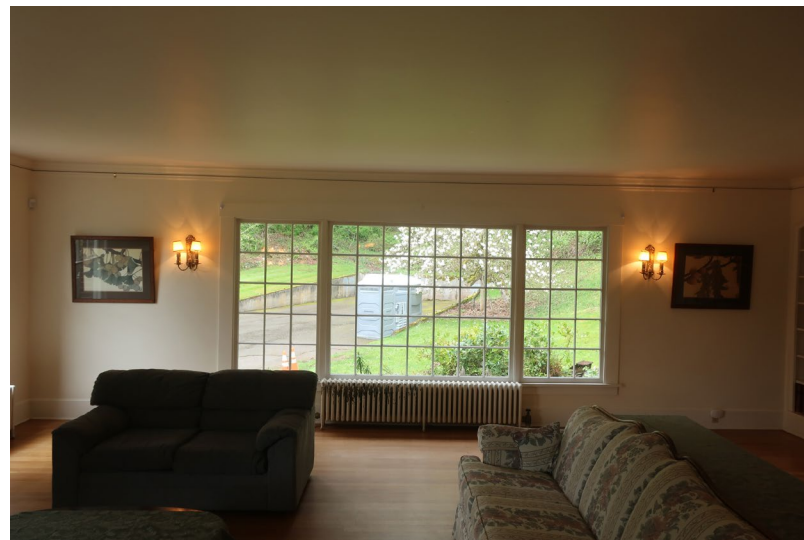
Figure 295. View looking east. Windows have been replaced from original 4-gang double hungs.

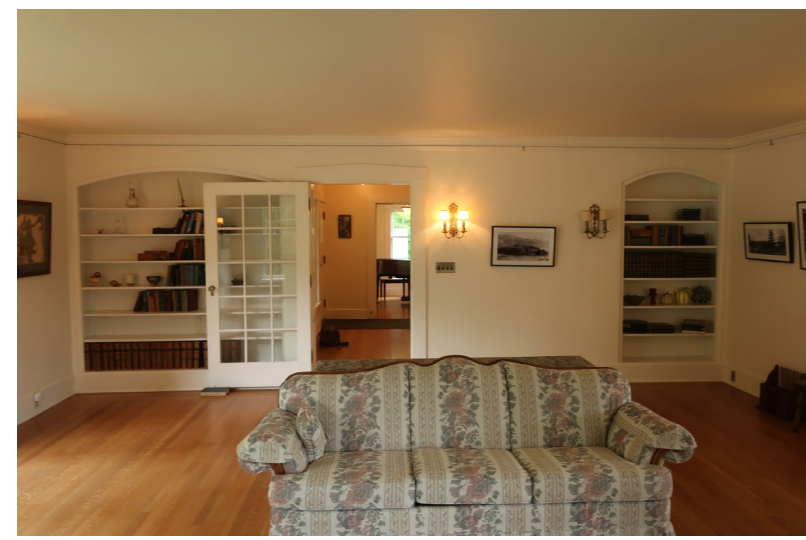
Figure 296. View looking south. Built-in book shelves are in thick wall between original and 1923 addition.

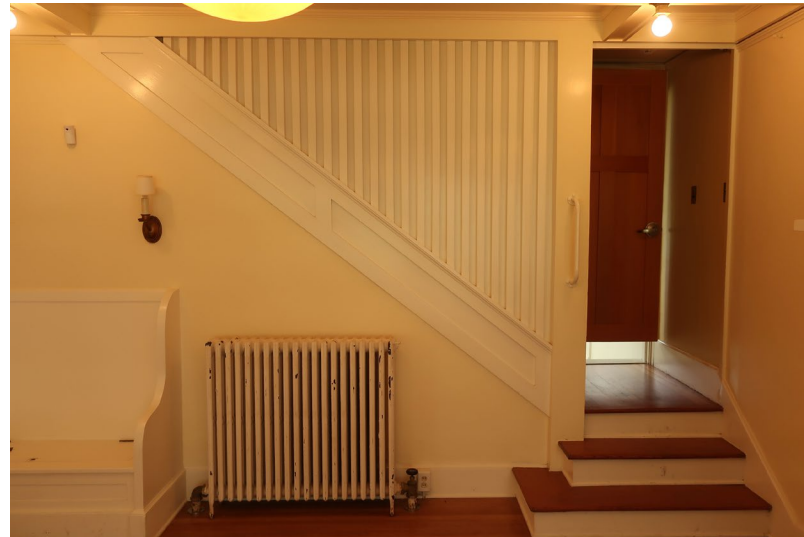
Figure 301. View looking west at the cascading bottom steps, and 2" balluster with infill panel behind..

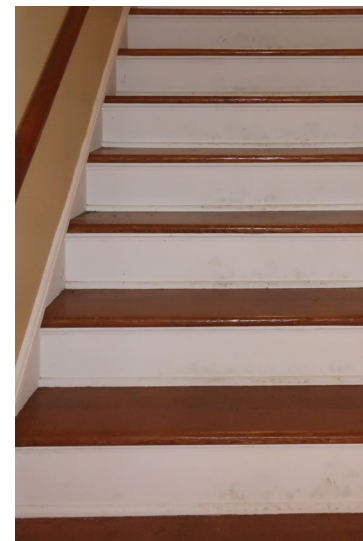
Figure 305. Detail of painted risers and stained fir treads.

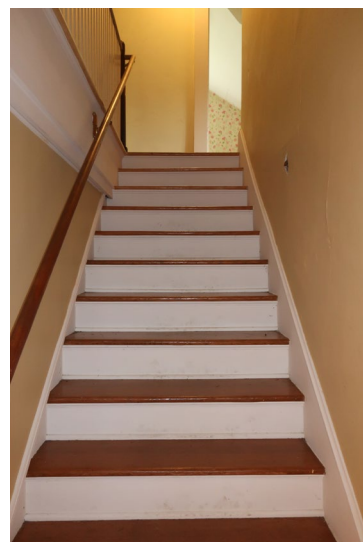
Figure 306. View looking south up stairs.

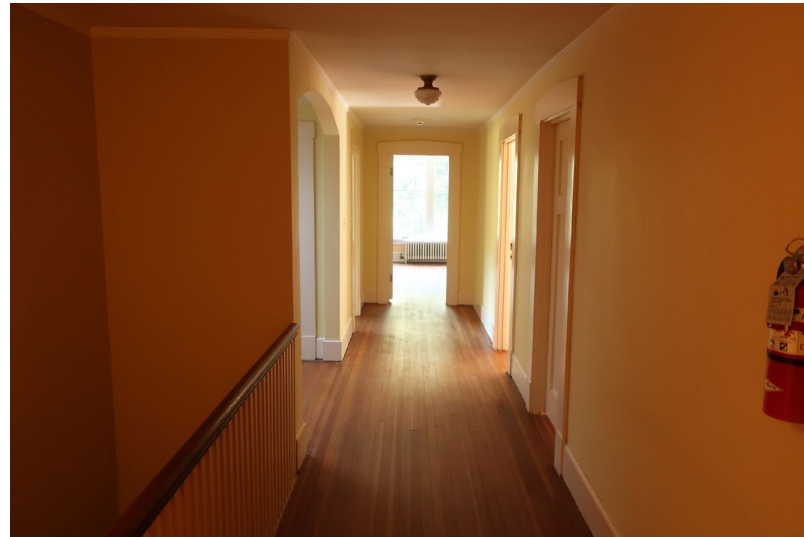
Figure 309. View looking north, with fir floors and plaster walls, and acorn globe ceiling mount fixture.

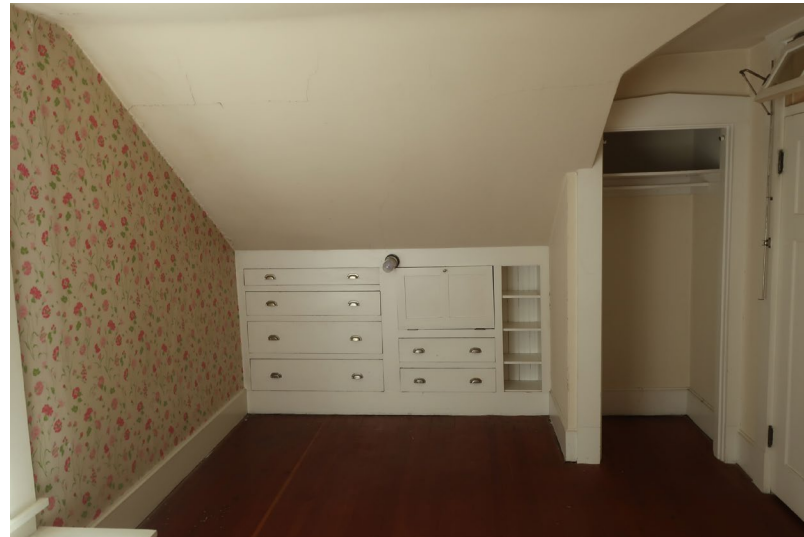
Figure 319. View looking north, with sloped ceiling, and built-in cabinets in the knee wall space, and a closet at right.

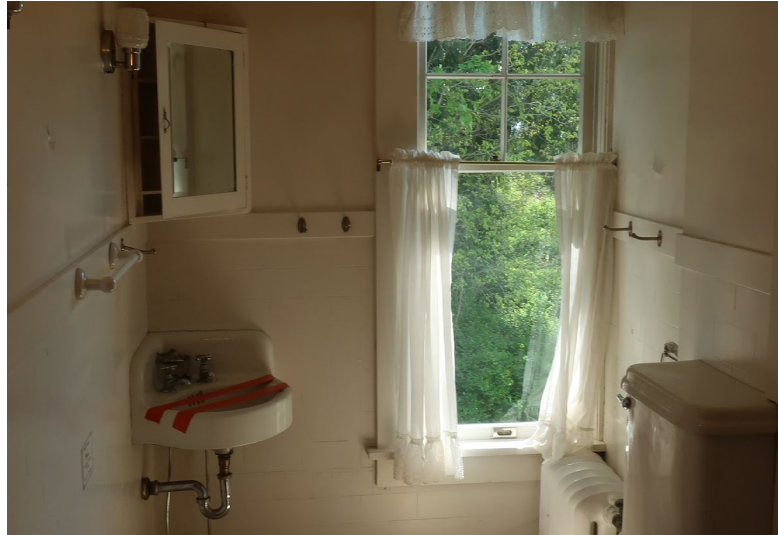
Figure 328. View looking south, with original plumbing fixtures and radiator.
