WOODSTOCK FARM NATIONAL HISTORIC DISTRICT
City of Bellingham, Washington

CYRUS AND MABEL GATES HOUSE
HISTORIC STRUCTURE REPORT

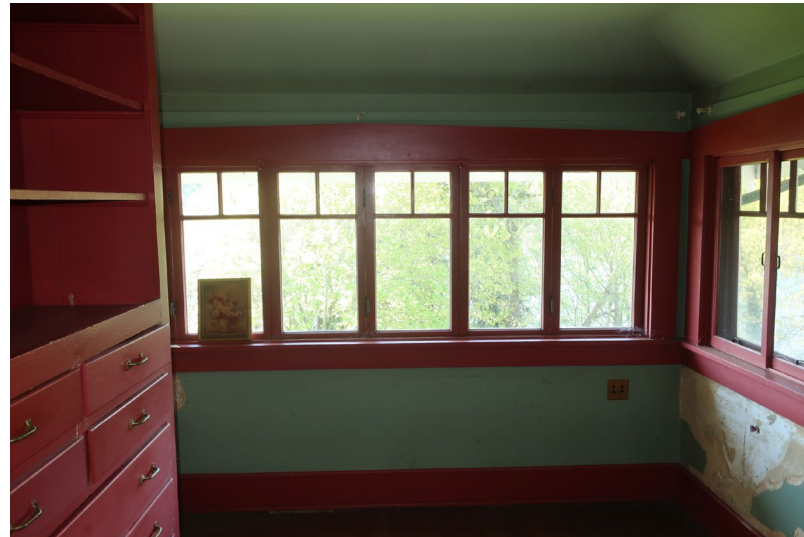
Figure 353. View looking west.

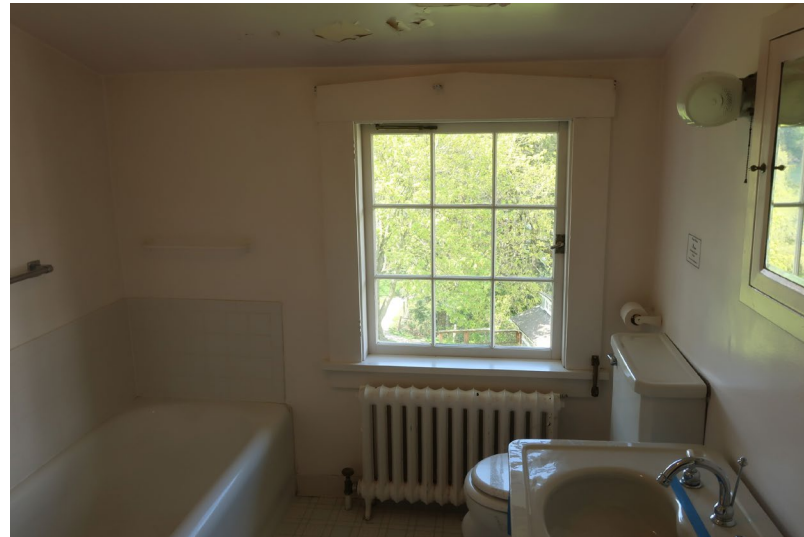
Figure 361. View looking west at dormer window, radiator, and original plumbing fixtures.

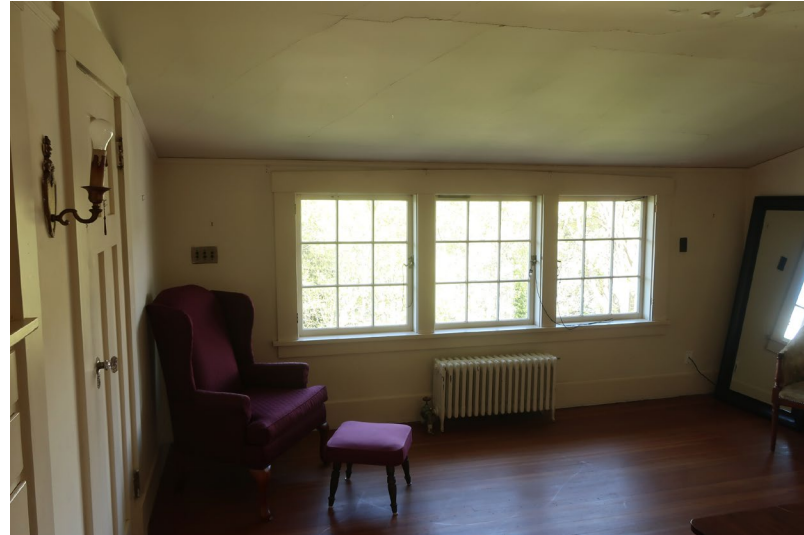
Figure 370. View looking west at dormer windows and radiator.

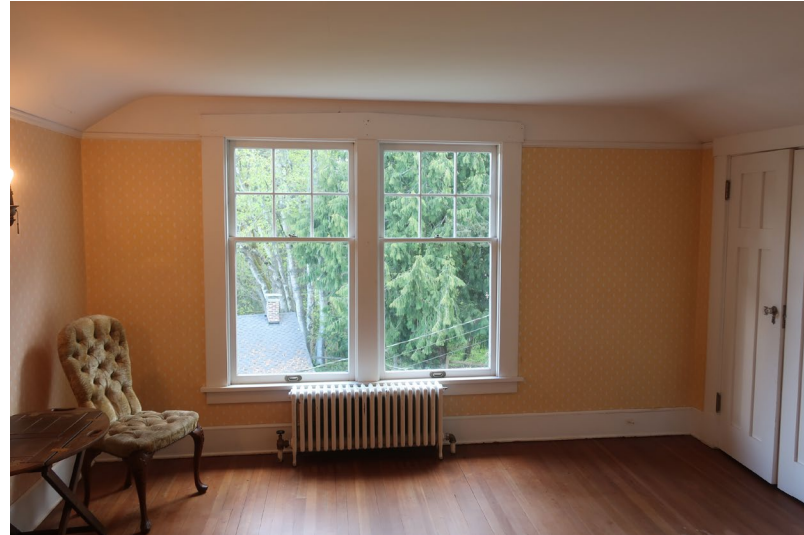
Figure 390. View looking north.

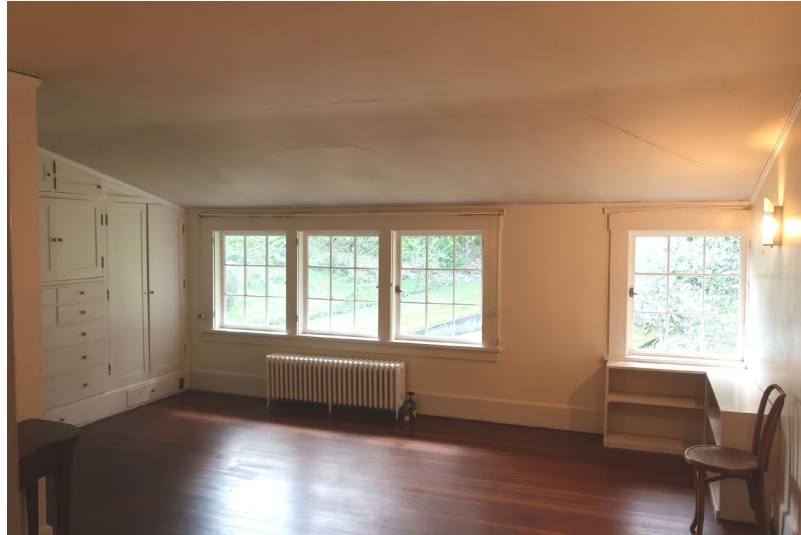
Figure 399. View looking east.

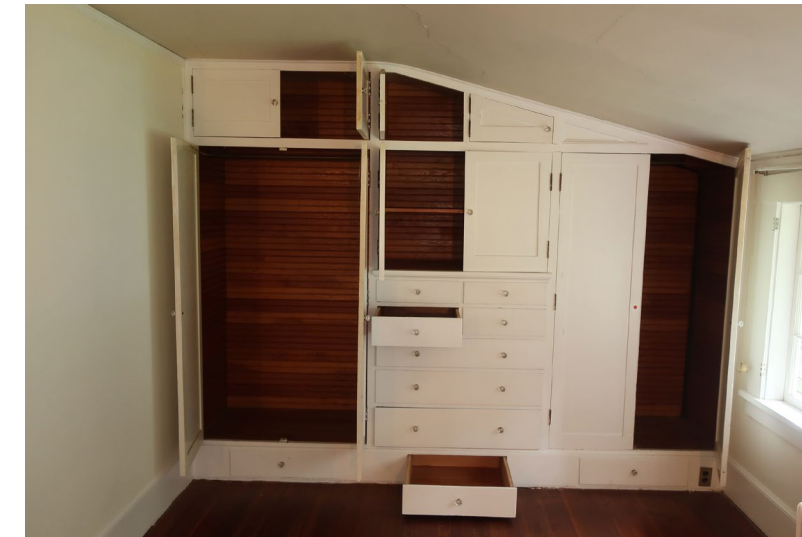
Figure 402. Detail of open cabinetry and stained fir-lined compartments.

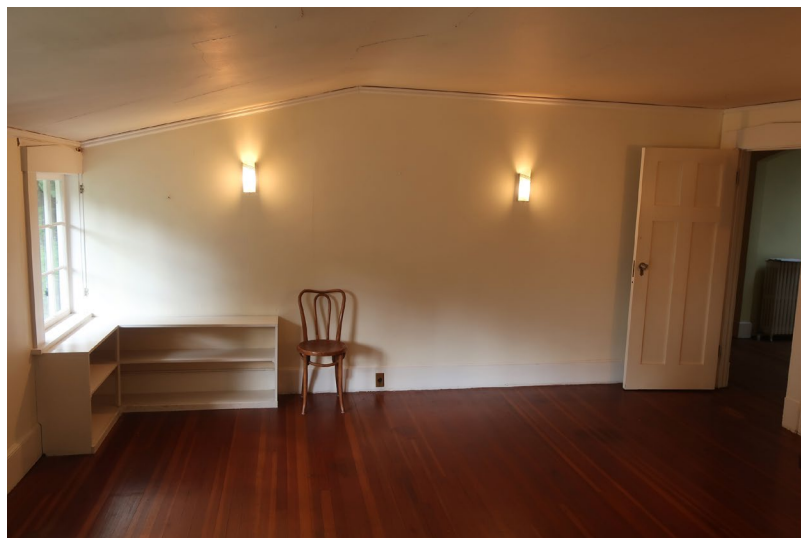
Figure 403. View looking south.

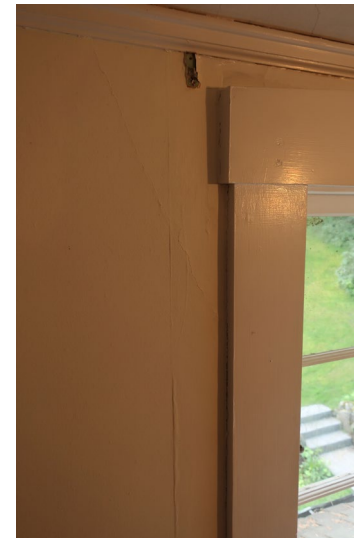
Figure 405. Detail plaster crack

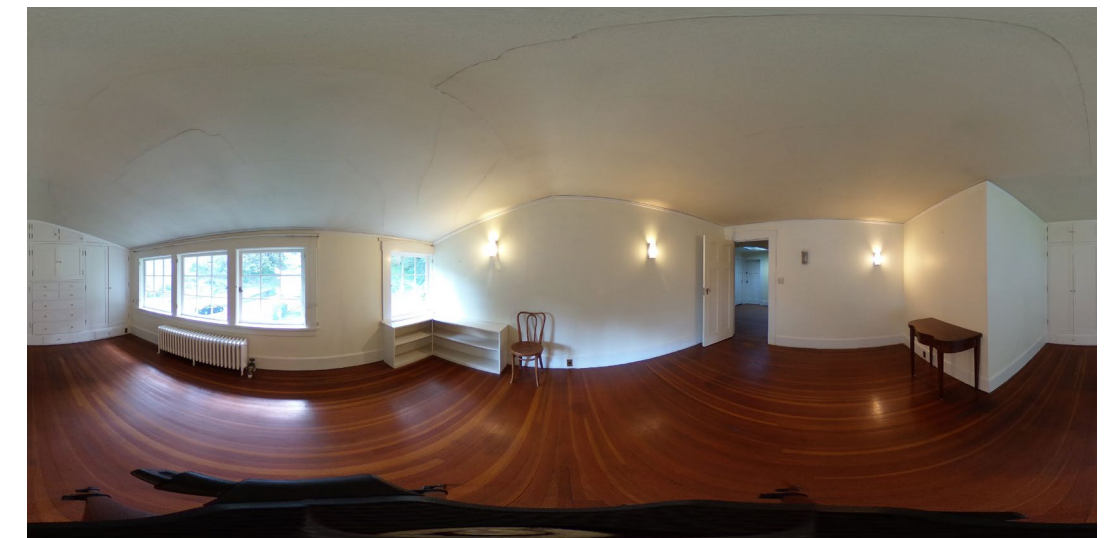
Figure 406. Fish-eye thumbnail of 360 camera image. See <https://data.cob.org/tours/planning/woodstockhistoricstructuresreport/>

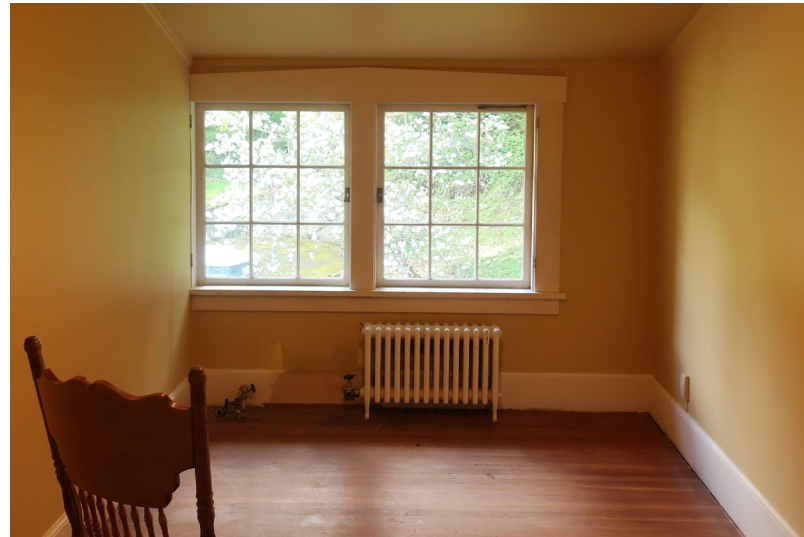
Figure 407. View looking east.

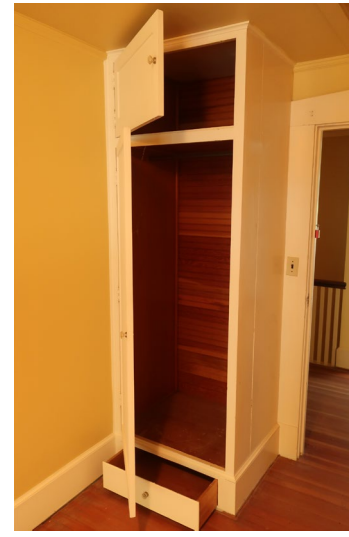
Figure 409. Detail of open wardrobe with stained fir lining.

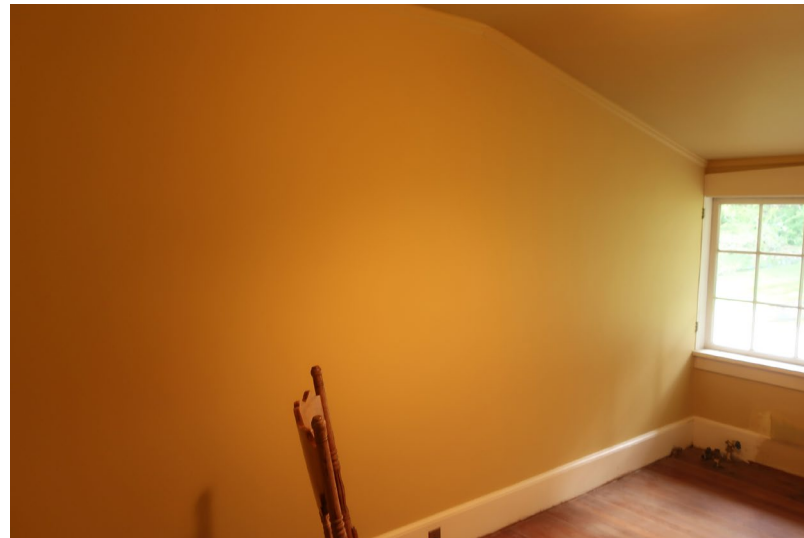
Figure 410. View looking north.
