HENDERSON HOUSE

HISTORIC STRUCTURES REPORT

Published: May 6, 2014.

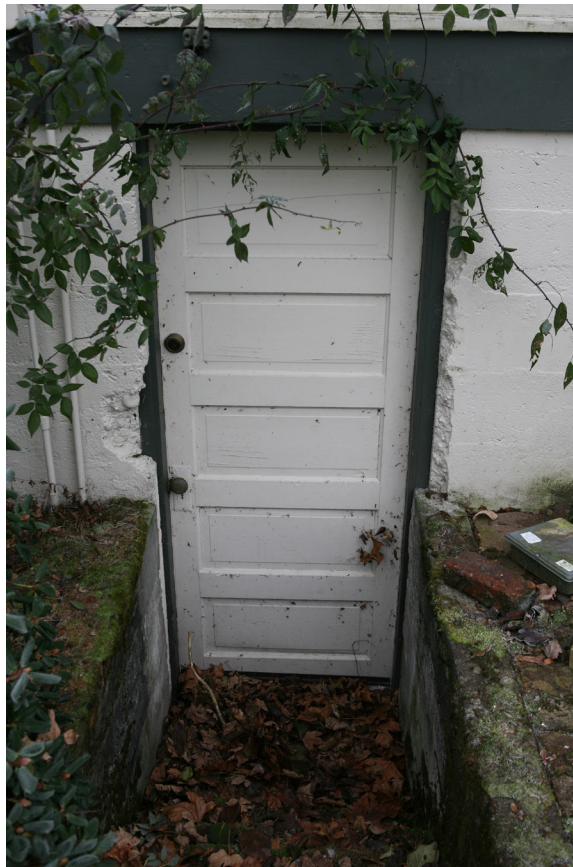
CP 33. Rear porch detail. Paint deterioration along the rear facade. Source: Artifacts Consulting, Inc.

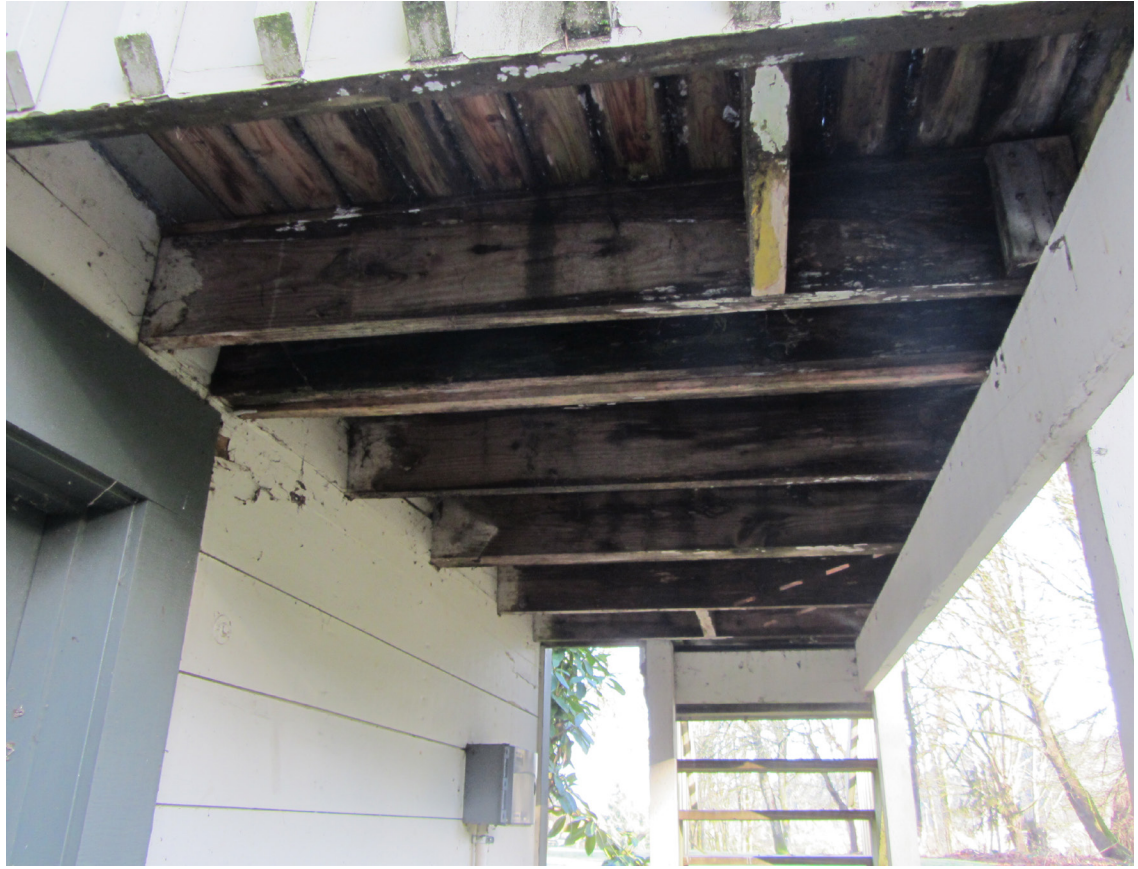
CP 36. Detail of front porch condition issues. Source: Artifacts Consulting, Inc.

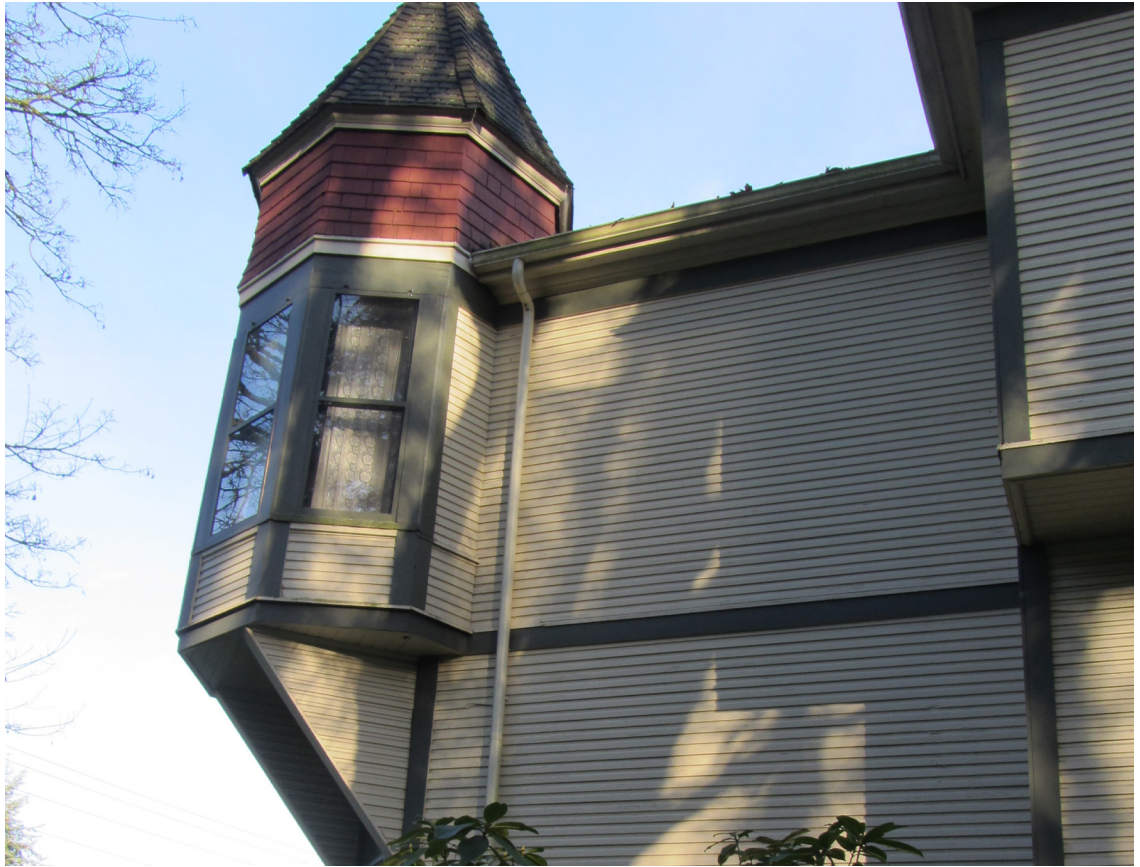
CP 38. Leaf debris collecting in gutter. Source: Artifacts Consulting, Inc.

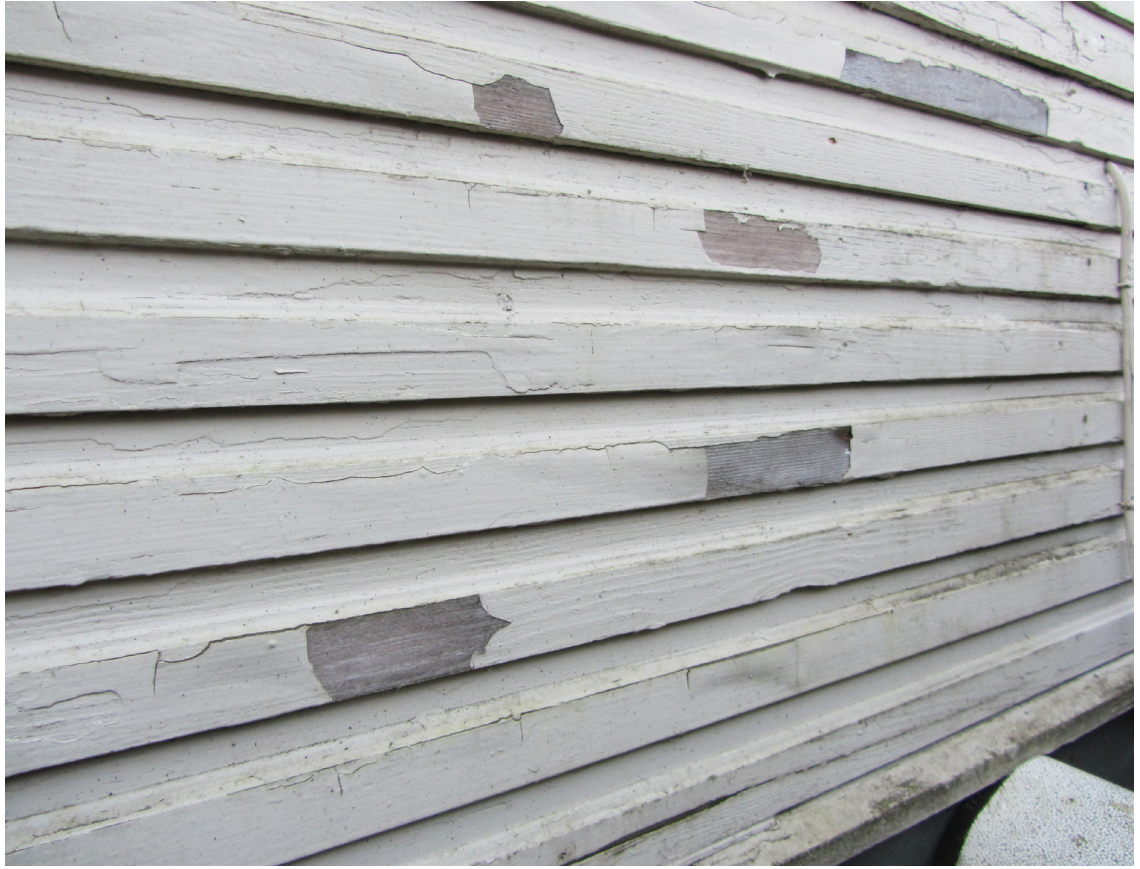
CP 37. Deteriorated paint. Source: Artifacts Consulting, Inc.

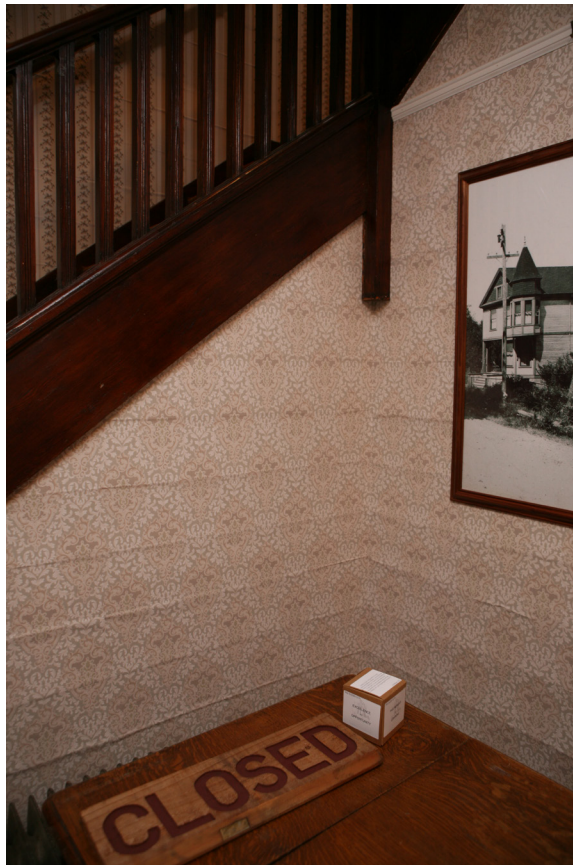
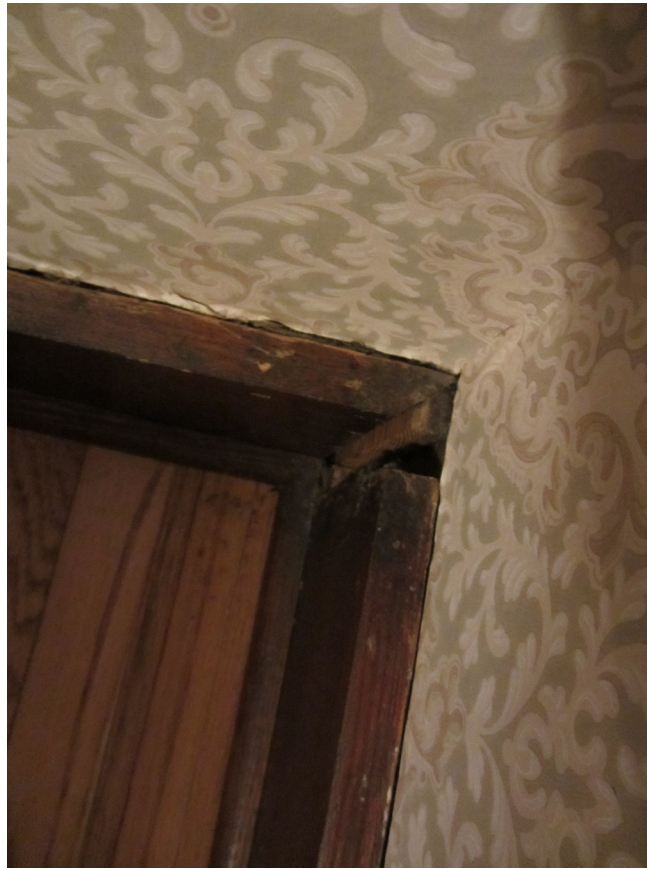
CP 40. Missing end piece on stair newel. Source: Artifacts Consulting, Inc. CP 39. Baseboard detail, missing corner piece. Source: Artifacts Consulting, Inc.
