HISTORIC STRUCTURE REPORT

ST. EDWARD'S SEMINARY KENMORE, WASHINGTON

Prepared by Bassetti Architects

DRAFT September 28, 2007

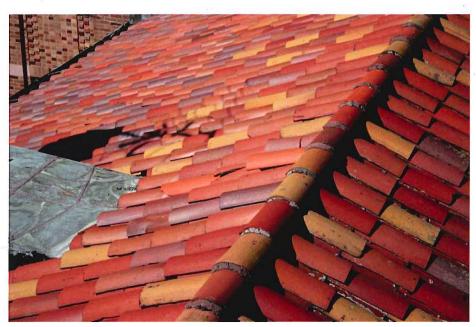
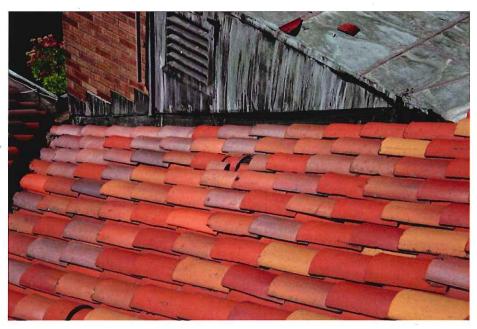
The roofing tiles themselves appear in fair condition with some limited breakage. The condition of the underlayment and fasteners is not known and should be the subject of further investigation. The copper flashing material, copper, appears to be in fair condition. Signs of water penetration in the building below and adjacent to flashing structures, deformation of copper and large areas of asphalt compounds applied to flashing, however, indicate a broad scope of mechanical failure.

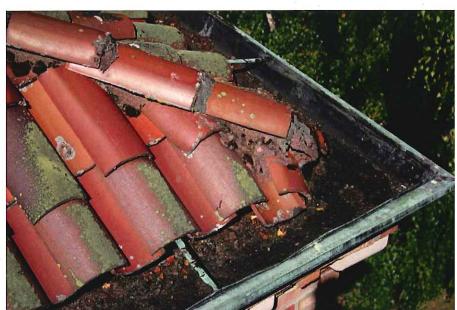
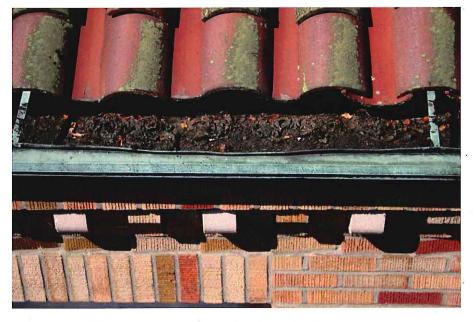
The gutters, like other copper flashing structures, show evidence of wide spread leaking with water migrating between the structural wall and exterior cladding and into the interior of the building. Water migration associated with these structures appears at various points along their length, but is often particularly prevalent at the connections to leaders. The leaders are internal to the building. Some show signs of leaking. The leaks are most prevalent at the upper floors. It is not clear what percentage of the leaking occurs at the joint with the gutter and what percentage is the result of actual leaks in the cast iron leaders. The patterns of water damage in the building strongly suggest that the former is a greater

Issues with the site drainage structures (discussed at more length later) are clearly exacerbating water infiltration related to gutters and leaders. It is reported by the owner that in heavy rains water actually gushes from the leader heads and spills out over the edge of the gutters. Gutters and leaders are gravity systems, when they are pressurized with standing or upward moving water even small leaks can cause a big impact.

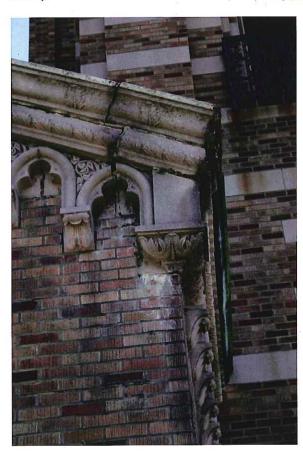
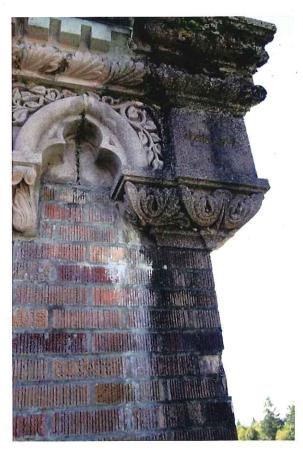
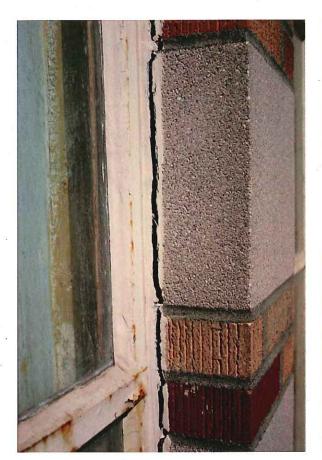
Where unaffected by water, the masonry is in good condition. The original tapestry brick is solid and the pointing in good condition. The cast stone is generally sound and details remain crisp. The exceptions are areas where water has migrated. In these areas a broad area of efflorescence occurs with a smaller region of black biological growth within it. In larger joints and crevices and in less sunny areas the biological growth includes moss, fern or other plants. In limited areas some displacement of the facade cladding occurs. These are most notable at window heads and narrow pilasters where the cladding is not as supported by the adjacent fabric. These displacements are likely early signs of failure in the ties between the structural wall and cladding

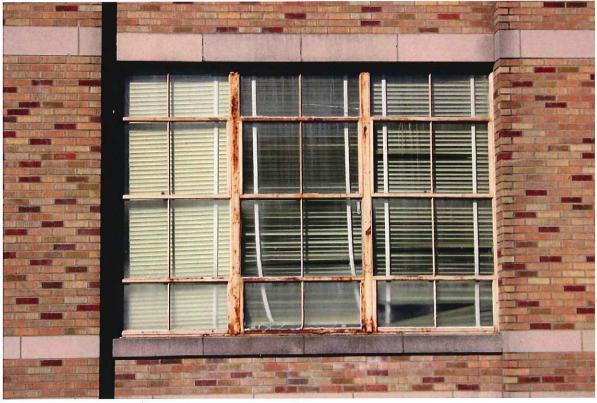
Where unaffected by water, the steel windows are in fair condition. The steel is rusting and paint loss is common, but the bulk of the profile remains intact. Again, the exceptions are areas of water migration. Accelerated rust occurs at points of water damage. Rust expansion results in difficulty closing operable sashes and in some instances sashes are rusted open. Some windows have rusted to the point of total loss.

Some Ground Floor sash are rusted open and the grade is only inches from the open window. This is an optimal entry point for animals.

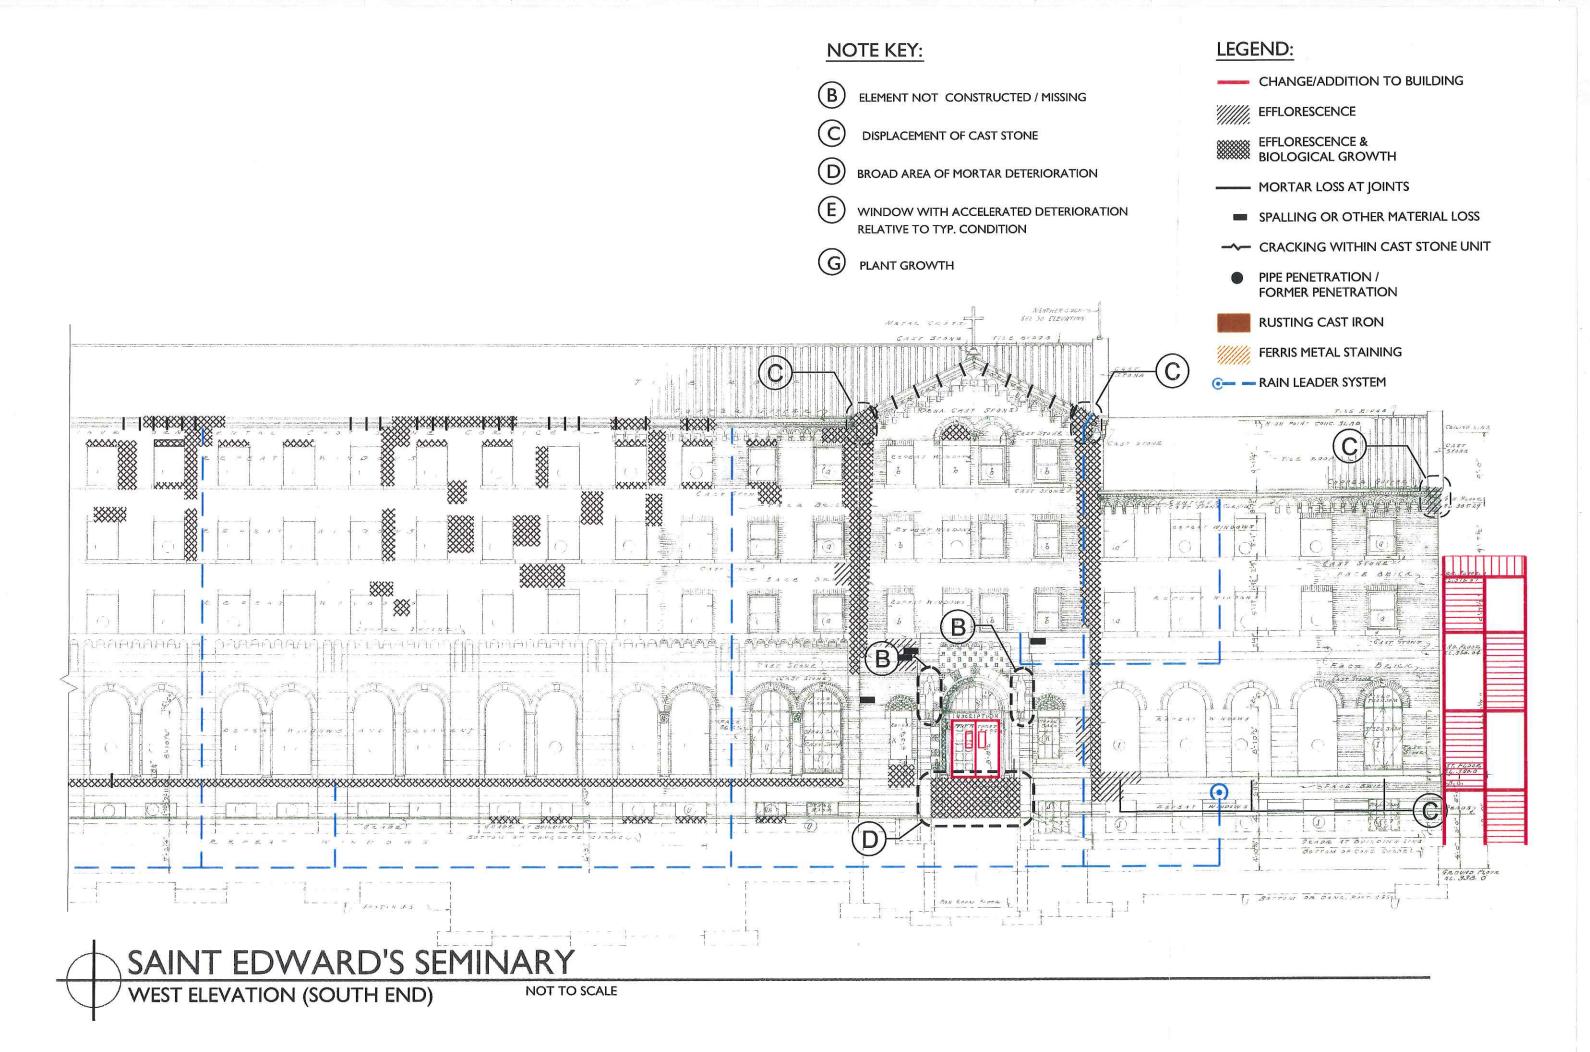
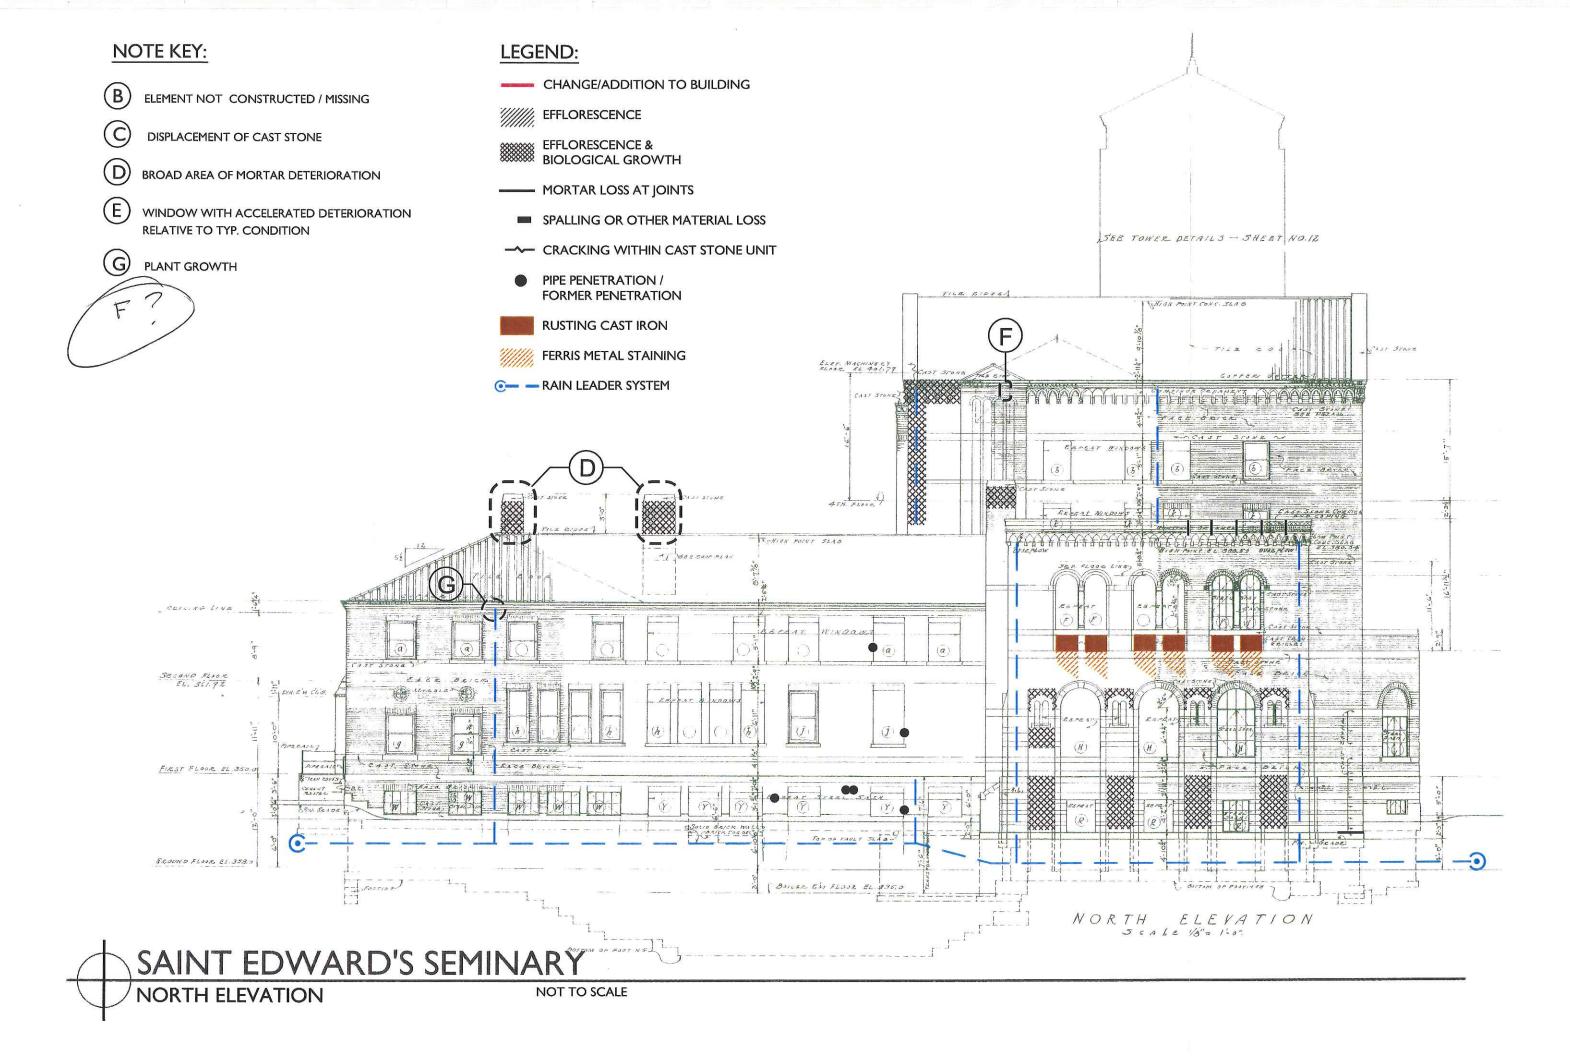
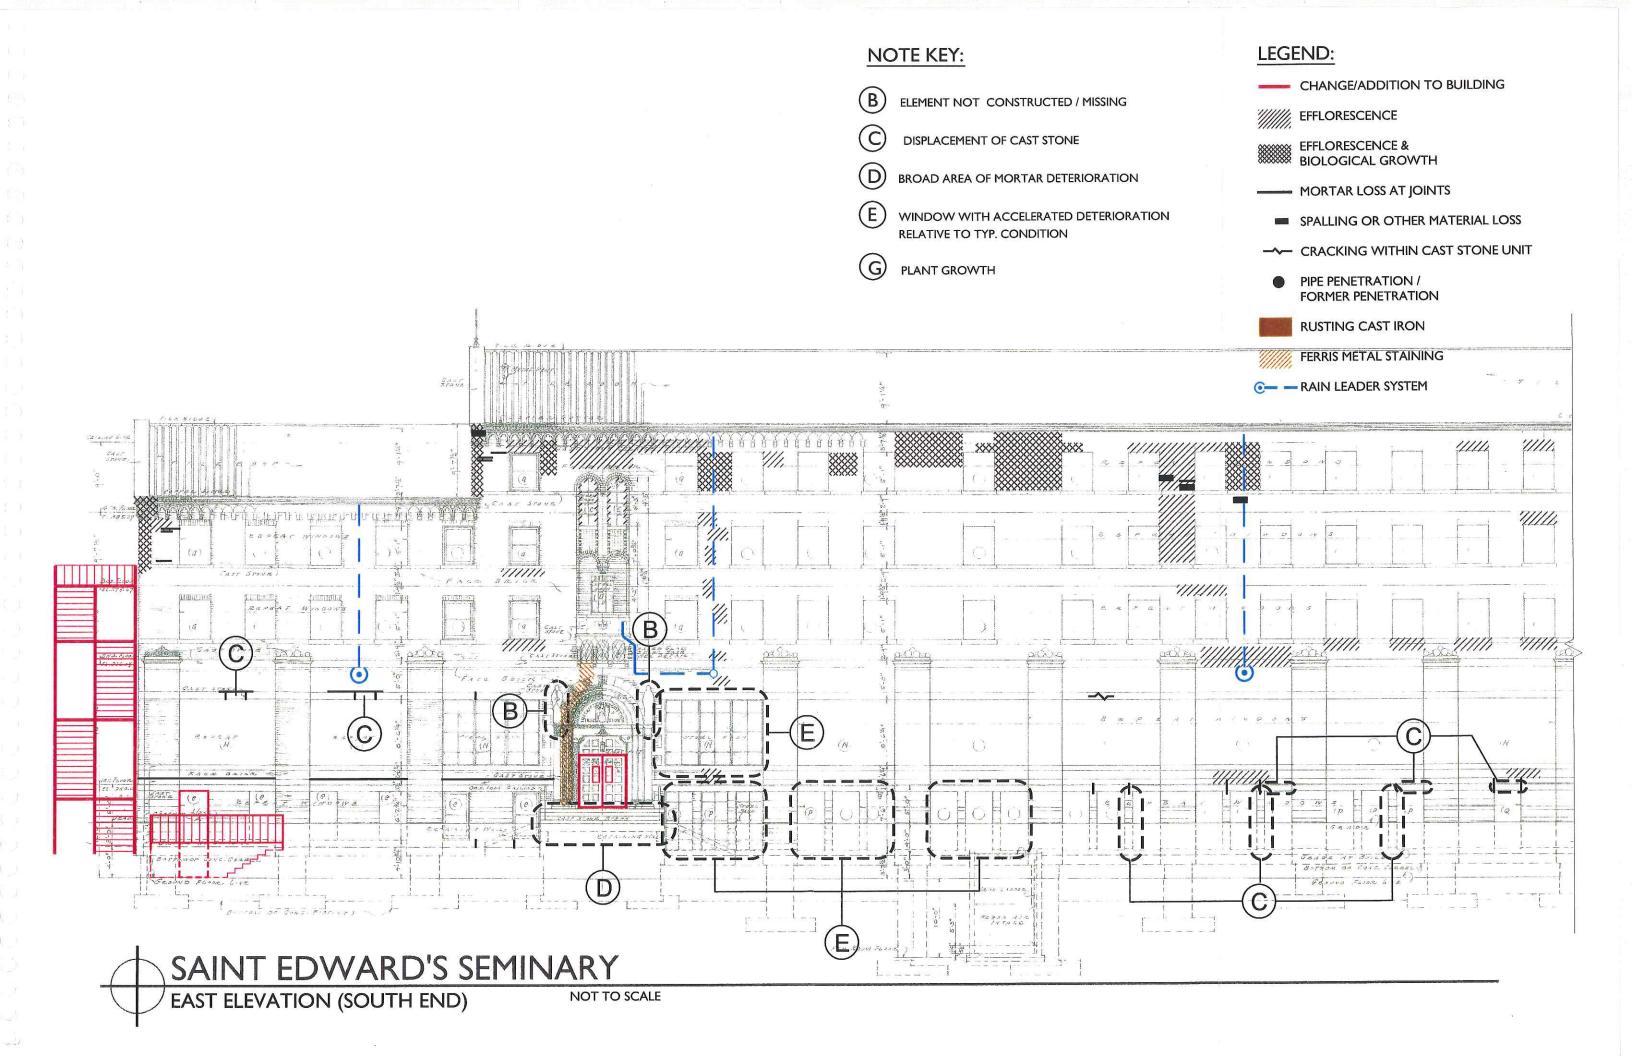
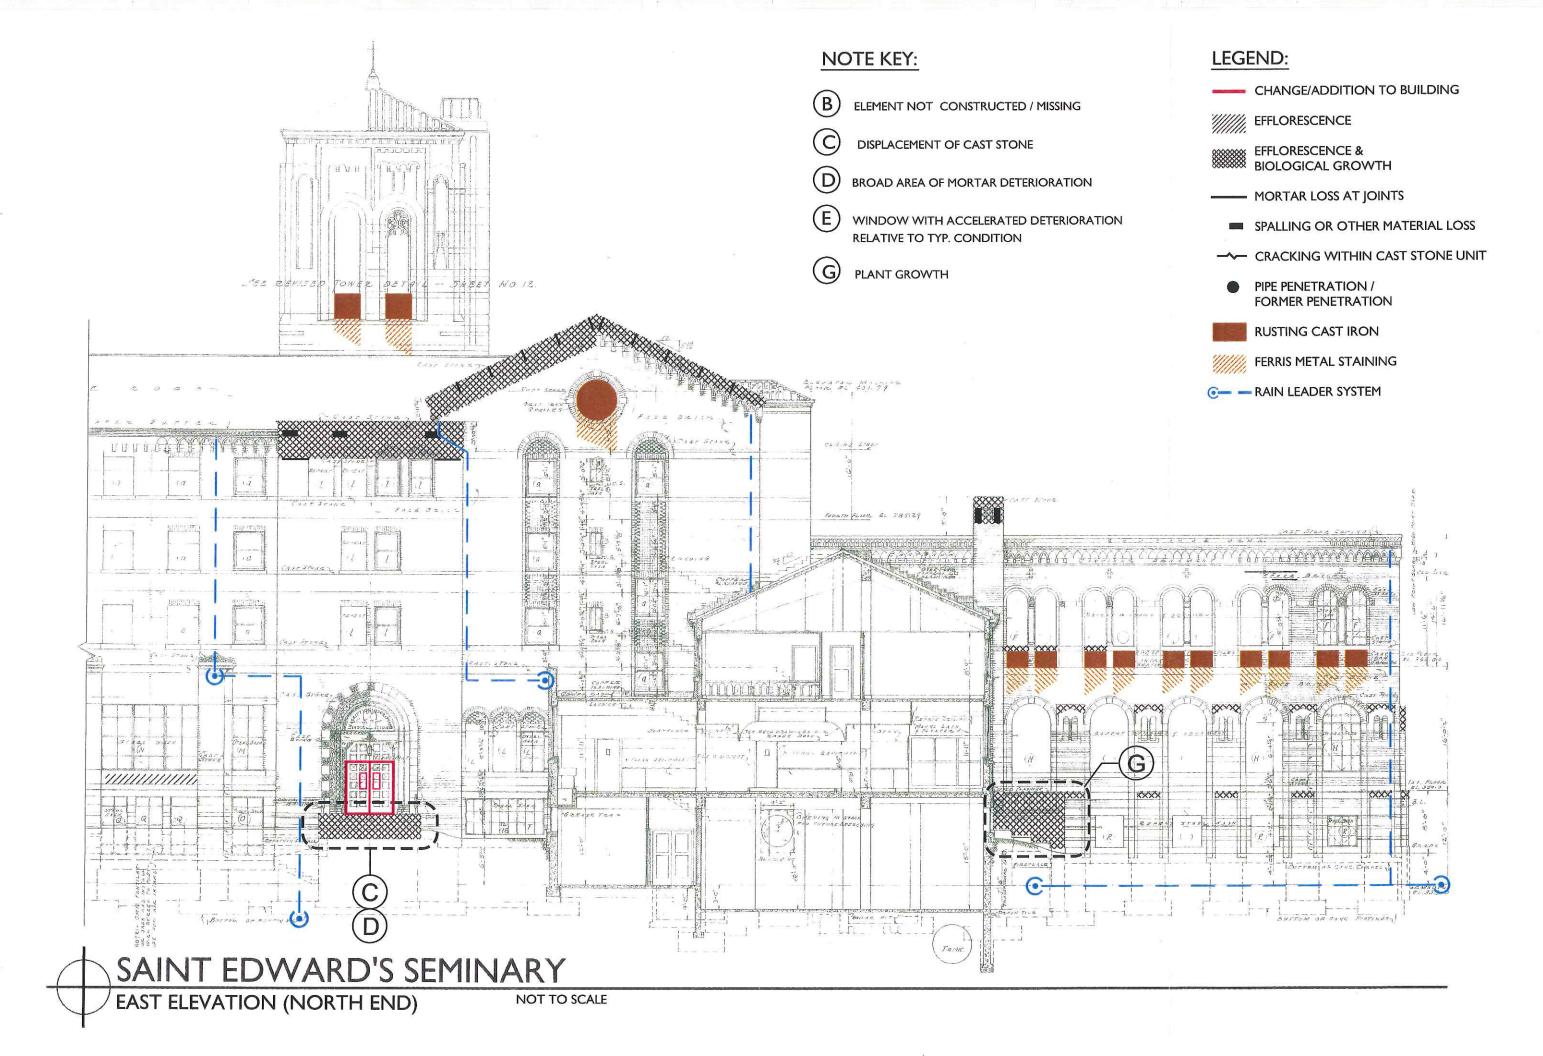
- (B) ELEMENT NOT CONSTRUCTED / MISSING
- C DISPLACEMENT OF CAST STONE
- D BROAD AREA OF MORTAR DETERIORATION
- E WINDOW WITH ACCELERATED DETERIORATION RELATIVE TO TYP. CONDITION
- G PLANT GROWTH

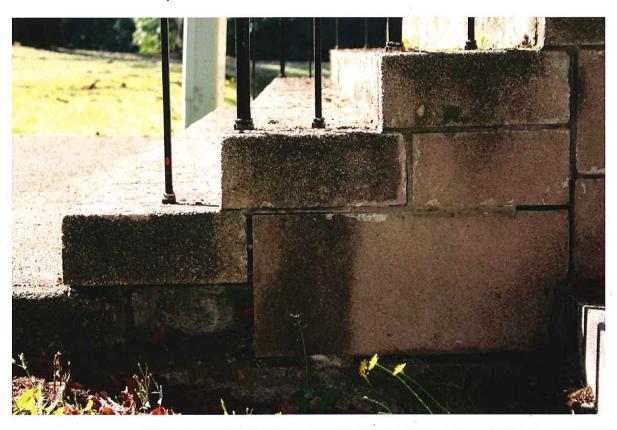
All exterior stairs have badly deteriorated mortar and some loose treads.

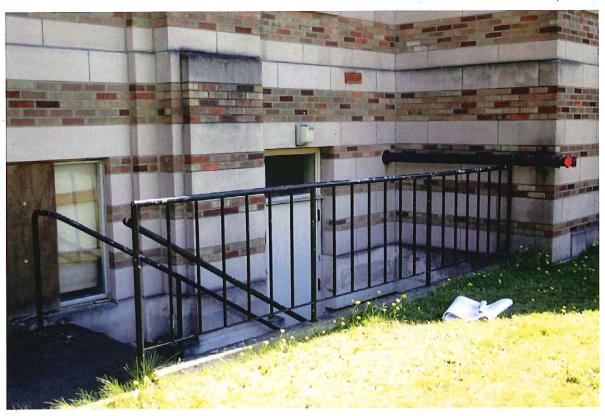
Two new exits and associated areaways were added in the 1776 egress work. The materials are in fair condition, but they are not of the same quality or finish as the original construction. Additionally, these exits do not fully satisfy current code requirements.

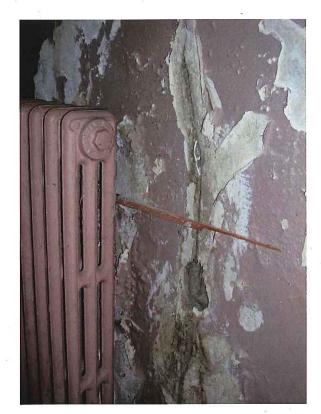
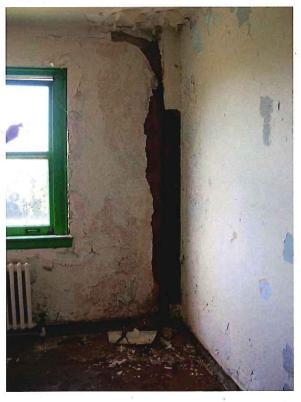
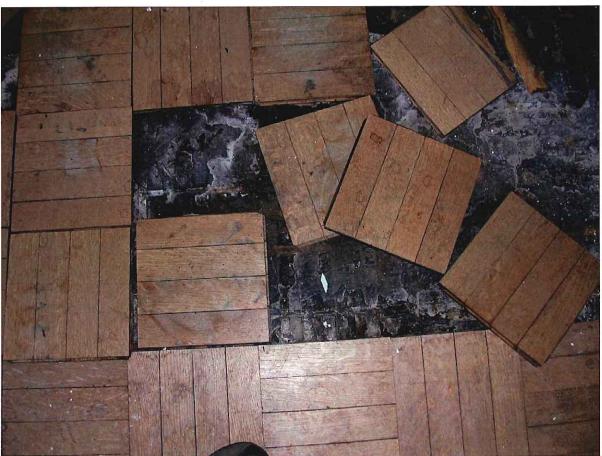
Water infiltration, both exterior sources and interior plumbing have caused the greatest amount of interior damage. In affected areas staining, plaster deterioration and loss is typical. Rust stains, from metal lath are evident on plaster finishes. Rot and material loss is occurring on wood finishes. Rubber tiles are cupped and delaminated from the floor. Linoleum is stained. And, stone stools and bases are showing displacement, presumably from expansion of underlying materials.

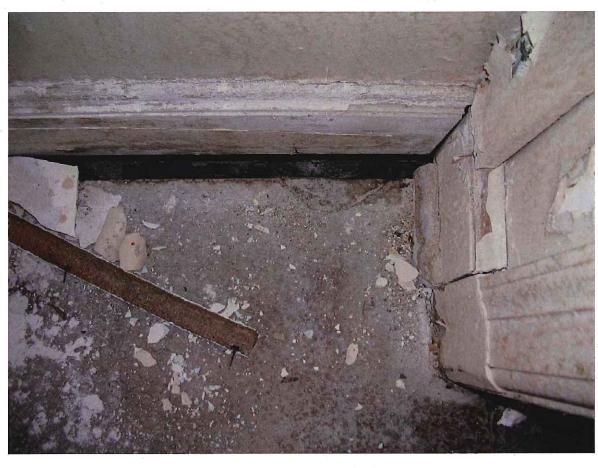
Seismic events have resulted in damage to finishes. These cracks are the result of finish materials that are more brittle than the structure and are not necessarily indicative of structural damage. Cracks are typically small and appear in the same pattern or formation room after room especially, on upper levels of the South Wing. The kitchen also has several cracks in tile finishes. Particularly notable is surface damage associated with seismic movement at the expansion joint between the building center and South Wing. The joint is visibly displaced by a couple inches, especially on upper floors.
