Preservation Tech Notes

NUMBER 20

Aluminum Replacement Windows for Steel Projecting Units with True Divided Lights and Matching Profiles

Sears Roebuck and Company Mail Order Store (Landmark Center) Boston, Massachusetts

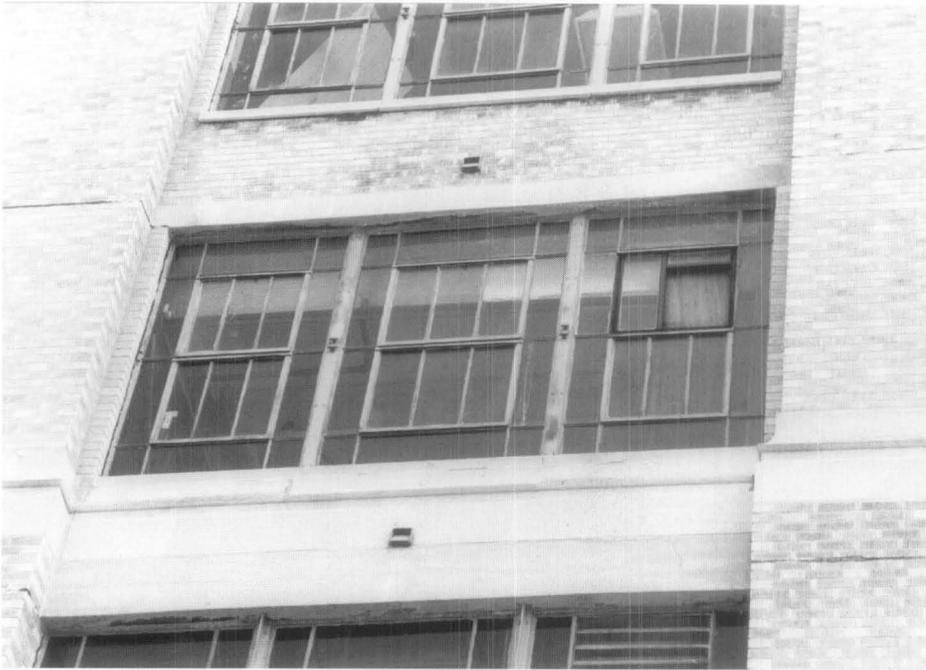
Figure 1. Many of the original Lupton windows incorporated a pair of stacked ventilators that projected outward. The vents were centrally located within a multi-light frame each of which was set either individually or in groups of two or three. Photo: Bruner/Cott & Assoc., Inc.

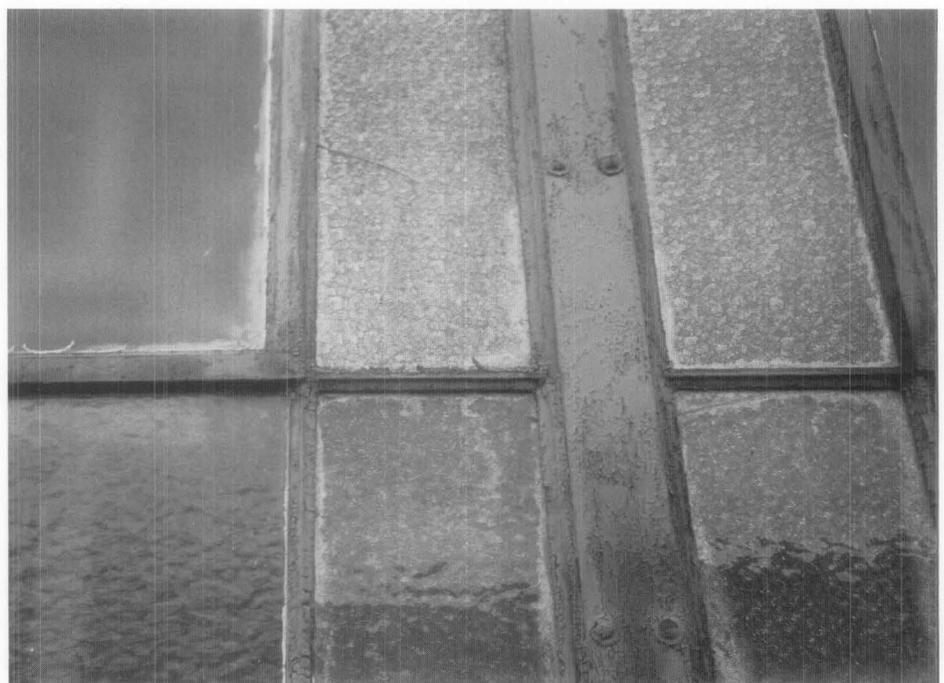
Figure 2. Narrow sightlines, ventilator weathering flanges and mullion boltheads were all distinguishing features of the original steel windows. Photo: Bruner/Cott & Assoc., Inc.

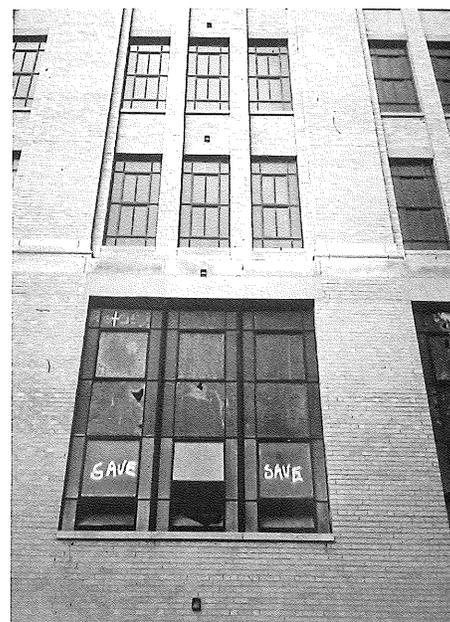
Figure 4. Among the retained and repaired original windows were these large units on the second floor level. Photo: Bruner/Cott & Assoc., Inc.

Existing historic windows in areas that were not to be continuously occupied, such as common lobbies and fire stairwells, were retained and repaired in situ. In addition, all of the tall windows on the second level (which would be devoted to retail functions) were repaired and reglazed where needed with historic glass salvaged from other locations in the building (see figure 4).

While the new windows were being manufactured, a local contractor began the three month long process of stripping, repairing, repainting and reglazing the historic second floor windows and other retained units in stairwells and other non-office locations. As the new windows began to arrive in Boston, the general contractor removed the original units that were slated for replacement and a team of eight to ten workers started installing the new windows.

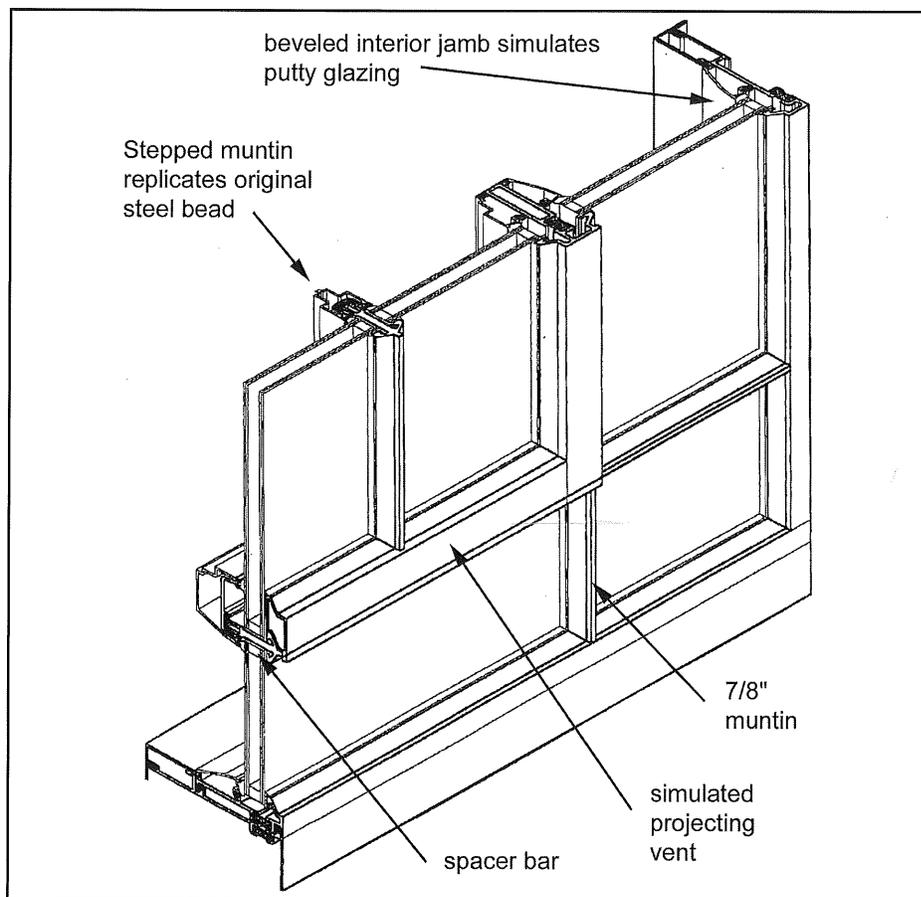
Figure 3. Isometric drawing of aluminum replacement window. Drawing: Greg Gibson.

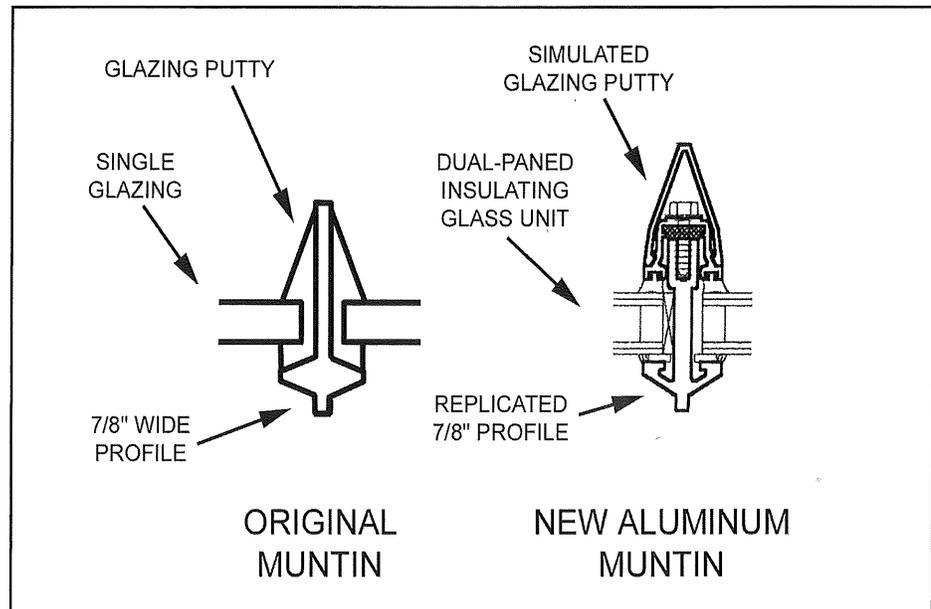
replication of the original 7/8" muntin (see figure 5). Substituting a dark bronze anodize finish further reduced the visibility of the spacer making it appear as a shadow line when viewed from an angle.

Figure 5. The replacement aluminum muntin accurately replicated original profiles while accommodating insulating glass and thermal stops. Drawing: Bruner/Cott and Custom Window.

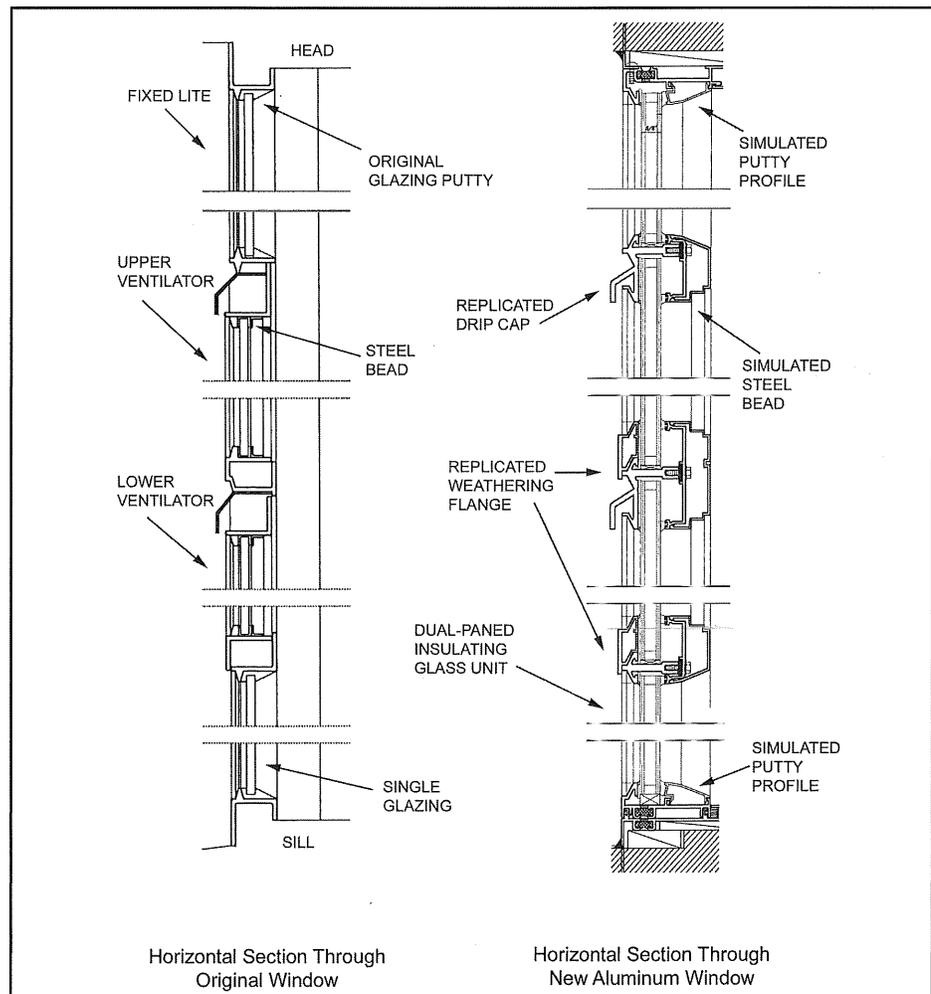
the original interior putty profiles, the fixed-light muntins were tapered to the same 1/8" thickness of the original sections while stepped muntins were used in the central vent where steel beads had originally secured the glazing. Jambes in the replacement units were also beveled to recall the shape of the old glazing putty (see figure 6).

Figure 6. Sections of original and replacement windows. Drawings: Bruner/Cott and Custom Window.

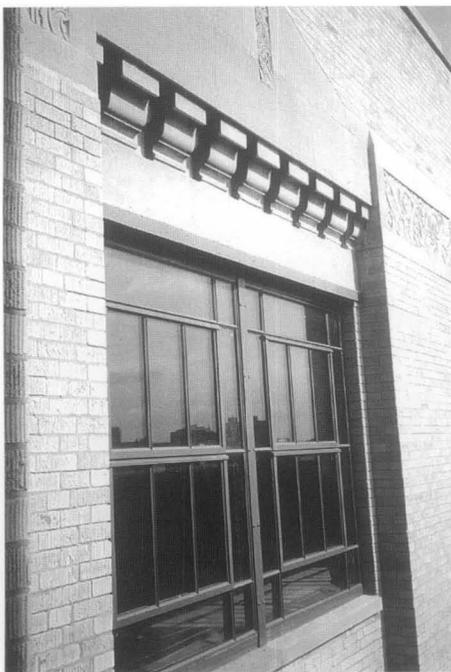
Figure 7. Installed replacement window. Photo: Bruner/Cott & Assoc., Inc.

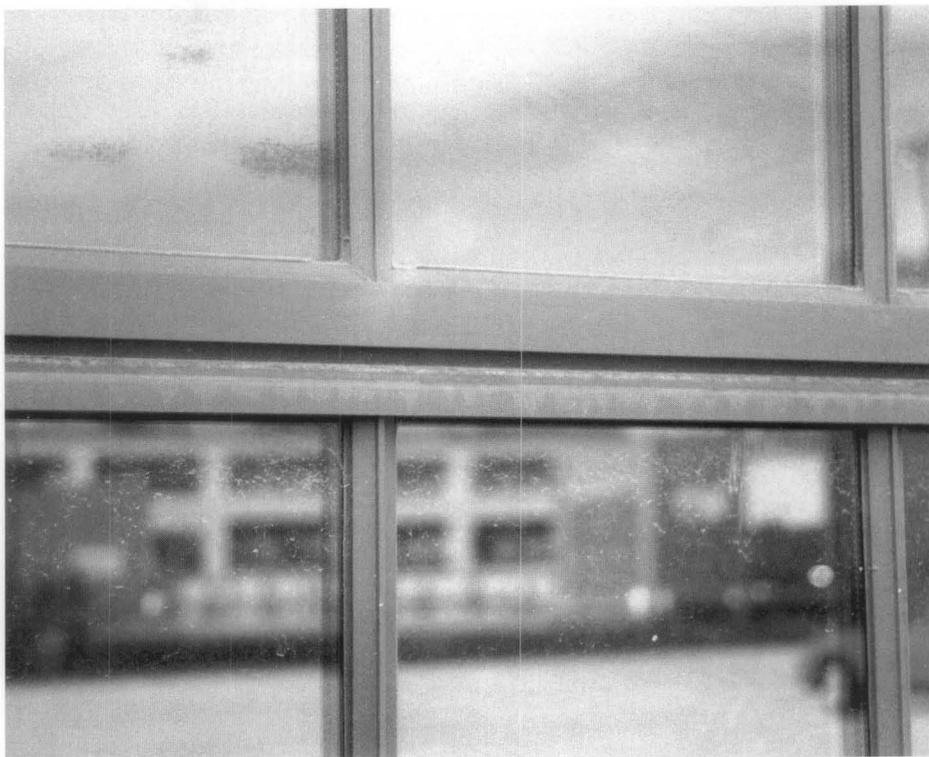
Figure 8. A close up view of the replacement window showing the replicated ventilator drip cap and narrow muntins. Photo: Bruner/Cott & Assoc., Inc.

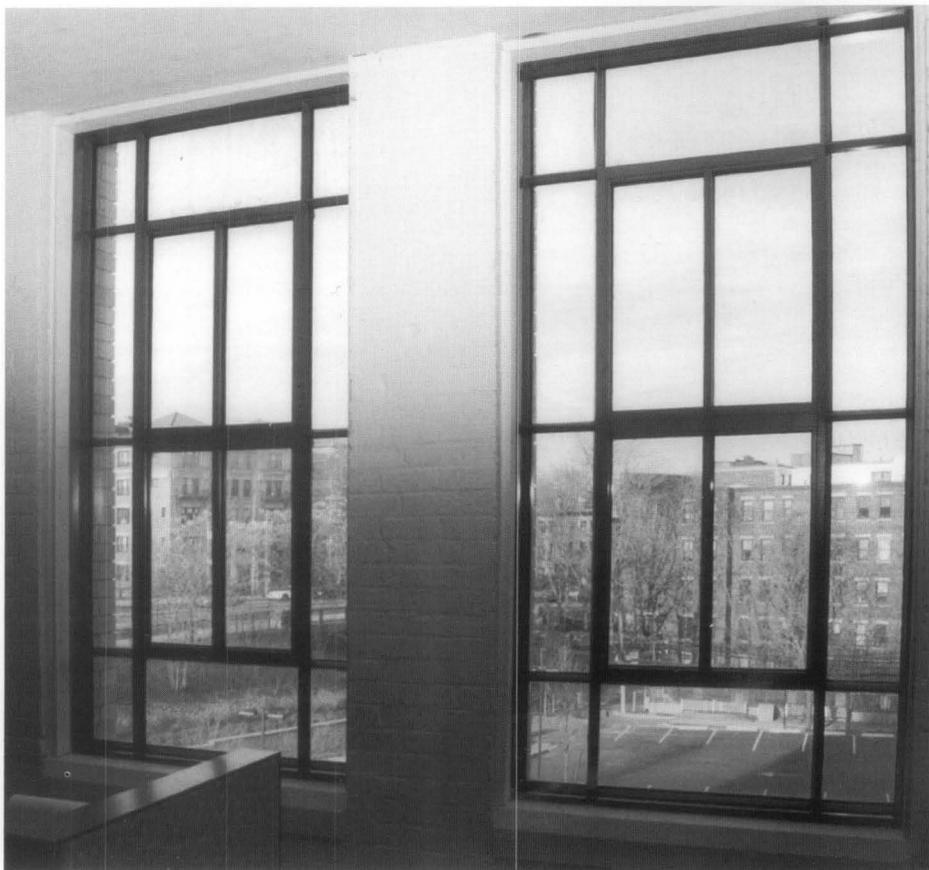
Figure 9. The interior profiles of the original windows were accurately reproduced in the aluminum replacement units. Photo: Bruner/Cott & Assoc., Inc.

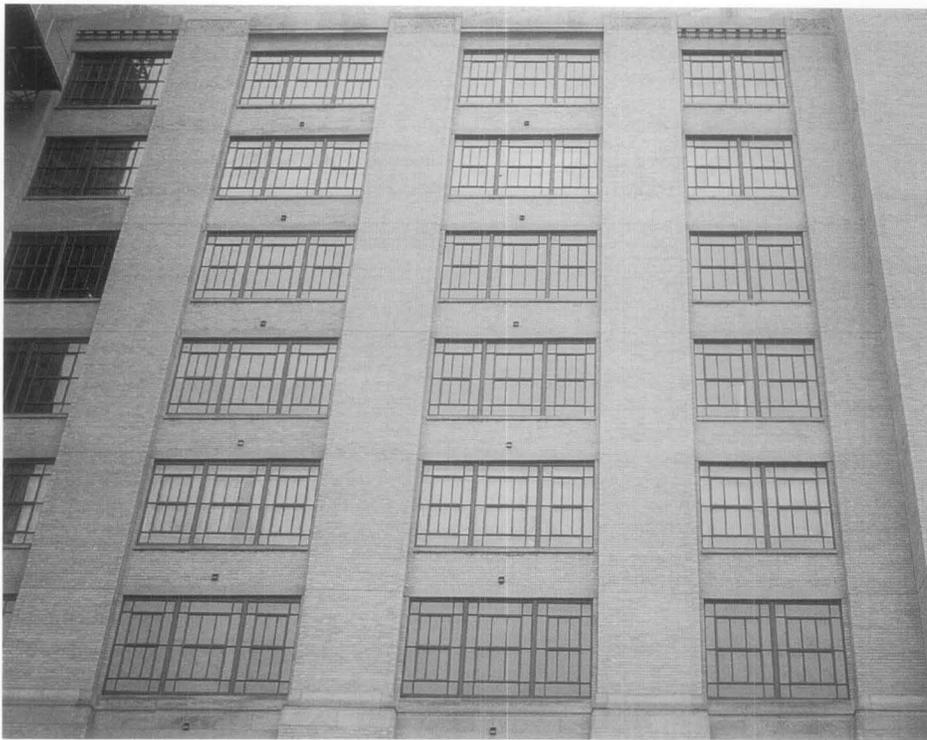
Figure 10. The replacement windows designed for the Sears building rehabilitation met energy efficiency and aesthetic goals while providing for the continued historic appearance of the structure. Photo: Bruner/Cott & Assoc., Inc.
