COLONIAL WILLIAMSBURG

PRESERVATION

Tech Notes

Interior Storm Windows: Magnetic Seal

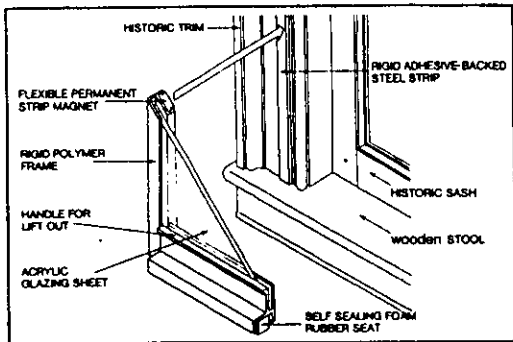
Figure 1. The interior storm window system chosen consisted of a clear acrylic glazing sheet set into a polymer frame that adhered to the existing window trim through use of a magnetic seal. Drawing: Christina Henry.

The interior storm window system selected by Colonial Williamsburg consisted of a clear acrylic sheet in a polymer frame that contained a flexible magnet on the back side. When the storm window was set against an adhesive-backed steel strip pre-attached to the historic interior window trim, a magnetic seal was formed

A slightly different polymer frame configuration was used for the bottom of the storm window in cases where a window stool existed. The sill framing was attached to the acrylic sheet like the typical polymer frame, with the exception that the bottom was extruded with a 1/4" U-channel that had a latex gasket glued in place to form a tight seal (see figure 1).

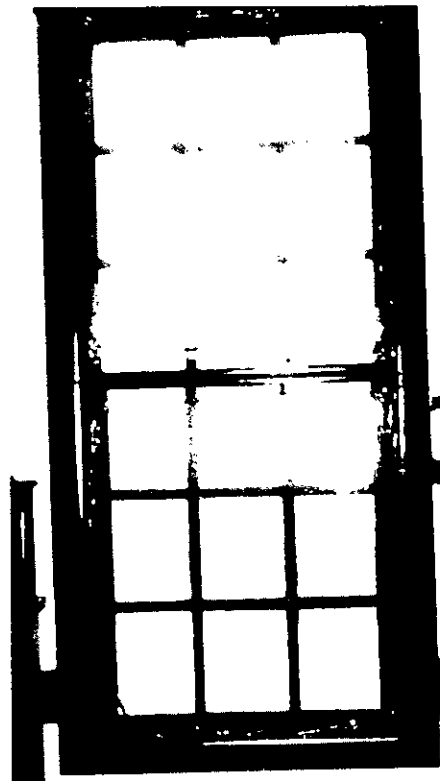
Figure 2. The thin-framed storm unit is shown attached by a magnetic seal to the existing trim. The protective film on the acrylic will later be removed. Photo: Tom H. Taylor.

Most of the historic windows at Colonial Williamsburg had been trimmed with a stool so that a magnetic seal was obtained only on three sides of the polymer frame (see figure 2). A small metal angle frame or wood stop could have been added to the stool to permit a magnetic seal on the fourth side but such alterations were avoided.

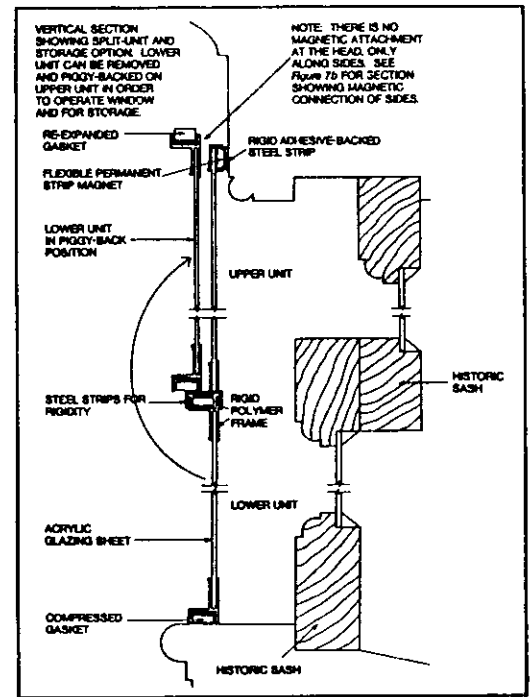
Figure 3. Vertical section showing a split unit in place and the option of piggybacking the lower unit onto the upper for storage during the summer. See figure 6 for detail on the manner of attaching the piggybacked unit. Drawing: Christina Henry.

The storm window design most commonly used at Colonial Williamsburg consisted of a separate upper and lower part with an interconnecting meeting bar. This style was used in windows where the original double-hung sash needed to remain operable. A split-unit interior storm window has an advantage over a single unit in that it did not need to be removed and stored in the summer months. By attaching the lower unit to the upper unit via a magnetic seal, the storm window could be left in place, thereby avoiding problems of storage and reducing the chances of the acrylic sheets being scratched or warped (see figure 3).

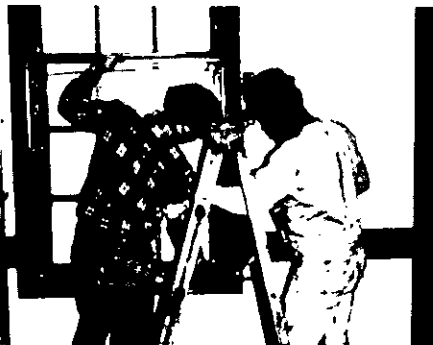
Figure 5. The meeting bar of the split storm unit was located adjacent to the historic meeting rail in windows where the upper and lower sash were the same size. Photograph shows the installers checking to make sure the lower unit will properly align. Photo: Tom H. Taylor.

The placement of this meeting bar primarily depended on its visual impact on the outside. Where the historic upper and lower sash were the same size, the meeting bar of the interior storm was lined up as closely as possible behind the meeting rail of the historic sash (see figure 5). In a number of windows, however, the pane configuration made it harder to disguise the appearance of the interior storm meeting bar from the outside. These windows had 6 panes over 9, the bottom sash being considerably larger. In such cases, it was specified that the bottom of the top storm unit would stop at the first horizontal muntin below the meeting rail on the historic sash.

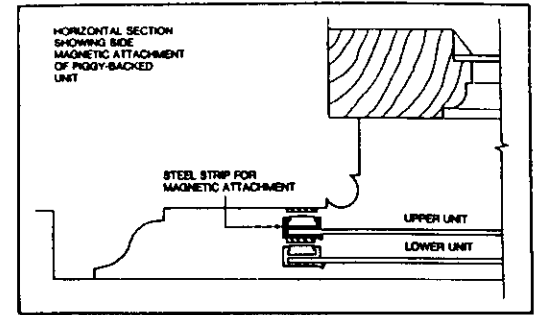
Figure 6. Horizontal section of the upper storm unit shows how with an additional adhesive backed steel strip added to the sides of the upper storm frame it was possible to piggyback the lower storm unit for storage purposes during the summer. Drawing: Christina Henry.

To allow for the storage of the lower unit, an adhesive-backed steel strip was attached to the face of the vertical polymer frame on the upper unit. Thus the two vertical framing members in the upper unit had a magnet on one side and a steel strip on the other. The addition of the metal strip allowed the lower unit to be magnetically attached to the steel on the upper unit when in a storage position (see figure 6).

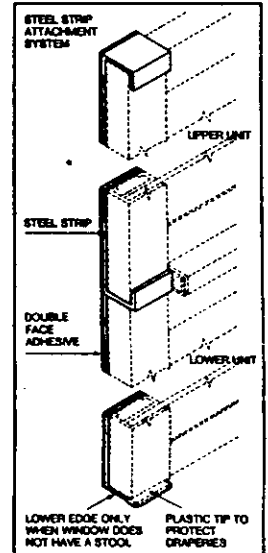
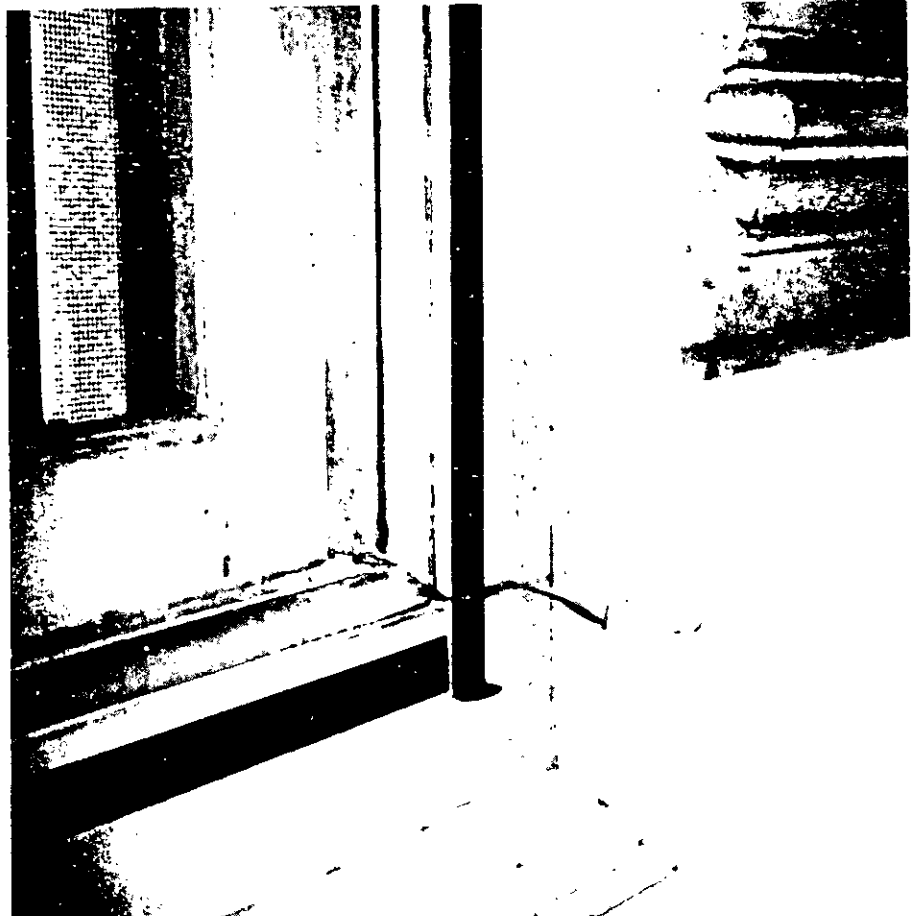
Figure 7(a) In cases where there were no stools and also where a split unit was used to facilitate self-storage, small "shelves" were made in the vertical steel strips to deter creeping. Photograph shows a 90 degree angle at the bottom of the vertical steel strip in a situation where there was no stool. Photo: Tom H. Taylor. (b) The adjacent drawing shows the two "shelves" used with split units as well as a top safety catch formed at the end of the steel strip. Drawing: Christina Henry.

To keep the upper unit from creeping downward due to the additional weight of the piggybacked lower storm, a $\frac{3}{8}$ " shelf with a $\frac{3}{16}$ " upward turn was formed in the two wood-adhering vertical steel strips at a point aligning with the bottom of the upper unit (see figure 7).

A similar feature was added at the bottom of both single and split units when no stool existed in the historic window. To deter possible creeping and, as a safety measure, the bottom of the vertical steel strip was turned 90 degrees outward to act as a small shelf for the storm window. A small plastic tip was attached to the sharp edge of this shelf to protect draperies.

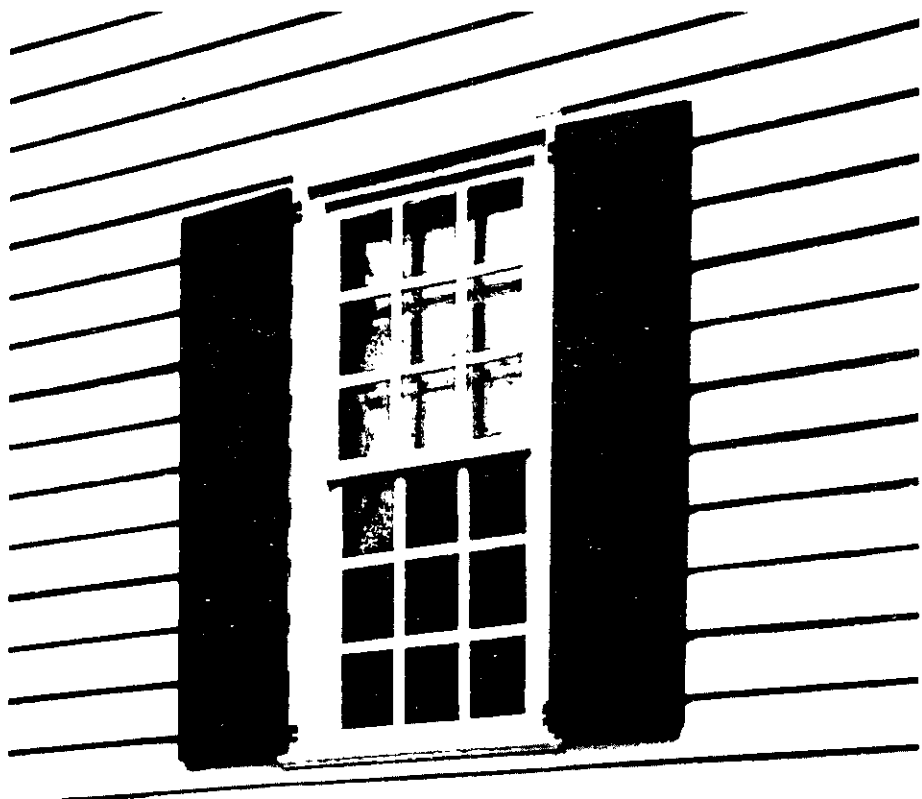
The unobtrusive nature of these storm windows is an advantageous feature, along with the fact that no physical damage or alteration to the original window is required (see figure 8).

Figure 8. The unobtrusive interior storm window required no physical damage or exterior visual alteration to the original window. Photo: Tom H. Taylor.
