## Evaluating Non-Historic Exteriors

Contents: Assessing Integrity 1 | Simulated Masonry 2 | Manufactured Weatherboard 4

The examples in this inaugural issue of the *Best Practices Review* look at assessing the integrity of buildings with non-historic exteriors. The illustrated examples are all listed properties in the National Register.

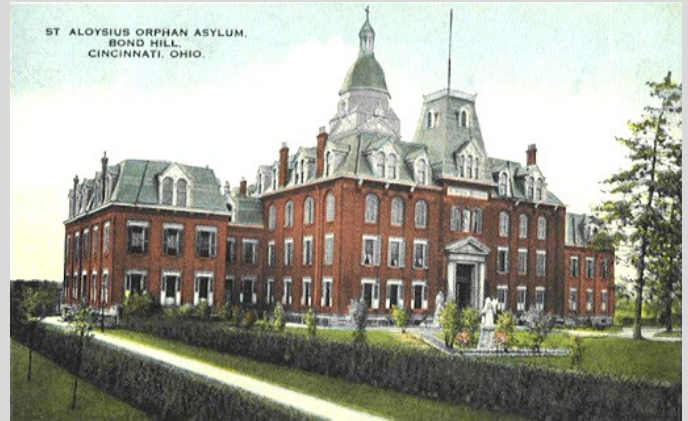
Postcard showing main building (1856-61) and wings (1869). Courtesy of Cincinnati Public Library, Hamilton County.

The nomination documents that in 1953, the building exterior's soft brick was deteriorating, and Perma-Stone was added. The color chosen closely matched the orphanage's 1923 limestone chapel. Although the application covered brick walls and stone lintels and sills, important character-defining features of the exterior design were maintained by the historic institution. In addition to the mansard roof with its cornice brackets and dormers, the pedimented entrance survives along with historic window openings. The historic context describes a major remodeling of the orphanage within the period of significance. As the area of significance is social history, not architecture, the original nineteenth century design was not the reason for listing, providing greater latitude in assessing integrity.

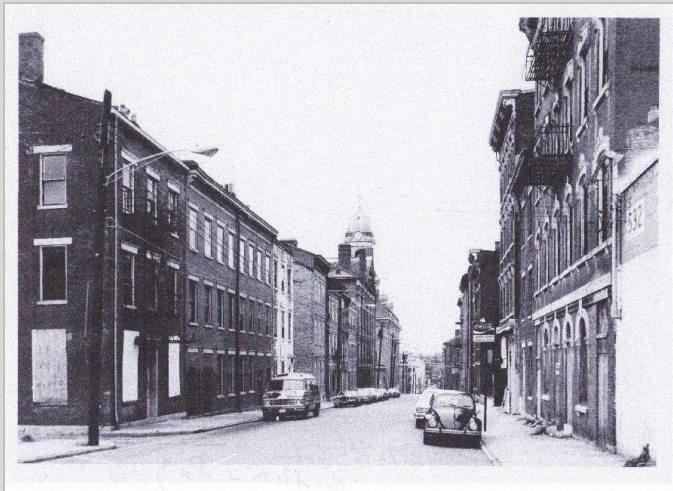
12th Street between Pendleton and Reading Road, 1983.

As the image above shows, the character of the district is defined by the large concentration of brick commercial/residential buildings built in the late nineteenth century. As is also evident in this view, the brick walls, simple cornices, and flat stone lintels are character-defining features that create the context for assessing integrity in this district.

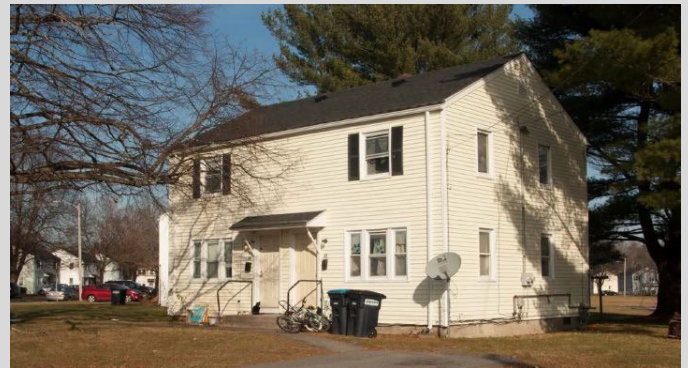
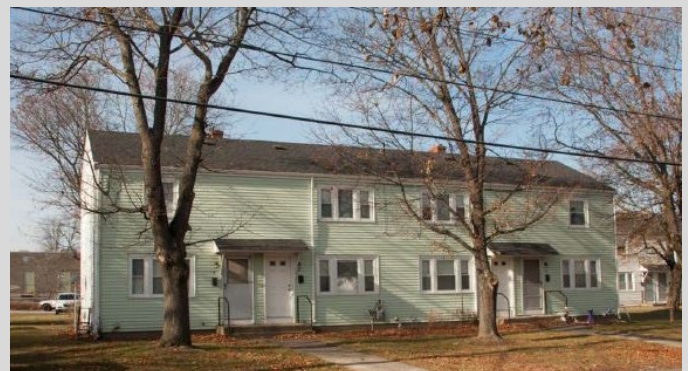
Typical housing types.

Constructed in 1942, all 90 apartment houses and the community building survive on the 29.5-acre site. In 1987, the Portland Housing Authority undertook a lead abatement program that entailed covering wood clapboard siding with vinyl siding. The Housing Authority also replaced all of the wood windows with wood/vinyl combination sash. As stated in the nomination, “[t]he character defining features of the Sagamore Village Historic District are identified in its spatial layout and repetition of forms. The similarity of scale, roof form, fenestration, plan and materials of all the buildings defines the district. The street layout, uniform housing unit setback, uniform side lots, open spaces and undefined lot lines identify the designed character of the district.” Although every building has non-historic weatherboards, the survival of all the buildings in their original form and fenestration creates an intact representation of historic Sagamore Village.

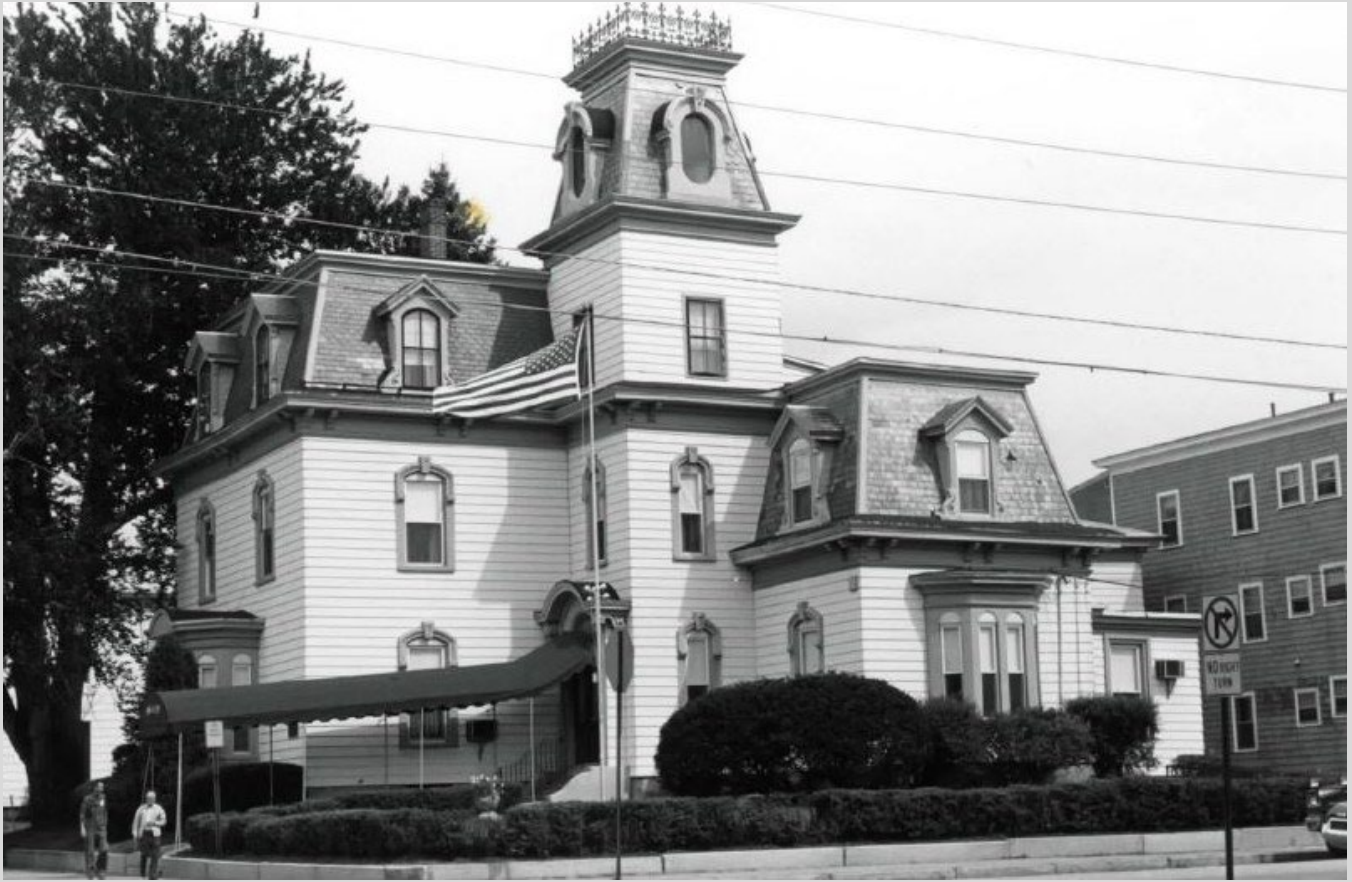
View of Wedgewood House, 1985.

The Wedgewood House, a three story building with a mansard roof and a four story tower, was built in 1873 for prominent local physician Milton C. Wedgewood. In 1955, aluminum siding was added to the exterior. The wide exposure and lack of corner boards as seen in this image were typical of aluminum siding installation at that time.

Although the siding does not contribute to the architectural significance of the property, it was installed in a manner to preserve all the known major character-defining features of the building's exterior design. These include the mansard roof and tower with slate shingles, and wood dormers and cornices, as well as wood window and door trim. As stated in the *Criteria Bulletin* at page 47, "if the historic exterior building material is covered by non-historic material (such as modern siding), the property can still be eligible if the significant form, features, and detailing are not obscured."

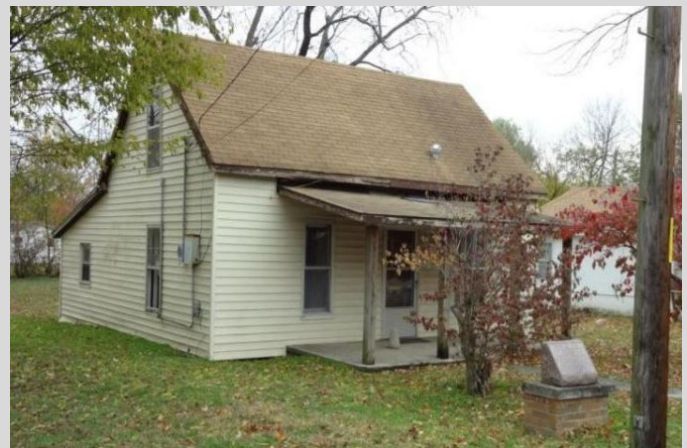
Before porch, lean-to, and contemporary siding removal, 2012.

As shown in the 2012 image, the building at that time bore little resemblance to the historic school. A historic structures report in that year documented surviving historic fabric. (Susan Richards Johnson & Associates, 2012.)

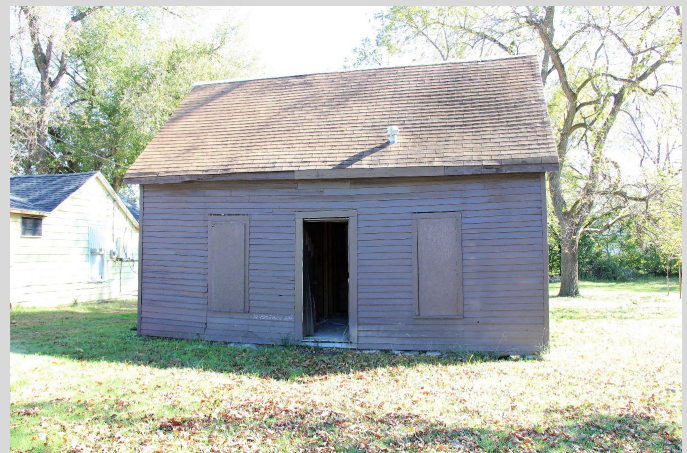
After initial rehabilitation work, c. 2016.

In 2016, restoration work revealed historic wood weatherboard, an essential physical feature as it reflects the period of use by African American students, including George Washington Carver. The porch and lean-to, part of the building's non-historic residential use, were removed at that time.
