20 PRESERVATION BRIEFS

The Preservation of Historic Barns

Michael J. Auer

U.S. Department of the Interior
National Park Service
Cultural Resources
Heritage Preservation Services

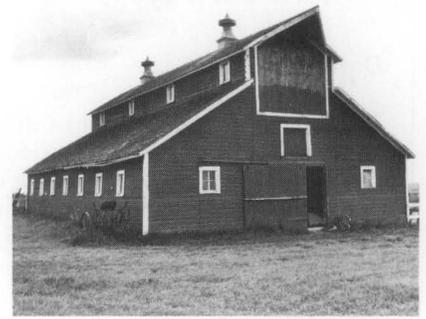
Fig. 1. Arch roof, native limestone walls two feet thick at the base, porthole window, dormers, silos, rooftop ventilators, weathervanes, windmill, fences, fields, and family pride in the builder are all components of the historic character of this Iowa barn. Photo: John Walter, Successful Farming.

From the days when Thomas Jefferson envisioned the new republic as a nation dependent on citizen-farmers for its stability and its freedom, the family farm has been a vital image in the American consciousness. As the main structures of farms, barns evoke a sense of tradition and security, of closeness to the land and community with the people who built them. Even today the rural barn raising presents a forceful image of community spirit. Just as many farmers built their barns before they built their houses, so too many farm families look to their old barns as links with their past. Old barns, furthermore, are often community landmarks and make the past present. Such buildings embody ethnic traditions and local customs; they reflect changing farming practices and advances in building technology. In the imagination they represent a whole way of life (Fig. 1).

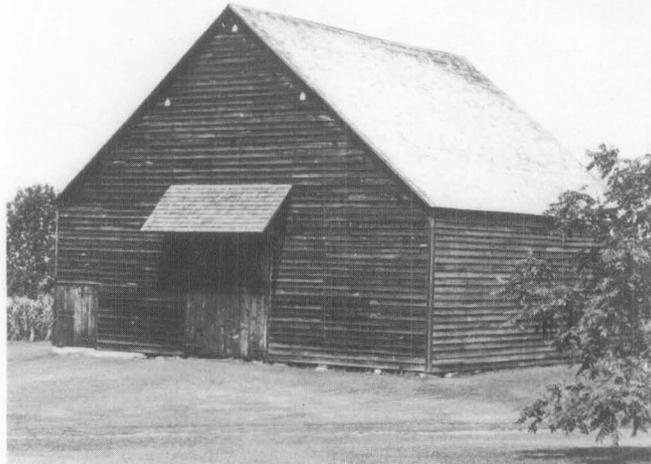
Built in the late 1700s, this New York Dutch barn survives in excellent condition. Gable roof, center wagon doors with pent roof, stock door at the corner and horizontal clapboarding are all typical features of the Dutch barn. Three holes for martins, traditional features of Dutch barns, can be seen near the top of the facade (they have been plugged and are lighter than the surrounding clapboards). Photo: Clarke Blair.

The first great barns built in this country were those of the Dutch settlers of the Hudson, Mohawk, and Schoharie valleys in New York State and scattered sections of New Jersey.² On the exterior, the most notable feature of the Dutch barn is the broad gable roof, which in early examples (now extremely rare), extended very low to the ground. On the narrow end the Dutch barn features center doors for wagons and a door to the stock aisles on one or both of the side ends. A pent roof (or pentice) over the center doors gave some slight protection from the elements. The siding is typically horizontal, the detailing simple. Few openings other than doors and traditional holes for martins puncture the external walls.³ The appearance is of massiveness and simplicity, with the result that Dutch barns seem larger than they actually are.

To many observers the heavy interior structural system is the most distinctive aspect of the Dutch barn. Mortised, tenoned and pegged beams are arranged in "H"-shaped units that recall church interiors, with columned aisles alongside a central space (here used for threshing). This interior arrangement, more than any other characteristic, links the Dutch barn with its Old World forebears. The ends of cross beams projecting through the columns are often rounded to form "tongues," a distinctive feature found only in the Dutch barn.

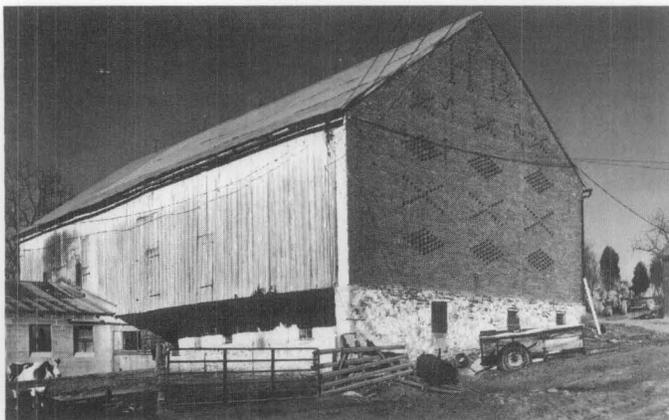
The gently sloping roadbed in this photograph shows the "bank" from which bank barns get their name. Massive timbers stretching across the full width of the barn create the overhang that also characterizes these barns. In barns with brick end walls, patterns were sometimes created by leaving spaces between bricks. The device furnishes ventilation as well as decoration. Photo: Jack E. Boucher, HABS.

levels served as threshing floor and storage. The hillside entrance gave easy access to wagons bearing wheat or hay. (Fodder could also be dropped through openings in the floor to the stabling floor below.) The general form of the bank barn remained the same whether it was built into a hillside or not. Where a hill was lacking, a "bank" was often created by building up an earthen ramp to the second level.

Bank barns were ordinarily constructed with their long side, or axis, parallel to the hill, and on the south side of it. This placement gave animals a sunny spot in which to gather during the winter. To take further advantage of the protection its location afforded, the second floor was extended, or cantilevered, over the first. The overhang sheltered animals from inclement weather. The extended forebay thus created is one of the most characteristic features of these barns. In some bank barns, the projecting beams were not large enough to bear the entire weight of the barn above. In these cases, columns or posts were added beneath the overhang for structural support.

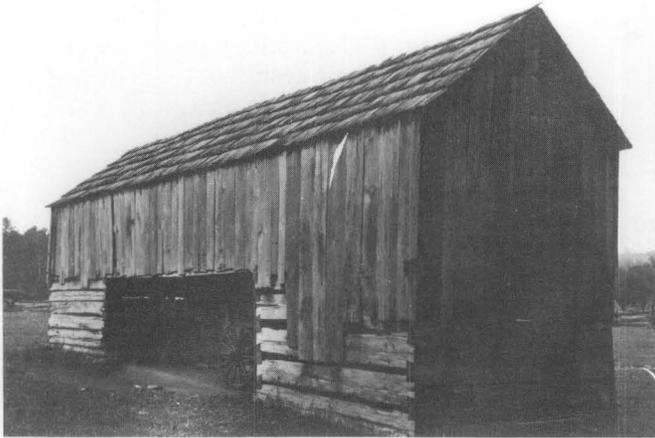
This late-nineteenth century crib barn is located in eastern Tennessee, in what is now the Great Smoky Mountains National Park. The central driveway between the cribs allowed a team and wagon to drive through after unloading. The materials and details are typical of the region. They include, on the exterior: hand-hewn saddle notched logs on the lower, crib portion; board framing on the upper, loft area; wood shingle roof. The interior features wood hinges on the crib doors and earth floor. Photo: Robert Madden.

The cribs sometimes face a covered gallery or aisle running across the front. In another arrangement, the cribs are separated by a central driveway running through the building. This latter arrangement defines the *double crib barn*.

In double crib barns the second story hayloft is sometimes cantilevered over the ground floor, resulting in a barn of striking appearance.

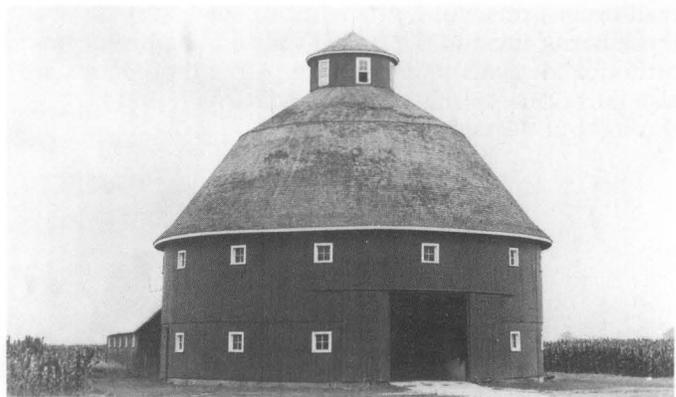
Circular barns are found throughout the country, but are especially numerous in the Midwest. This 1911 Illinois round barn is 60 feet in diameter. The cupola atop the hipped roof is 60 feet above ground. Its 10 single and 5 double stalls on the ground floor were fed from a loft. The square windows spaced at regular intervals around the perimeter add a note of simple contrast to the overall circular motif. Photo: Keith A. Sculle, Illinois Historic Preservation Agency.

Round barns were promoted for a number of reasons. The circular form has a greater volume-to-surface ratio than the rectangular or square form. For any given size, therefore, a circular building will use fewer materials than other shapes, thus saving on material costs. Such barns also offer greater structural stability than rectangular barns. And because they can be built with self-supporting roofs, their interiors can remain free of structural supporting elements, thereby providing vast storage capabilities. The circular interior layout was also seen as more efficient, since the farmer could work in a continuous direction.

In general, multi-sided barns—frequently of 12 or 16 sides—are earlier than “true round” barns. Earlier examples also tend to be wood sided, while later ones tend to be brick or glazed tile. Interior layouts also underwent an evolution. Early round barns placed cattle stanchions on the first floor, with the full volume of the floor above used for hay storage. In later barns, the central space rose from the ground floor through the entire building. Cattle stanchions arranged around a circular manger occupied the lower level; the circular

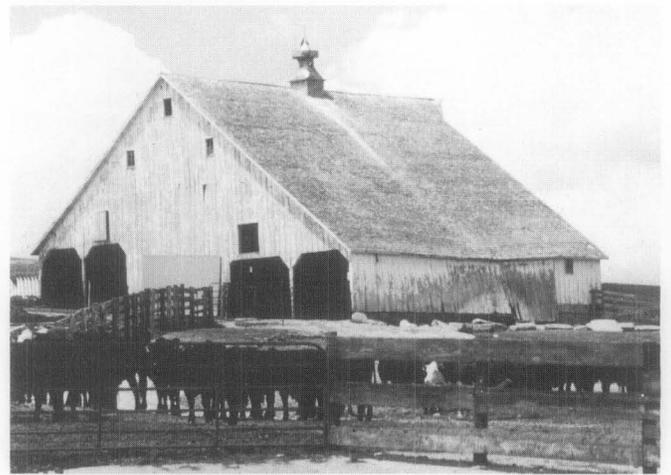
The long, sweeping roof is a characteristic of the Prairie or Western barn. The projecting peak over the hayloft is another. This Iowa barn was built about 1910. Photo: Mary Humstone.

A peak roof projecting above a hayloft opening is one of the most familiar images associated with barns. The feature belongs to the prairie barn, also known as the Western barn. The larger herds associated with agriculture in the West and Southwest required great storage space for hay and feed. Accordingly, prairie barns are on average much larger than the other barns discussed in this brief.⁶ Long, sweeping roofs, sometimes coming near the ground, mark the prairie barn; the extended roof created great storage space. (Late in the nineteenth century, the adoption of the gambrel roof enlarged the storage capacity of the haymow even more.)

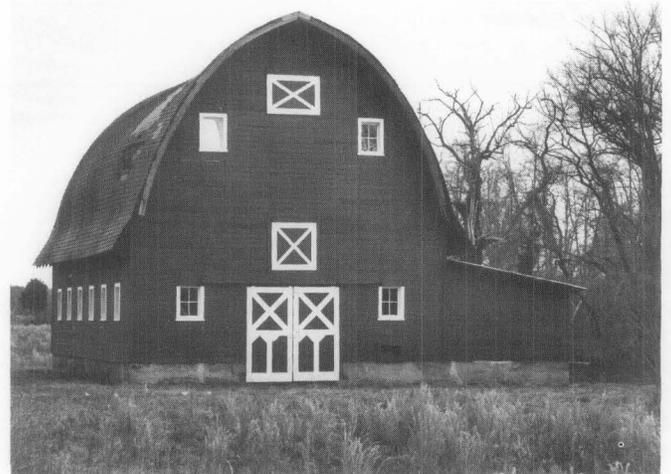
In the early 20th century barn patterns were developed by agricultural schools and prefabricated units were sold by mail-order firms. This Maryland barn was bought about 1920 from a Sears catalogue. Photo: Robert J. Hughes

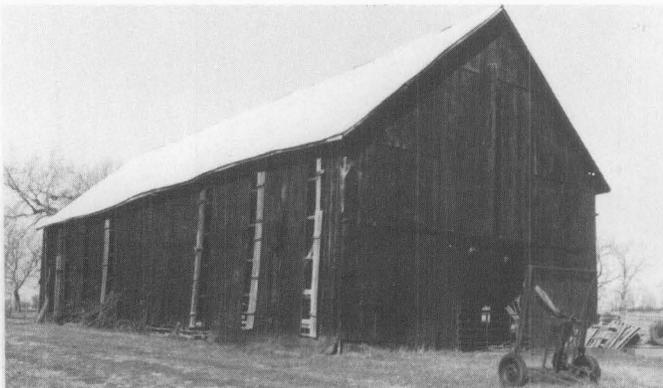
Panels on this 1900 Kentucky tobacco barn open to aid in the curing process. Photo: Christine Amos, Kentucky Heritage Council.

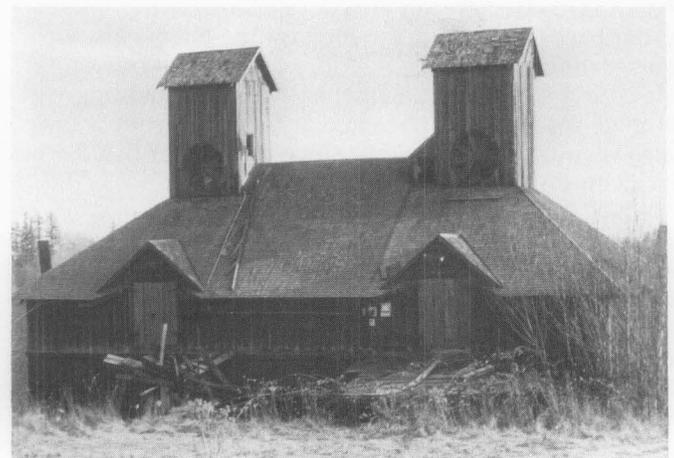
The two ventilating towers are the character-defining aspect of this Oregon hop-drying barn. Photo: Allan Nelson.

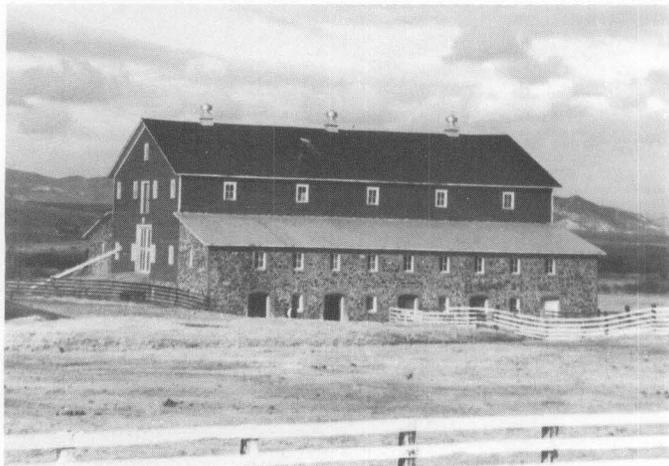
Fig. 2. Mountains, fields, fences, sheds, trees: The setting of this enormous Montana barn is an important element of its character. The barn was built in 1887-1889 after disastrous livestock losses in the winter of 1886-1887. It could hold 500 cattle and store a quarter-million cubic feet of hay. Photo: John N. DeHaas, Jr., Montana Historical Society.

Setting. Setting is one of the primary factors contributing to the historic character of a barn (see Fig. 2). Farmers built barns in order to help them work the land; barns belong on farms, where they can be seen in relation to the surrounding fields and other structures

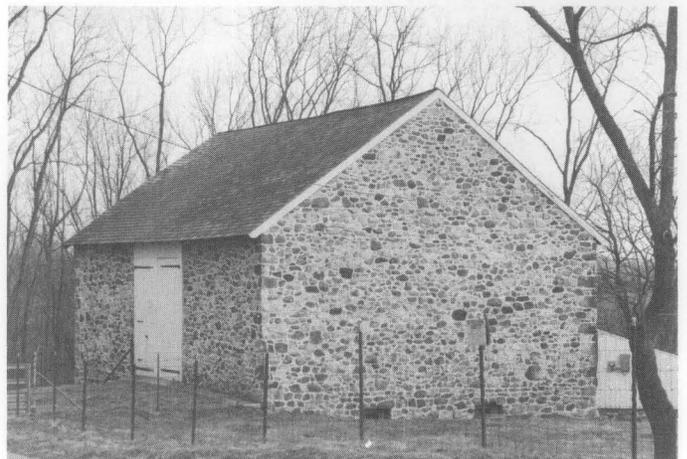
Fig. 3. The stone walls of this Delaware barn are its most notable feature. Built about 1810, the barn is a bank barn. Photo: Valerie Cesna, Delaware Bureau of Archeology and Historic Preservation.

Materials. Among the major impressions given by well-maintained historic barns are those of strength, solidity and permanence (see Fig. 3). These impressions largely result from the durability and ruggedness of the materials used in them. Weathered wood siding, irregularly shaped stones, or roughhewn logs on the exterior; dressed beams, posts scarred by years of use, and plank flooring on the interior all contribute to the special character of barns.

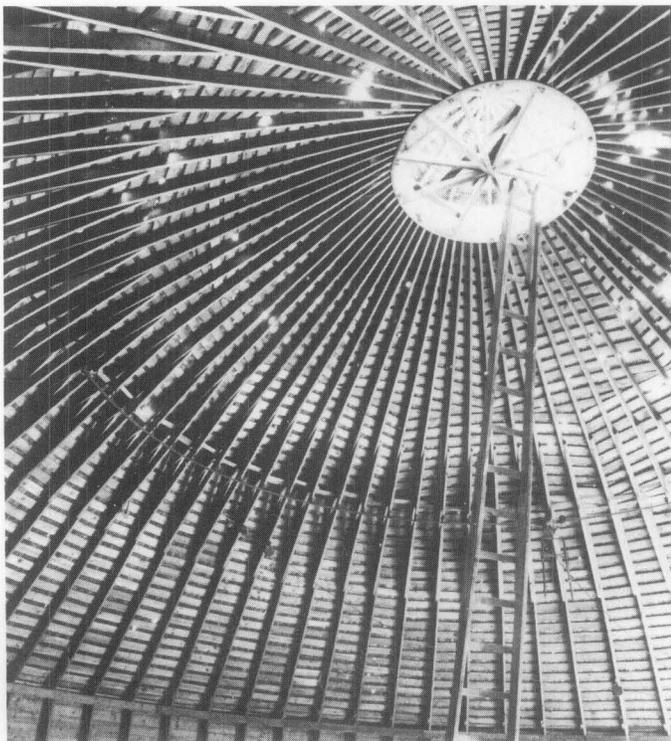
Fig. 4. Nowhere is the sense of space associated with barn interiors more evident than in a round barn. The storage capacity of this 1930 barn is immense. Just visible midway up the wall is a circular track and pulley system used to move hay from the wagon entrance on the lower level and to distribute it around the loft. When needed, hay was dropped to the stalls below through an opening in the loft floor. Photo: Keith A. Sculle, Illinois Historic Preservation Agency.

Interior Spaces. The impression received upon stepping into many historic barns is that of *space* (see Fig. 4). Not infrequently, the entire building appears as a single large space. To enter these buildings is sometimes to experience the entire expanse of the building at once. Even when haylofts and animal stalls “consume” part of the building, they often do not keep the full expanse of the interior from being seen. In large barns, this can be an imposing sight. More commonly, the barn is a combination of confined spaces on the lower floor and a large open space above; in this case, the contrast between the confined and open spaces is also striking. The openness of the interior, furthermore, often contrasts with the “blankness” typical of many barn exteriors, with their relatively few openings.

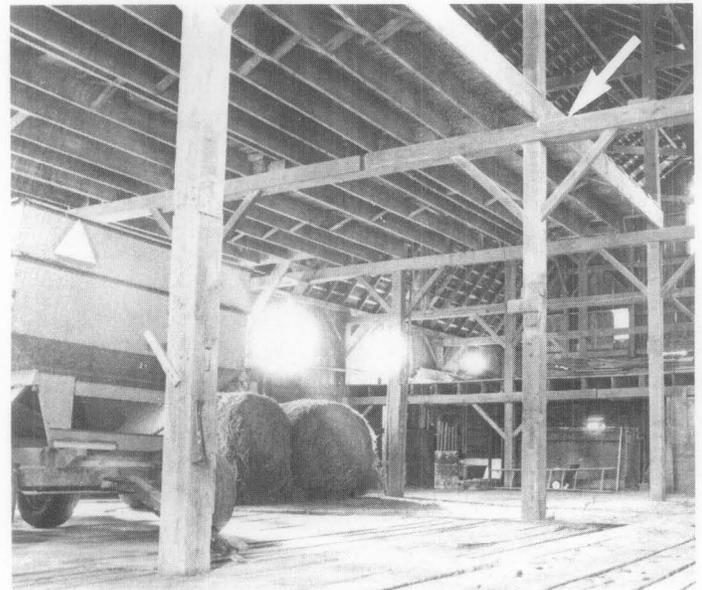
Fig. 5. The exposed structural framework of this large 1890 Illinois barn is impressive. In a recent rehabilitation a portion of the haymow floor (see arrow) was raised to provide clearance for large machinery. Photo: Dale Humphrey, Galesburg Register Mail.

Structural Framework. The exposed structural framework is a major component of the character of most historic barns (see Fig. 5). Typically, barns were built for strictly utilitarian purposes. Accordingly, barn builders made no effort to conceal the structural system. Yet for that very reason, barns achieve an authenticity that accounts for much of their appeal.

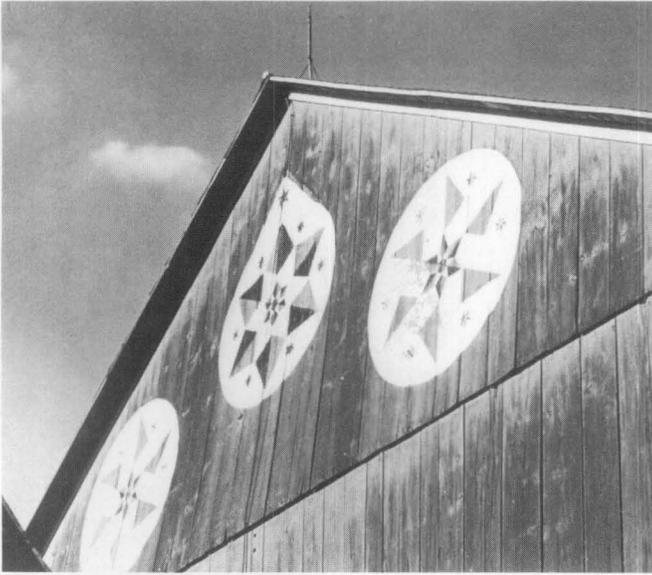
Fig. 6. Hex signs are among the wide range of decorative elements found on American barns. Photo: Lee H. Nelson.

Decorative Features. Historic barns, like modern ones, are structures built for *use*. Nevertheless, decorative elements are not lacking on barns. Foremost among these is color (red being most common). Dutch barns traditionally sported distinctively shaped martin holes in the upper reaches of the building. Traditional hex signs on Pennsylvania barns are so well known as to have entered the mainstream of popular culture and taken on a life of their own (see Fig. 6). Decorative paint schemes, including contrasting colors to “pick out” cross members of the external framework, are common (these most frequently take the form of diamonds or “X’s” on the main doors). Sign painters often took advantage of the size and visibility of barns in an age before billboards. “Mail Pouch Tobacco” signs were nearly as numerous in the first quarter of the 20th century as patent medicine ads were in the last quarter of the 19th. Another decorative motif on historic barns is the arrangement of spacings between bricks to form decorative patterns (as well as to ventilate the barn).

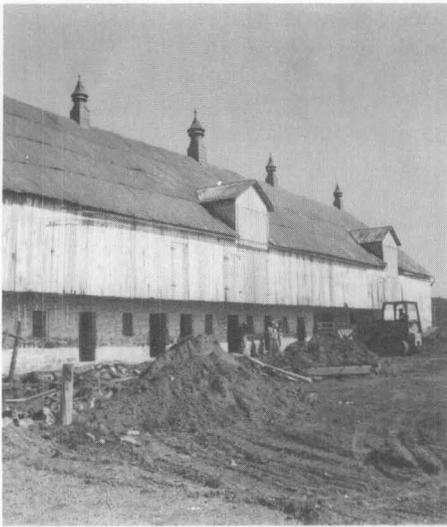
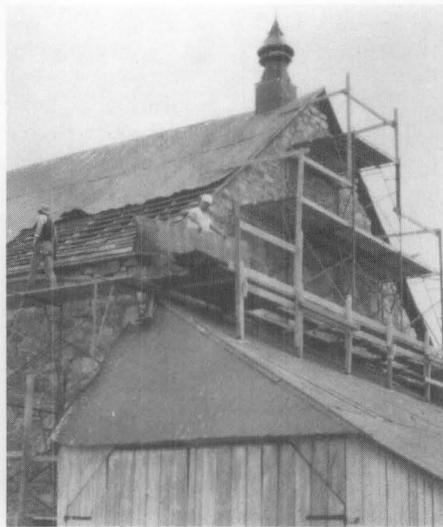
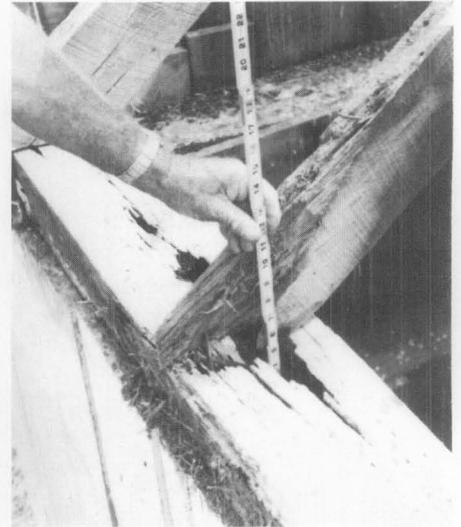
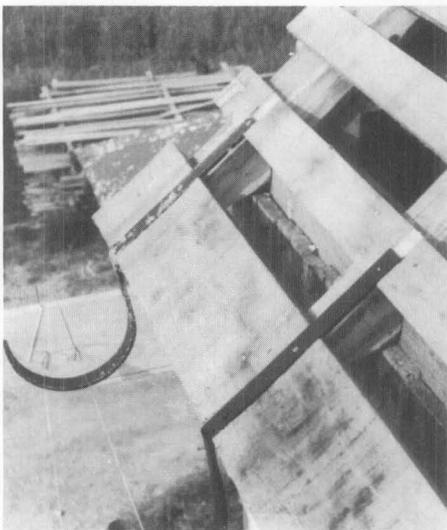
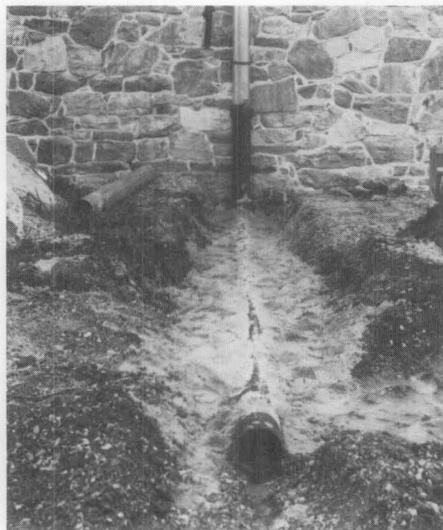
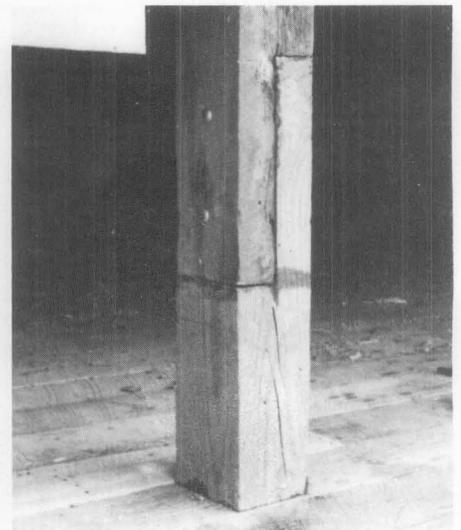
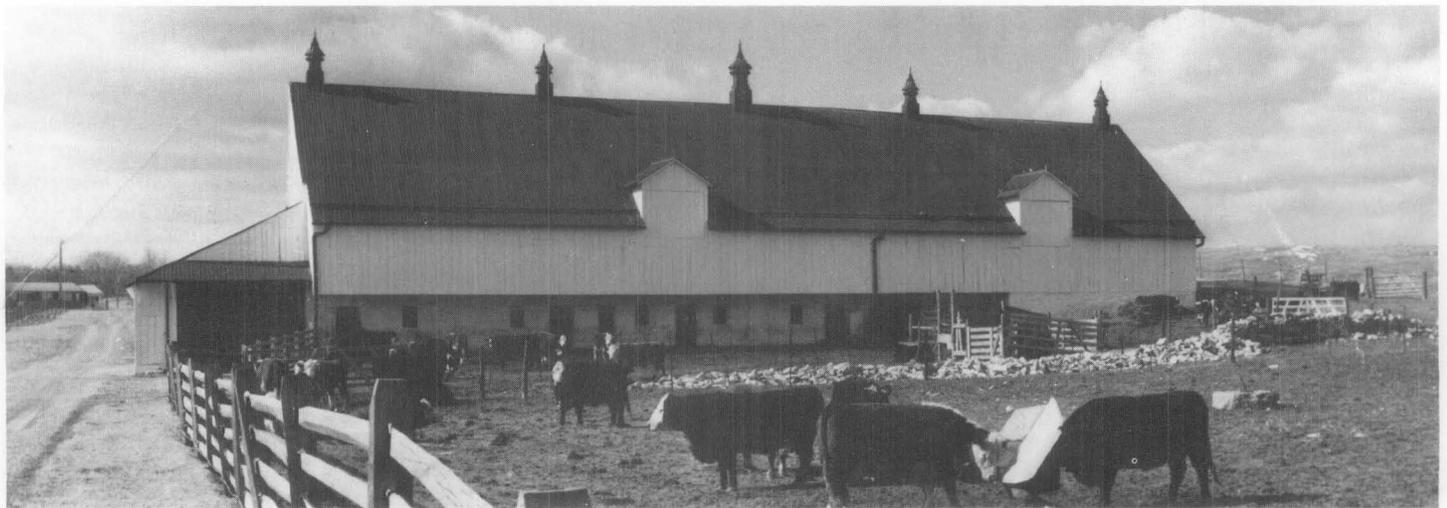
Fig. 7. Now part of Antietam National Battlefield, this bank barn (built in the 1820s and enlarged in 1898 and 1914) looks out over fields and hills where Union and Confederate armies fought on the bloodiest day in American history. Owned by the National Park Service, the barn underwent major repairs: (a) the foundation was regraded for better drainage; (b) the deteriorated metal roof was removed; (c) removal of the metal roof disclosed the rotten wall plate and roof rafters; (d) these elements were replaced, and collars to hold a new gutter system were added; (e) new downspouts and drain pipes were installed to carry water off the roof and away from the foundation; (f) damaged structural members were strengthened with new sections; (g) new roof and other work finished, the barn remains a working farm structure. Photos: (a-f), Courtesy, Williamsport Preservation Training Center, NPS; (g), Jack E. Boucher, HABS.

Many historic barns require more serious repairs than those normally classed as "routine maintenance" (see Fig. 7). Damaged or deteriorated features should be repaired rather than replaced wherever possible. If replacement is necessary, the new material should match the historic material in design, color, texture, and other visual qualities and, where possible, material. The design of replacements for missing features (for example, cupolas and dormers) should be based on historic, physical, or pictorial evidence.

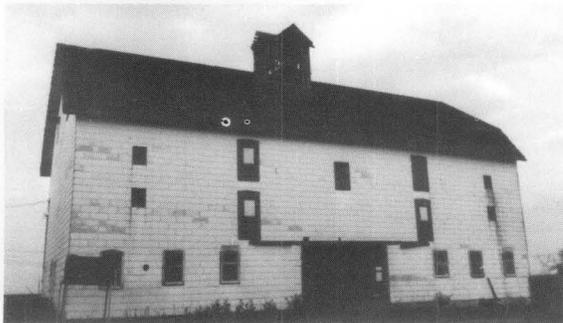
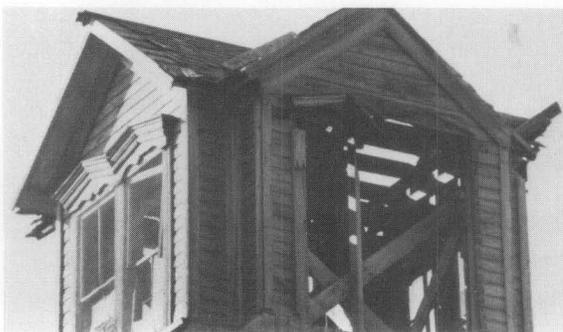
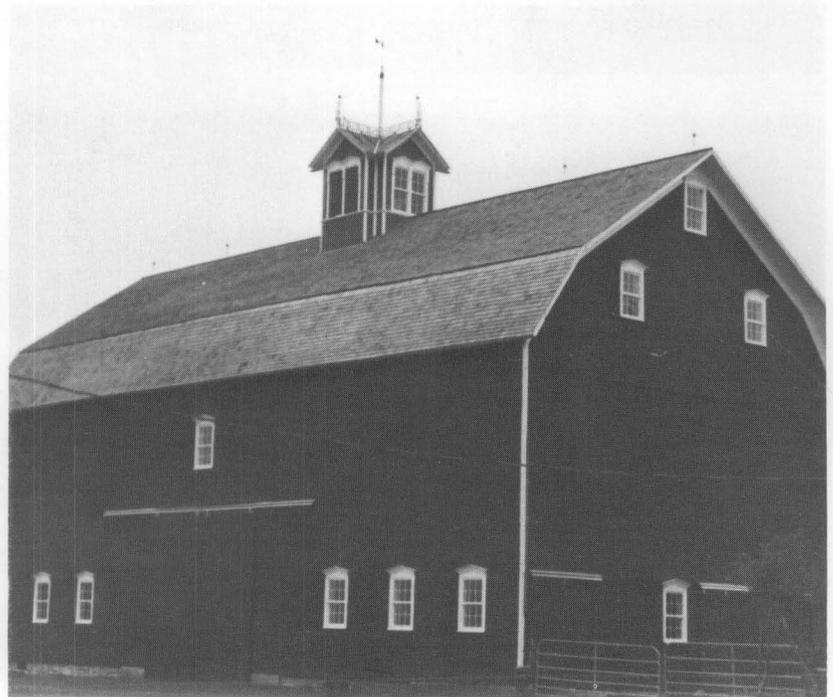
Fig. 8. Built in the Gothic Revival style in the 1890s, this four-story Indiana barn had fallen into disuse, and was deteriorating. In the process of returning it to use, the owner installed a new roof that matches the wooden shingles found beneath the deteriorating asphalt shingle roof; removed the modern asbestos shingle siding; repaired the windows, and reconstructed the cupola (including its lightning rod and weathervane). (Before and after views are of opposite sides of barn.) Photos: Before, Courtesy, Gary Post-Tribune; After, Courtesy, Kankakee Valley News.

Some barns have served the same uses for generations, and need only periodic repairs and routine maintenance. Others have become obsolete and need extensive updating for modern farming methods. (To house livestock, for example, a barn may need new feeding, watering, waste removal, electrical, plumbing and ventilation systems.) Similarly, barns that can no longer be used for agriculture at all normally require changes to adapt them for commercial, office, or residential use. In such cases barns need more extensive work than the maintenance and repair treatments outlined above. However, when rehabilitating a historic barn for a new farming operation or a new use entirely, care must be taken to preserve its historic character while making needed changes (see Figs. 8, 9 and 10).

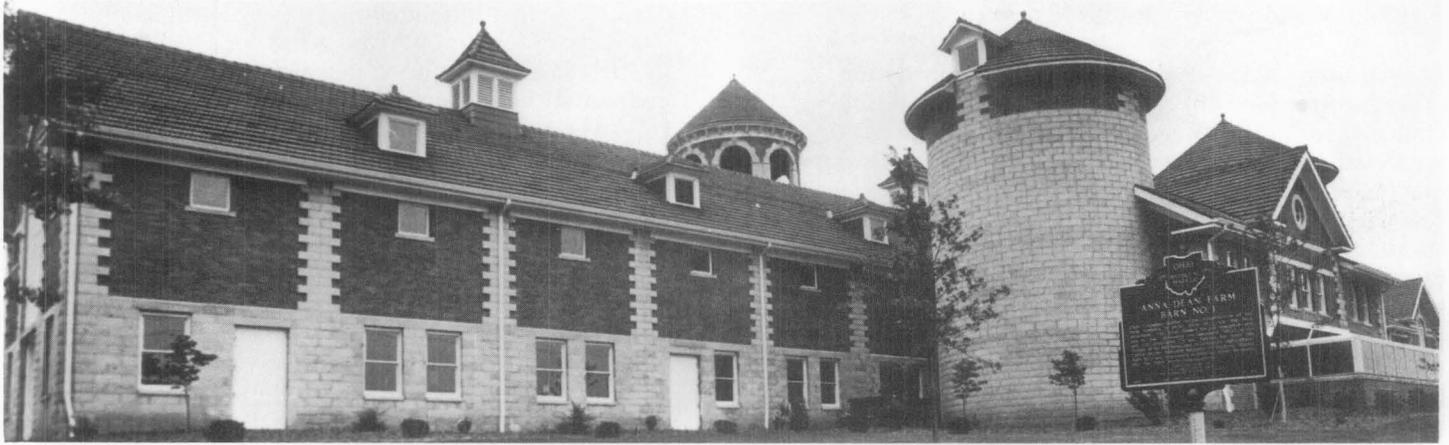
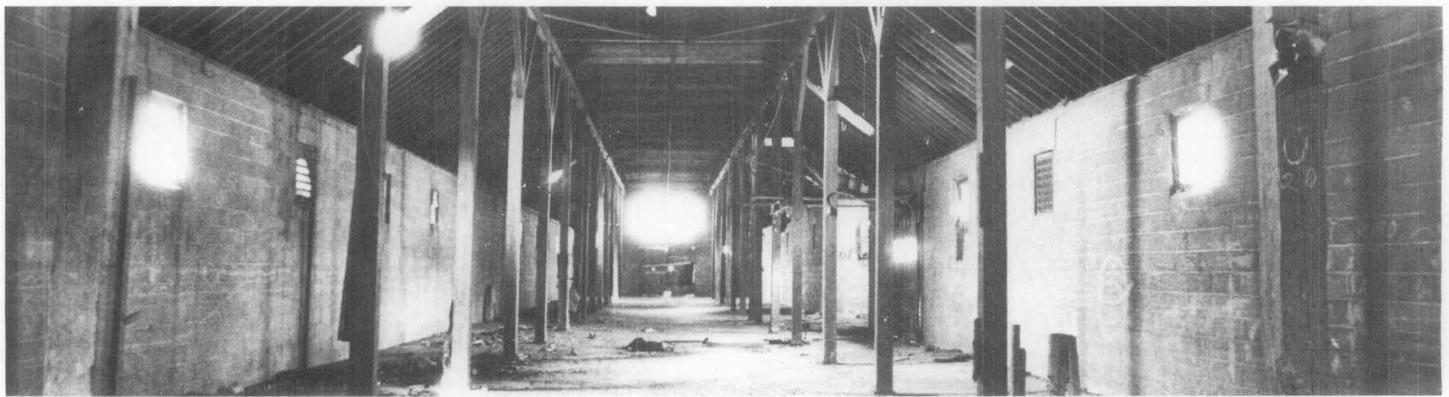
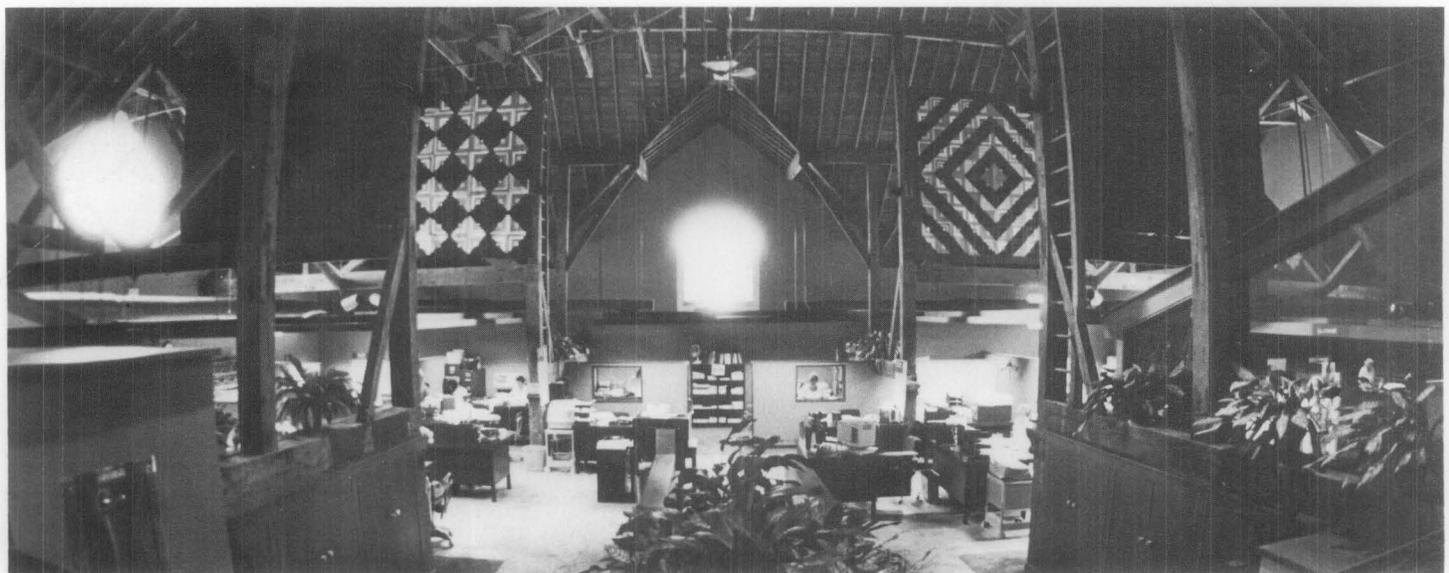
Fig. 9. This enormous Ohio barn (285 feet by 125) was built between 1909 and 1912. It was one of 102 structures on "America's Finest Farm." (Other buildings included the world's largest greenhouse and the world's largest barn—nearly 800 feet long). The barn seen here was rehabilitated for use as headquarters for an international agricultural firm. Although the use has changed, comparison of the interior photographs shows that the barn has retained its historic character. (After view, interior, is taken from a cross axis; distortion is from fish-eye lens.) Photos: Exterior and interior, after: Ron Kuntz, UPI; Interior, before: Courtesy, Barberton (Ohio) Historical Society.

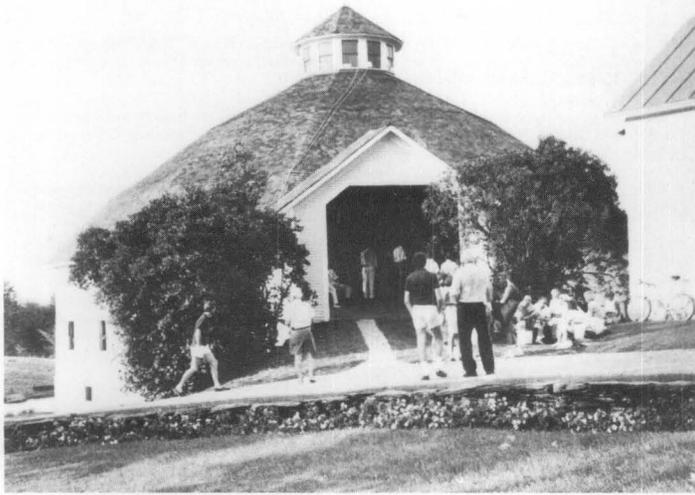
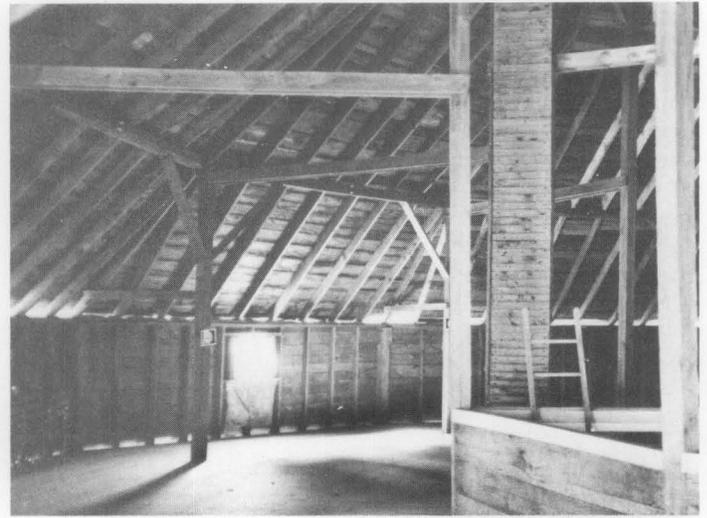
Fig. 10. This 1910 Vermont round barn is 80 feet in diameter. Disused and decaying, the building was converted to a community center, with artists' studios and spaces for weddings, parties and conferences. The barn underwent extensive structural repair and other work. Careful selection of new use permitted the building to be rehabilitated while retaining its principal spaces and features—and its historic character—intact. Photos: Jay White.
