Best Practices Review

Assessing Integrity, Not Condition

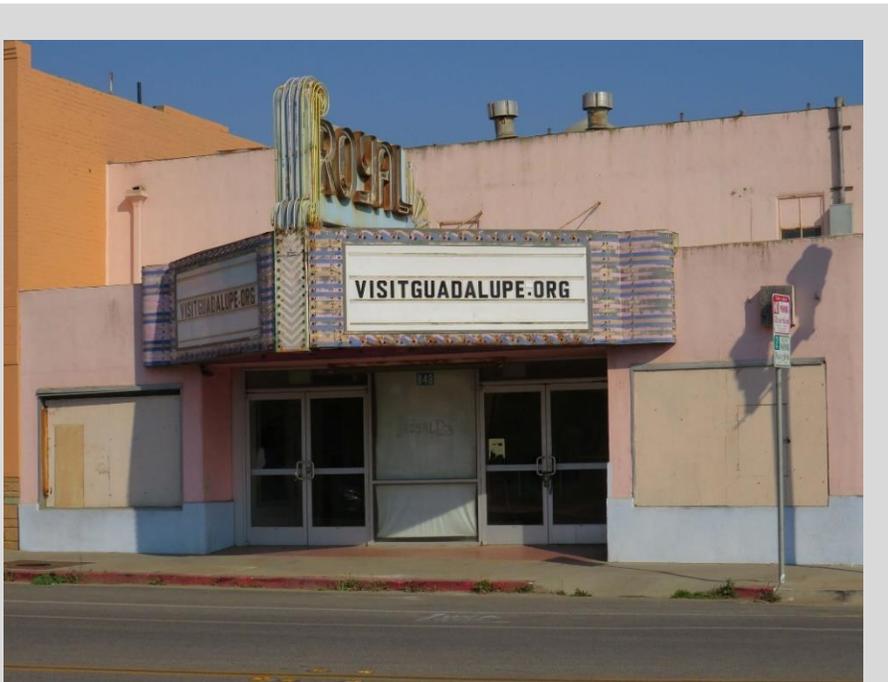
Royal Theater, Guadalupe, California, front façade. (Carole Denardo, 2021)

Alterations were made to the building over the course of several changes in ownership. The last round of alterations date to more than 25 years ago, in 1997, and included roof replacement, asbestos removal, repainting, replumbing, rewiring, and new projection equipment installation. The building has been vacant since 2001 (Registration Form, pp. 6, 16).

The nomination walks the reader through the seven aspects of integrity, with one to three sentences addressing each, for example: “Materials: Most of the original materials, including the building fabric and fenestration, are still evident and unchanged” and “Feeling: There are few alterations and/or removal of original materials, and the building still substantially conveys the feeling of an earlier era and aesthetic” (Registration Form, pp. 6-7).

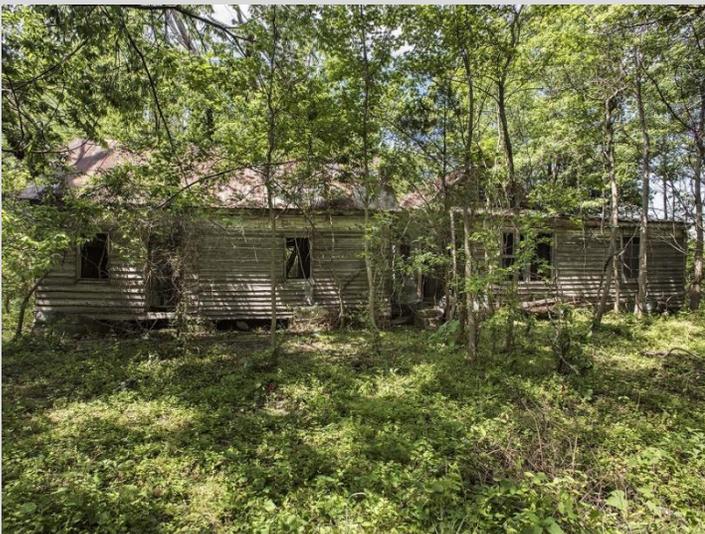
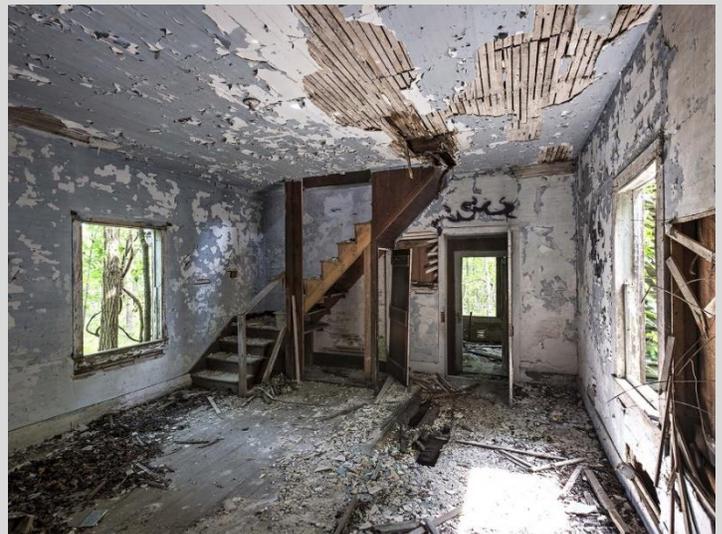
Chief Otho S. and Susie P. Nelson House, King and Queen County and Essex County, Virginia, south elevation (left), interior views of living room (right), where Tribal meetings were held. (William J. Graham, 2018)

The Chief Otho S. and Susie P. Nelson House is significant for the period 1924 to 1967, the years Otho Nelson served as chief of the Rappahannock Tribe. The present form of the Nelson House is the result of several expansion campaigns since construction in the late nineteenth century: it is “a frame two-level ‘T’-shaped vernacular building with a metal roof. The house exhibits a blend of conservative construction techniques, traditional planning, and old-fashioned technology with newer architectural construction methods” (Registration Form, p. 4). Because of the extensive additive nature of the building, the architectural description is detailed over six pages. This includes oral history from the Nelson granddaughters that brings the interior spaces to life through descriptions of activities here during the time the building served as the Nelson home and farm, Tribal meeting place and cultural practices repository, and Tribal children’s school.

The house is clearly in poor condition: windows and doors are missing, and interior finishes have crumbled, exposing the lath in many areas. The integrity analysis is short but focused, methodically addressing each aspect of integrity and placing the poor condition of the house into context. For example, with respect to design, materials, and workmanship, the nomination explains that even in its current state, it presents “considerable information about historic uses of the dwelling and its evolution over several decades. Likewise, because the dwelling has not been substantially altered in the past several decades, its integrity of design has been retained” (Registration Form, p. 16).

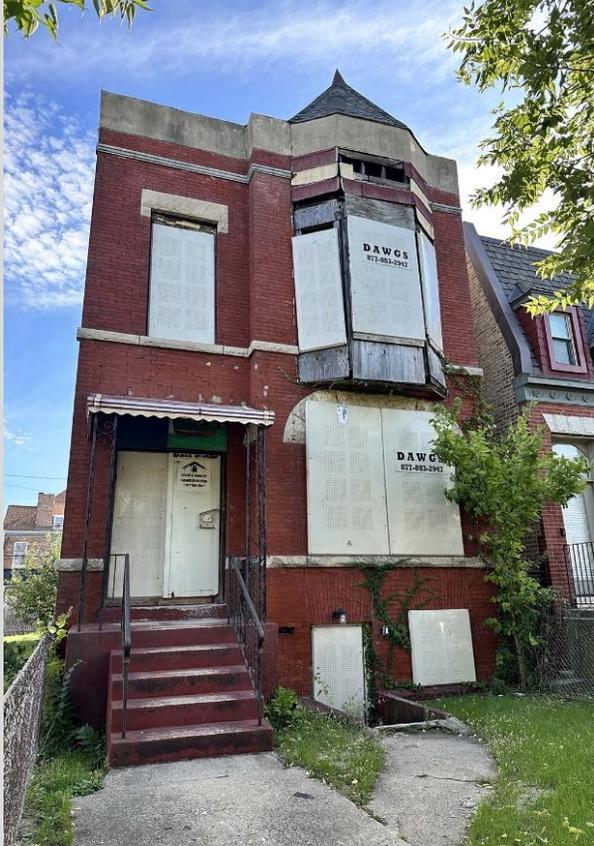
Muddy Waters House, 4339 S. Lake Park Avenue, Chicago, IL, front façade. (Erica Ruggiero, 2022)

The integrity discussion in Section 7 “Narrative Description” describes the lack of integrity at other extant properties associated with Waters. The discussion of the Lake Park Avenue home frankly details changes that occurred after his death, including the extensive loss of materials.

After Waters died in 1983, the property eventually entered into receivership during the 1990s, and ultimately fell vacant. It was during this period that the home was

vandalized and scrappers stripped the home of salvageable materials that could be resold, rendering the building uninhabitable and open to the elements. The nomination describes the conditions, relating them to the original design:

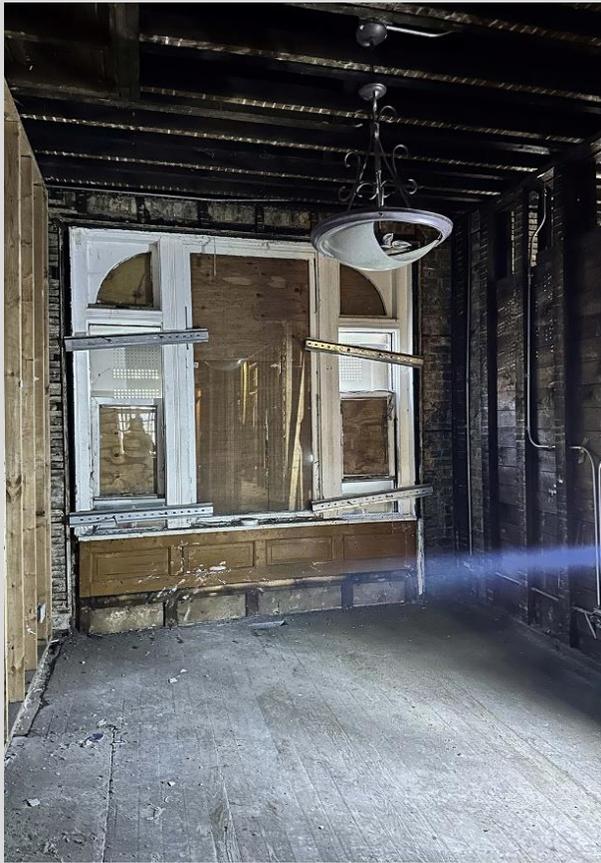
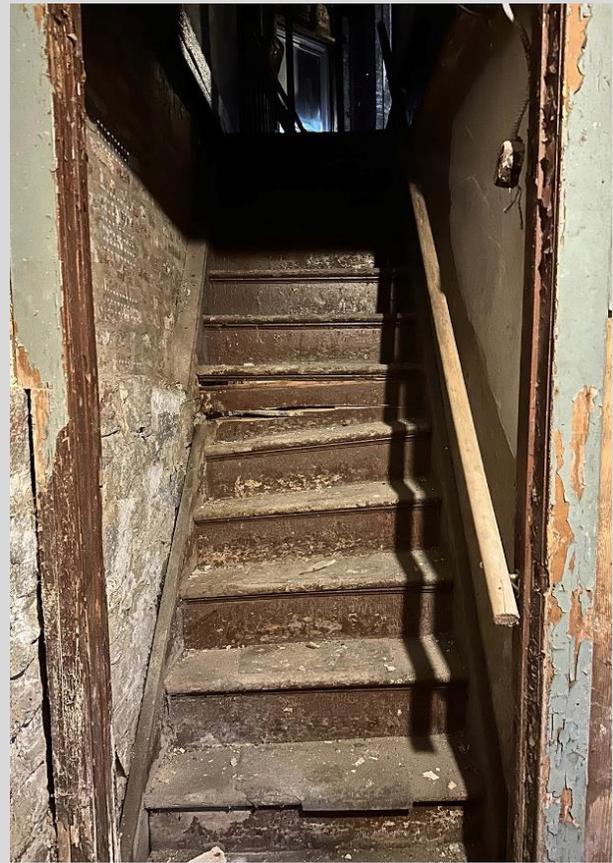
Muddy Waters House, 4339 S. Lake Park Avenue, Chicago, IL, first floor living room (left), stairs from basement to first floor (right). (Erica Ruggiero, 2022)

The original wood floors, as well as the remaining simple rectilinear trim at the first floor living room arched window remain. The original stairs (only the treads, risers, and stringer) between the basement and first floor and the first floor and second floor also remain intact.

In late 2021 and early 2022, what remained of the interior was removed down to the studs. The original layout of each floor, except for the basement, remains intact. The basement originally also had partition walls that separated the rehearsal studio from the living quarters. The original layout is unknown as the walls have been previously removed. New steel columns on concrete footings have been introduced through the center of the space to stabilize the wood frame structure.
