Disaster Mitigation for Historic Structures: Protection Strategies

Prepared by 1000 Friends of Florida on behalf of the Florida Department of State, Division of Historical Resources and the Florida Division of Emergency Management

AUGUST 2008

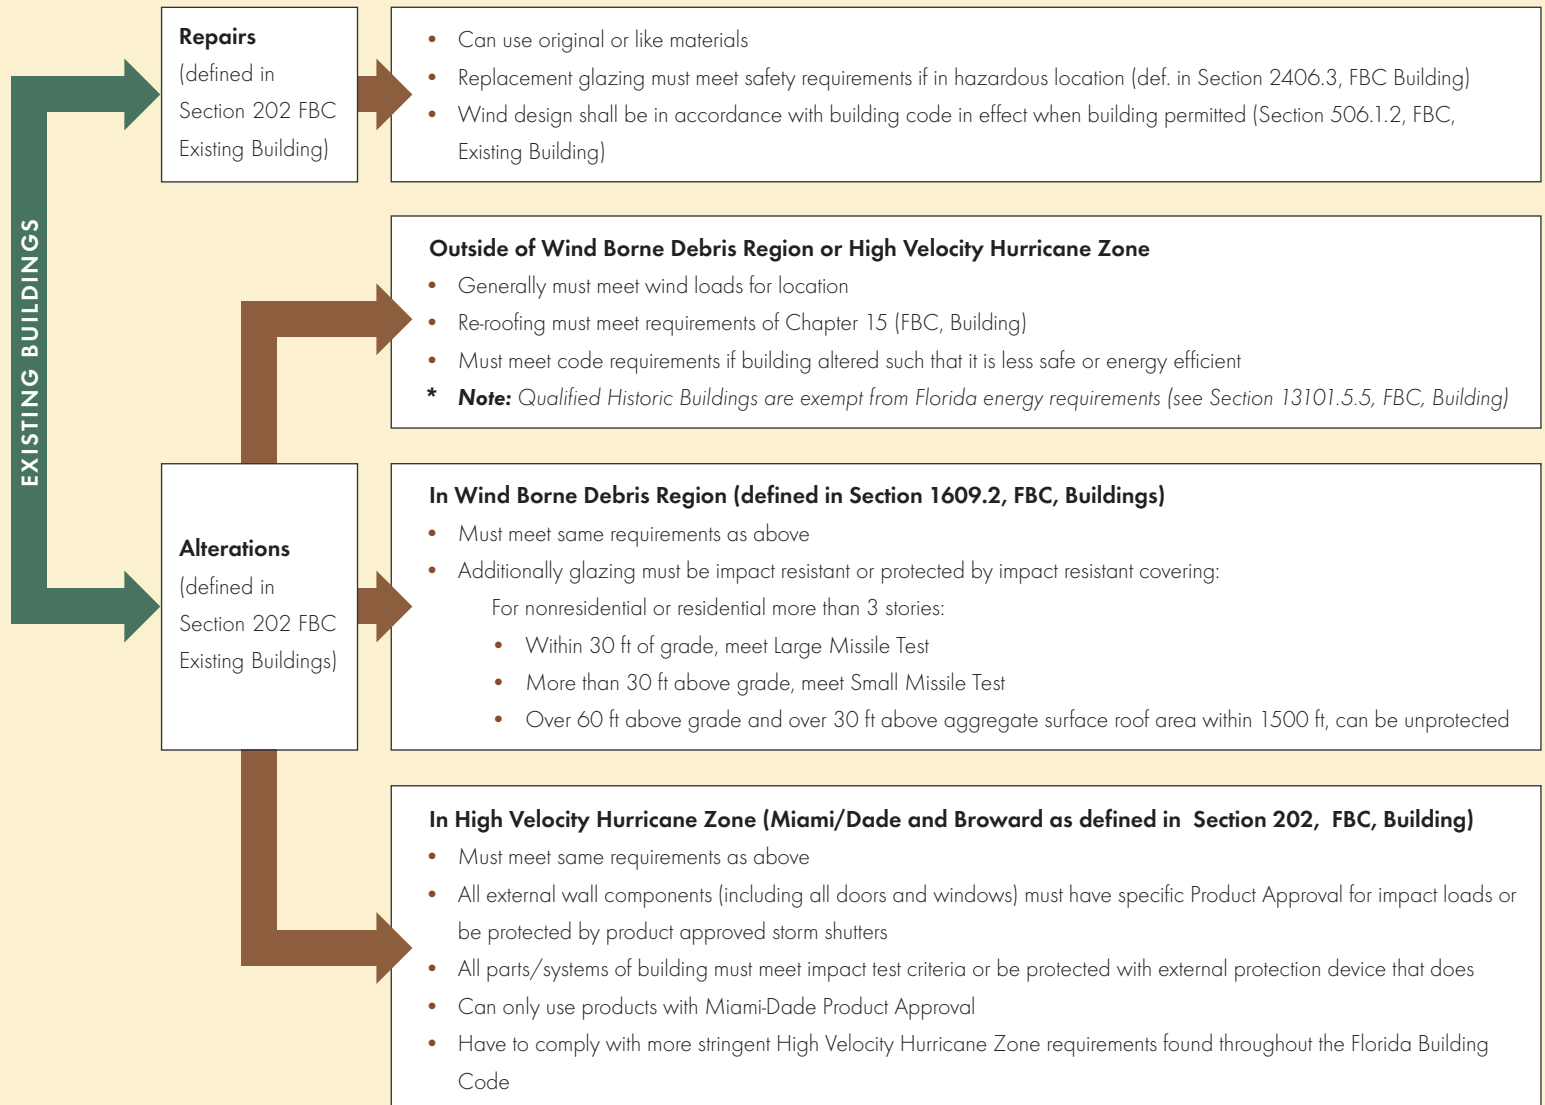
Figure on page 5 (General Overview of Requirements) provides an overview of the primary building code requirements for existing buildings in terms of disaster preparedness. As shown in that figure, code requirements are different for repairs versus alterations. Additionally, the requirements also change for alterations to existing buildings depending on where the building is geographically located within the state. Buildings located in a windborne debris region have to meet additional glazing protection requirements, while buildings in the High Velocity Hurricane Zone (basically Miami-Dade and Broward Counties) must also comply with the more stringent requirements.

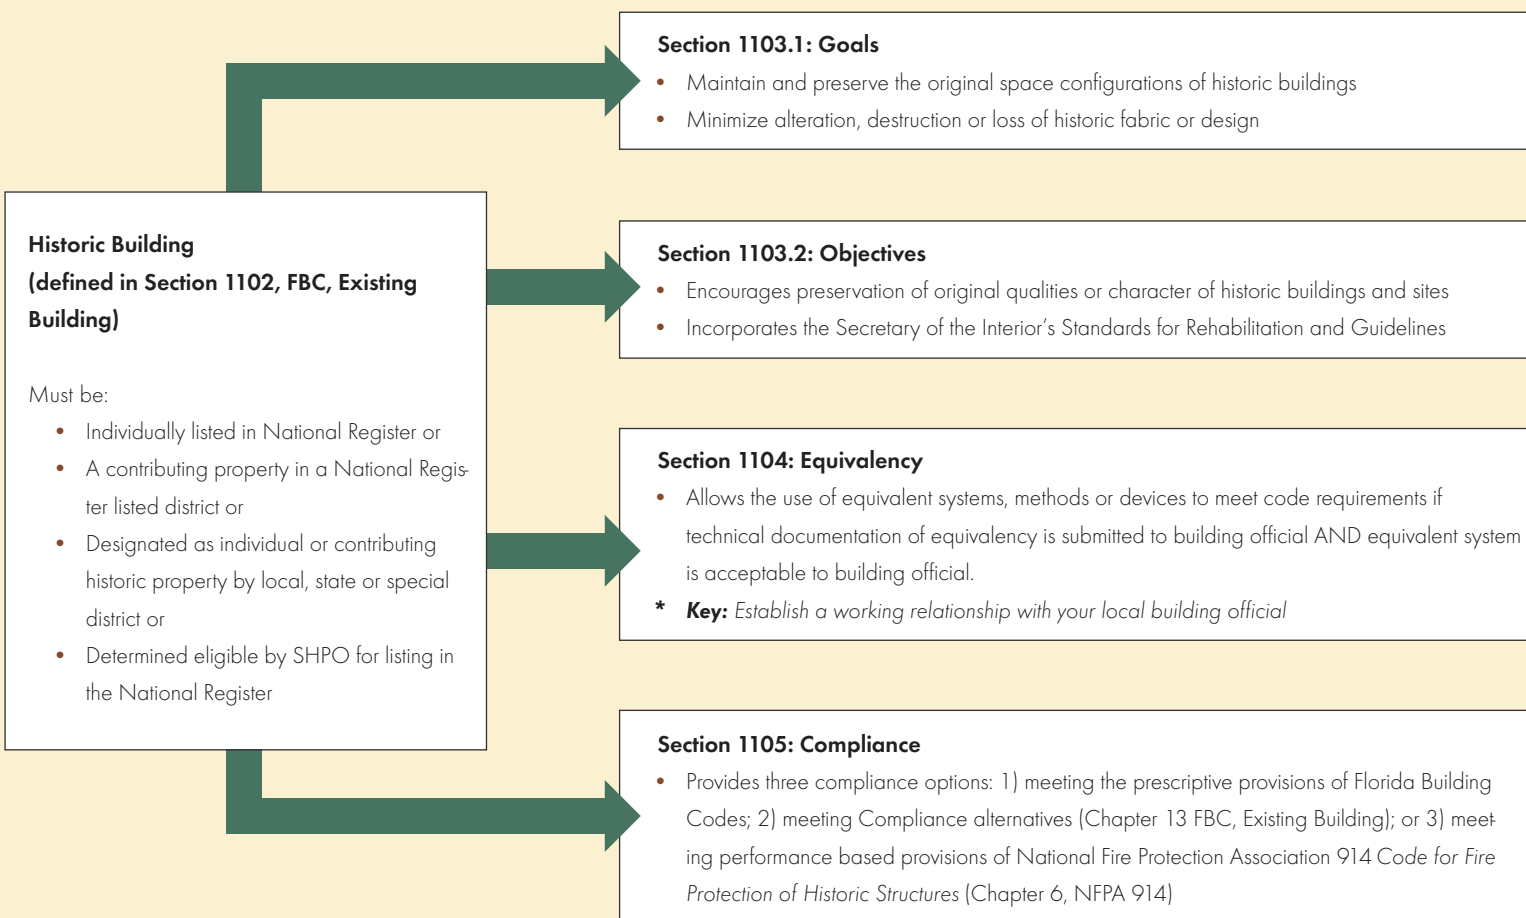
OVERVIEW OF GOALS, OBJECTIVES AND OPTIONS

(Please refer directly to Florida Building Code for specific requirements)

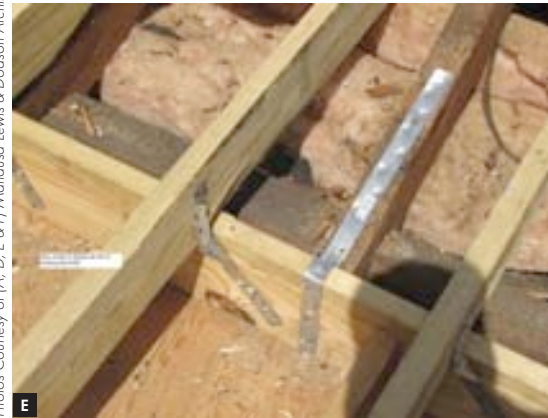
A) Rafter tie down straps in masonry from Old City Waterworks, Tallahassee; B) Hurricane clips, Key West Armory; C) Hurricane straps, Key West Armory; D) Sill beam tie down strap from Jones Family Tenant House at Tall Timbers Research, Inc., Tallahassee; E & F) New rafters and tie down straps from the Wesley Mansion at Eden Gardens State Park, Santa Rosa Beach

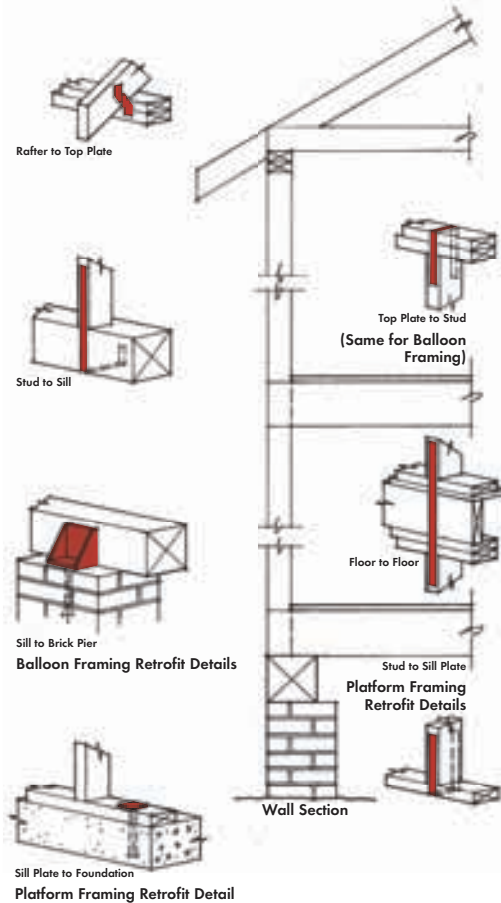
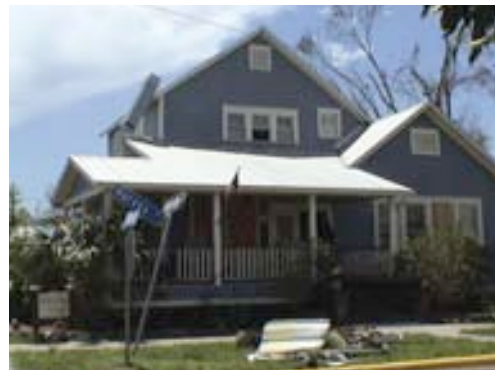
Typical Connections Used to Create A Continuous Load Path

Chimneys are vulnerable roof features that require securing.

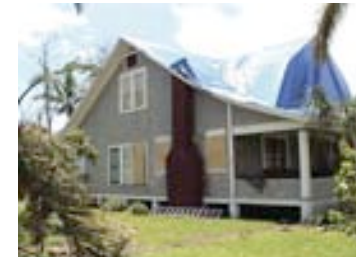
A roof tarp provides temporary stabilization.

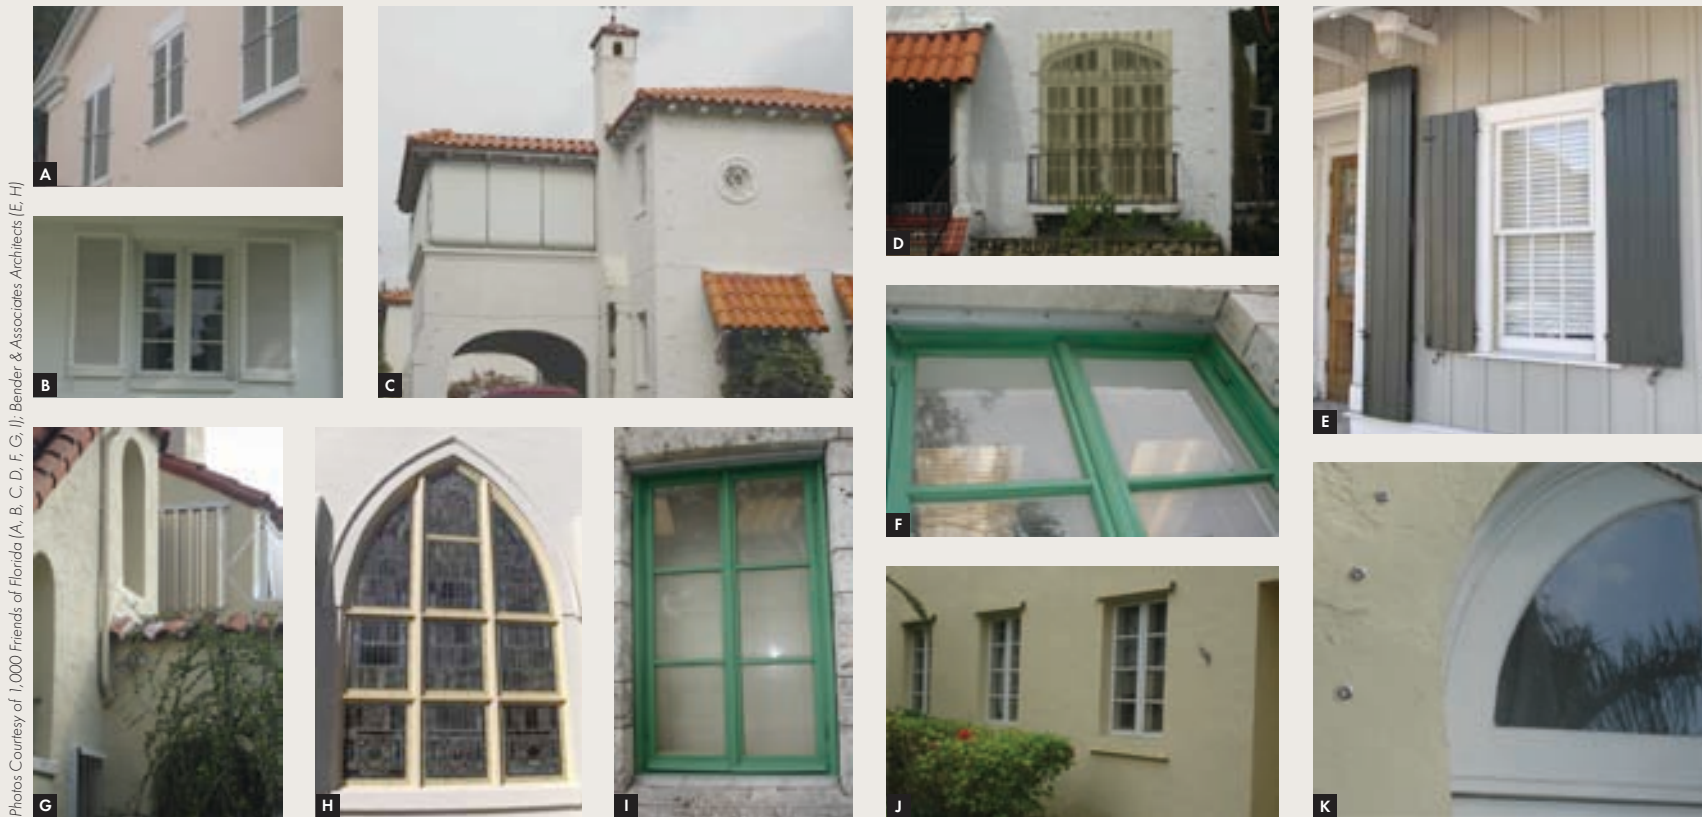
A) Closed Louvered Shutters; B) Open Louvered Shutters; C) Aluminum Awning Shutter; D) Removable Clear Polycarbonate Storm Panel; E) Solid Board Shutter; F) Concealed track above; G) Metal Storm Panel; H) Permanent 3/8" lexan® storm panels from the Southernmost Prayer and Faith Center Church, Key West; I) Track above & below; J) Painted Storm Track K) Direct mount storm panel attachment points can be hidden with colored plugs when not in use.

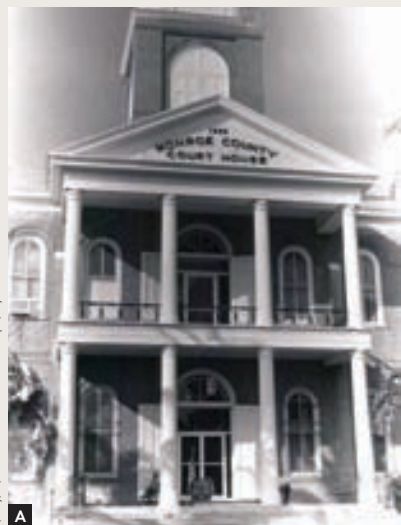
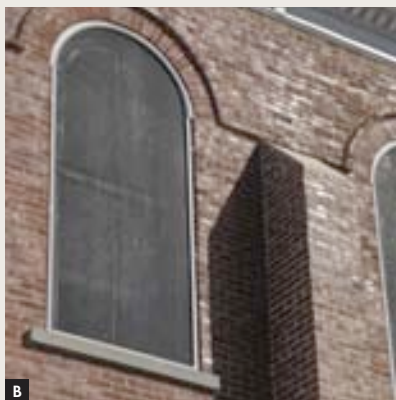
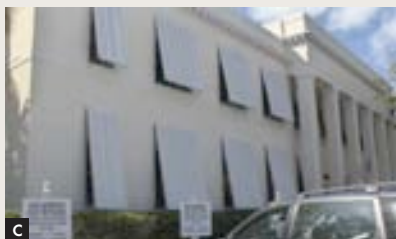
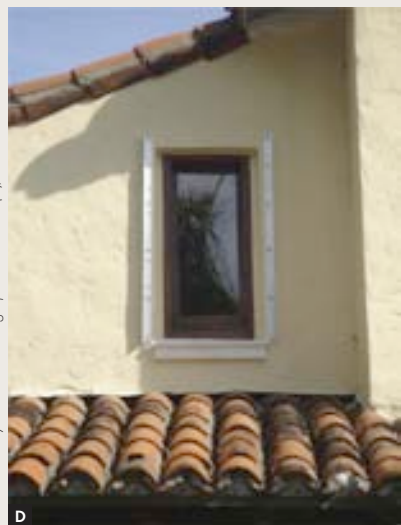
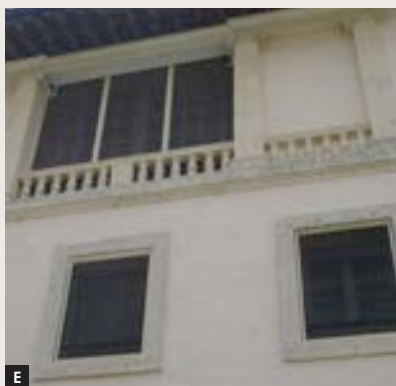
A) Monroe County Court House prior to installation of perforated metal panels; B) The permanent installation of perforated metal panels obscures the historic windows of the Monroe County Court House; C) Bahama Shutters from the Harvey Government Center, Key West; D) Unpainted Storm Panel Track; E) Perforated Metal Panel from the Vizcaya Museum & Gardens in Miami

Perforated Metal Panels (image on pages 24: B & E)

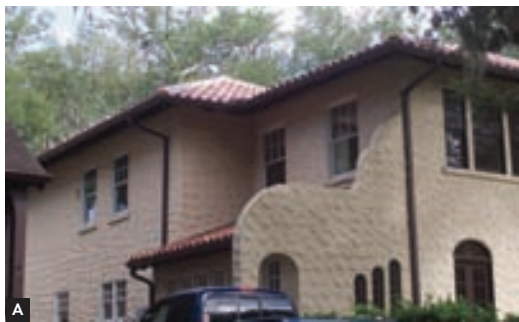
Replacement windows on side of residence.

Replace non-historic windows with Miami-Dade County certified windows. New windows should match the historic window as closely as possible in size, type, style, proportion, material, element profiles, frame, arrangement and number of divided lights. When replacing failed windows, preserve the original casing and frame if feasible, and install replacement sash matching the original design as closely as possible. If an exact match is not possible, consider all of a window's characteristics and its importance in the facade when selecting a replacement. The attachment of the window to the surrounding framing, whether historic or a replacement, is very important to the effectiveness of a protective window system. No matter how strong the window is, if it is not properly installed, the system can

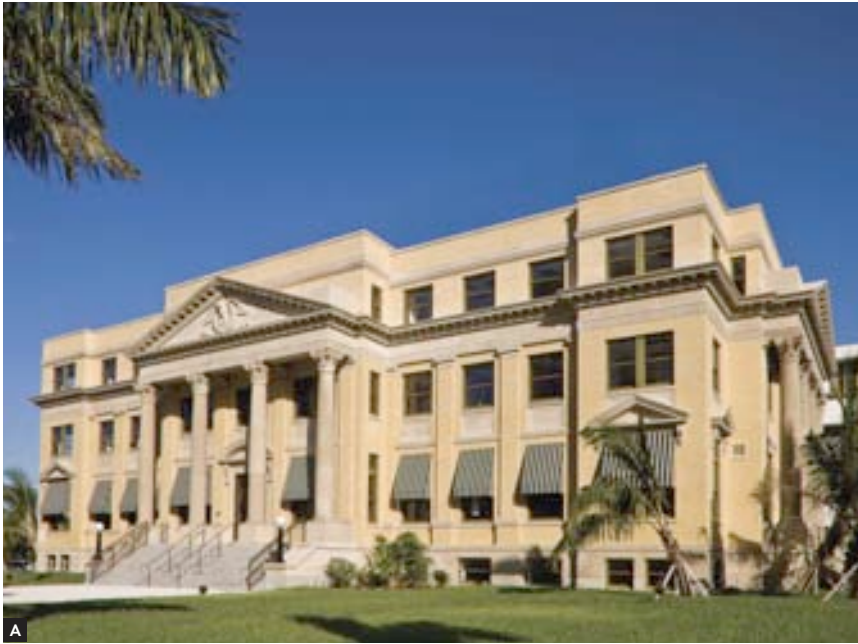
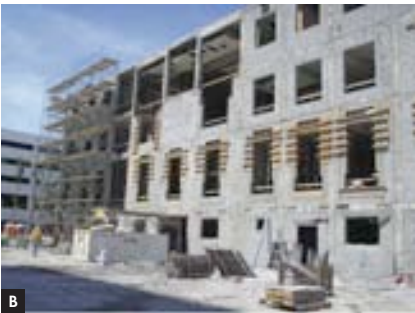
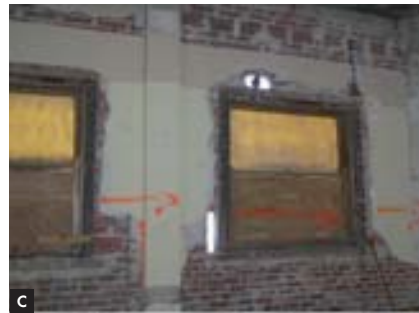
A) Restored West Elevation; B) East Elevation May 06; C) Existing Window Condition

Over the years, the 1916 Historic County Courthouse in Downtown West Palm Beach had undergone substantial alterations that changed its appearance. This included a wraparound building which encapsulated the original building inside of a new structure. In 2002, the Palm Beach County Board of County Commissioners committed to restoration of the building to its 1916 form. Once the wraparound structure was removed, it was noted that the entire east ele-

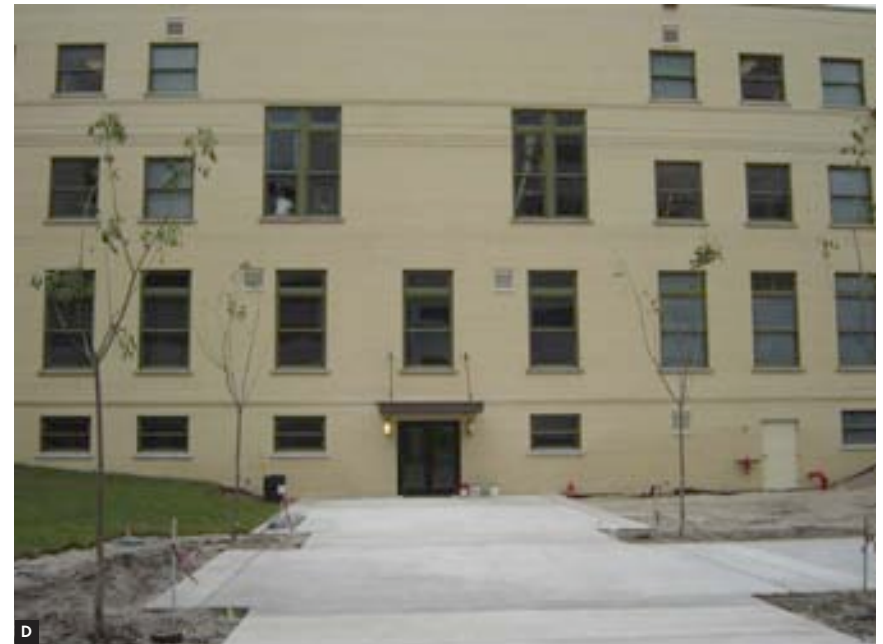
D) Final Reconstruction East Elevation

The second challenge was addressed by providing structural support for the windows in the existing walls prior to re-installing the existing windows on the north, west and south elevations. The existing structure was primarily terra cotta block with brick exterior. In order to strengthen the surrounding structure, a detail was created to install inboard steel columns to be placed on both sides of the window openings. A steel header and steel sill were also provided in some cases. In other cases concrete headers and sills with concrete columns were installed on either side of the window opening. The reinforcing structure was attached to the concrete floors and ceilings.

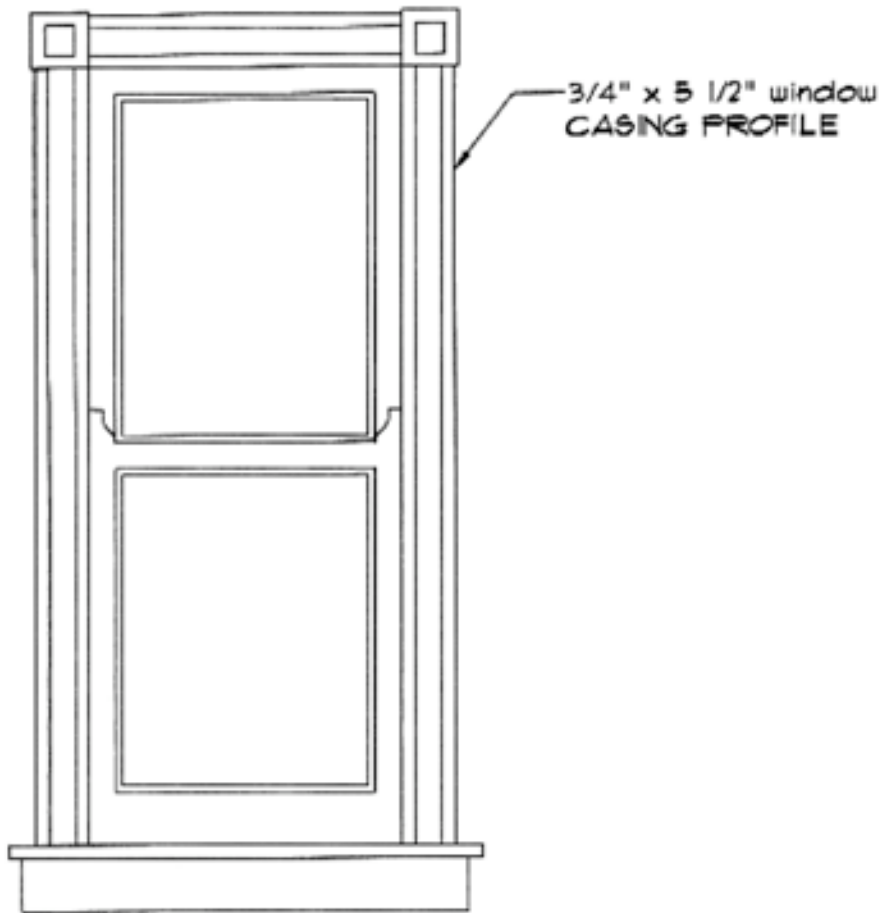
A) Elevation of Window on Interior Side of Opening; B) Reinforced Window Jam Detail; C) Window Sill Detail

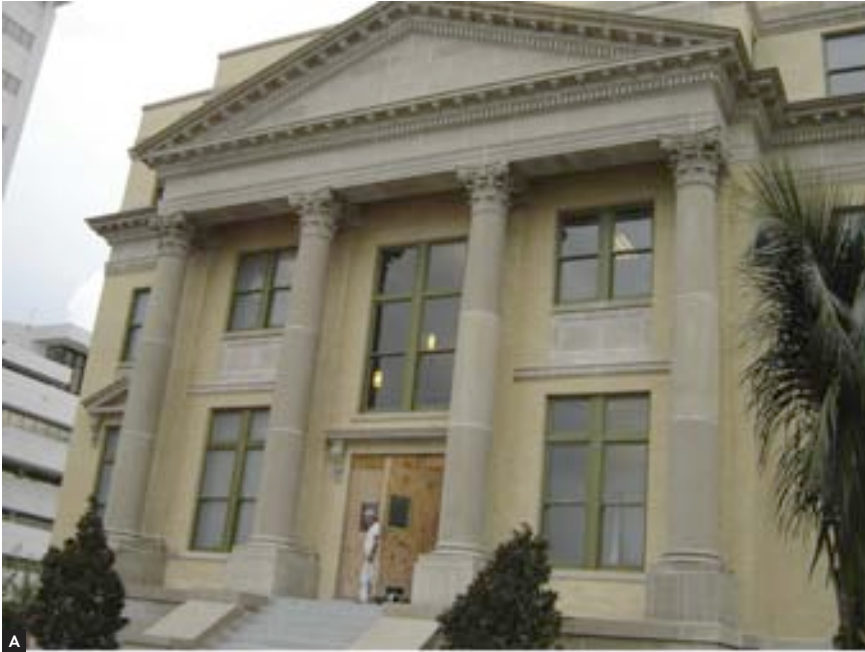
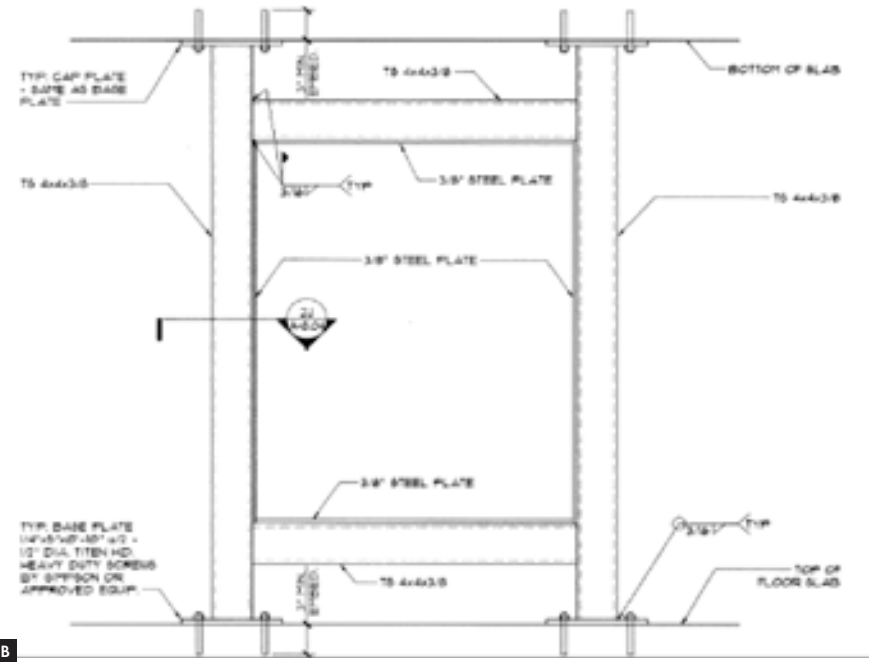
A) Restored Wood Windows (North Elevation); B) Window Opening Reinforcing Detail; C) Restored Wood Windows; D) Column Detail

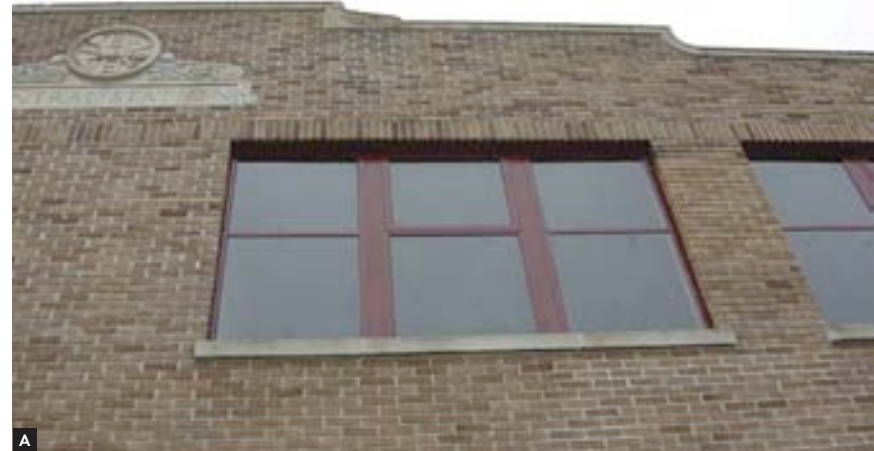
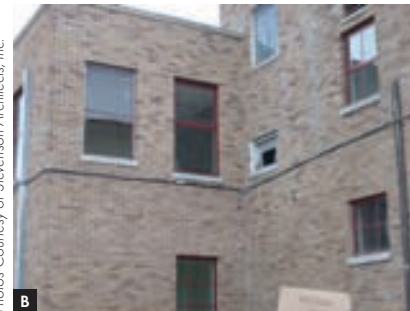
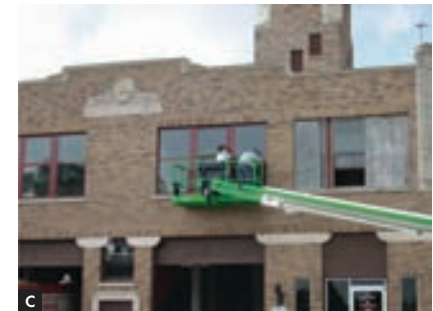
A) North-Window; B) West Wall After New Window; C) Window Installation on Facade

The selected product, Jamestown 175, impact glass, windows met the project criteria. There were two installation conditions, the first floor windows were installed with masonry clips. The second floor windows were installed on pressure treated 2 x framing installed within the original brick masonry "pocket".

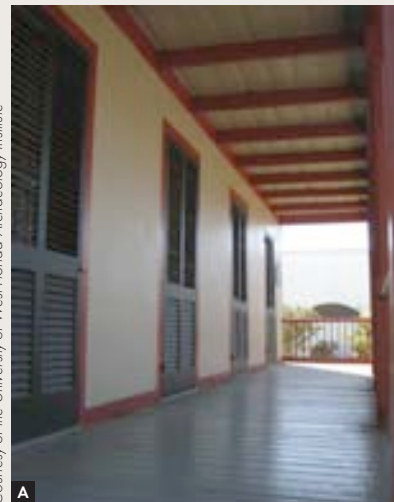
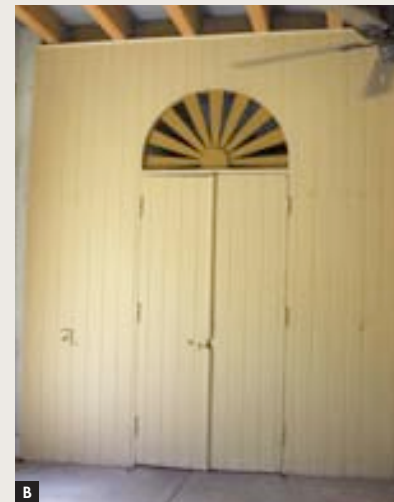
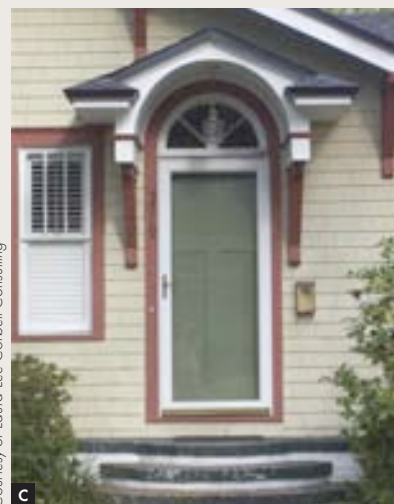
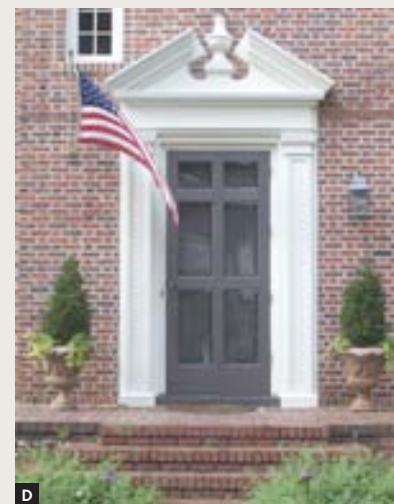
A) Closed Louvered Door, Lavelle House; B) Closed Shutter Door, Historic Bonnet House; C) Storm Door; D) Storm Door

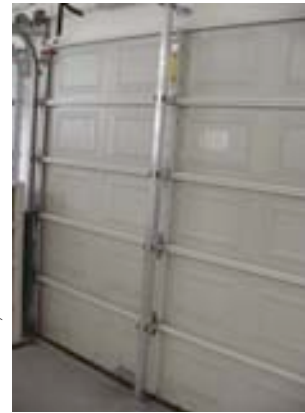
This telescoping vertical brace made of aluminum that attaches to the inside of the largest opening in most homes is available at local home centers. It is suitable for use with practically any garage door without modifying the garage door itself.

Historic garage doors should be retrofitted at the interior. Alterations that would change their exterior appearance should be avoided. Vertical bracing systems can be effective for supporting the door against wind pressure loading. An acceptable retrofit includes installation of a removable vertical post or posts (attached to the wall at the head of the opening and also to the floor) subdividing the width of the door(s). The door(s) must be securely attached to these posts so as to withstand both positive and negative wind pressures. The garage door track may also need to be

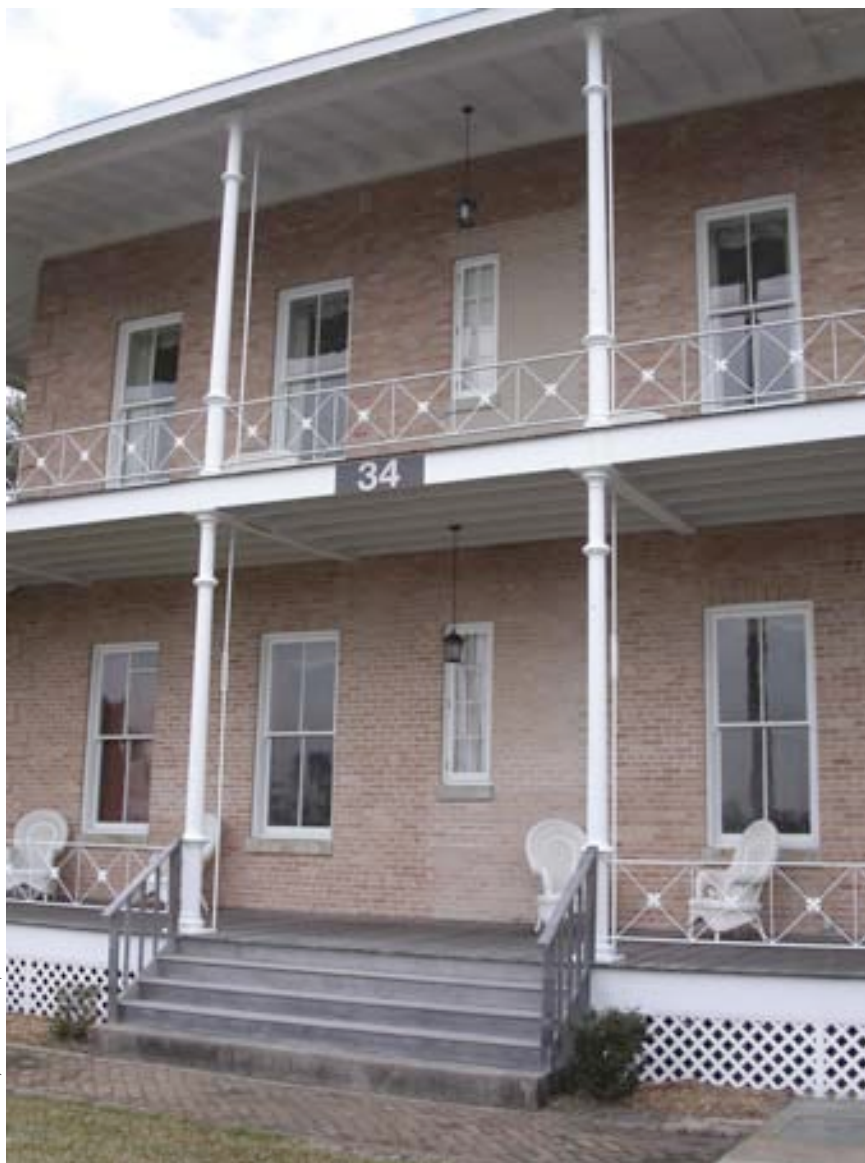
Tie rods were installed behind the historic cast iron columns of Building 34, the 1873 Bachelor Officer's Quarters at NAS Pensacola, to provide uplift resistance to the historic wrap-around porch.

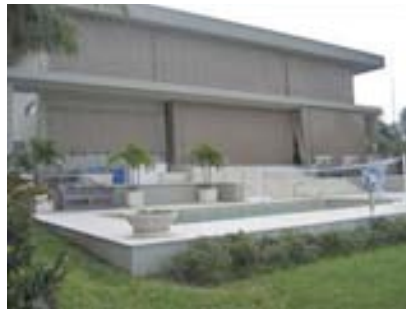
A flexible wind abatement system enclosing an entire porch helps to keep wind and flying debris away from the openings.

There are several new plastic mesh curtain products that may have application in protecting large open areas like open or screened porches, elaborate entry compositions including side-lights and transoms, or the entire sides of buildings. Typically these products are attached to a series of hooks, or loops in a metal track, installed above the opening to be protected. The bottom of the curtain is commonly anchored to an augered anchor a distance away from the base of the wall and stretched tight. Flexible wind abatement systems are designed to stretch a pre-calculated amount to allow for the deceleration and deflection of impacting missiles. One example is a curtain that extends over an entire structure, anchored to the ground on opposite sides of the structure, providing protection against flying debris while anchoring down the entire building. Sectional curtain type wind abatement systems appear acceptable for use on historic buildings. Those products designed to protect the entire home may be appropriate for buildings with simple roof forms and without features such as dormers and chimneys.

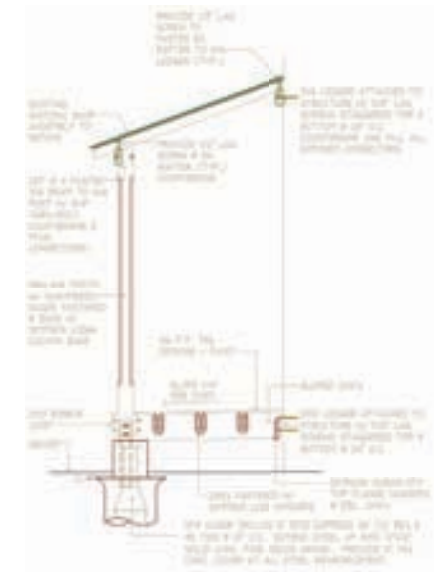
A) This column is held down by two rusty tech screws.; B) This porch on an older Florida house was enclosed. Note that the roof was resting on the brick columns with no anchor to hold the roof down.; C) Porch Roof Connection.

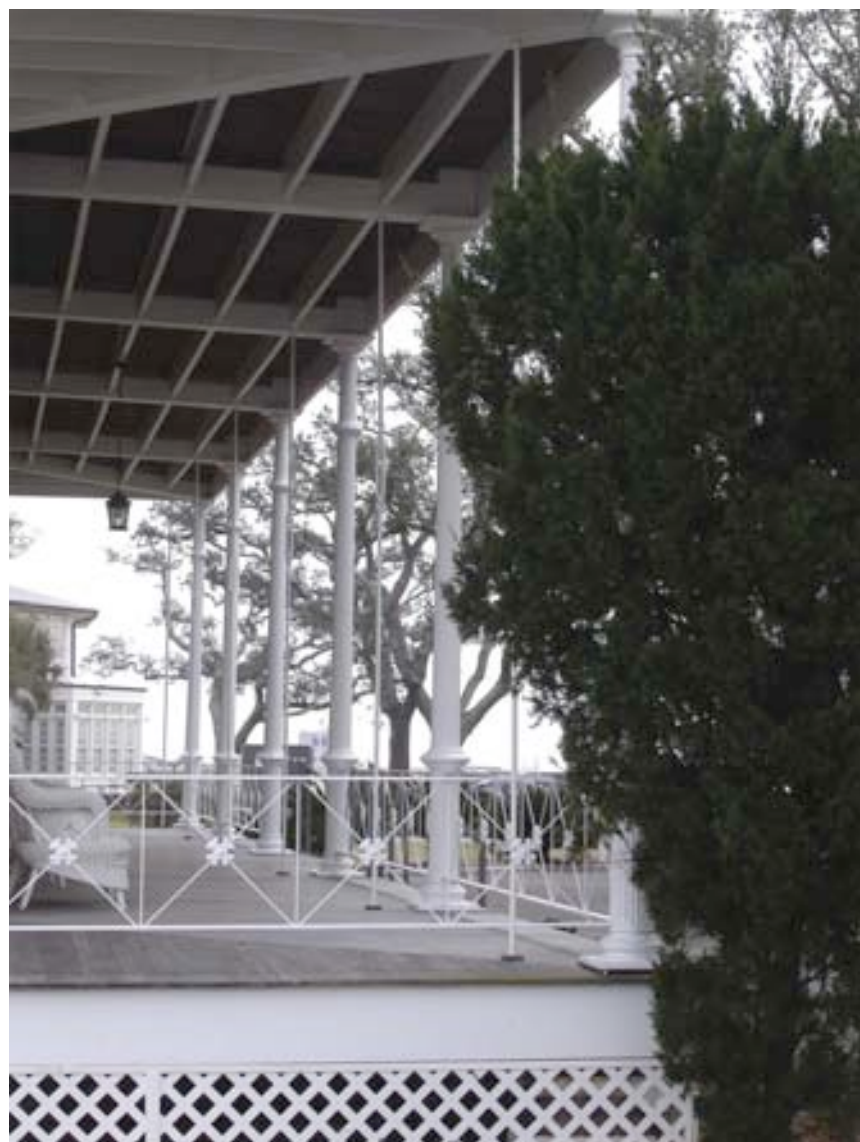
Here is another view of the tie rods installed behind the cast iron columns of Building 34, the 1873 Bachelor Officer's Quarters at NAS Pensacola, to provide uplift resistance to the historic wrap-around porch.

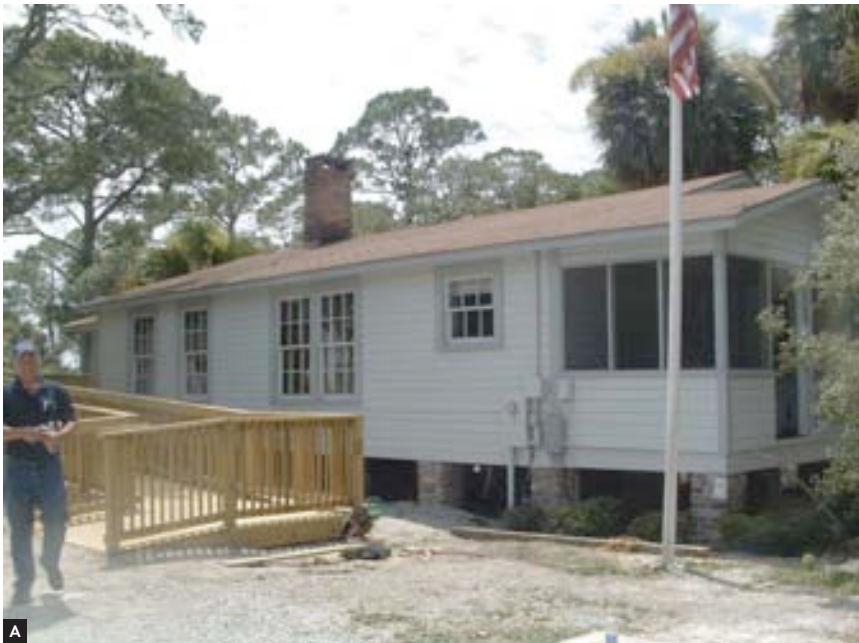
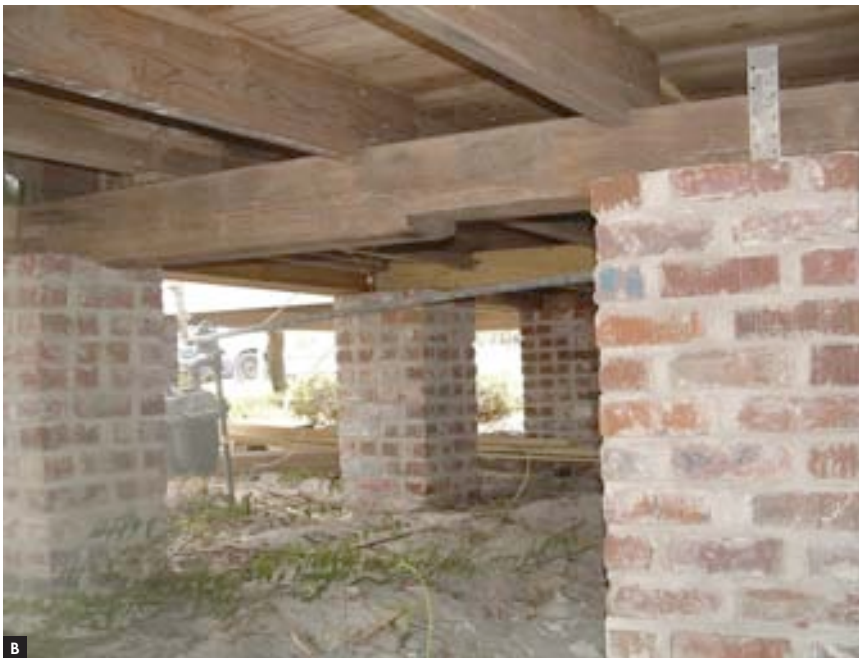
A) 1937 Maddox House in Port St. Joe; B) Sill Beam Tie Downs Trap to New Masonry Piers

A slab on grade foundation is a single, continuous layer of concrete with turned-down edges that sits directly on the ground and acts as the floor and foundation system. A slab-on-grade foundation is typically reinforced with welded wire fabric and longitudinal steel reinforcement (rebar) in the perimeter footing or turndown and elsewhere where it supports load-bearing partitions. For wood-framed construction, the bottom plate of the wall should be anchored to the slab with anchor bolts and washers. In order to retrofit, drill through the wall's sill plate into the concrete slab to anchor the wood-framed walls. Install 5/8" retrofit anchors with minimum 3"x3"x1/8"; washers every 16 inches and within a foot of each corner. Again, it is important to install these products following manufacturer's recommendations. Threaded rods set in epoxy adhesive are

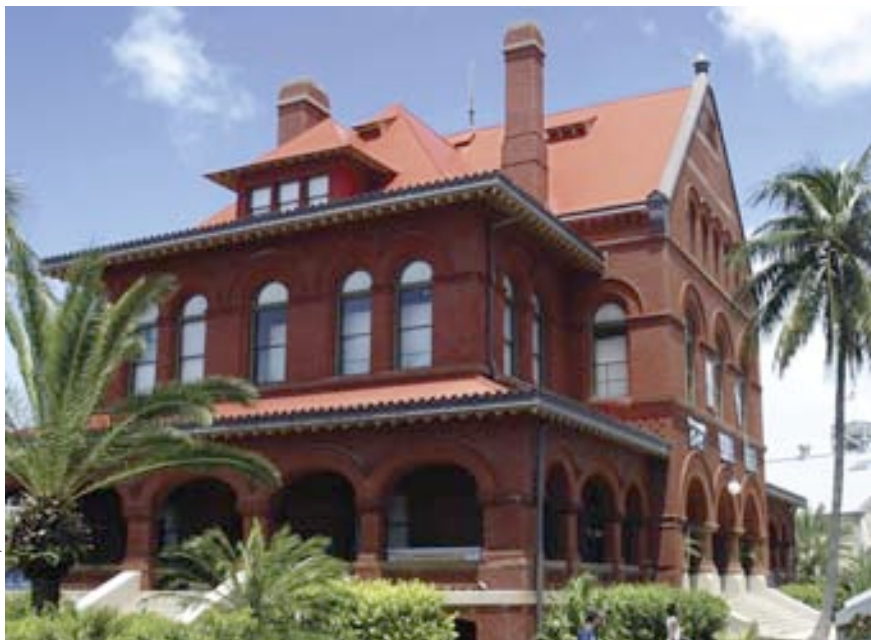
The Key West Custom House shows several significant historic metal roofing conditions. The lower roof is standing seam painted red, the upper roof is Victorian shingles painted red. Gutters and fascia trim are copper and were fabricated to match the historic configuration.

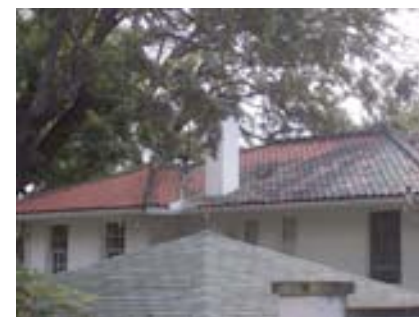
Not Recommended – Asphalt shingles are an incompatible replacement substitute for the original clay tiles on this residential garage.

- Asphalt shingles are an incompatible replacement substitute for the original clay tile roofing.
- Do not use tile options that replicate the look of stone, slate or wood shingles.
- Do not use stone coated metal panel systems replicating the look of clay tile.
- Unless consistent with a historic use, painted finish metal panel systems replicating the look of clay tile are inappropriate.

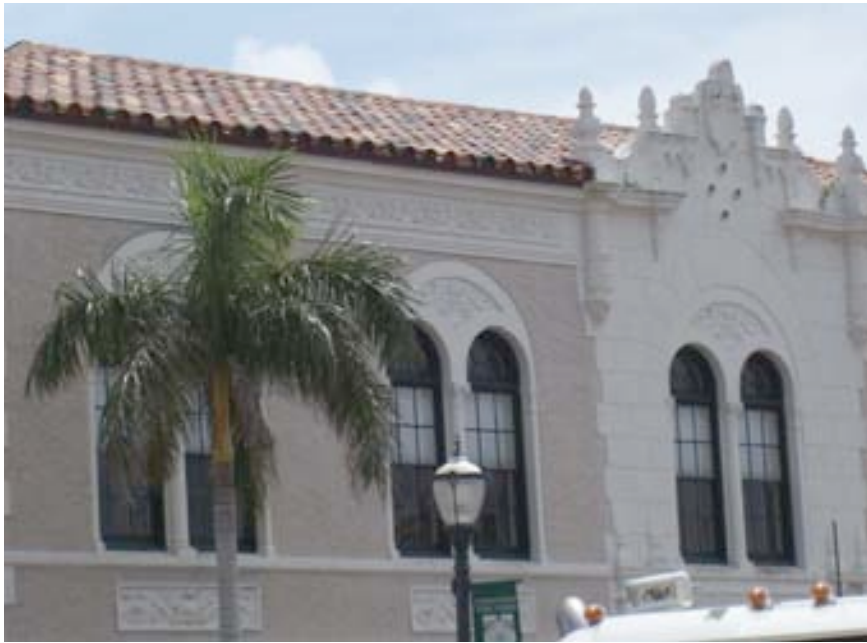
**Old City Hall****Downtown Fort Pierce**

Tiles installed on historic 1925 City Hall are a color mixture or "blend" of 40% Clay Red, 20% 165-01, 20% Impressionist Tuscan, 10% Empire Green with Ebony Mist and 10% Brookville Green-High Gloss.

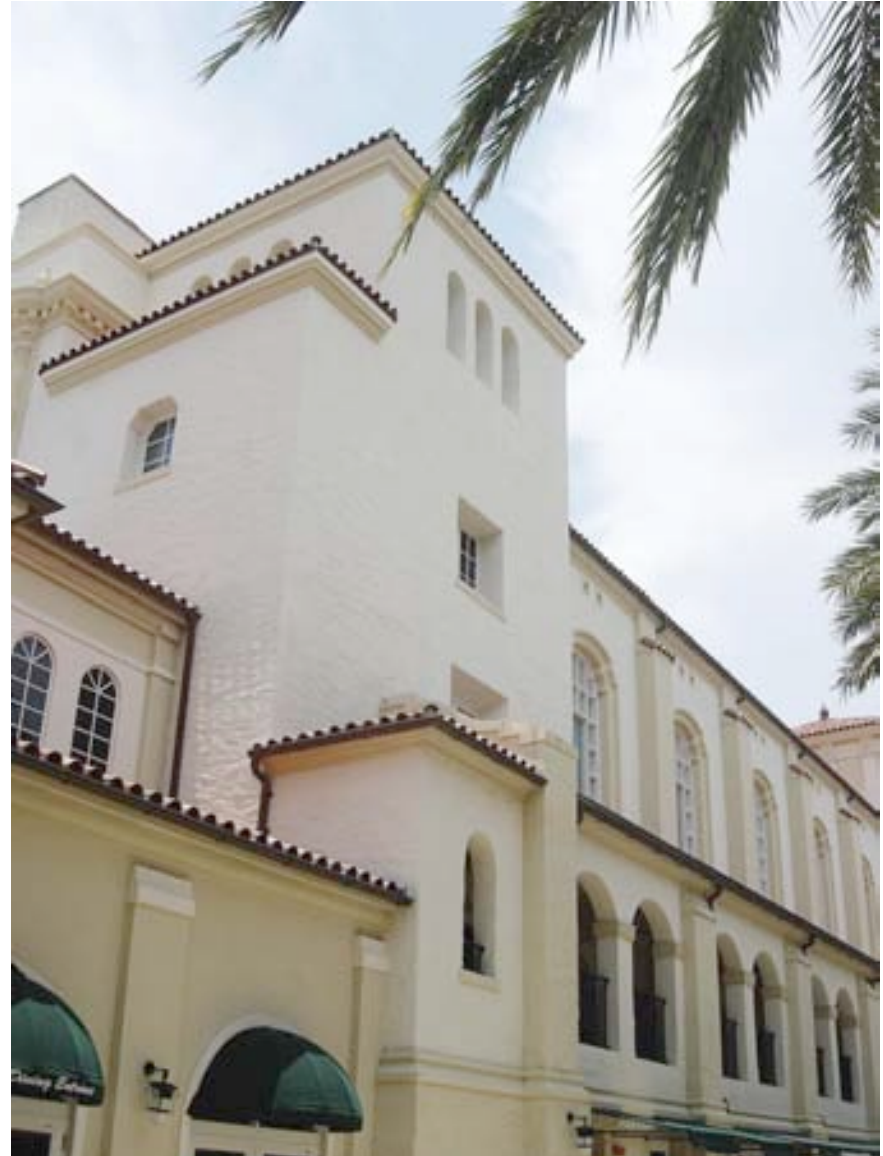
Clay tile roofing installed on the Harriet Himmel Gilman Theater for Cultural and Performing Arts originally built in 1926 as the First United Methodist Church.

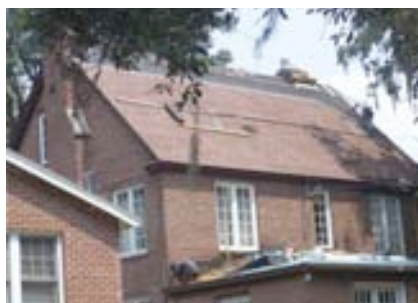
Installation of an asphalt shingle roof.

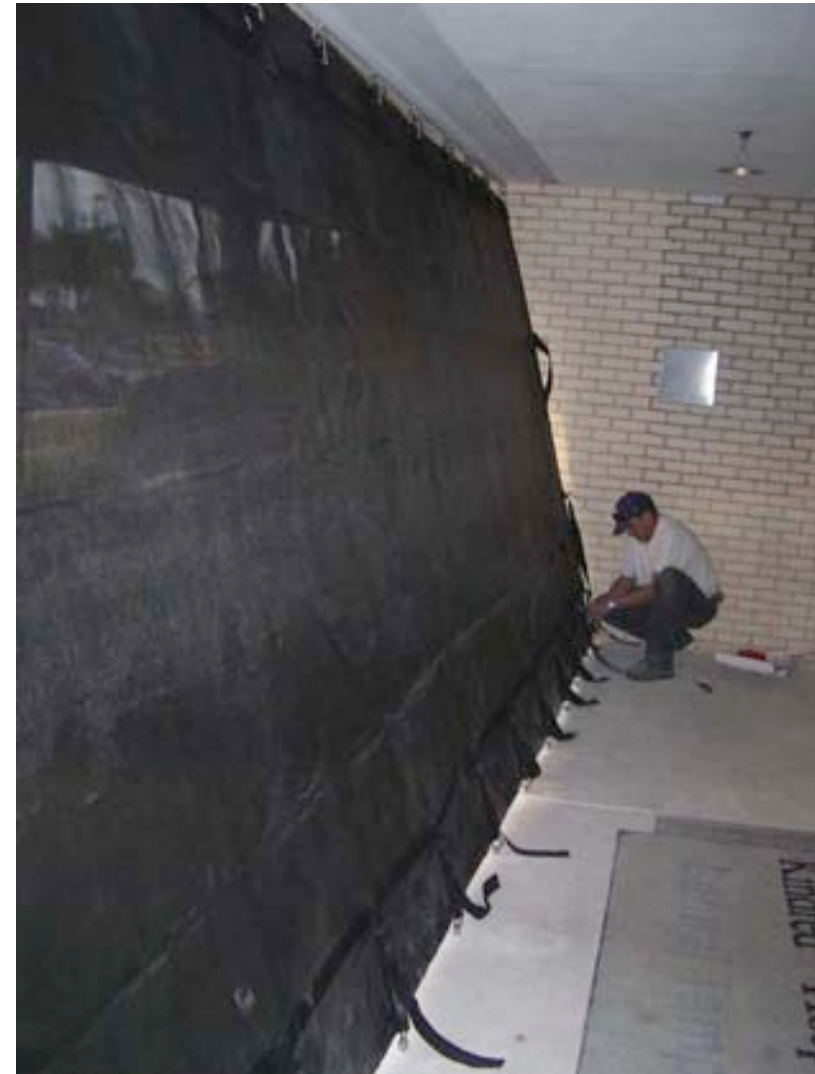
Flexible wind abatement system installation.

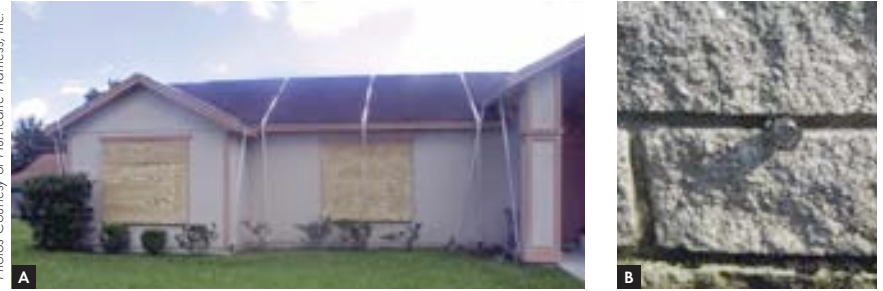
A) Roof straps installed on a home.; B) Roof strap anchor.
