RAINIER SCHOOL

Cultural Landscape Assessment

WASHINGTON STATE DEPARTMENT OF SOCIAL & HEALTH SERVICES

PROJECT NO. 2014-418A(1)

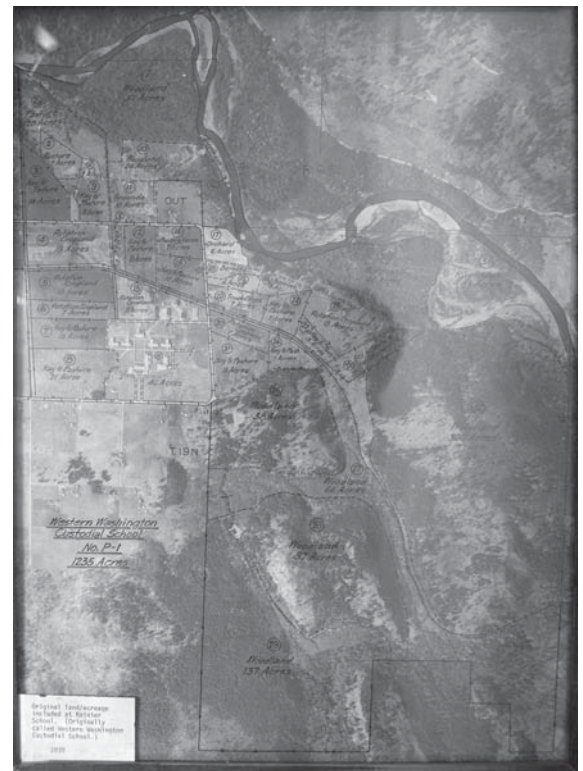
1939 MAP OF ORIGINAL ACREAGE AND LAND USES AT THE WESTERN WASHINGTON CUSTODIAL SCHOOL, LATER RENAMED AS RAINIER SCHOOL.
SOURCE: RAINIER SCHOOL ARCHIVES, DEPARTMENT OF SOCIAL AND HEALTH SERVICES.

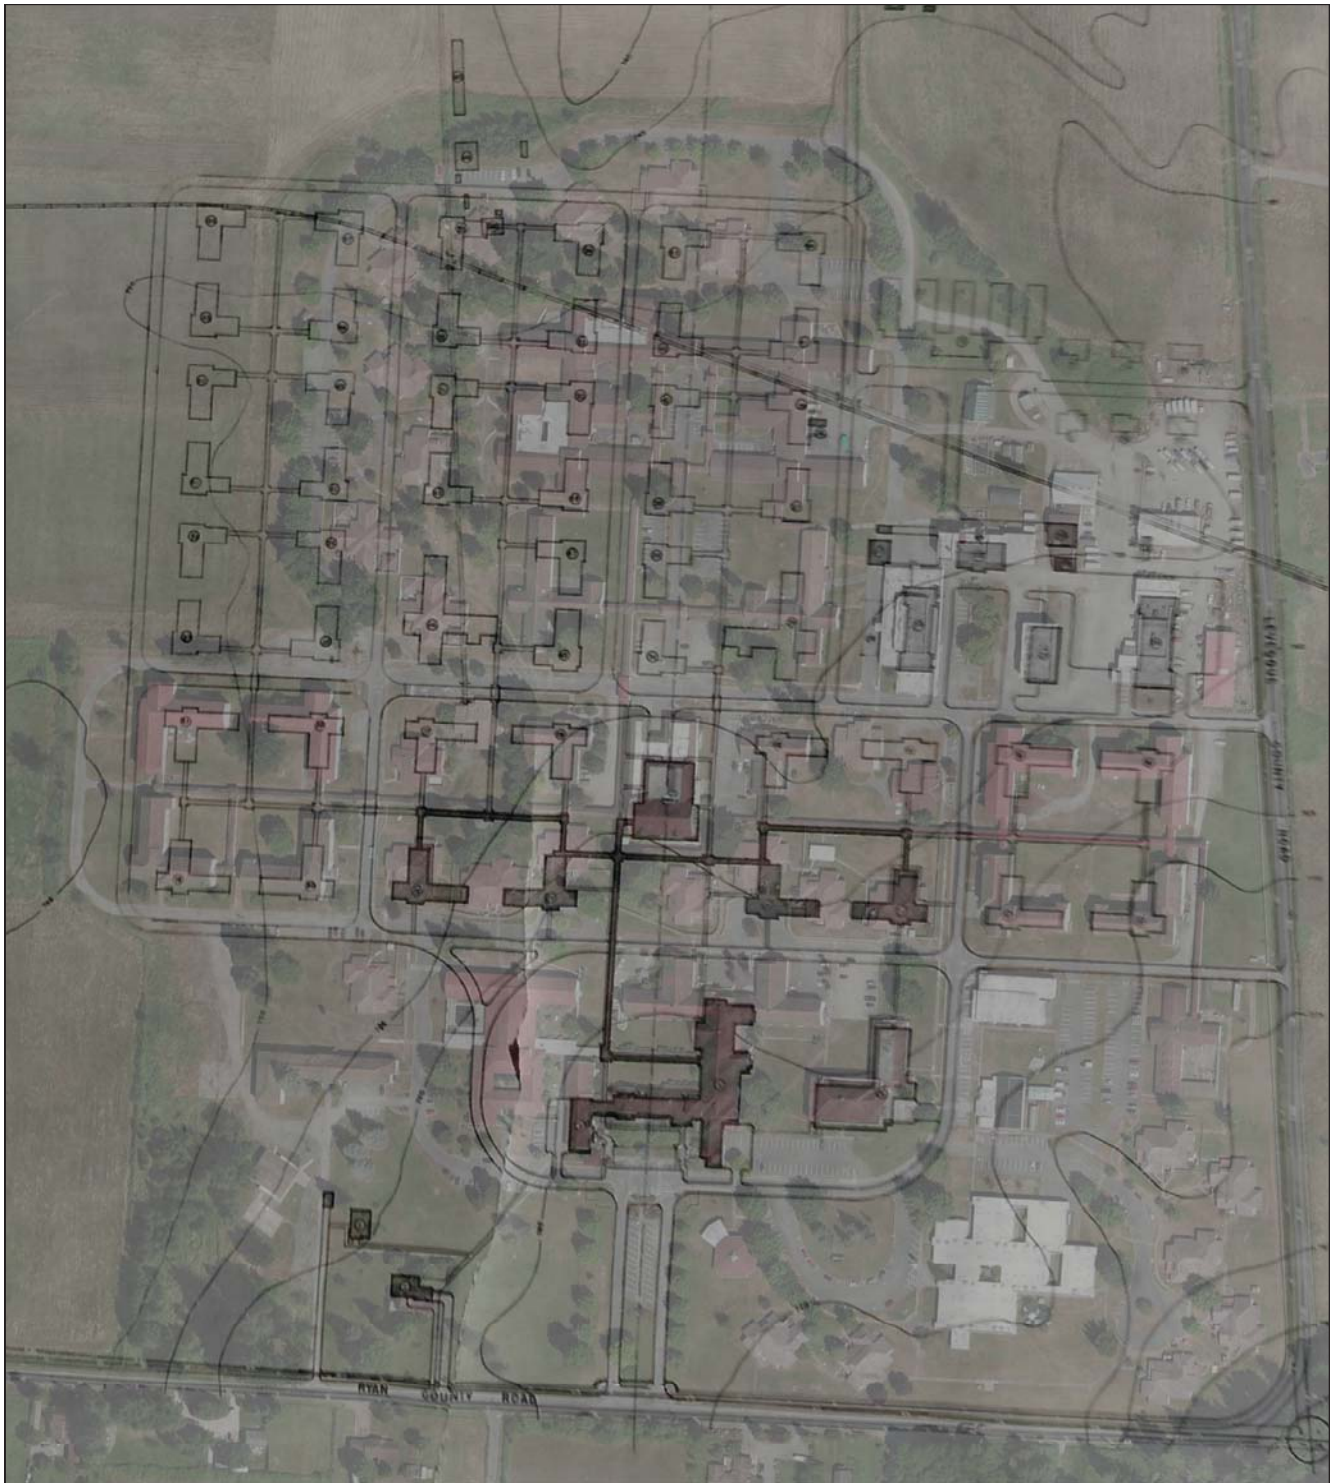
1944 proposed development plan that was not implemented overlaid on a contemporary aerial image.

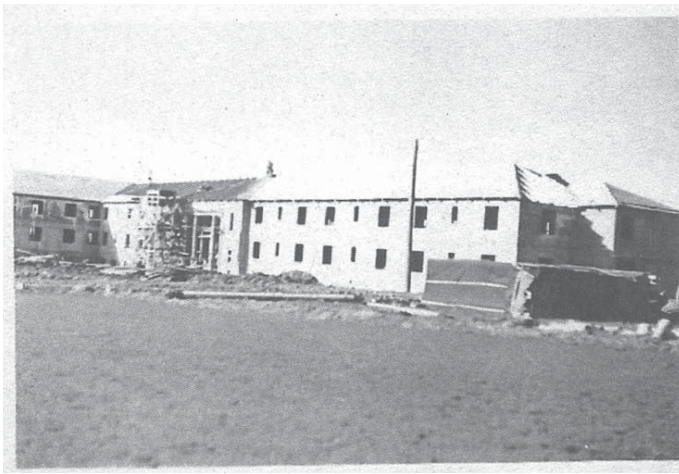
MARCH, 1948 VIEW OF THE STAFF DORM UNDER CONSTRUCTION.
SOURCE: RAINIER SCHOOL ARCHIVES, DEPARTMENT OF SOCIAL AND HEALTH SERVICES.

Graham and Painter had even been contracted to design a nurses' home to meet this need, but funding fell through. Finally, funds became available and the state hired Seattle architects Carl Collins and Paul Delaney of Collins and Delaney to design a staff dormitory for the site. Construction was authorized to proceed on December 12, 1947³² and progressed steadily, passing the official inspection on August 30, 1948.³³ The staff dormitory was located on the west side of the campus, near other staff residences including the superintendent's house and the doctor's and engineer's cottages. The new residence featured private rooms for staff members living on site.

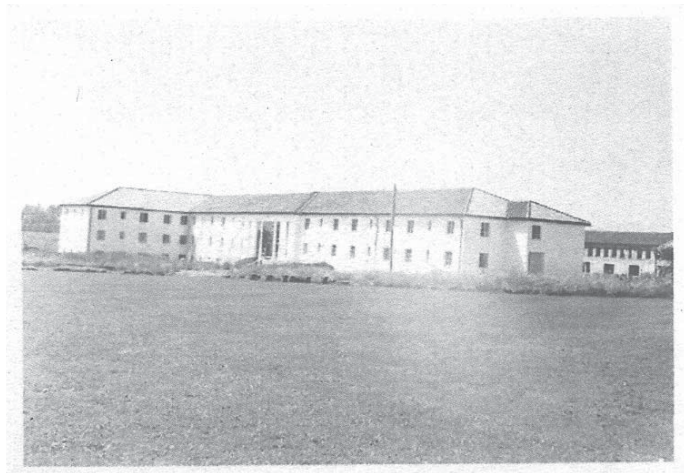
JULY, 1948 VIEW OF THE STAFF DORM NEARLY OR JUST COMPLETED.
SOURCE: RAINIER SCHOOL ARCHIVES, DEPARTMENT OF SOCIAL AND HEALTH SERVICES.

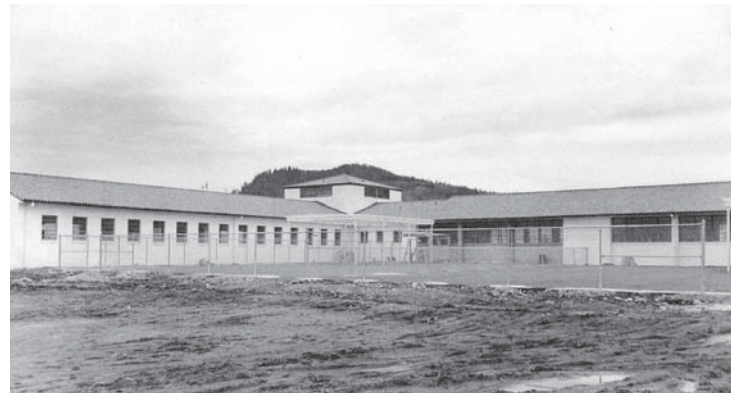
1955 VIEW OF THE EVERGREEN CENTER (B50), NOW KNOWN AS SPRUCE,
HEMLOCK, FIR AND PINE.
SOURCE: RAINIER SCHOOL ARCHIVES, DEPARTMENT OF SOCIAL AND
HEALTH SERVICES.

continued to work for the school, designing a large building featuring four wings, two each for boys and girls, and located at the north edge of the campus. This building, known as the Evergreen Center but sometimes considered four buildings with its large wings, was completed in 1954. The individual wings came to be known as Hemlock, Spruce, Fir, and Pine and were the last dormitory-style buildings constructed on the campus.

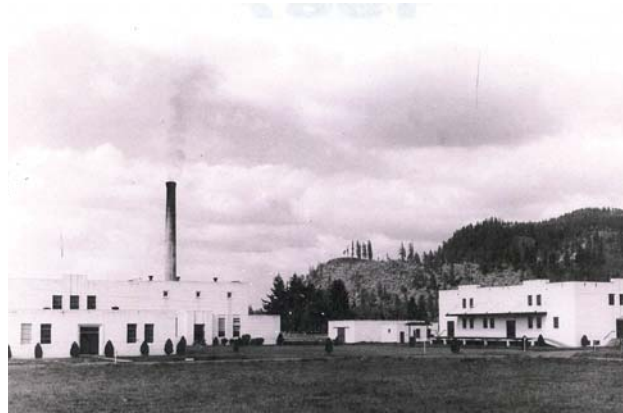
1948 VIEW OF THE LAUNDRY (L), POWERHOUSE (CENTER), AND COMMISSARY (R); THE PAINT STORAGE AND PUMPHOUSE ARE VISIBLE BETWEEN THE POWERHOUSE AND COMMISSARY.

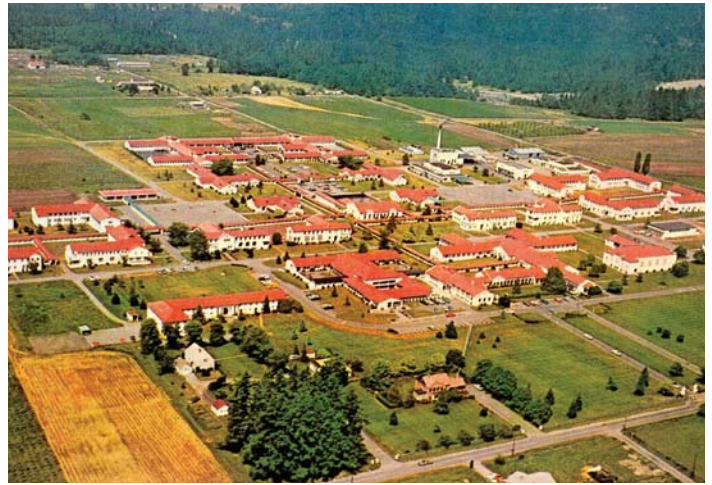
1967 AERIAL VIEW OF CAMPUS, LOOKING NORTHWEST.
SOURCE: RAINIER SCHOOL ARCHIVES, DEPARTMENT OF SOCIAL AND
HEALTH SERVICES.

Successive residential wards were constructed on the same axis as the original wards, spreading out to the east, west, and north. A 1944 plot plan showed John Graham had moved away from the cross-shaped layout of earlier designs.⁶⁰ Proposed buildings remained aligned with the original and subsequently built wards but in greater numbers. New plans showed additional covered walkways and roundabouts were no longer present. The Administration and Hospital remain the primary buildings fronting the main entrance.

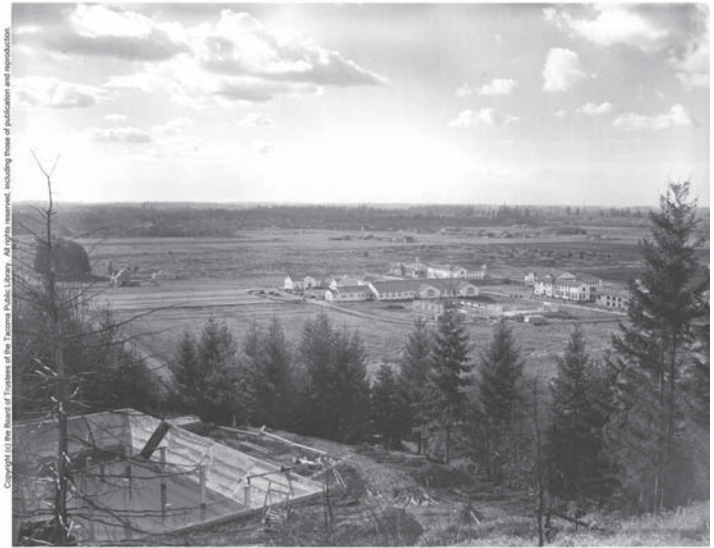
1940 AERIAL VIEW OF THE CAMPUS, SHOWING A WATER RESERVOIR IN THE FOREGROUND, LOOKING NORTHWEST.
SOURCE: TACOMA PUBLIC LIBRARY, RICHARDS STUDIO COLLECTION.

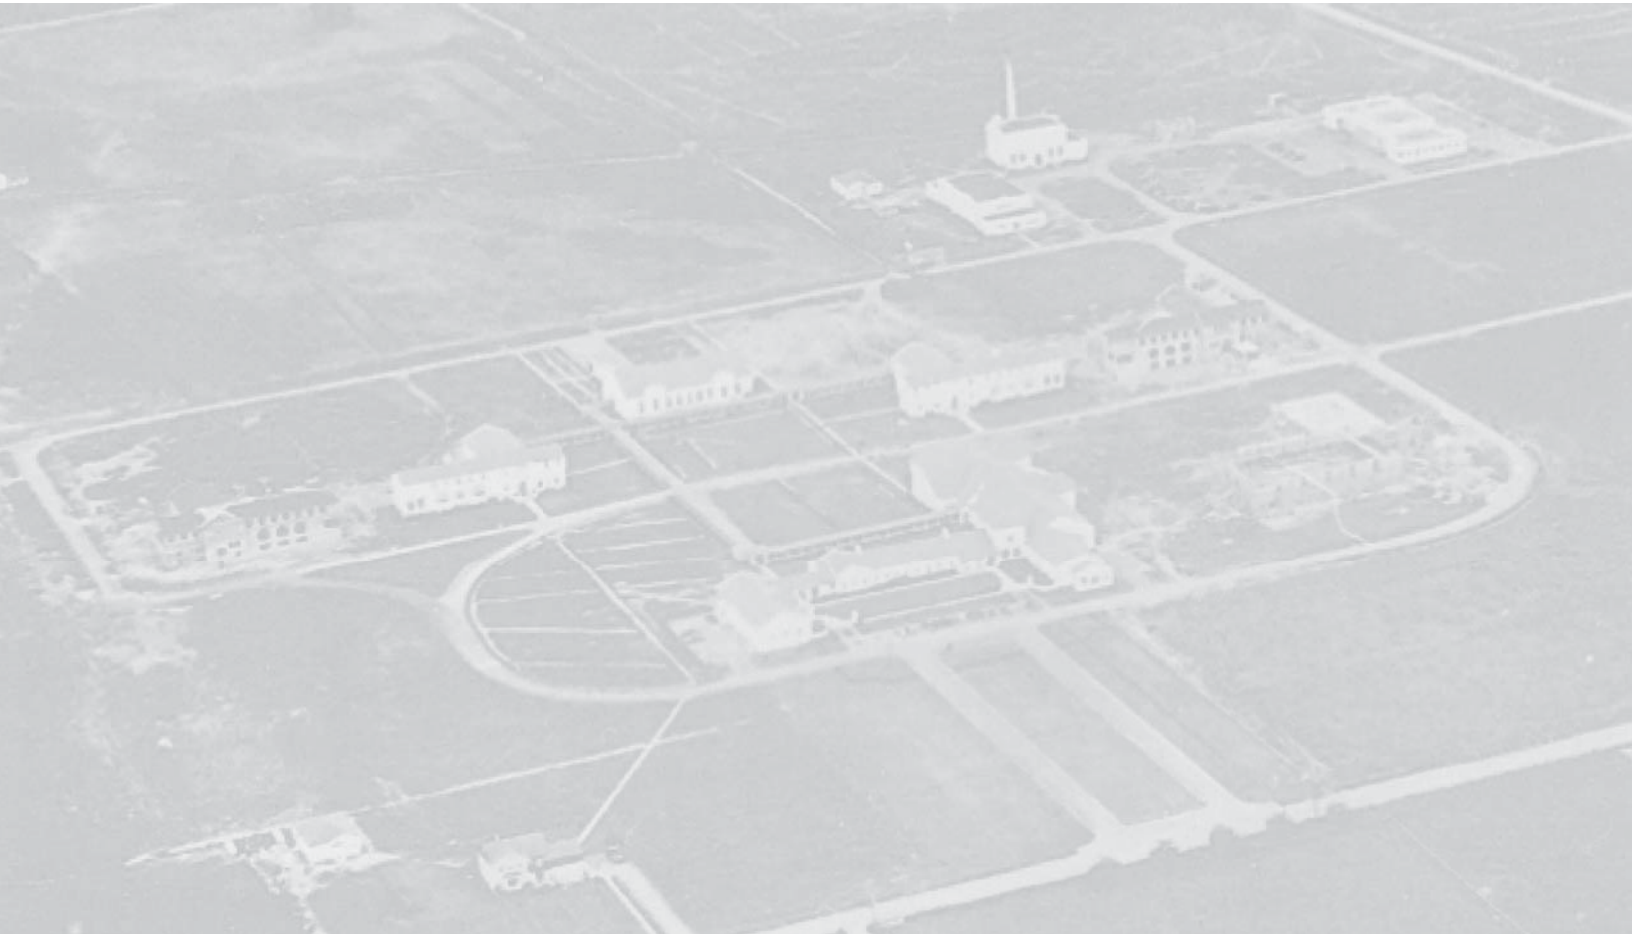
1940 AERIAL VIEW OF CAMPUS, LOOKING NORTHWEST (CAPTION FOR ABOVE IMAGE AND IMAGE ON PRECEDING PAGE).
RAINIER SCHOOL ARCHIVES, DEPARTMENT OF SOCIAL AND HEALTH SERVICES.

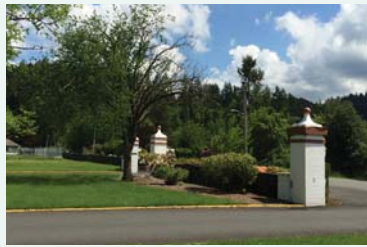
NAME	SIGNIFICANCE	CHARACTER-DEFINING FEATURES	ALTERATIONS	Image(s)
Entrance Court	<p>Landscape designed by Edwin Clair Heilman in 1939; however, the design was not implemented, for reasons unknown.</p> <p>The entrance court provided the public automobile drive entering the site from Ryan road. The overall layout consisted of two parallel drives off Ryan Road for entering and exiting the site. A lawn median separated the lanes with a 14-foot-wide east-west road section connecting the two near the main gate. This connecting road allowed for cars to make the loop without having to exit and reenter the site.</p> <p>Heilman's design provided the landscaping along the rock wall, main gate, and roadway into the campus. American elm trees specified for the sides defined an allee along the entrance court. A second set of smaller ornamental trees specified for behind the rows would have provided an understory to transition to the lawn and ground plantings. Curvilinear planting beds extended along the entrance court behind the allee of elms with low shrubs ranging in heights from 30 inches to 4 feet in height.</p>	<ul style="list-style-type: none"> • Overall configuration of parallel drives and a grass median 	<ul style="list-style-type: none"> • By 1955, plantings along the entrance court consisted of lawn and a dotting of short sculpted evergreen shrubs along the road that departed dramatically from the original design. None of the planting beds or originally specified tree types were evident. The north end of the grass median soon converted to parking. • At the rock wall added alternating low and high shrubs, with the lower shrubs removed by the mid-1950s • During the 1990s an allee of trees was planted along the road

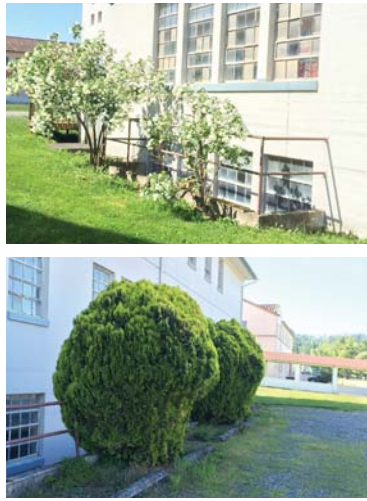
Foundation Plantings	<p>Foundation plantings consisted primarily of sculpted evergreen shrubs, trimmed to rounded and conical shapes within a narrow planting bed alongside the buildings.</p> <p>These departed from the 1938 and 1939 plans prepared for the Administration and Hospital buildings. No planting plans were identified for subsequent buildings constructed at the site during the 1940s through 1950s.</p>	<ul style="list-style-type: none"> • None 	<ul style="list-style-type: none"> • Unknown

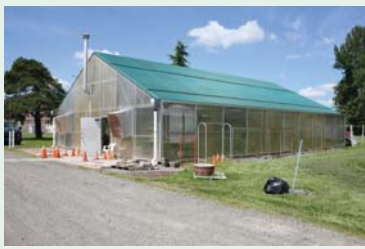
ID	SIGNIFICANCE	CHARACTER-DEFINING FEATURES	ALTERATIONS	IMAGE(S)
B4	<p>Common name: Greenhouse (B4)</p> <p>Built since 1976, this non-historic building provides greenhouse space for residents and staff.</p>	<ul style="list-style-type: none"> • NA 	<ul style="list-style-type: none"> • NA

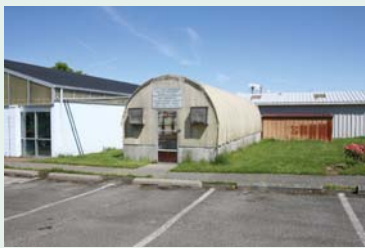
B6	<p>Historic name: Greenhouse</p> <p>Common names: Annex Greenhouse, Greenhouse 3 (B6)</p> <p>This building provides greenhouse space for residents and staff.</p>	<ul style="list-style-type: none"> • Rectangular plan • Single story • Poured concrete foundation • Transparent, corrugated siding as cladding and roofing • Barrel vault roof

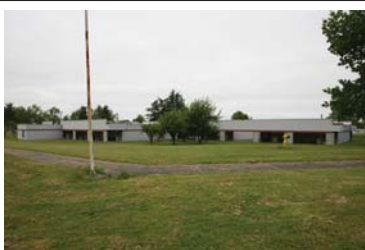
B7	<p>Historic name: Training, Service, Volunteer Service Building</p> <p>Common name: Instructional Services (B7)</p> <p>Built in 1973 and designed by Harris, Reed and Litzenberger in the Modern style, this non-historic structure provided training space for volunteers at the school.</p>	<ul style="list-style-type: none"> • NA 	<ul style="list-style-type: none"> • NA

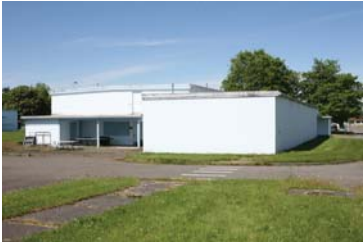
ID	SIGNIFICANCE	CHARACTER-DEFINING FEATURES	ALTERATIONS	IMAGE(S)
B17	<p>Historic name: Activity Building, Bowling Alley</p> <p>Common name: Ray Peel, Canteen (B17)</p> <p>Built in 1966 in the Modern style, this building continues to provide indoor recreation space for residents and staff. It contains game tables and a bowling alley.</p>	<ul style="list-style-type: none"> • Original rectangular footprint, plus two smaller rectangular additions along the north and east facades • Single story • Painted, concrete masonry unit structure and cladding • Metal framed, multi-lite window in east facade • Flat roof form • Two pairs of unglazed wood doors at west/main entry • Single and paired unglazed wood doors at secondary (south, east) entries • Saw-tooth profile to north exterior wall • Metal pipe railings • Painted wood cornice • Four-lane bowling alley • Shoe rental counter, including shoes, cubbies, wood counter and shelves • Bi-color, synthetic, curved benches 	<ul style="list-style-type: none"> • Undated, north addition to create the bowling alley • Undated, east addition to cover the outdoor concession stand area

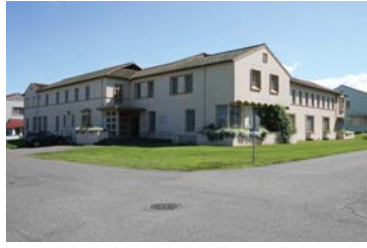
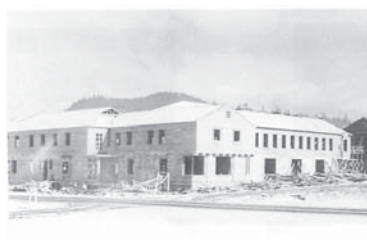
ID	SIGNIFICANCE	CHARACTER-DEFINING FEATURES	ALTERATIONS	IMAGE(S)
B19	<p>Historic name: Ward, Boys' (B1)</p> <p>Common name: Olsen (B19)</p> <p>Built in 1947-1948 and designed by Miller and Ahlson in the Spanish Colonial Revival style with Art Deco and Streamlined Moderne influences. H. R. Olson Construction Company of Tacoma served as the builders. This building served as a residential dormitory and shared living space for male residents of the school. It contains large, open dormitory spaces as well as shared bathrooms, isolation rooms, offices and quarters for attendants, and activity rooms. It is presently vacant. It presently serves as storage space for the campus.</p>	<ul style="list-style-type: none"> • Original primarily L-shaped footprint • Two stories • Painted, reinforced concrete foundation and water table • Painted, board formed concrete cladding • Hybrid gable and hip roof form • Multi-lite, metal framed windows • Windows that wrap a corner • Oriel window(s) • Broad, continuous concrete frames around exterior windows • Reinforced concrete steps and porch at main entrance • Jetty with scalloped underside • Quoining at select walls • Square and circular vent openings • Cluster of abstract wall perforations centered high in gable end • Streamlined, round cornered concrete awning • Incorporated planters and flowerboxes in exterior walls • Painted, projecting beltcourse on select facades • Red clay roof tiles • Copper, half-round gutters • Shaped rafter ends • Original floor plan, including corridors, dormitories, activity rooms, isolation rooms, and staff offices • Terrazzo flooring • Original double exterior and interior doors with portholes 	<ul style="list-style-type: none"> • 1993, heating system modifications

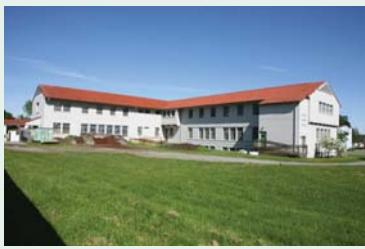
ID	SIGNIFICANCE	CHARACTER-DEFINING FEATURES	ALTERATIONS	IMAGE(S)
B20	<p>Historic name: Ward (B3)</p> <p>Common name: Cedar (B20)</p> <p>Built in 1952 and designed by NBBJ in a Spanish Colonial Revival style with Art Deco and Streamlined Moderne influences. This building served as a residential dormitory and shared living space for male residents of the school. It contains large, open dormitory spaces as well as shared bathrooms, isolation rooms, offices and quarters for attendants, and activity rooms. It is presently used as storage.</p>	<ul style="list-style-type: none"> • Original primarily L-shaped footprint • Two stories plus daylight basement • Painted, reinforced concrete foundation and water table • Painted, board formed concrete cladding • Hybrid gable and hip roof form • Multi-lite, metal framed windows • Windows arranged singly, in pairs, and in ribbons • Groups of glass block set into exterior walls • Broad, continuous concrete frames around exterior windows • Multi-lite, metal framed double doors, sidelites and transom at main entrance • Reinforced concrete steps and porch at main entrance • Decorative metal railings • Metal pipe railings at areaways • Cluster of geometric wall perforations centered high in gable ends • Thin, inset beltcourse • Oriels at second floor • Red clay roof tiles • Copper, half-round gutters • Original floor plan, including corridors, dormitories, activity rooms, isolation rooms, and staff offices • Terrazzo flooring • Original interior doors with hand-painted numbering • Ceiling flush mounted, pointed cone light shades 	<ul style="list-style-type: none"> • 1993, heating system modifications • Undated, added ADA ramps at rear and alterations to interior finishes • Undated, contemporary partitions added to some of the larger rooms

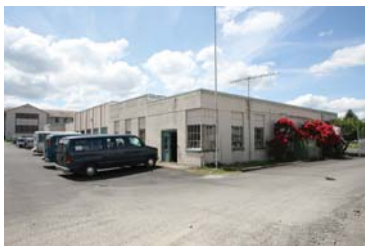
ID	SIGNIFICANCE	CHARACTER-DEFINING FEATURES	ALTERATIONS	IMAGE(S)
B23	<p>Historic name: Garage</p> <p>Common name: Maintenance Building (B23)</p> <p>Built in 1940 and designed by Graham and Painter in the Art Deco and Streamlined Moderne style. This building provided maintenance support for the campus and contains the maintenance office, auto shop/garage, electric shop, plumbing/steam shop, and lawn and garden department.</p>	<ul style="list-style-type: none"> • Original I-shape footprint, plus additions for present irregular plan • Single story • Painted, reinforced concrete foundation and water table • Painted, board formed concrete cladding • Flat roof form with surrounding parapet • Multi-lite, metal framed windows • Windows wrapping at least one corner • Concrete window slip sills • Single and double wood door, multi-lite glazing in upper half • Wood, sectional overhead garage doors, multi-lite glazing in upper half • Horizontal reeding details in exterior walls • Thin, inset beltcourse • Skylight opening over auto shop 	<ul style="list-style-type: none"> • 1956, north addition providing administrative offices • 1958, south-west addition expanding shop spaces • 1959 post, west addition • 1993, heating system modifications • Undated, many windows painted over and select garage doors replaced or infilled

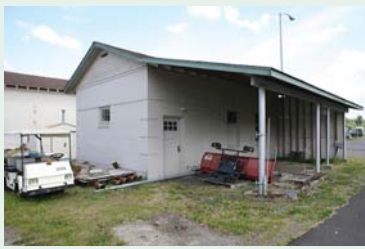
ID	SIGNIFICANCE	CHARACTER-DEFINING FEATURES	ALTERATIONS	IMAGE(S)
B26	<p>Historic/common name: Pumphouse (B26)</p> <p>Built in 1940 and designed by Marius Anderson, Supervising Engineer, in the Vernacular style. This building has always served as the pumphouse, drawing water from the off-site reservoirs to the campus proper. It contains active pump operations.</p>	<ul style="list-style-type: none"> • Original rectangular footprint, plus roof extension to south • Single story • Brick and wood beam structure • Brick cladding, except for horizontal wood cladding in gable ends • Recessed bricks at corners suggest quoining • Wood framed, multi-lite sash windows • Wood doors, glazed in upper half • Hollow clay tile interior wall treatment 	<ul style="list-style-type: none"> • Undated, roof extended to the south providing additional covered storage space • One window partially infilled with plywood • Gable roof form added to formerly flat roof

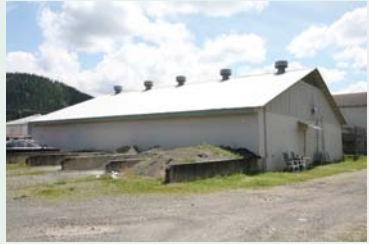
ID	SIGNIFICANCE	CHARACTER-DEFINING FEATURES	ALTERATIONS	IMAGE(S)
B28	<p>Historic name: Root House, Commissary Annex</p> <p>Common name: Maintenance Storage (B28)</p> <p>Built in 1948, this utilitarian building is part of the Maintenance Department. It provides weather protected storage space for the department.</p>	<ul style="list-style-type: none"> • Original rectangular footprint • Single story • Painted, reinforced concrete structure and cladding • Gable roof form • Corrugated metal roofing • Metal, round roof ventilators 	<ul style="list-style-type: none"> • 1993, heating system modifications • Undated, CMU infill in west facade, gable end cladding veneer

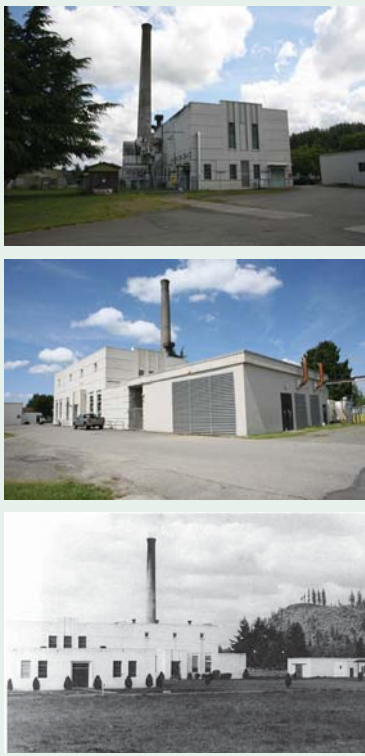
ID	SIGNIFICANCE	CHARACTER-DEFINING FEATURES	ALTERATIONS	IMAGE(S)
B30	<p>Historic/common name: Powerhouse (B30)</p> <p>Built in 1938 and designed by Graham and Painter in the Art Deco – Streamlined Moderne style. This building has always served as the central boiler plant for the campus.</p>	<ul style="list-style-type: none"> • Original rectangular footprint; east and west additions maintained a rectangular plan • Single story, with multi-story open volume in main portion • Painted, reinforced concrete foundation and water table • Painted, board formed concrete cladding • Flat roof form with surrounding parapet • Multi-lite, metal framed windows • Horizontal reeding details in exterior walls • Shaped beltcourses inscribed into exterior walls 	<ul style="list-style-type: none"> • 1948, improvements to Boiler Plant including adding a new (third) boiler, designed by Peter W. Mourer, Jr., Mechanical Engineer • 1974, west addition by Valentine, Tomlinson and Fisher, Engineers • 1974, remodel of gas lines, switched from original coal fuel source • 1974–1979, north addition around stack • 1979 ca, east addition to house emergency generator • 2005, boiler replacement and associated replacement of portions of southeast corner walls, windows

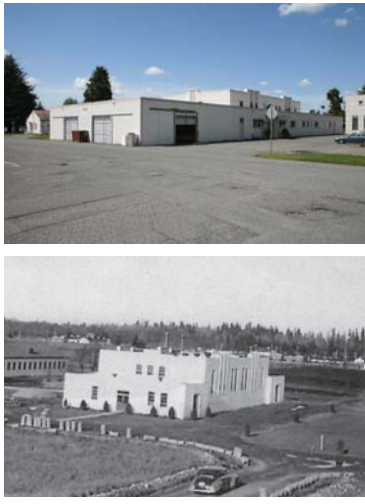
B31	<p>Historic/common name: Laundry (B31)</p> <p>Built in 1938-1939 and designed by Graham and Painter in the Art Deco and Streamlined Moderne style. This building has always served as the central laundry facility and contains the industrial scale laundry facilities for the campus, where all the bed linens, clothes, etc. are cleaned, dried, pressed, and folded.</p>	<ul style="list-style-type: none"> • Original rectangular footprint, plus surrounding additions for a current L-shaped plan • Single story • Poured concrete foundation • Painted, board formed concrete cladding • Flat roof form with surrounding parapet • Multi-lite, metal framed windows • Metal security doors with minimal glazing • Metal, unglazed security doors • Horizontal reeding details in exterior walls 	<ul style="list-style-type: none"> • 1958, west addition • 1959–67, south addition expanding the washing operations • 1968, L-shaped addition extending the east and north sides for additional laundry facility space • 1971, interior and mechanical remodel

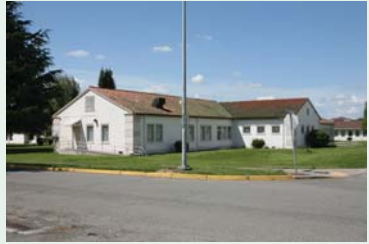
ID	SIGNIFICANCE	CHARACTER-DEFINING FEATURES	ALTERATIONS	IMAGE(S)
B32	<p>Historic name: Ward, Boys' Custodial</p> <p>Common name: Hurlbert (B32)</p> <p>Built in 1946-1948 and designed by John Graham with James Taylor Jr. as consulting architect in the Spanish Colonial Revival style with Colonial Revival influences. This building originally served as a dormitory for young male residents of the school. It presently contains vocational programming for school residents.</p>	<ul style="list-style-type: none"> • Original irregular footprint • Single story • Painted, reinforced concrete foundation and water table • Painted, board formed concrete cladding • Gable roof form • Multi-lite, metal framed windows • Select wood, multi-lite exterior doors intact • Reinforced concrete ramps and/or stoops at entrances • Quoins at all corners • Square vent openings in gable ends and foundation • Copper, half-round gutters • Red clay roof tiles • Concrete cornice returns • No eave overhangs • Metal pipe railings • Original floor plan, including double loaded corridors, bedrooms, dormitory hall, and shared activity rooms • Terrazzo flooring • Glazed tiles on lower half of interior walls and as baseboards, throughout rooms and corridors • Interior wood doors with portholes

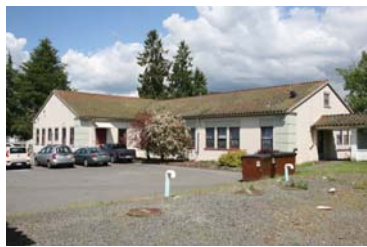
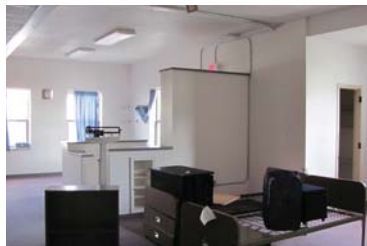
ID	SIGNIFICANCE	CHARACTER-DEFINING FEATURES	ALTERATIONS	IMAGE(S)
B35	<p>Historic name: Nursery, Boys'</p> <p>Common name: Oakley (B35)</p> <p>Built in 1946-1947 and designed by John Graham with James Taylor Jr. as consulting architect in the Spanish Colonial Revival style with Colonial Revival influences. This building originally served as a nursery for young male residents of the school. It presently is vacant.</p>	<ul style="list-style-type: none"> • Original L-shaped footprint • Single story • Painted, reinforced concrete foundation and water table • Painted, board formed concrete cladding • Gable roof form • Wood, eight panel front door • Reinforced concrete steps and porch at main entrance • Reinforced concrete ramps at entrances • Elaborate concrete entry surround at main entrance (e.g., quoins, entablature, medallion) • Multi-lite sidelites and transom at front entrance • Quoins at all corners • Square vent openings in gable ends and foundation • Copper, half-round gutters • Red clay roof tiles • Concrete cornice returns • No eave overhangs • Metal pipe railings 	<ul style="list-style-type: none"> • Undated, all windows replaced • Undated, interior floor plan and finishes remodeled

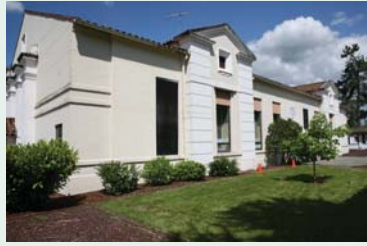
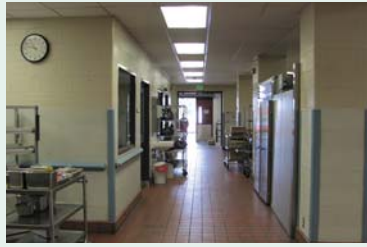
B36	<p>Historic/common name: Central Kitchen (B36)</p> <p>Built in 1938-1939 and designed by Graham and Painter in the Spanish Colonial Revival style. This building has always served as the central food preparation facility for the campus. It also contains a coffee shop for staff and residents.</p>	<ul style="list-style-type: none"> • Original primarily rectangular footprint, plus additions for present U-shaped plan • Single story, with taller volume at south end • Painted, reinforced concrete foundation and water table • Painted, board formed concrete cladding • Gable roof form • Painted, projecting beltcourse • Projecting concrete pilasters topped with square capitols and scrollwork • Projecting bays topped with broken pediments • Quoins on south facade • Square vent openings • Ornate scrolled ventilation grille surrounds • Concrete cornice and returns • Red clay roof tiles • Copper, half-round gutters • Concrete, ornated ventilation tower with colored tiles and scrollwork 	<ul style="list-style-type: none"> • 1940–1957, square north/northeast addition • 1958, L-shaped northwest addition • 1963, square northwest addition • 1964 post, east and northeast additions • 1983-1984, major renovation and rearrangement of interior functions and installation of new equipment • 1988, roof repairs • Undated, windows and doors replaced, select doorways relocated

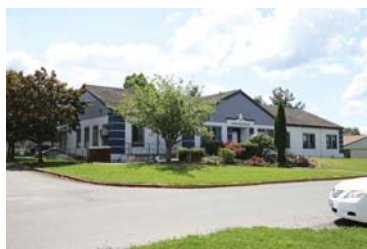
ID	SIGNIFICANCE	CHARACTER-DEFINING FEATURES	ALTERATIONS	IMAGE(S)
B37	<p>Historic name: Nursery, Girls'</p> <p>Common name: Meyer (B37)</p> <p>Built in 1946-1947 and designed by John Graham with James Taylor Jr. as consulting architect in the Spanish Colonial Revival style with Colonial Revival influences. This building originally served as a nursery for young female residents of the school. It presently contains the Computer Services Department.</p>	<ul style="list-style-type: none"> • Original L-shaped footprint • Single story • Painted, reinforced concrete foundation and water table • Painted, board formed concrete cladding • Gable roof form • Multi-lite, metal framed windows • Wood, eight panel front door • Reinforced concrete steps and porch at main entrance • Reinforced concrete ramps at entrances • Elaborate concrete entry surround at main entrance (e.g., quoins, entablature, medallion) • Multi-lite sidelites and transom at front entrance • Quoins at all corners • Square vent openings in gable ends and foundation • Copper, half-round gutters • Red clay roof tiles • Concrete cornice returns • No eave overhangs • Metal pipe railings 	<ul style="list-style-type: none"> • Undated, select windows replaced (front facade) • Undated, interior floor plan and finishes remodeled

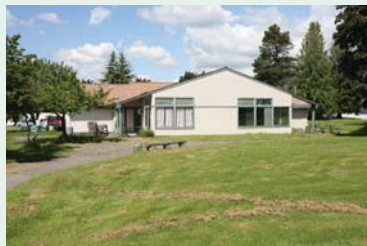
B38	<p>Common name: Chinook (B38)</p> <p>Built in 1980 and designed by Schmidt and Smith Architectural Partners, this non-historic building provides multi-family, apartment style domestic space for Rainier School residents.</p>	• NA	• NA

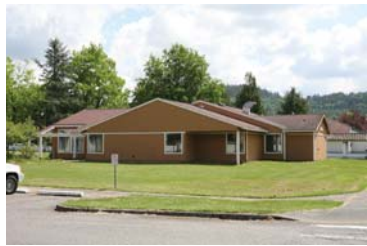
B39	<p>Common name: Cascade (B39)</p> <p>Built in 1980 and designed by Schmidt and Smith Architectural Partners, this non-historic building provides multi-family, apartment style domestic space for Rainier School residents.</p>	• NA	• NA

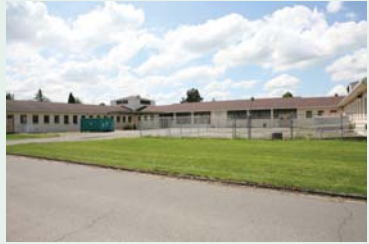
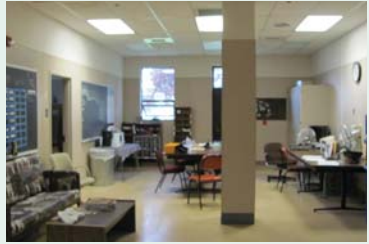
ID	SIGNIFICANCE	CHARACTER-DEFINING FEATURES	ALTERATIONS	IMAGE(S)
B50	<p>Historic name: Custodial Building</p> <p>Common names: Hemlock (northwest wing), Spruce (southwest wing), Fir (northeast wing), Pine (southeast wing), Evergreen Complex (B50)</p> <p>Built in 1954 and designed by NBBJ in the Spanish Colonial Revival style. This building served as a residential dormitory and shared living space for residents of the school. Girls' spaces were in the west half, boys in the east half. It presently contains offices and vocational education, arts, and other training/work spaces for school residents.</p>	<ul style="list-style-type: none"> • Original irregular footprint, plus multiple additions • Single story except for slightly taller ventilation towers • Painted, poured concrete foundation • Painted, board formed concrete cladding • Gable roof form overall • Multi-lite, metal framed windows • Concrete window slip sills • Metal security doors with varying sizes of glazing in upper half • Hipped roof towers nearly center in each of four wings • Square or rectangular vent openings in gable ends • Metal pipe railings • Reinforced concrete delivery docks • Double loaded corridors • Terrazzo flooring and glazed tile wall treatments extant in east half (Fir, Pine) of building • Ceramic, wall mounted water fountains • Interior wood doors, solid and partially glazed types 	<ul style="list-style-type: none"> • 1955-1976, east addition to Fir wing (subsequently removed after 1976) • 1990 pre, first western addition to Spruce wing • 1991 post, second western addition to Spruce wing • Various, window replacements in select wings

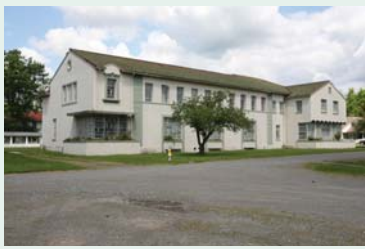
ID	SIGNIFICANCE	CHARACTER-DEFINING FEATURES	ALTERATIONS	IMAGE(S)
B53	<p>Historic name: Ward, Girls' (G2)</p> <p>Common name: Belle King</p> <p>Built in 1947-1949 and designed by Miller and Ahlson in the Spanish Colonial Revival style with Art Deco and Streamlined Moderne influences. H. R. Olson Construction Company of Tacoma served as the builders. This building served as residential dormitory and shared living space for female residents of the school. The building contains large, open dormitory spaces as well as shared bathrooms, isolation rooms, offices and quarters for attendants, and activity rooms. It is presently vacant.</p>	<ul style="list-style-type: none"> • Original primarily L-shaped footprint • Two stories • Painted, reinforced concrete foundation and water table • Painted, board formed concrete cladding • Hybrid gable and hip roof form • Multi-lite, metal framed windows • Windows that wrap a corner • Broad, continuous concrete frames around exterior windows • Reinforced concrete steps and porch at main entrance • Jetty with scalloped underside • Quoining at select walls • Square and circular vent openings • Streamlined, round cornered concrete awning • Incorporated planters and flowerboxes in exterior walls • Painted, projecting beltcourse on select facades • Red clay roof tiles • Copper, half-round gutters • Original floor plan, including corridors, dormitories, activity rooms, isolation rooms, and staff offices • Terrazzo flooring • Original interior doors with portholes 	<ul style="list-style-type: none"> • 1993, heating system modifications

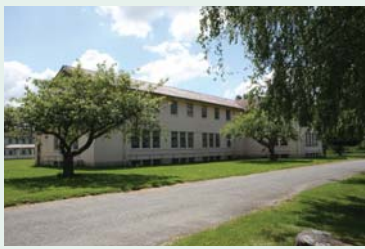
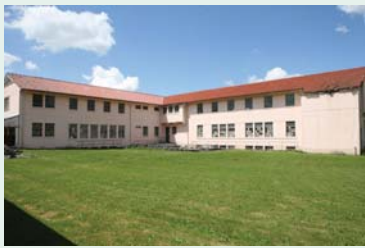
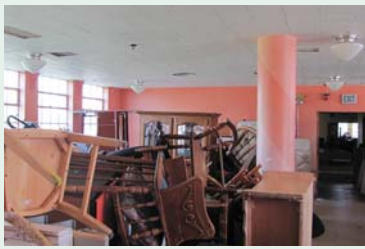
ID	SIGNIFICANCE	CHARACTER-DEFINING FEATURES	ALTERATIONS	IMAGE(S)
B55	<p>Historic name: Ward (G3)</p> <p>Common name: Holly</p> <p>Built in 1952 and designed by NBBJ in a Spanish Colonial Revival style with Art Deco and Streamlined Moderne influences. This building served as a residential dormitory and shared living space for female residents of the school. The building contains large, open dormitory spaces as well as shared bathrooms, isolation rooms, offices and quarters for attendants, and activity rooms. It is presently used for storage.</p>	<ul style="list-style-type: none"> • Original primarily L-shaped footprint • Two stories plus daylight basement • Painted, reinforced concrete foundation and water table • Painted, board formed concrete cladding • Hybrid gable and hip roof form • Multi-lite, metal framed windows • Windows arranged singly, in pairs, and in ribbons • Groups of glass block set into exterior walls • Broad, continuous concrete frames around exterior windows • Multi-lite, metal framed double doors, sidelites and transom at main entrance • Reinforced concrete steps and porch at main entrance • Decorative metal railings • Metal pipe railings at areaways • Cluster of geometric wall perforations centered high in gable ends • Thin, inset beltcourse • Oriels at second floor • Red clay roof tiles • Copper, half-round gutters • Original floor plan, including corridors, dormitories, activity rooms, isolation rooms, and staff offices • Terrazzo flooring • Original interior doors with hand-painted numbering • Ceiling flush mounted, pointed cone light shades 	<ul style="list-style-type: none"> • 1993, heating system modifications

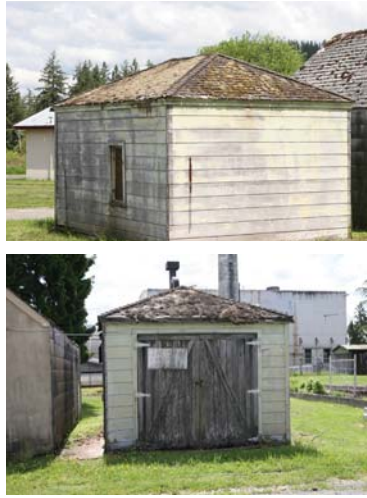
ID	SIGNIFICANCE	CHARACTER-DEFINING FEATURES	ALTERATIONS	IMAGE(S)
B59	<p>Common name: NA</p> <p>Installed after 1983, this is a contemporary port-a-john unit.</p>			
B60	<p>Common name: Shed (B60)</p> <p>This building appears to predate 1976, when it first appears in its current location. The original location is not known. This utilitarian shed provides storage space.</p>	<ul style="list-style-type: none"> • Original rectangular footprint • Single story • Concrete pad • Hip roof form • Wood framing • Horizontal wood cladding • Wood roof shingles • Wooden barn doors • No eave overhangs 	• NA

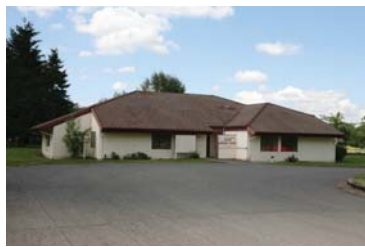
ID	SIGNIFICANCE	CHARACTER-DEFINING FEATURES	ALTERATIONS	IMAGE(S)
B70	<p>Common name: 2035 Quinault (B70)</p> <p>Built in 1982 and designed by Schmidt and Smith Architectural Partners, this non-historic building provides multi-family, apartment style domestic space for Rainier School residents.</p>	<ul style="list-style-type: none"> • NA 	<ul style="list-style-type: none"> • NA

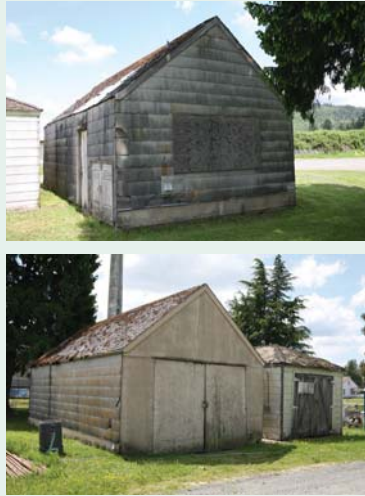
B71	<p>Common name: Shed</p> <p>This building appears to predate 1976, when it first appears in its current location. The original location is not known. This utilitarian shed provides storage space.</p>	<ul style="list-style-type: none"> • Original rectangular footprint • Single story • Concrete pad • Gable roof form • Wood framing • Asbestos shingle cladding over horizontal wood shiplap • Plywood cladding, doors • Asphalt-composition shingle roofing • No eave overhangs 	<ul style="list-style-type: none"> • NA

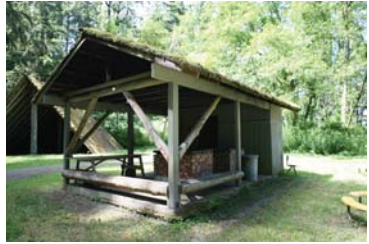
ID	SIGNIFICANCE	CHARACTER-DEFINING FEATURES	ALTERATIONS	IMAGE(S)
B92	<p>Historic/common name: Picnic shelter (B92)</p> <p>Built between 1970 and 1976 in a modified Rustic style. This building served as part of the former Boy Scout Camp associated with Rainier School. This camp provided outdoor recreation/camping opportunities for students of the Rainier School. This shelter contains an enclosed storage room and an outdoor kitchen.</p>	<ul style="list-style-type: none"> • Original rectangular footprint • Single story, open volume • Gable roof • Open on three facades • Dimensional lumber and round log framing • Concrete floor 	<ul style="list-style-type: none"> • Undated, framing repairs resulting in variety of materials and dimensions

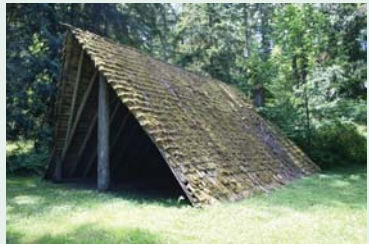
B93	<p>Historic/common name: Boy Scout Camping shelter, main (B93)</p> <p>Built between 1970 and 1976 in the A-Frame/Rustic style. This building served as part of the former Boy Scout Camp associated with Rainier School. This camp provided outdoor recreation/camping opportunities for students of the Rainier School. This shelter contains a large stone fireplace in the end wall.</p>	<ul style="list-style-type: none"> • Original rectangular footprint • Single story, open volume • A-frame roof • Open on one facade • Round log framing • Wood shake cladding • Stone fireplace • Dirt floor 	<ul style="list-style-type: none"> • No known alterations

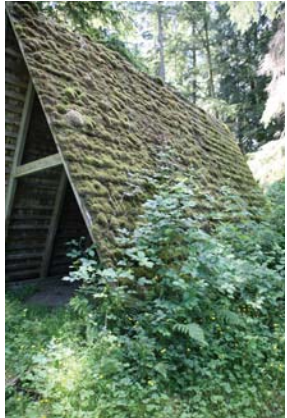
B94	<p>Historic/common name: Camping shelter (B94)</p> <p>Built between 1970 and 1976 in the A-Frame/Rustic style. This building served as part of the former Boy Scout Camp associated with Rainier School. This camp provided outdoor recreation/camping opportunities for students of the Rainier School. This shelter contains a sleeping loft and an interior wall mounted wood ladder in the end wall.</p>	<ul style="list-style-type: none"> • Original rectangular footprint • Single story, open volume • A-frame roof • Open on one facade • Dimensional lumber framing • Wood shake cladding • Dirt floor • Wood platform sleeping loft • Wood ladder, wall mounted 	<ul style="list-style-type: none"> • No known alterations

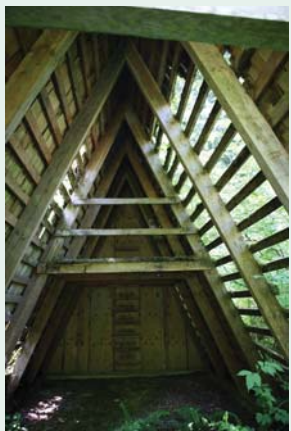
ID	SIGNIFICANCE	CHARACTER-DEFINING FEATURES	ALTERATIONS	IMAGE(S)
B95	<p>Historic/common name: Camping shelter (B95)</p> <p>Built between 1970 and 1976 in the A-Frame/Rustic style. This building served as part of the former Boy Scout Camp associated with Rainier School. This camp provided outdoor recreation/camping opportunities for students of the Rainier School. This shelter contains a sleeping loft and an interior wall mounted wood ladder in the end wall.</p>	<ul style="list-style-type: none"> • Original rectangular footprint • Single story, open volume • A-frame roof • Open on one facade • Dimensional lumber framing • Wood shake cladding • Dirt floor • Wood platform sleeping loft • Wood ladder, wall mounted 	<ul style="list-style-type: none"> • No known alterations

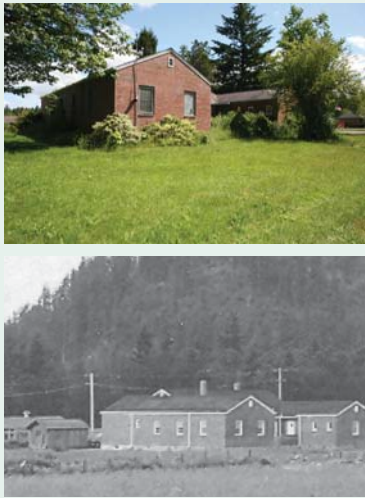
B97	<p>Historic name: Colony House</p> <p>Common names: Collins School, Collins Hall, Collins Cottage (B97)</p> <p>Built in 1941 in the Colonial Revival style by federal work relief efforts, campus lore attributes it to the Civilian Conservation Corps. This building served lodging and recreation functions. The building is now vacant.</p>	<ul style="list-style-type: none"> • Original U-shaped footprint • Single story • Board formed, reinforced concrete foundation • Brick veneer cladding • Cross gable roof form • Wood framed, multi-lite sash windows • Brick rowlock course window sills • Brick soldier course window headers 	<ul style="list-style-type: none"> • Select windows replaced • Gutters replaced

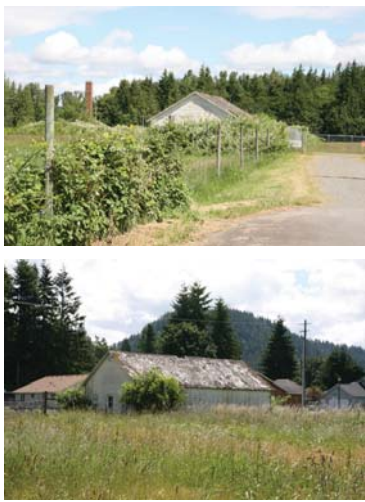
ID	SIGNIFICANCE	CHARACTER-DEFINING FEATURES	ALTERATIONS	IMAGE(S)
B102	<p>Common name: Farm building (B102)</p> <p>Built in ca 1938, this outbuilding is associated with the historic agricultural land use surrounding the Rainier School. The building is currently vacant.</p>	<ul style="list-style-type: none"> • Original rectangular footprint • Single story • Wood framing • Painted, horizontal wood shiplap cladding • Gable roof form • Wood framed, multi-lite windows 	<ul style="list-style-type: none"> • No known alterations

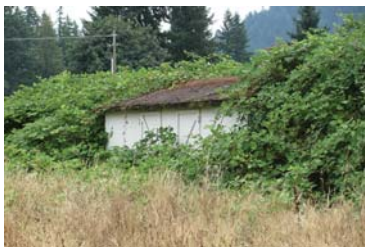
B104	<p>Historic/common name: Farm building, animals (B104)</p> <p>Built between 1955 and 1976, this outbuilding is associated with the historic agricultural land use surrounding the Rainier School. It is currently vacant.</p>	<ul style="list-style-type: none"> • Original rectangular footprint • Single story • Gable roof form • Wood framing and cladding 	<ul style="list-style-type: none"> • No known alterations

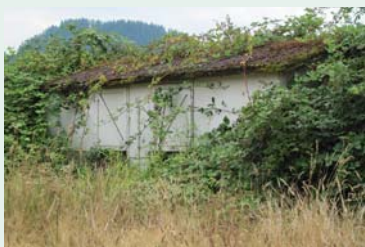
B105	<p>Historic/common name: Farm building (B105)</p> <p>Built between 1955 and 1976, this outbuilding is associated with the historic agricultural land use surrounding the Rainier School. It is currently in ruins.</p>	<ul style="list-style-type: none"> • Original rectangular footprint • Single story • Gable roof form • Wood framing and cladding 	<ul style="list-style-type: none"> • No known alterations

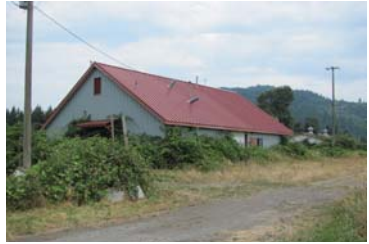
ID	SIGNIFICANCE	CHARACTER-DEFINING FEATURES	ALTERATIONS	IMAGE(S)
B106	<p>Common name: Barn (B106)</p> <p>Built in ca 1938, this barn is associated with the historic agricultural land use surrounding the Rainier School.</p>	<ul style="list-style-type: none"> •Original rectangular footprint •Single story •Gable roof form 	<ul style="list-style-type: none"> •Cladding, windows, and roofing replaced

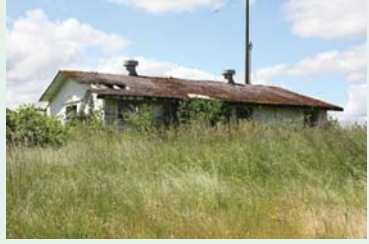
B107	<p>Common name: Farm building (B107)</p> <p>Built between 1955 and 1976, this outbuilding is associated with the historic agricultural land use surrounding the Rainier School. The building is currently vacant.</p>	<ul style="list-style-type: none"> •Original rectangular footprint •Single story •Gable roof form •Painted, concrete masonry unit structure •Two metal roof ventilators 	<ul style="list-style-type: none"> •NA

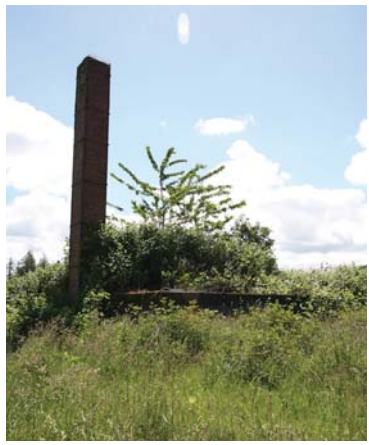
B108	<p>Common name: Brick stack (B108)</p> <p>Built in ca 1938, this structure is associated with the historic agricultural land use surrounding the Rainier School. The structure is currently vacant.</p>	<ul style="list-style-type: none"> •Tall brick stack •Reinforced concrete, sloped ramp 	<ul style="list-style-type: none"> •Abandoned

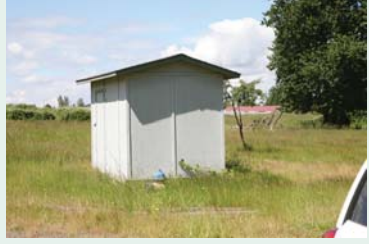
B109	<p>Common name: Sewage treatment facility (B109)</p> <p>Built since 1976, this non-historic building is associated with the school's sewage treatment facility.</p>	<ul style="list-style-type: none"> •NA 	<ul style="list-style-type: none"> •NA

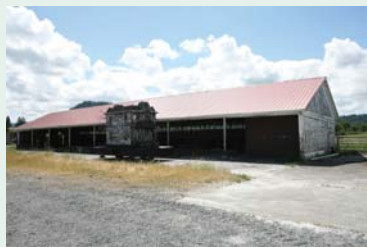
ID	SIGNIFICANCE	CHARACTER-DEFINING FEATURES	ALTERATIONS	IMAGE(S)
B111	<p>Common name: Sewage treatment facility (B111)</p> <p>Built since 1976, this non-historic building was associated with the school's sewage treatment facility.</p>	<ul style="list-style-type: none"> • NA 	<ul style="list-style-type: none"> • Removed 	
B112	<p>Common name: Sewage treatment facility (B112)</p> <p>Built since 1976, this non-historic, small building was associated with the school's sewage treatment facility.</p>	<ul style="list-style-type: none"> • NA 	<ul style="list-style-type: none"> • Removed 	
B113	<p>Historic/common name: Barn (B113)</p> <p>Built between 1955 and 1976, this building is associated with the historic agricultural land use surrounding the Rainier School.</p>	<ul style="list-style-type: none"> • Original rectangular footprint • Single story • Gable roof form 	<ul style="list-style-type: none"> • No known alterations

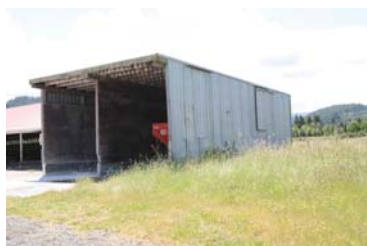
B114	<p>Common name: Barn (B114)</p> <p>Built after 1976, this non-historic outbuilding is associated with the historic agricultural land use surrounding the Rainier School.</p>	<ul style="list-style-type: none"> • NA 	<ul style="list-style-type: none"> • NA

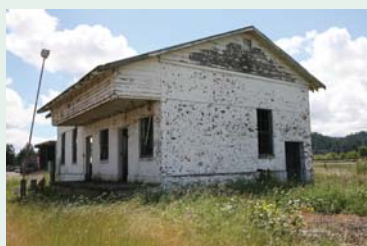
B115	<p>Common name: Farm building (B115)</p> <p>Built ca. 1939, this outbuilding is associated with the historic agricultural land use surrounding the Rainier School. It is currently vacant.</p>	<ul style="list-style-type: none"> • Original rectangular footprint • Single story volume • Gable roof form • Painted, reinforced concrete foundation and water table • Open, overhanging eaves • Brick cladding, except for horizontal wood cladding in gable ends and on loading dock hood • Inset beltcourse above windows • Multi-lite, metal framed windows • Poured concrete loading dock 	<ul style="list-style-type: none"> • No known alterations

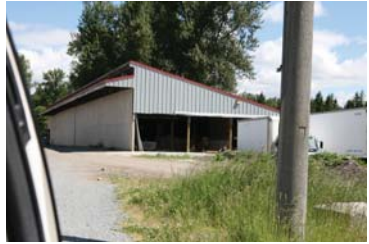
ID	SIGNIFICANCE	CHARACTER-DEFINING FEATURES	ALTERATIONS	IMAGE(S)
B116	<p>Common name: Barn (B116)</p> <p>Built after 1976, this non-historic outbuilding is associated with the historic agricultural land use surrounding the Rainier School.</p>	<ul style="list-style-type: none"> •NA 	<ul style="list-style-type: none"> •NA

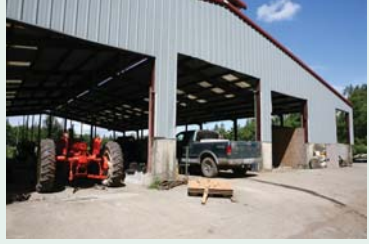
B117	<p>Common name: Barn (B117)</p> <p>Built after 1976, this non-historic outbuilding is associated with the historic agricultural land use surrounding the Rainier School.</p>	<ul style="list-style-type: none"> •NA 	<ul style="list-style-type: none"> •NA

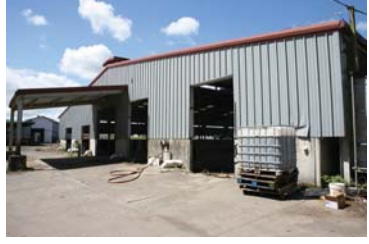
B118	<p>Common name: Barn (B118)</p> <p>Built after 1976, this non-historic outbuilding is associated with the historic agricultural land use surrounding the Rainier School.</p>	<ul style="list-style-type: none"> •NA 	<ul style="list-style-type: none"> •NA

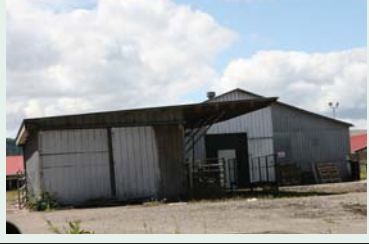
B119	<p>Common name: Barn (B119)</p> <p>Built after 1976, this non-historic outbuilding is associated with the historic agricultural land use surrounding the Rainier School.</p>	<ul style="list-style-type: none"> •NA 	<ul style="list-style-type: none"> •NA

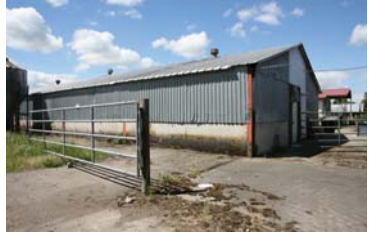
B120	<p>Historic/common name: Barn (B120)</p> <p>Built between 1955 and 1976, this building is associated with the historic agricultural land use surrounding the Rainier School.</p>	<ul style="list-style-type: none"> •Original rectangular footprint •Single story •Poured concrete foundation •Gable roof form •Corrugated metal cladding •Round, metal roof ventilators •Attached metal tank, east side 	<ul style="list-style-type: none"> •No known alterations
