RAINIER SCHOOL

Cultural Landscape Assessment

WASHINGTON STATE DEPARTMENT OF SOCIAL & HEALTH SERVICES

PROJECT NO. 2014-418A(1)

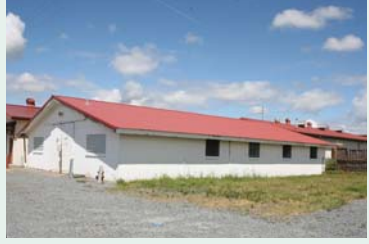
B121	<p>Historic/common name: Barn (B121)</p> <p>Built between 1955 and 1976, this building is associated with the historic agricultural land use surrounding the Rainier School.</p>	<ul style="list-style-type: none"> •Original rectangular footprint plus rectangular extension/addition •Single story •Gable roof form •Painted, concrete masonry unit structure •Wood framed roof •Corrugated metal roofing 	<ul style="list-style-type: none"> •1976 post, north addition

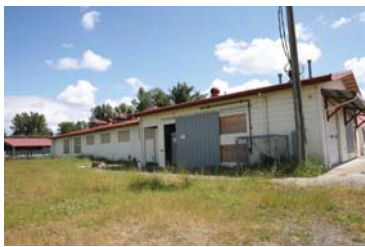
ID	SIGNIFICANCE	CHARACTER-DEFINING FEATURES	ALTERATIONS	IMAGE(S)
B122	<p>Historic/common name: Barn (B122)</p> <p>Built ca 1938, this outbuilding is associated with the historic agricultural land use surrounding the Rainier School.</p>	<ul style="list-style-type: none"> • Rectangular footprint • Single story • Painted, reinforced concrete structure and cladding • Gable roof form, wood framed • Thin, inset beltcourses and vertical joints 	<ul style="list-style-type: none"> • Roofing, doors replaced • South awning added

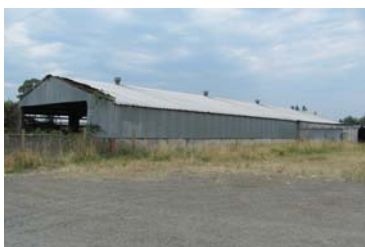
B124	<p>Historic/common name: Barn (B124)</p> <p>Built between 1955 and 1976, this building is associated with the historic agricultural land use surrounding the Rainier School.</p>	<ul style="list-style-type: none"> • Original L-shaped footprint • Single story • Gable roof form

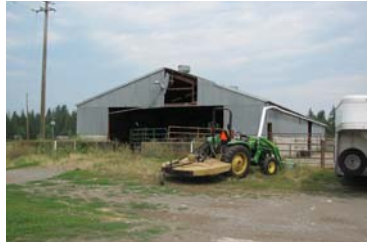
ID	SIGNIFICANCE	CHARACTER-DEFINING FEATURES	ALTERATIONS	IMAGE(S)
B128	<p>Common name: Barn (B128)</p> <p>Built after 1976, this non-historic outbuilding is associated with the historic agricultural land use surrounding the Rainier School.</p>	<ul style="list-style-type: none"> • NA 	<ul style="list-style-type: none"> • NA

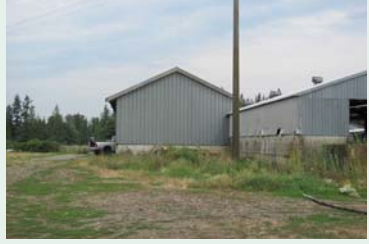
B129	<p>Historic/common name: Barn (B129)</p> <p>Built between 1955 and 1976, this building is associated with the historic agricultural land use surrounding the Rainier School.</p>	<ul style="list-style-type: none"> • Original rectangular footprint • Single story • Gable roof form 	<ul style="list-style-type: none"> • No known alterations

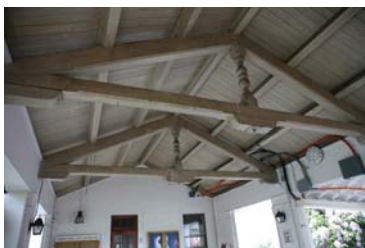
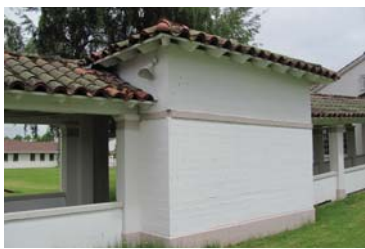
ID	SIGNIFICANCE	CHARACTER-DEFINING FEATURES	ALTERATIONS	IMAGE(S)
CW1	<p>Historic name: Loggia</p> <p>Common name: Covered walkway (CW1)</p> <p>Built in 1938 and designed by Graham and Painter in the Spanish Colonial Revival style. The Loggia between the Administration (B1) and Residential Health Center (B2) was the first portion constructed. Subsequent additions extended this circulation system of covered walkways, providing weather protection for pedestrians.</p>	<ul style="list-style-type: none"> • Original rectangular plan, plus additions for an irregular footprint • Single story • Painted, board formed concrete low walls, coping and water table • Square plan, painted, reinforced concrete piers and pilasters capped with friezes and cornices • Gable roof form along most of the length • Hip roof intersections • Long, tapered gaps between walls and floor, allowing for drainage • Red clay roof tiles • Shaped, exposed wooden trusses • Shaped rafter ends • Wood plank ceilings • Wood beams as roof plates • Utilities run overhead • Finished concrete flooring 	<ul style="list-style-type: none"> • 1939, addition by Graham and Painter from Loggia to the north as far as the Central Kitchen (B36) • 1946, addition segment by John Graham with James Taylor Jr. consulting, extending the walkway to the north as far as Robin (B49) and Hurlbert (B32) • 1954, additional segment by NBBJ extending walkway to the north as far as Spruce and Pine (B50)

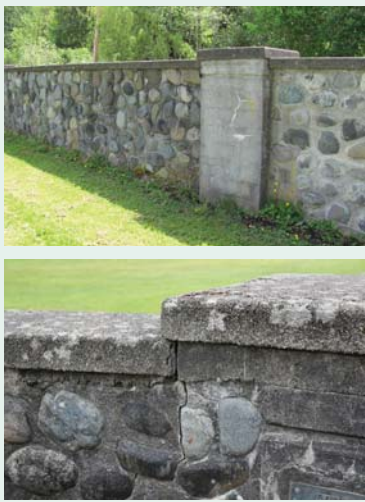
ID	SIGNIFICANCE	CHARACTER-DEFINING FEATURES	ALTERATIONS	IMAGE(S)
S1	<p>Historic/common name: Rock wall (S1)</p> <p>Built in 1940 and designed by Graham and Painter, this Rustic style wall serves as a visual and decorative perimeter boundary for the Rainier School campus. This portion of the rock wall is the longest, wrapping the south and most of the east side of campus.</p>	<ul style="list-style-type: none"> • Square plan, reinforced board formed concrete piers spaced regularly along the wall • Thin, inset beltcourses in all normal piers • Painted, square piers rising above the rest of the wall with projecting ribs, capped with a cornice, peaked cap and ball finial (all concrete) • Overhanging concrete pier caps and coping • Uncoursed river rock wall between piers • Cement mortar • Metal lanterns attached to piers 	<ul style="list-style-type: none"> • Added paint

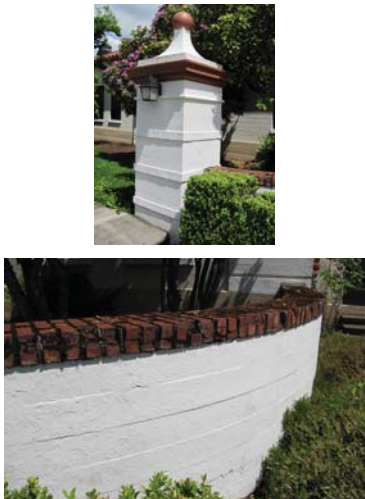
S2	<p>Historic/common name: Concrete wall (S2)</p> <p>Built in 1938 and designed by Graham and Painter, this concrete wall stretches between the Administration (B1) and Resident Health Center (B2), adding symmetry and reinforcing the Spanish Colonial Revival style of the adjacent buildings. The wall is interrupted twice by sidewalks. The two end segments of the wall are curved, leading away from the adjacent buildings. As a group, the wall is associated with the campus' formal entrance.</p>	<ul style="list-style-type: none"> • Original quarter-round footprint • Painted, board formed concrete structure and cladding • Rowlock brick course coping • Painted, square piers rising above the rest of the wall with projecting ribs, capped with a cornice, peaked cap and ball finial (all concrete) • Metal lanterns attached to piers 	<ul style="list-style-type: none"> • No known alterations

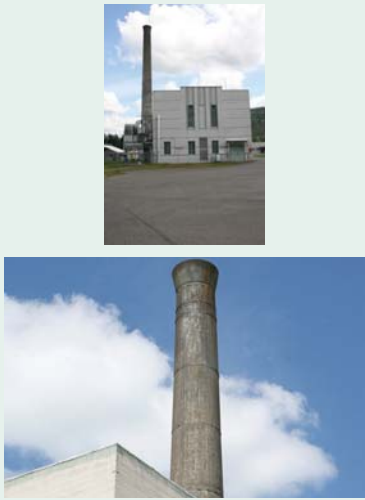
S3	<p>Historic/common name: Powerhouse stack (S3)</p> <p>Built in 1938, this stack is associated with the Powerhouse, channeling smoke out and upwards from the boiler(s).</p>	<ul style="list-style-type: none"> • Reinforced concrete stack, poured in stages 	<ul style="list-style-type: none"> • No known alterations

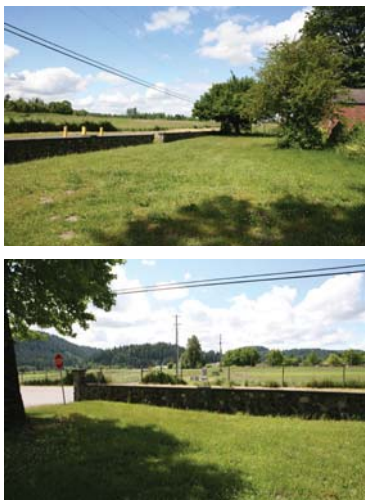
ID	SIGNIFICANCE	CHARACTER-DEFINING FEATURES	ALTERATIONS	IMAGE(S)
S8	<p>Historic/common name: Rock wall (S8)</p> <p>Built in 1941, this Rustic style wall serves as a visual and decorative perimeter boundary along the south side of the former Collins farmstead, in front of the current Collins Cottage (B97). This portion of the rock wall is in two sections, both stretching along the north side of the Levesque Road.</p>	<ul style="list-style-type: none"> • Uncoursed river rock wall between piers of same material • Overhanging concrete pier caps and coping • Cement mortar 	<ul style="list-style-type: none"> • No known alterations

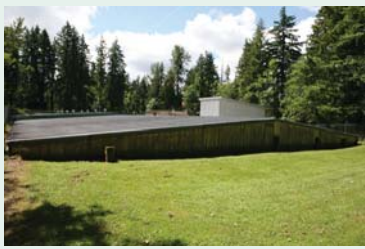
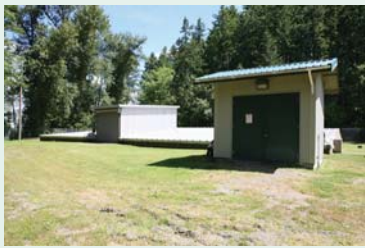
ID	SIGNIFICANCE	CHARACTER-DEFINING FEATURES	ALTERATIONS	IMAGE(S)
S17	<p>Historic name: Reservoir (S17)</p> <p>Built in 1939, this reservoir is associated with the fresh water supply for the school campus. Designed by engineer A.T. Kane. It is one of two reservoirs in active use.</p>	<ul style="list-style-type: none"> • Rectangular footprint • Below grade pool • Reinforced concrete floor and walls • Low-rise gable roof cover

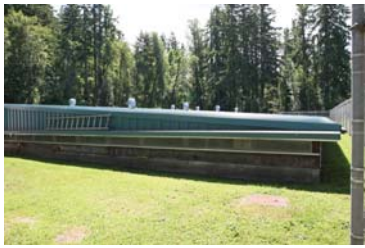
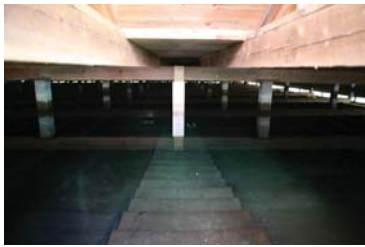
S18	<p>Historic name: Reservoir (S18)</p> <p>Built in 1948, this reservoir is associated with the fresh water supply for the school campus. Designed by engineer A.T. Kane. It is one of two reservoirs in active use.</p>	<ul style="list-style-type: none"> • Rectangular footprint • Below grade pool • Reinforced concrete floor and walls • Low-rise gable roof cover

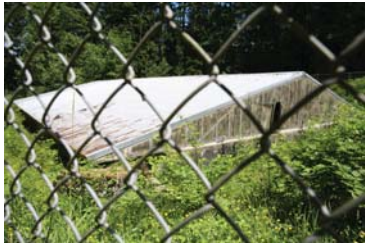
S20	<p>Historic name: Reservoir, City of Buckley</p> <p>Common name: Reservoir (S20)</p> <p>Built ca 1907 by the City of Buckley as a municipal water reservoir, this structure still has water flowing through it.</p>	<ul style="list-style-type: none"> • Original rectangular footprint • Reinforced concrete tank 	<ul style="list-style-type: none"> • Added gable roof to cover the tank

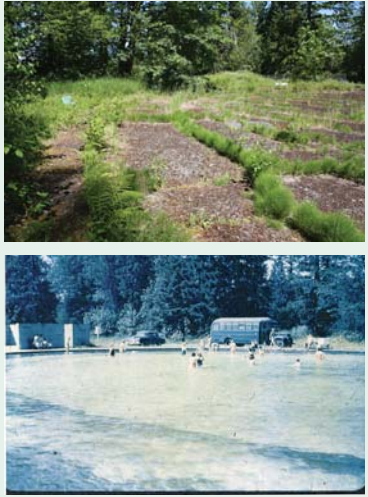
ID	SIGNIFICANCE	CHARACTER-DEFINING FEATURES	ALTERATIONS	IMAGE(S)
S21	<p>Historic/common name: Pool (S21)</p> <p>Built between 1950 and 1952, this outdoor pool provided a shallow water recreation amenity for the students at the Rainier School. The pool itself is no longer in use but small features remain, including benches along the perimeter and ladders along the perimeter walls for climbing in and out of the water.</p>	<ul style="list-style-type: none"> • Oblong footprint • Poured concrete structure (e.g., floor, walls) • Metal ladders • Composite benches 	<ul style="list-style-type: none"> • Abandoned

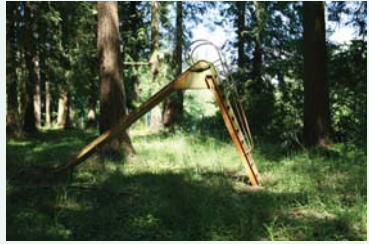
ID	SIGNIFICANCE	CHARACTER-DEFINING FEATURES	ALTERATIONS	IMAGE(S)
J6	<p>Historic/Common name: Slide, metal (J6)</p> <p>Built 1950–1952, this metal slide is part of the abandoned Riverside Park, adjacent to the Rainier School campus and surrounding agricultural fields. This park provided playground equipment.</p>	<ul style="list-style-type: none"> • All metal construction, including ladder 	<ul style="list-style-type: none"> • No known alterations

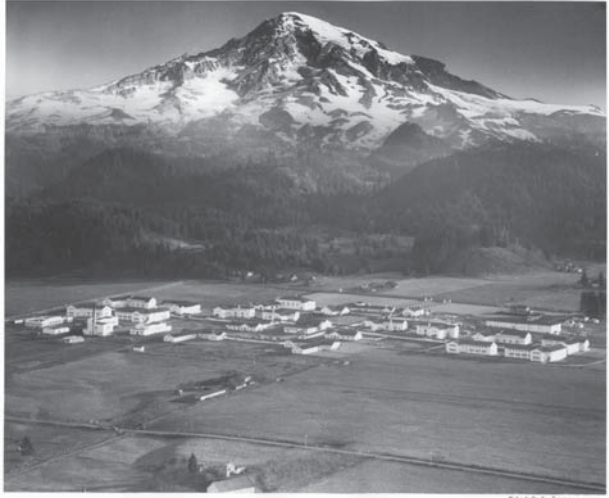
DECEMBER 1952 VIEW OF CEREBRAL PALSY CENTER (B40) UNDER CONSTRUCTION; ADMINISTRATION BUILDING AT LEFT.
SOURCE: TACOMA PUBLIC LIBRARY, RICHARDS STUDIO COLLECTION.

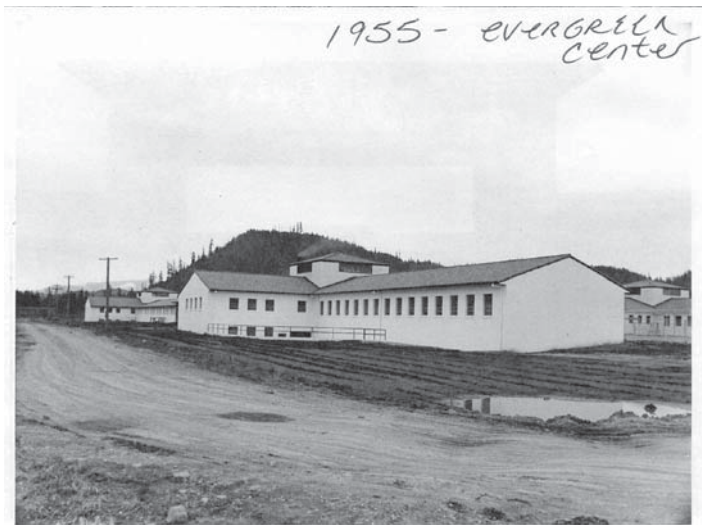
VIEW OF EVERGREEN CENTER AND ASSOCI-
ATED COVERED WALKWAY UNDER CON-
STRUCTION, 1953-1954.

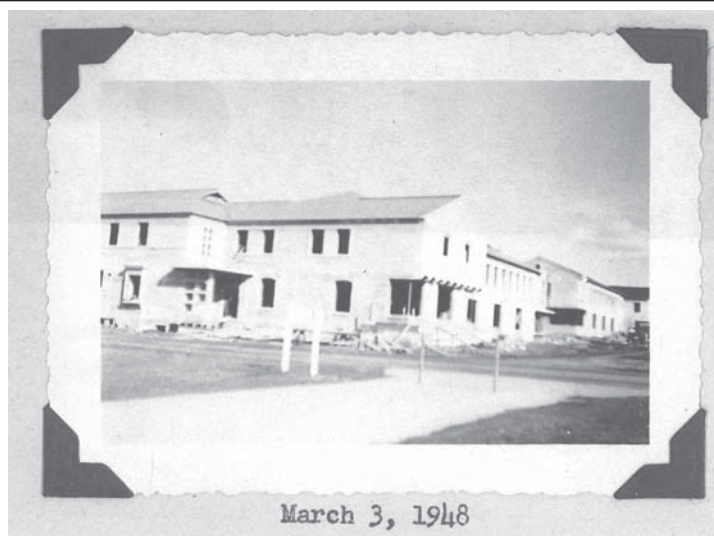
1947-1948 VIEW OF OLSEN AND MARTIN UNDER CONSTRUCTION, LOOKING NORTH-EAST.
SOURCE: RAINIER SCHOOL ARCHIVES, DEPARTMENT OF SOCIAL AND HEALTH SERVICES.

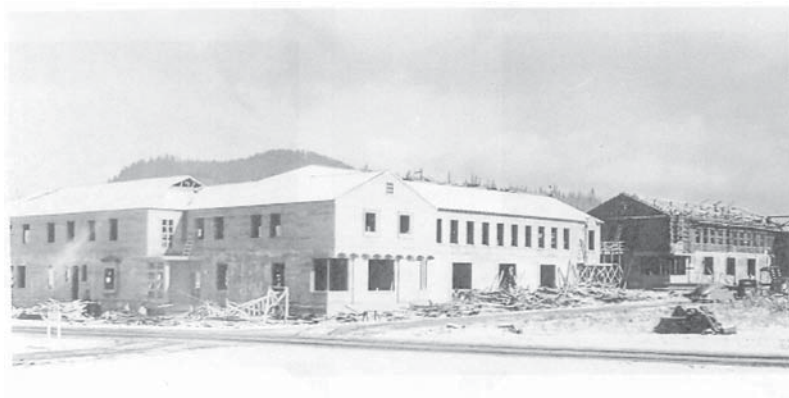
1947-1948 VIEW OF KERR AND BELLE KING UNDER CONSTRUCTION, LOOKING NORTH-WEST.
SOURCE: RAINIER SCHOOL ARCHIVES, DEPARTMENT OF SOCIAL AND HEALTH SERVICES.

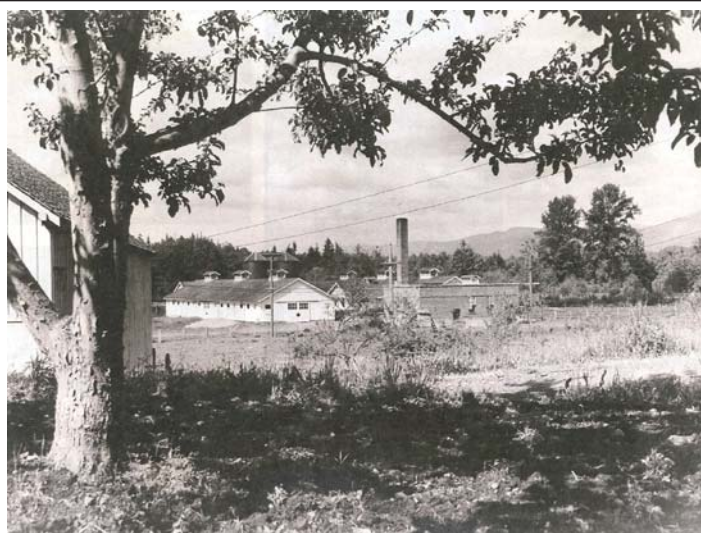
1940S VIEW OF THE FARM, INCLUDING A
BARN AND SILO.
SOURCE: RAINIER SCHOOL ARCHIVES,
DEPARTMENT OF SOCIAL AND HEALTH
SERVICES.

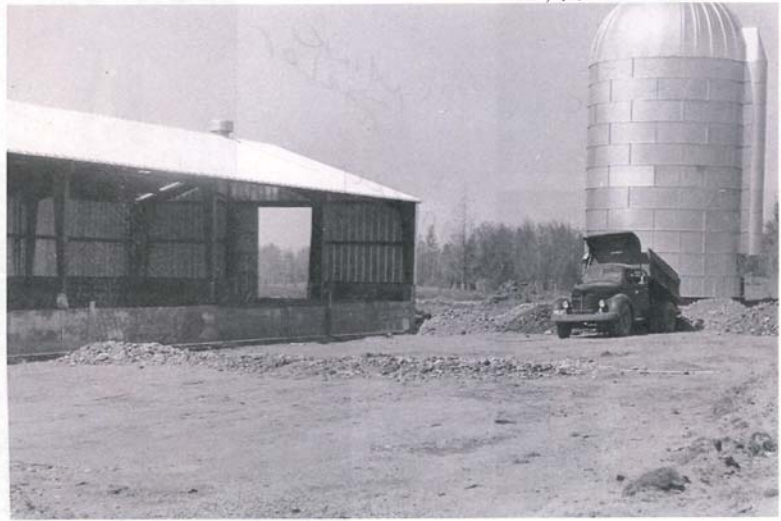
UNDATED HISTORIC CAMPUS VIEW.
SOURCE: RAINIER SCHOOL ARCHIVES,
DEPARTMENT OF SOCIAL AND HEALTH
SERVICES.
