# Historic Preservation Commission

## BAINBRIDGE ISLAND REGISTER OF HISTORIC PLACES NOMINATION FORM

<b>Property Name</b>			
Historic: <b>Historic Suyematsu Farmstead</b> Common: Suyematsu/Bentryn Farm			
<b>Location</b>			
Street Address 9229 NE Day Road, Bainbridge Island      Zip 98110			
Parcel No(s).	Legal Description and Plat or Addition:		
102502-1-052-2008 (portions of)			
<b>Nominated Elements</b>			
Please indicate below significant elements of the property that are included in the nomination by checking the appropriate box(es) below. These elements should be described specifically in the narrative section of this form.			
Principal Structure <input checked="" type="checkbox"/>	Site <input checked="" type="checkbox"/>		
Historic Additions <input checked="" type="checkbox"/>	Historic Landscaping, Fencing, Walkways, etc. <input checked="" type="checkbox"/>		
Ancillary Buildings/Outbuildings <input checked="" type="checkbox"/>	Interior Spaces/Other (inventory in narrative) <input checked="" type="checkbox"/>

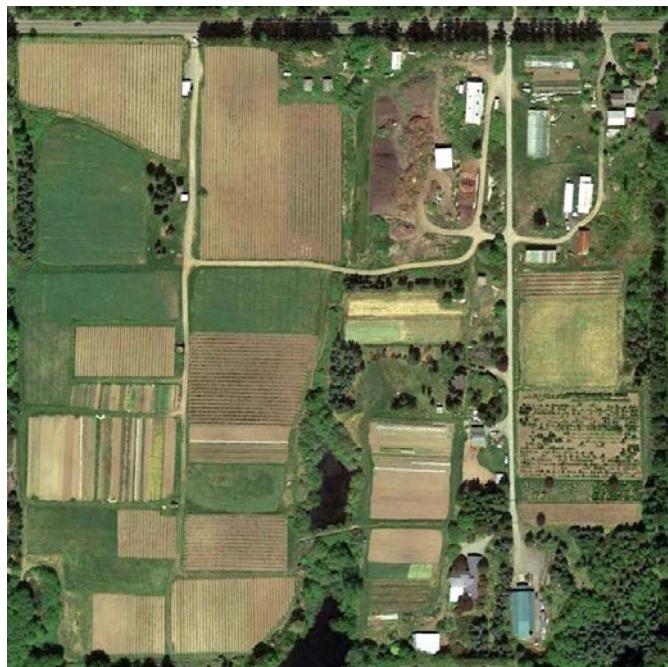
Aerial view of entire farm, 2015 (Google Earth)

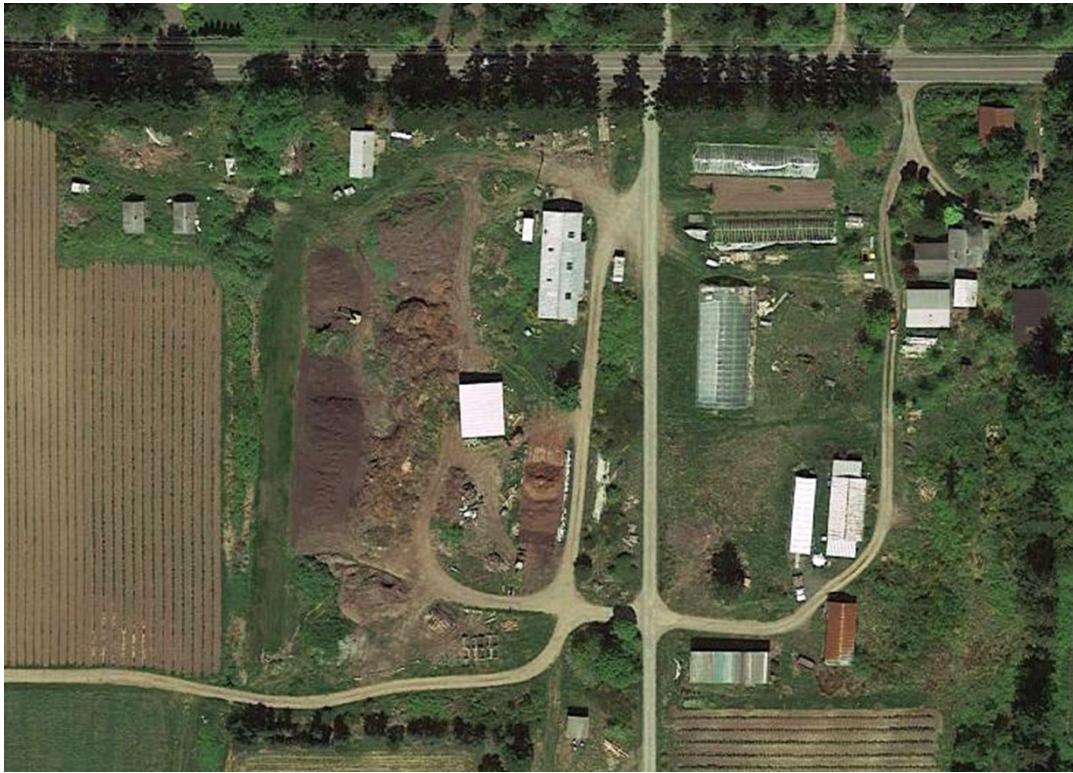
Access to the various buildings is on a system of unpaved roads. Within the historic area is the northern portion of the easternmost north-south road and the center entry on NE Day Road. Near the entry, a very rough side road, with a gate, leads west to the bunkhouses. Approximately 400 feet south of the entry, a secondary road curves east and north, past the tractor sheds, house and barn to a gate on Day Road.

Aerial view of historic area, 2015 (Google Earth)

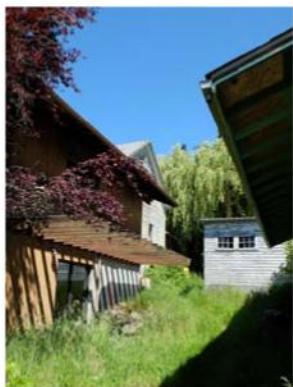
The house is 1.5 stories and rectangular in plan, with a simple 12:12 slope gable roof oriented north-south. The east side of the house has a covered deck with a hip roof. The total enclosed area is 1680 feet including 300 square feet in the basement. The exterior materials are painted wood shiplap siding, asphalt shingles on the roofs, and wood double-hung windows. In 1971, a concrete block foundation was constructed and the living room windows were replaced with aluminum sliders. At the same time, an addition was built on the west side, with vertical plywood siding, horizontal sliding windows with bronze anodized aluminum frames and a concrete block foundation.

South elevation of house

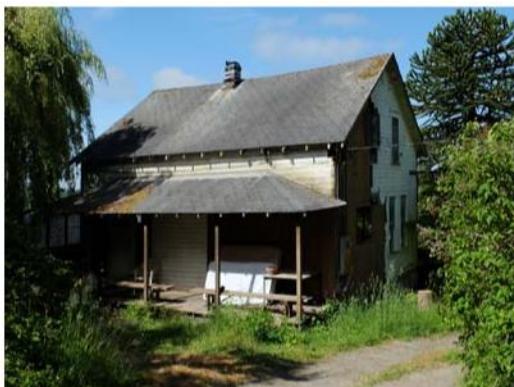
Front porch; east & north elevations

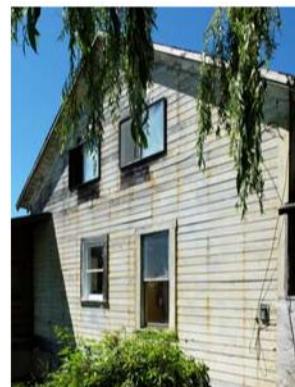
North elevation

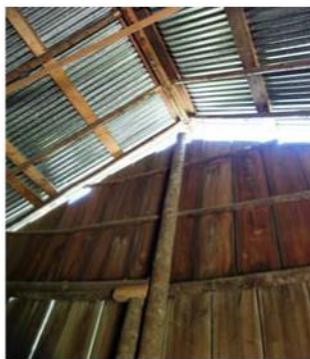
The gable roof barn is 24 wide by 30 feet long, oriented north-south, and is divided into three 10 x 24 feet long bays on the east elevation. The foundation consists of embedded 16-inch diameter treated poles, of various lengths, placed with one on each corner, one at each exterior midpoint and one in the middle for a total of nine column supports. Three large half-round 18-inch diameter pole beams connect the columns in the north-south direction. Logs ranging from 6 to 8 inches in diameter are placed at approximately 2 feet on center and connect the half-round beams in the east-west direction. The logs support 2 x 8 inch and 2 x 12 inch planks which make up the floor of the barn. The north, west and south walls have no openings, but the east side of the barn has two 8.5 x 8.5 feet high sliding wood board doors that can open up two thirds of the eastern wall of the barn. The sliding doors are supported by a 2 x 16 inch by 20 feet long header that spans between 3 columns. The entry to the barn is 8 feet 4 inches clear to the underside of the 2 x 16 inch beam. The sliding doors are fabricated from 1 x 8 inch shiplap boards and the remaining 10-foot panel is made of the same boards laid up horizontally. The walls and roof of the barn are supported by 9 log columns that vary from 6 to 10 inches in diameter. The columns are connected horizontally by 4-inch diameter logs which also serve as supports for the exterior wall assembly. The north, west and south walls of the barn are vertical 1 x 12 inch boards with a 1 x 4 inch batten. The roof rafters are 4 inch diameter logs spaced at 4 feet on center. There are 4 log crossties, located 10 feet clear from the floor that stabilize the roof structure and provide a storage space. The 2-foot wide galvanized corrugated steel roof panels are attached to the rafters.

Wall & ceiling of barn

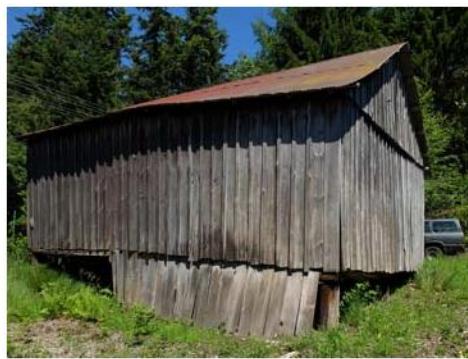
West elevation

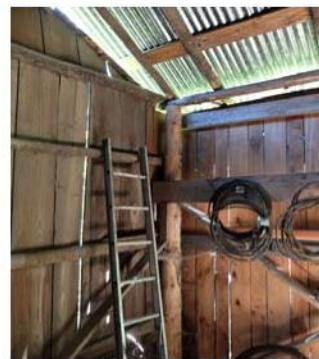
Interior detail

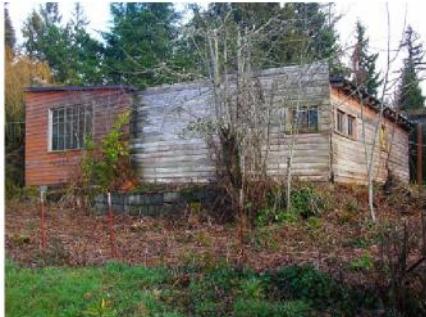
The combination garage/workshop/office structure is located 100 feet southeast of the barn. It is 30 x 44 feet long, oriented north-south, and is divided into two parts, the 20 x 30 feet wide northern garage and the 24 x 30 feet wide workshop area. The garage portion is covered by a shed roof that slopes down at 3:12

from north to south. The roof is supported by 2 x 10 inch rafters spaced 2 feet on center which are covered by 1 x 6 inch boards laid horizontally and nailed to the rafters. The north end of the structure is an open garage area and is 11 feet clear under the three 2 x 12 inch members nailed together to form the built-up beam that spans the 20-foot opening. The east and west walls and the 10-foot long fin wall are typical 2 x 4 inch at 2 feet on center framing that sit on a 14 x 16 inch beam resting on the concrete floor. The south side of the garage has two pairs of 6 x 8 feet high doors that open into the workshop area behind. The east, west and partial north walls are clad with 1 x 8 shiplap boards. The western wall has a 5.5 x 8 feet long fixed window with 18 lights and wood muntins which brings light into the garage area.

West elevation of workshop

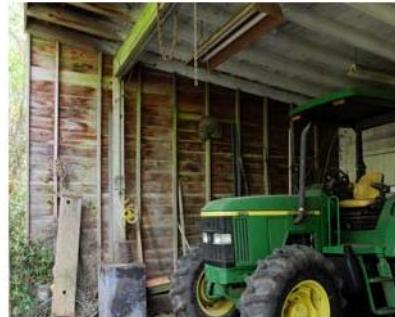
Tractor storage area

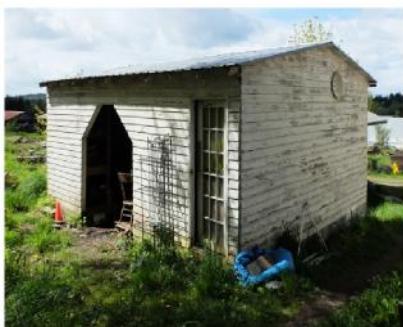
This storage building is located 15 feet south of the house. The structure is 16 x 20 feet long, is oriented north-south and has a 2:12 slope gable sheet metal roof. It is constructed with 2 x 4 inch studs at 2 feet on center. The roof is supported by 2 x 4 inch built-up trusses spaced 2 feet on center and covered with 1 x 6 inch boards laid up horizontally. The exterior walls are clad with 1 x 6 inch shiplap wood siding. The east elevation has a 12 x 16 feet deep open storage area with a dirt floor and a 6 x 8 feet high opening on the east. The north third of the structure is an enclosed space with a wood plank floor. The east wall has an 18-light wood door measuring 2 feet 6 inches wide x 6 feet 8 inches high.

Northeast elevation

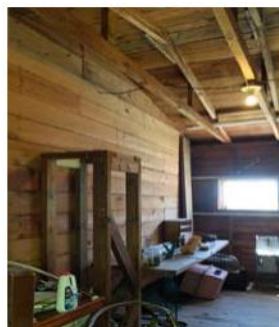
Office area

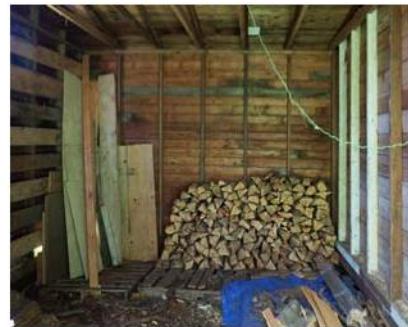
Storage area

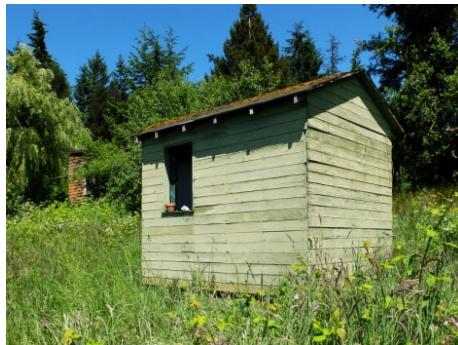
The shower shed is a simple wood frame structure feet 8 x 10 feet long. It is oriented north-south and has a 4:12 slope gable roof clad with asphalt shingles. It is constructed with 2 x 4 inch studs at 2 feet on center. The roof is supported by 2 x 4 inch rafters and cross ties spaced 2 feet on center and covered with horizontal 1 x 6 inch boards. The exterior walls are clad with 1 x 6 inch shiplap wood siding. The door on the north side opens to a room with a 2'8"x2'8" metal shower enclosure and a water heater. The foundation is not embedded into the ground and sits one foot above grade.

Southwest elevation of shower shed

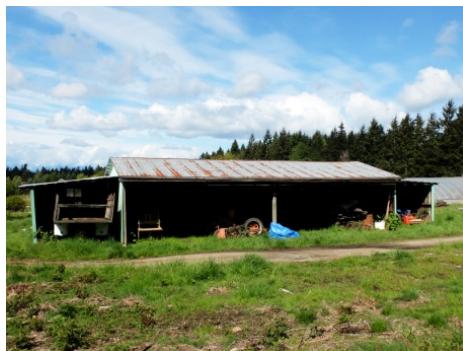
The northernmost shed (shed 1) is a half-open structure, oriented north-south. The main 2-bay central space is 48 x 25 feet deep, has a 3:12 gable roof and a dirt floor. The south, west and north walls are made of 1 x 10 inch boards and 1 x 3 inch batten attached to 2 x 4 inch studs at 4 feet on center. The three walls sit on 6 x 6 inch beams supported by regular footings. The gable roof is supported by 2 x 4 inch built up trusses spaced at 4 feet on center. The trusses are supported by two 2 x 12 inch members nailed together to form the built up beams on both sides. The metal roof is attached to 1 x 6 inch boards. The main central bays are flanked on the north and south sides by two identical shed structures (13 x 21 feet deep) that slope to the north and to the south. The 3:12 shed roofs are supported by 2 x 4 inch rafters at 3 feet on center. The metal roofing and the end and side walls of both sheds are similar construction to the central two-bay structure.

West elevation of Shed 1

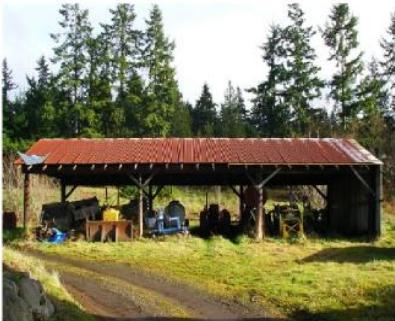
The southeastern shed (shed 2) is an open structure, oriented north-south, It is 20 x 48 feet long with a 6:12 gable roof and a dirt floor. The south wall is made of 1 x 10 inch boards and 1 x 3 inch battens. The main structural members are eight assorted poles that create three 16 x 20 foot bays. The gable roof is supported by 2 x 3 inch built up trusses spaced at 2 feet on center. The trusses are supported by two 2 x 12 inch members nailed together to form the built up beams on both sides. Separate footings support the poles. The roof is a palimpsest of historic layers including the original 1 x 6 inch boards, covered with asphalt sheeting, the occasional plywood panel and the most recent corrugated steel roofing.

West elevation of Shed 2

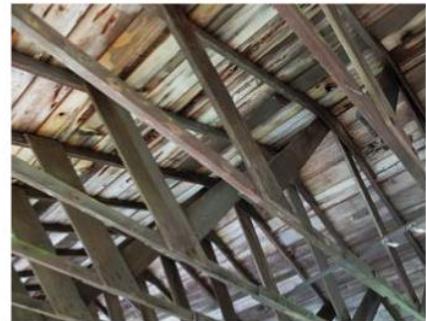
Roof trusses

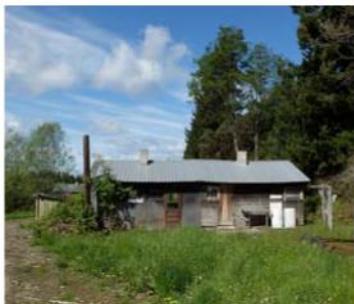
The large bunkhouse or pickers' cabin is located in the northwest of the developed farm structures. The north-south oriented gable roof cabin is 16 x 36 feet long and divided into four roughly equal rooms. It uses typical western framing with 2 x 4 inch studs at 2 feet on center. The roof framing is 2 x 4 inch rafters and 2 x 4 tie members also spaced at 2 feet on center. The exterior walls are made of 4 x 8 feet sheets of particle board nailed on top of continuous horizontal 1 x 8 inch boards. The cabin sits on individual 6 x 6 inch footings, three on the short sides and four on the long sides and down the middle. The walls and the 2 x 6 inch floor joists spaced at one foot on center, sit on two 2 x 6 inch members nailed together to form the built-up beams on both sides. Three of the rooms have a 2 feet 6 inch x 6 feet 6 inch door on the east side. All four rooms have a 4 x 4 foot two-light sliding aluminum window on the west side. The north and south end walls have no openings. The gable roof has a 6:12 slope and has metal roofing on top of asphalt sheeting which is attached to continuous 1 x 6 inch boards attached to the roof rafters. The cabin has two 16 x 16 x 8 inch concrete block chimney stacks located seven feet above the floor.

East elevation of bunkhouse

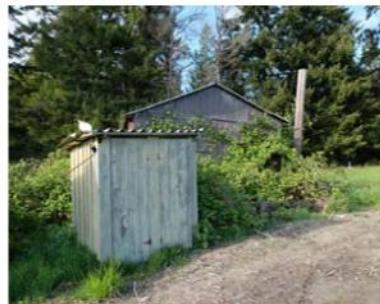
Near the large bunkhouse are two sets of double outdoor toilets, each with a pair of 2 feet x 6 feet doors. The toilet sets are 4 x 6 x 7 feet high and made of simple wood framing. The exterior walls are 1 x 8 inch boards and 1 x 2 inch battens and the roofs are made of corrugated metal. Two diamond shaped holes have been cut in the walls for easy relocation.

Outhouses

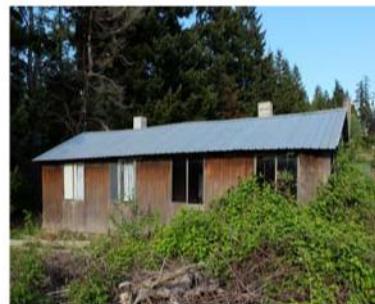
West elevation

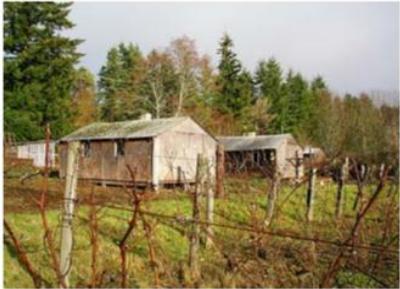
The small bunkhouses (No. 22, 23) are located in the far northwest corner of the developed farm structures. The north-south oriented gable roof cabins are each 16 x 24 feet long and divided into two equal rooms. They have typical framing with 2 x 4 inch studs at 2 feet on center. The roof framing is 2 x 4 inch rafters and 2 x 4 tie members also spaced at 2 feet on center. The exterior walls are made of 4 x 8 feet sheets of particle board nailed on top of continuous horizontal 1 x 8 inch boards. The cabins sit on individual 6 x 6 inch footings, three on the short sides and three on the long sides and down the middle. The walls and the 2 x 6 inch floor joists, spaced at one foot on center, sit on two 2 x 6 inch members nailed together to form the built up beams on both

sides. Each cabin has two 2 feet 6 inch wide x 6 feet 6 inch high doors on the east side and two 2x2 foot four light fixed windows (No.22 has one fixed and one aluminum 2x3 slider). The north and south end walls have no openings. The gable roofs have a 6:12 slope and have asphalt shingles on top of the continuous 1 x 6 inch boards attached to the roof rafters. There is a 16 x 16 x 8 concrete block chimney stack.

Southwest elevation of bunkhouse

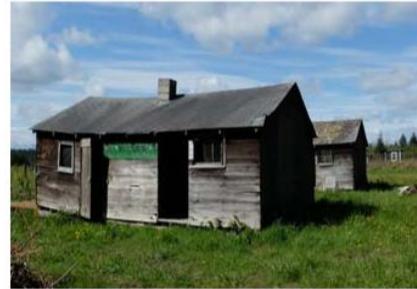
Northeast elevation

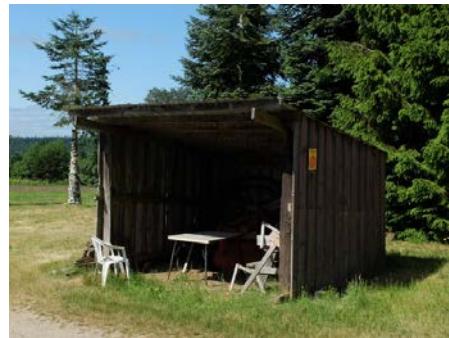
This Berry Shed (No. 29) is 10 x 10 feet and walled on three sides with vertical 1 x 6 boards and battens attached to 3 x 6 horizontal members located at the top bottom and middle of the wall. The 2:12 metal panel shed roof slopes up west to east and is held up by four quarter log portion posts set in each corner which support a structure of 2 x 4 joists spaced 2 feet on center.

Front and side of berry shed

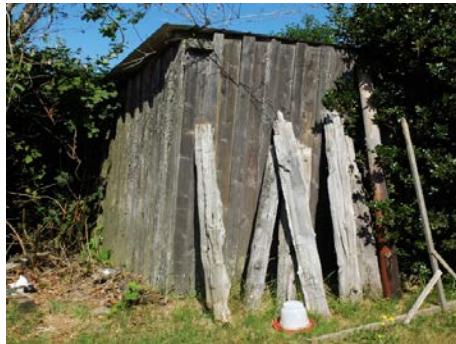
This Berry Shed (No. 30) is 10 x 10 feet and walled on all sides with vertical 1 x 10 boards and 1 x 4 battens attached to 3 x 6 horizontal members located at the top bottom and middle of the wall. The north wall has a 5 foot opening at the mid-point of the wall. The 2:12 metal panel shed roof slopes up west to east and is held up by four quarter log portion posts set in each corner which support a structure of 2 x 4 joists spaced 2 feet on center.

SW elevation

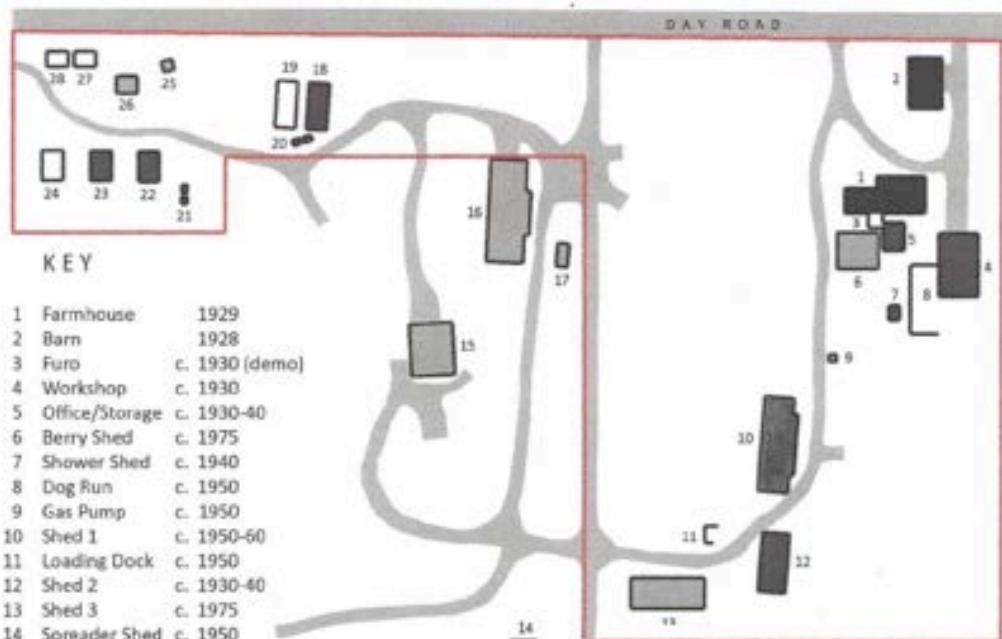
### **Map of Historic Area**

1	Farmhouse	1929
2	Barn	1928
3	Furo	c. 1930 (demo)
4	Workshop	c. 1930
5	Office/Storage	c. 1930-40
6	Berry Shed	c. 1975
7	Shower Shed	c. 1940
8	Dog Run	c. 1950
9	Gas Pump	c. 1950
10	Shed 1	c. 1950-60
11	Loading Dock	c. 1950
12	Shed 2	c. 1930-40
13	Shed 3	c. 1975
14	Spreader Shed	c. 1950
15	Backhoe Shed	c. 1990
16	Green Shop	c. 1985
17	Traveletez	c. 1960
18	Lge Bunkhse 1	c. 1950
19	Lge Bunkhse 2	c. 1950 (demo)
20	Lge Outhses	c. 1950
21	Sm. Outhses	c. 1950
22	Sm. Bunkhse 1	c. 1950
23	Sm. Bunkhse 2	c. 1950
24	Sm. Bunkhse 3	c. 1950 (demo)
25	Well House	c. 2000
26	Storage Shed	c. 2000
27	Storage Shed	c. 1950 (demo)
28	Chico's House	c. 1950 (demo)
29*	Berry Shed 1	c. 1940
30*	Berry Shed 2	c. 1940
