**Reconnaissance Built Environment  
Survey of Walla Walla's Germantown –  
Portions of Chase's Addition, Henderson's  
Addition, Freise Addition and an Unplatted  
Area, Walla Walla, Washington**

AHA! Project 2015-006

August 14, 2015

# CULTURAL RESOURCES REPORT COVER SHEET

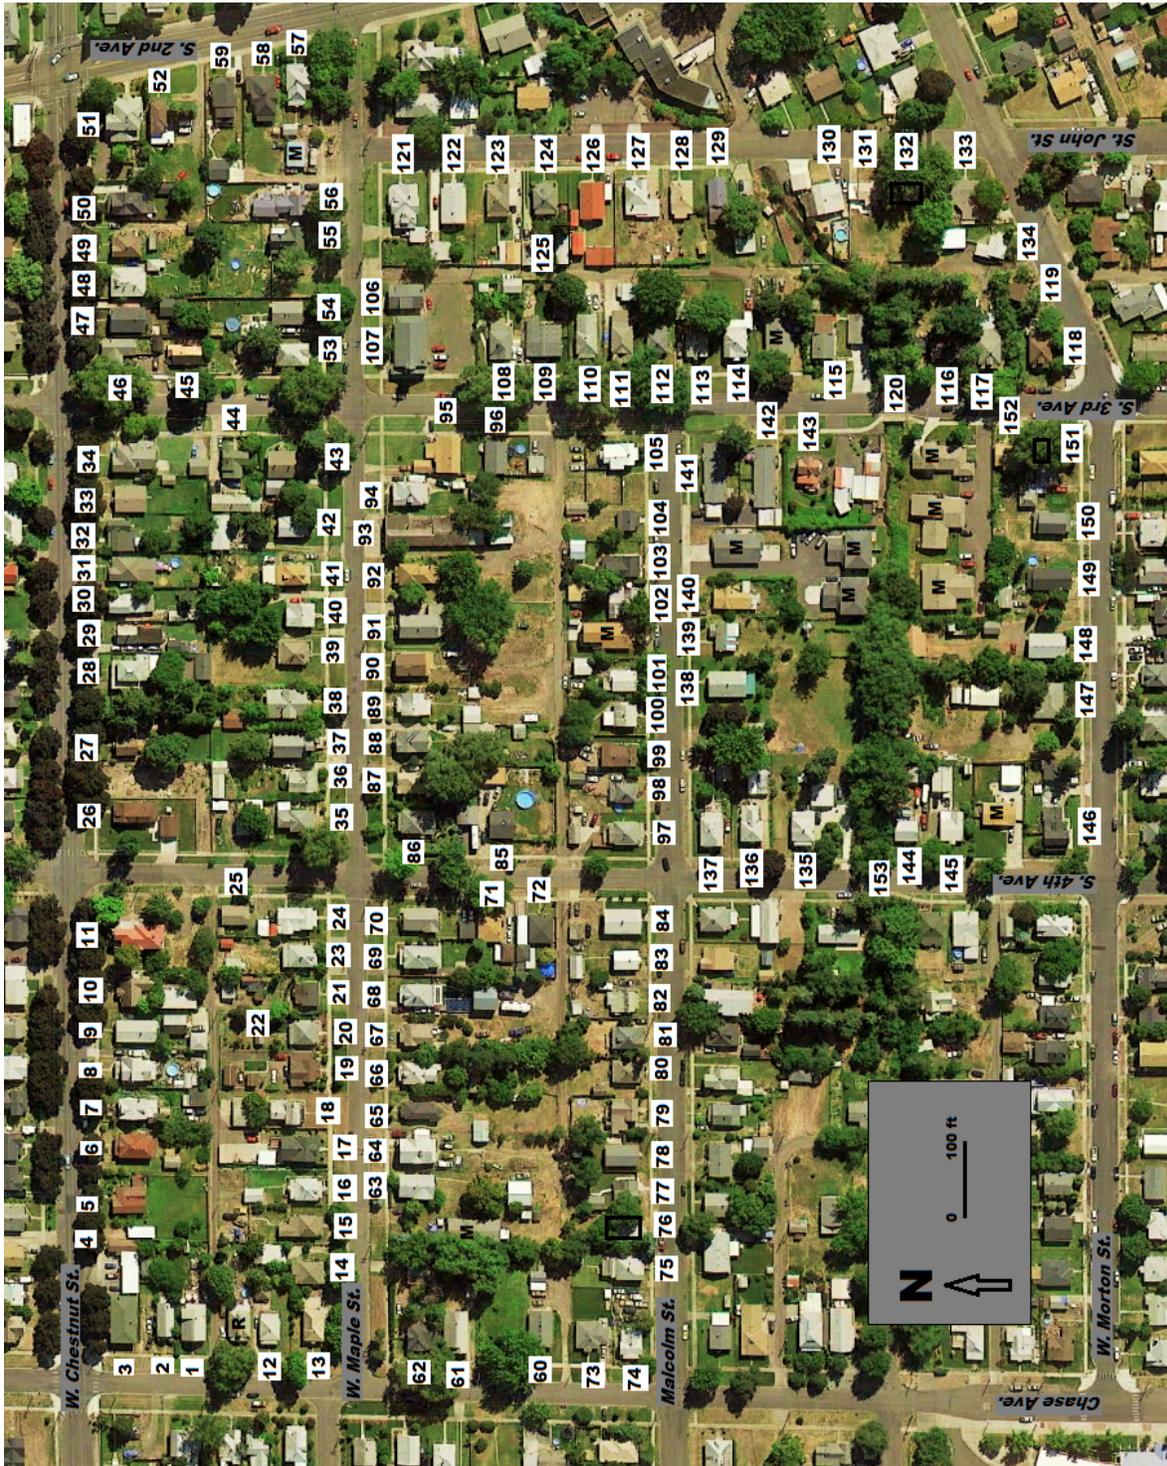
Figure 2. Survey Area, showing built environment resources (numbered), modern buildings (M), and removed buildings (R). Adapted from Google Earth aerial photograph, 2013.

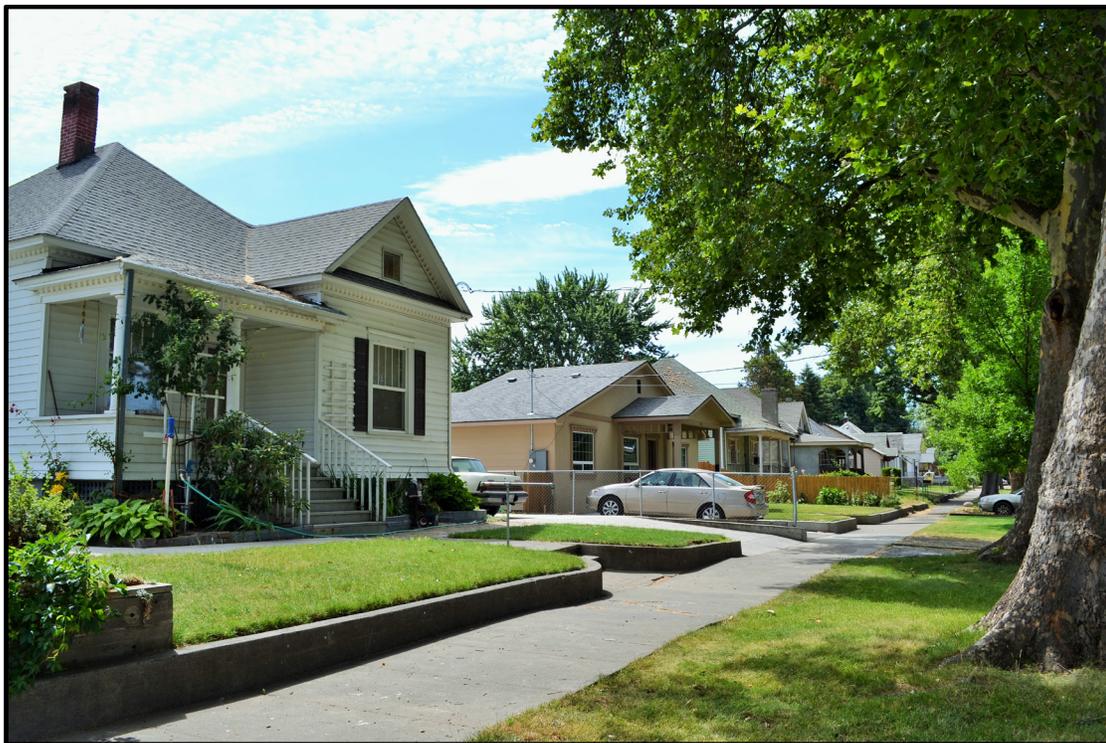
*Figure 3. Overview of the Survey Area: S.3<sup>rd</sup> Avenue just south of W. Maple Street; the building at the left is Project Number 108. View to the southeast.*

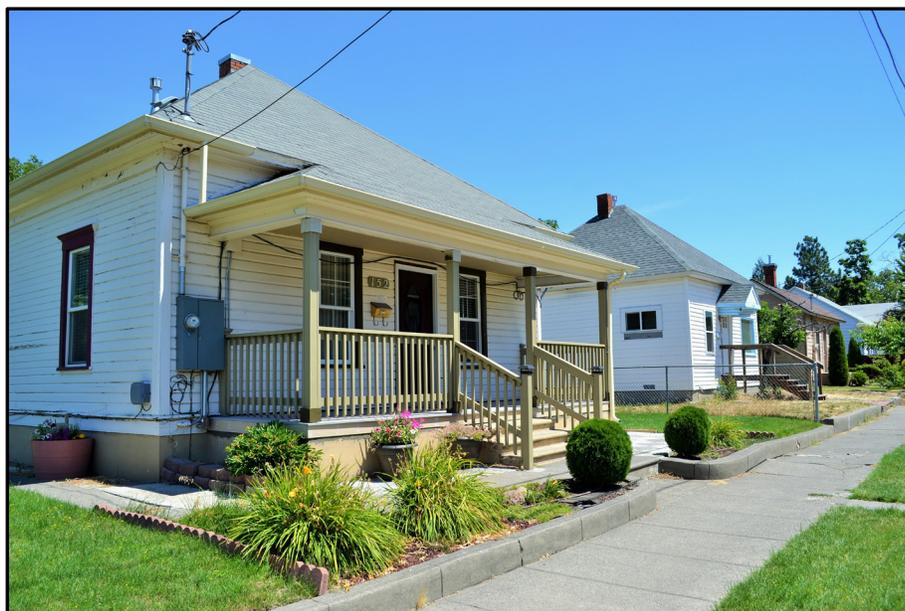
Most residences in the Survey Area are small entry-level workingman’s cottages with pyramidal, hipped, or gabled roofs (Figure 6). Despite variations in architectural style, large numbers of these small houses employ identical architectural elements and construction techniques—including classical wooden Tuscan columns, wood sash double-hung windows with decorative upper sash “tails,” and poured concrete foundations parged and scored to look like stone blocks—suggesting construction by a local developer during a discrete time period. Over the years most of these cottages have been enlarged with multiple rear additions, and nearly all have been updated with modern siding, doors, and windows. Most buildings, however, retain their historical form and remain readily recognizable as historical structures. Many residences are associated with small, detached garages or other historical outbuildings, sited to the rear of the house and accessed by narrow driveways or from the alleys.

***Figure 6. Overview of homes on Malcolm Street just east of S. 4<sup>th</sup> Avenue; the building at the left is Project Number 97. View to the northeast.***

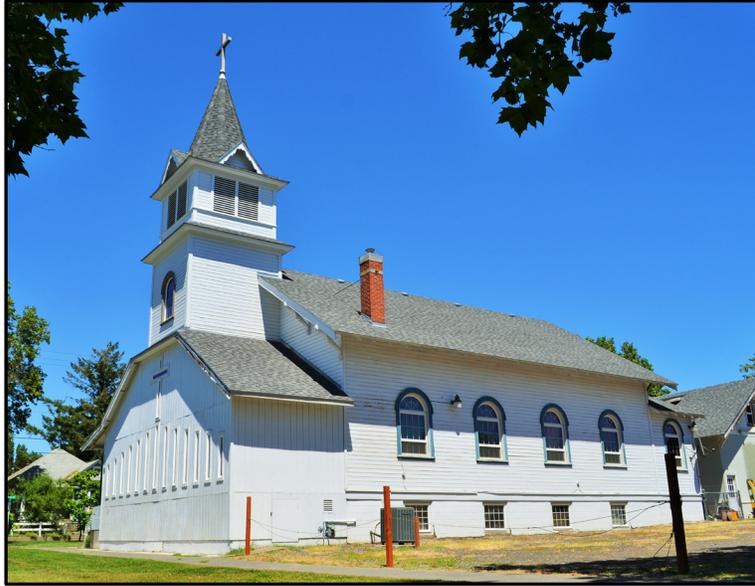
of the Christ Lutheran congregation left to found the Peace Evangelical Church. This was probably the German-speaking Lutheran church at 801 S. 3<sup>rd</sup> Avenue, since that building's cornerstone provides a construction date of 1922 as well as the inscription "*Friedens Gemeinde*", which Google translates as "Peace Community" (Christ Lutheran Church 2015; CVGS 2015; Harris 2012).

**Figure 7. German Lutheran Church built in 1922 at 801 S. 3<sup>rd</sup> Avenue (Project Number 107), west and south sides.**

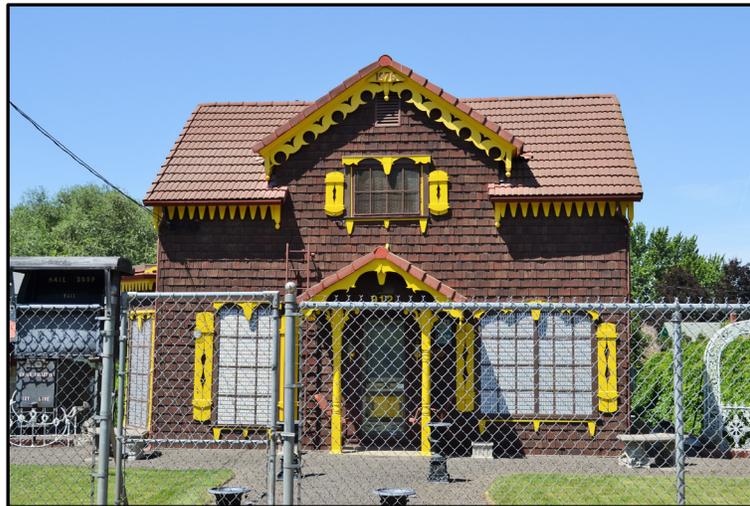
A large building identified by lifelong area resident Rondall “Ron” Brown (personal communication 2015) as the first home built in the area, the 1876 Henderson residence, is situated on S. 3<sup>rd</sup> Avenue in the southern Survey Area (Figure 8). This house, which predates the period of Volga German immigration, is believed to be the residence of the prominent Henderson family that platted Henderson’s Addition. Although this residence remains recognizable as a historical building, extensive remodeling has altered nearly all visible elements.

**Figure 8. Heavily remodeled home at 912 S. 3<sup>rd</sup> Avenue (Project Number 143), the 1876 Henderson House, east elevation.**

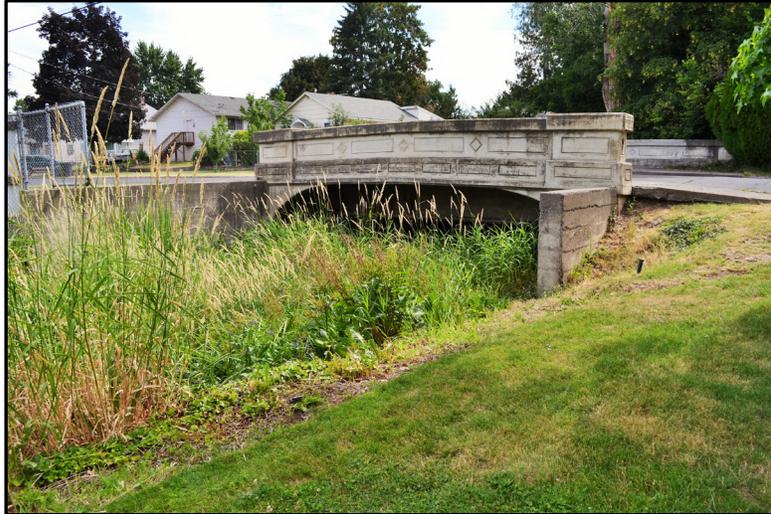
Two concrete bridges convey traffic on S. 3<sup>rd</sup> and S. 4<sup>th</sup> avenues over Garrison Creek in the southern Survey Area (Figure 9). The S. 3<sup>rd</sup> Avenue Bridge was built in 1928 (Rondall Brown, personal communication 2015), while the S. 4<sup>th</sup> Avenue Bridge was built in 1939, according to a bridge placard, as a Works Progress Administration Depression-relief project.

*Figure 9. S. 3rd Avenue Bridge (Project Number 120). View to the northeast.*

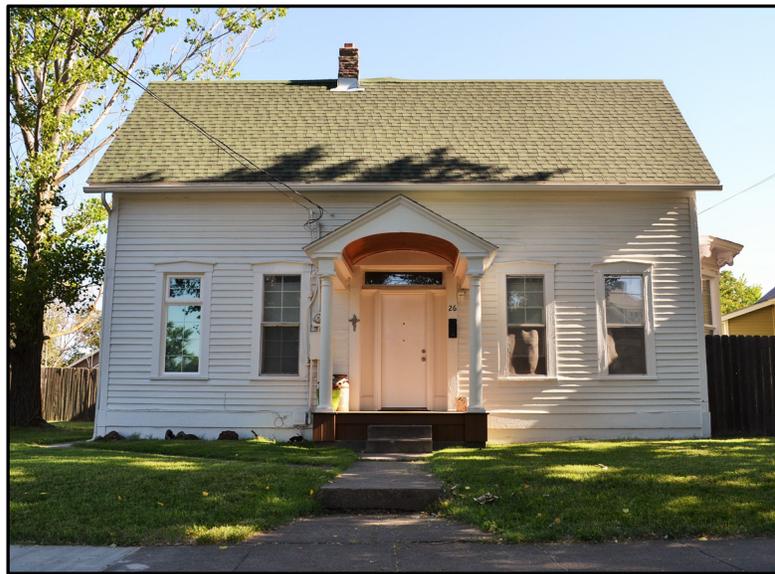
**Figure 10. Greek Revival style: House at 26 W. Maple St. (Project Number 55), south elevation.**

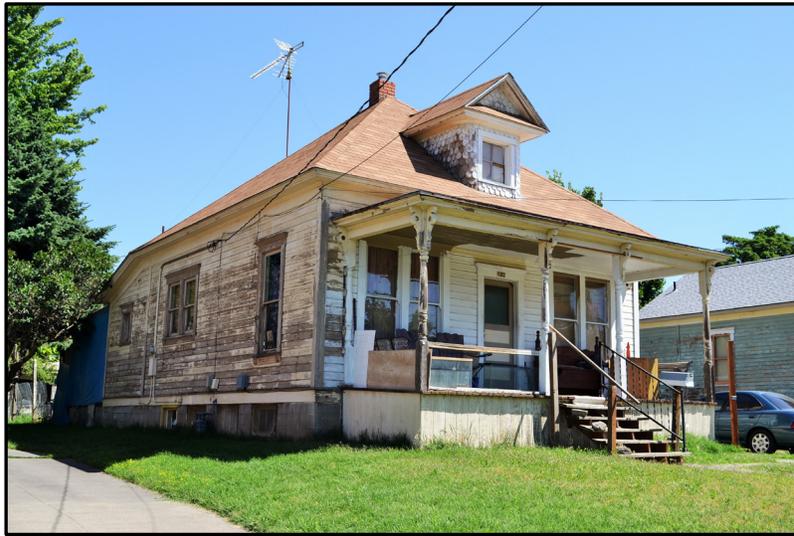
*Figure 11. Queen Anne – Spindework style: House at 122 W. Maple St. (Project Number 41), west and south (front) sides.*

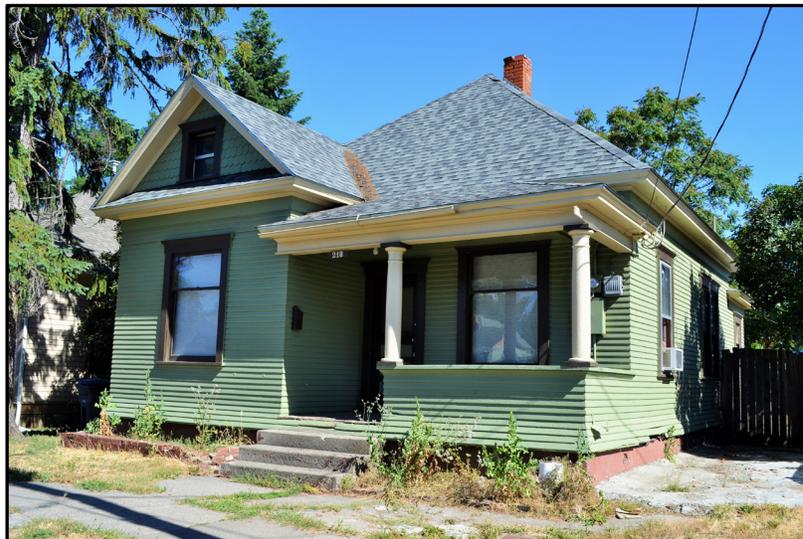
*Figure 12. Queen Anne – Free Classic style: House at 218 Malcolm St. (Project Number 81), south (front) and east sides.*

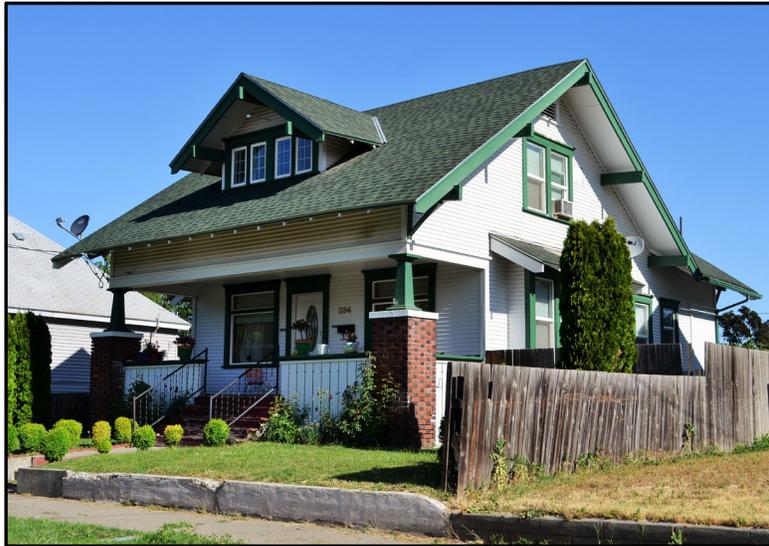
***Figure 13. Craftsman Bungalow style: House at 234 W. Maple St. (Project Number 17), south (front) and east sides.***

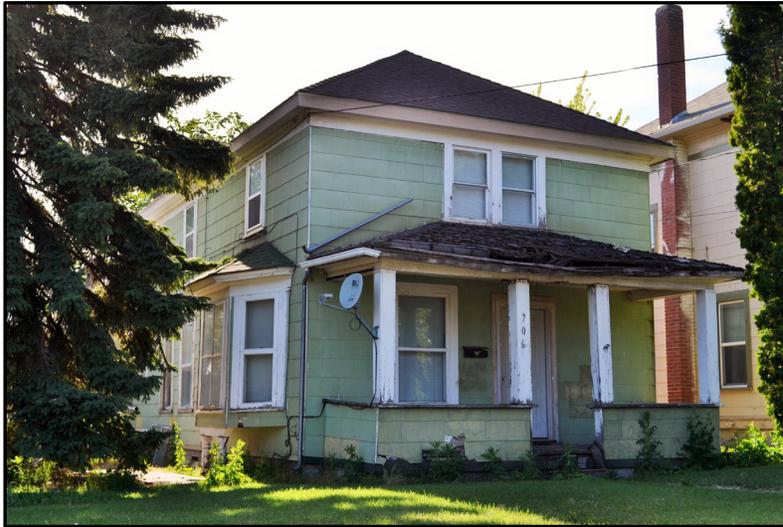
*Figure 14. Colonia Revival – American Foursquare style: House at 706 S. 2<sup>nd</sup> Ave. (Project Number 52), south and east (front) sides.*

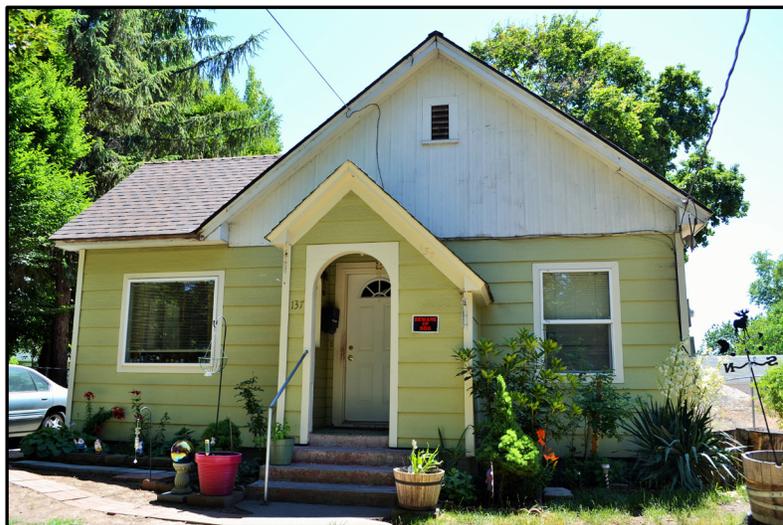
Only two Tudor buildings are present in the Survey Area (Project Numbers 27 and 34) (Figure 15), one a Tudor update to an older Queen Anne residence.

*Figure 15. Tudor style: House at 137 W. Chestnut St. (Project Number 27), north side.*

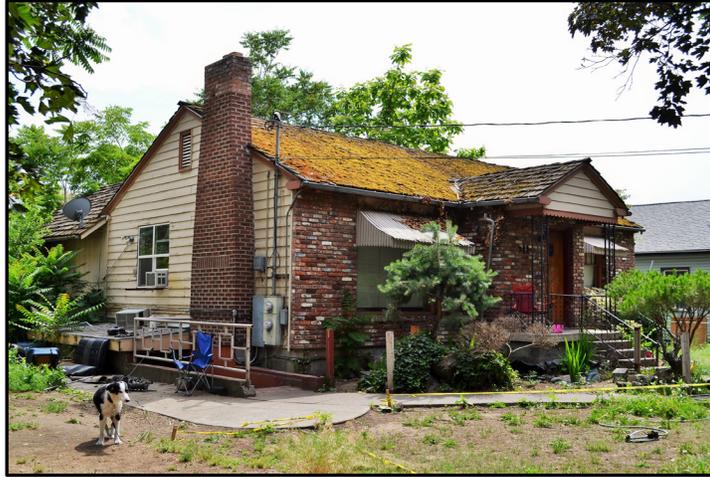
A number of Minimal Traditional houses occur in the Survey Area (Figure 16). Most of these homes are simple vernacular expressions of the style, rather than classic examples. The Minimal Traditional architectural style is a small economical house type, nearly devoid of stylistic ornament, developed in response to the Great Depression and built in large numbers from about 1935 to 1950. Typical Minimal Traditional features include low to moderately pitched roofs, close eaves and rake, large chimneys, and usually one or more front-facing gables.

***Figure 16. Minimal Traditional style: House at 211 W. Chestnut St. (Project Number 10), east and north (front) sides.***
