Title of Report: Waterville Architectural Survey, Phase II Project, Town of Waterville, Douglas County, Washington

**WATERVILLE ARCHITECTURAL SURVEY, PHASE II,  
TOWN OF WATERVILLE, DOUGLAS COUNTY,  
WASHINGTON**

**Historic Resources Survey**

**ESA Project Number D202200097.00**

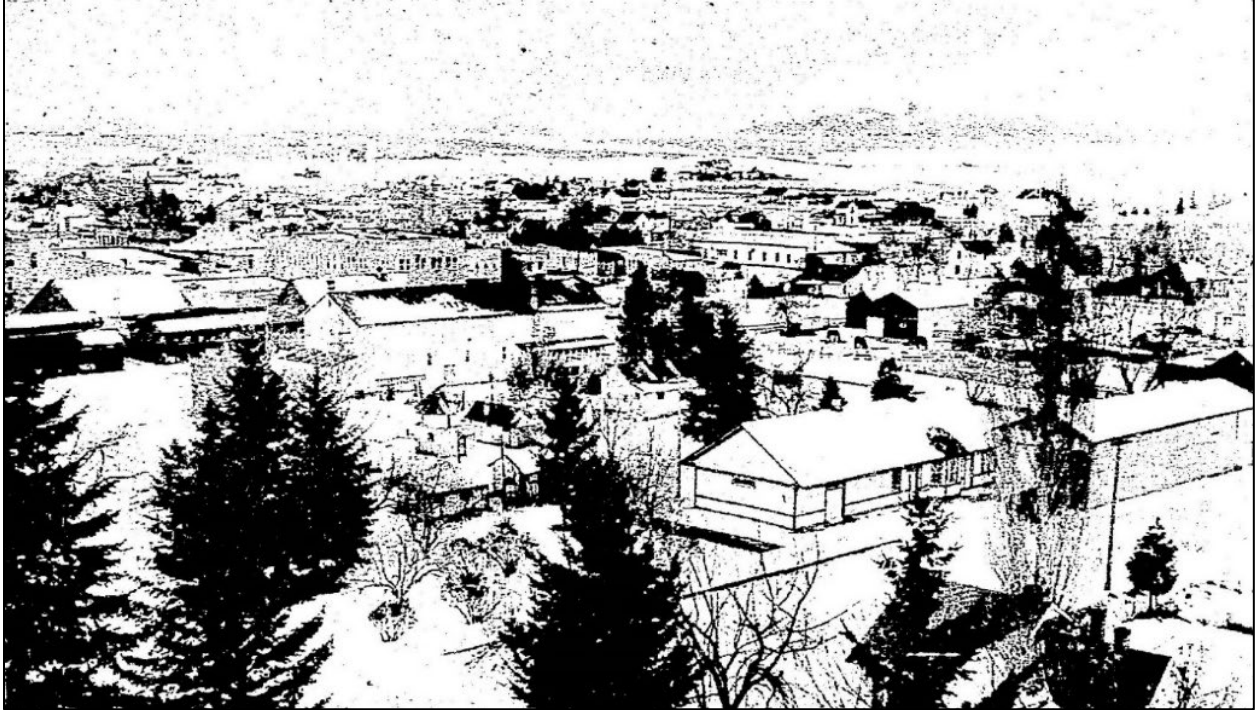
**Figure 5**  
An overview of Waterville in March 1942

By the end of World War II, the town had largely been developed (Figure 5) and did not see the significant post-war construction boom that was common in other parts of the state. At this time, Alternate SR 10 ran through Waterville and connected it to Western Washington and east to Idaho. In 1946, Alternate SR 10 was re-designated and became a continuation of SR 2. This change extended SR 2 from its previous termination point in Bonners Ferry, Idaho to Everett, Washington and connecting the latter to Houlton, Maine (Weingroff 2022). Waterville was hit by a flood in June 1948, which destroyed crops and “washed out all five bridges” of the Waterville Railway “and one mile of the line’s track in Douglas Canyon” (Benton 1960; Unknown Author 1989:54). The Town made efforts to repair the track but was never able to, and the line was officially abandoned on March 23, 1954.

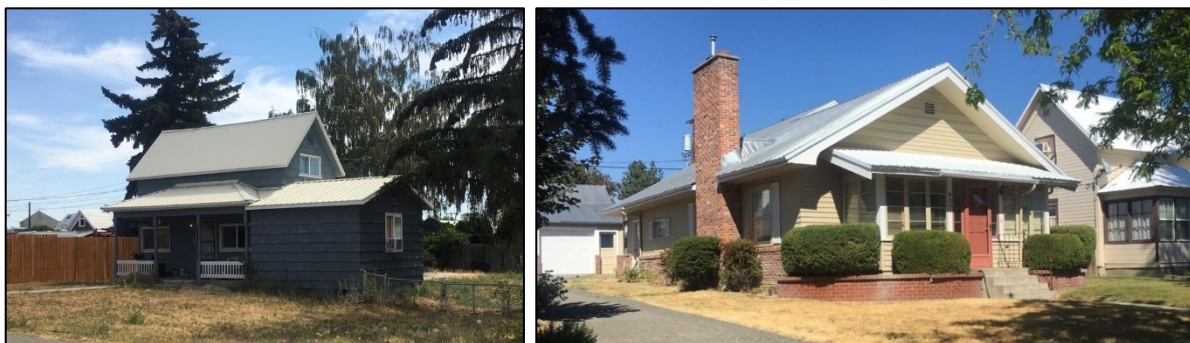
**Figure 6**  
Vernacular residences at 214 W Walnut Street (DAHP ID 578547), left,  
and 407 E Birch Street (DAHP ID 578302), right

Many wood frame buildings were constructed with no or few nods to architectural styles of the time. These can be called “no style;” “no architectural/academic style;” “vernacular,” which typically carries a descriptor of the construction style (i.e., frame or masonry); or occasionally “folk.” Frame Vernacular buildings generally feature gable or hip roofs and shingle, clapboard, and sometimes novelty siding. Following World War II, the popularity of wood frame buildings fell off considerably as concrete became more popular. Many Frame Vernacular structures were constructed by owners or local builders. Pattern books were also popular in the first part of the 20th century, which provided diagrams for owners to build their own houses. Examples of frame vernacular buildings in Waterville include the 1926 building at 214 W Walnut Street and 407 E Birch Street, built in 1910 (Figure 6).

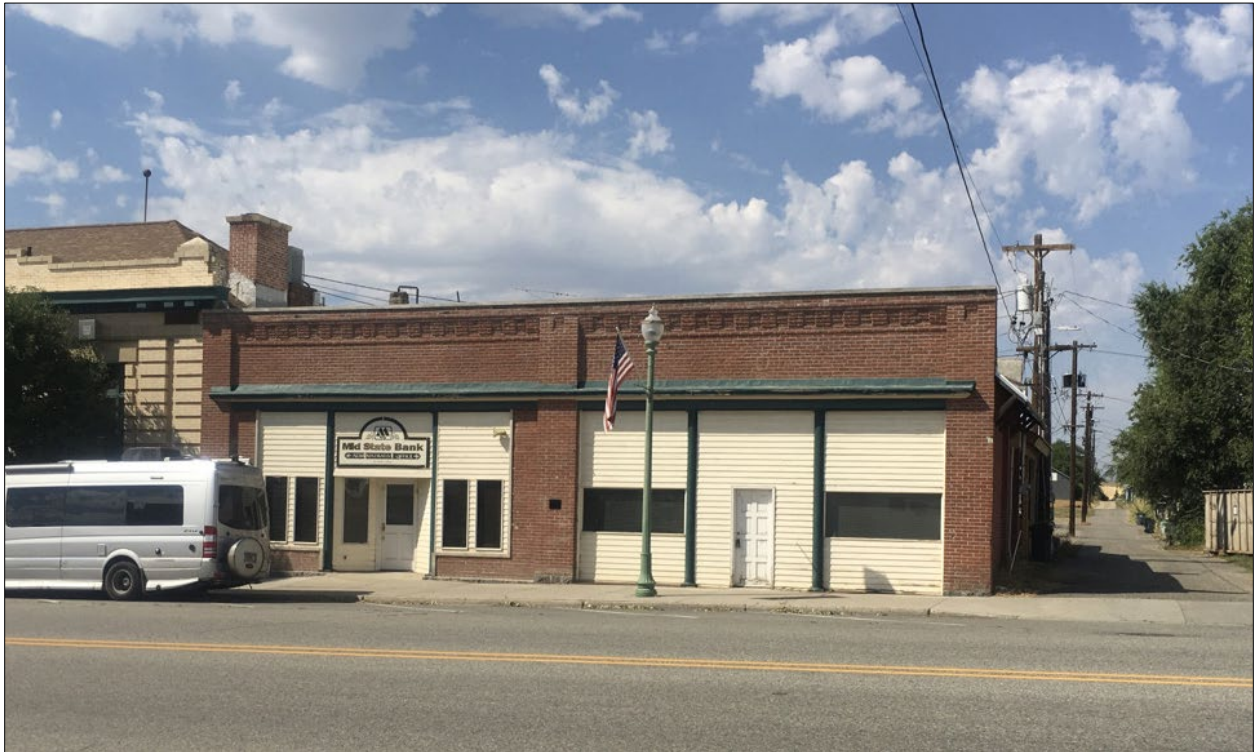
**Figure 7**  
A Commercial style building at 104 N Chelan Avenue (DAHP ID 581080)

As a style, commercial architecture began to emerge near the end of the 19th century. The advent of cast iron beams allowed space for larger display windows, and with advancements in mechanization and new technologies, design sensibilities moved towards simplified forms, eschewing surface decoration. Commercial buildings are typically visually dominated by window expanses – often grouped – with flat fronts and parapeted roofs (Whiffen 1969). They are typically faced in brick, and sometimes have corbeled or geometric designs on the upper portion of the façade. The single Commercial style building surveyed as a part of this Project is located at 104 N Chelan Avenue (Figure 7).

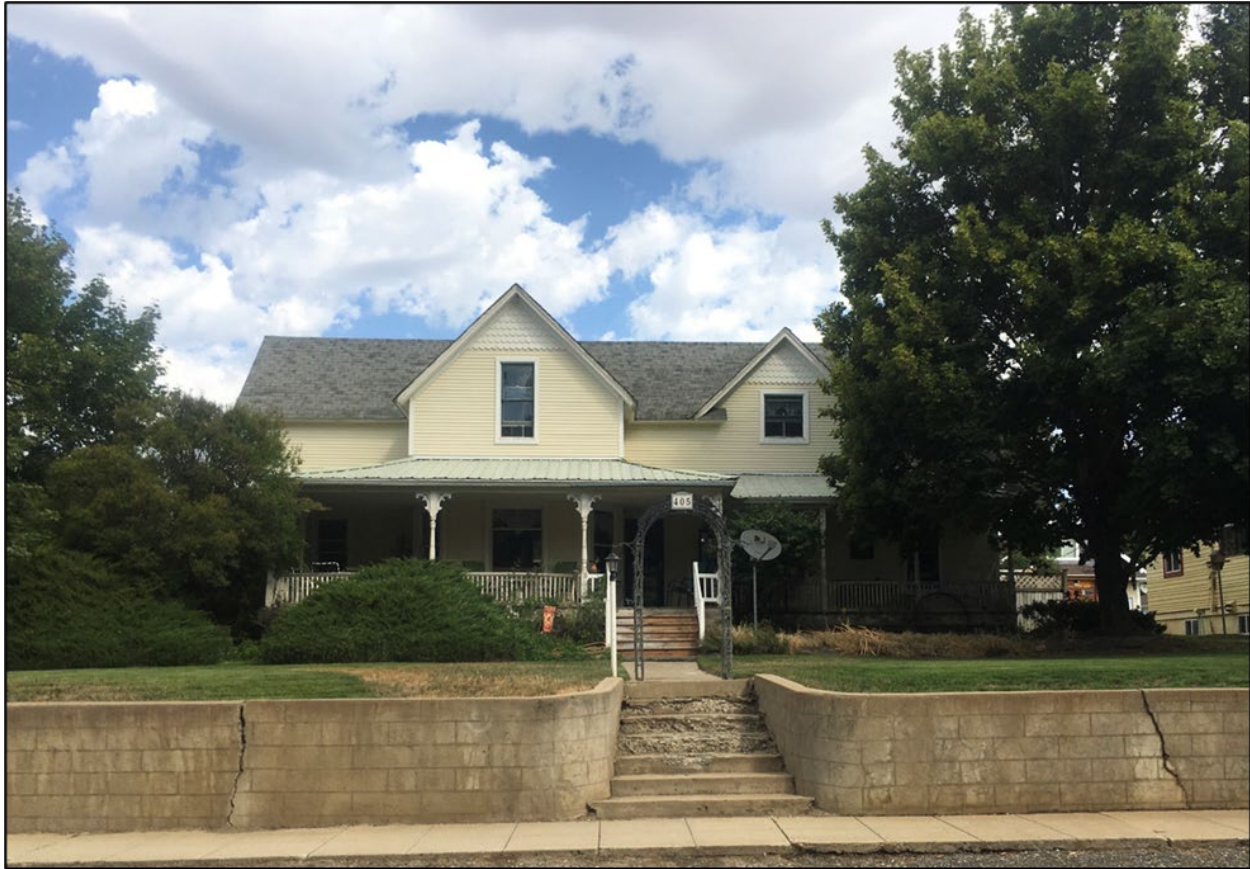
**Figure 8**  
A Folk Victorian residence at 405 E Locust Street (DAHP ID 578338)

Folk Victorian buildings are common throughout the United States and are largely due to the development of the railroad: with the establishment of new lines, new areas of the country had easy access to the heavy woodworking machines that could produce inexpensive details. These details, typically spindlework and jigsaw trim, could be applied to existing buildings as well as those under construction. The form of the building is typically a simple folk (or vernacular) building with these mass-produced details, most often found in the porch and cornice. The one Folk Victorian building surveyed during this Project is located at 405 E Locust Street (Figure 8)

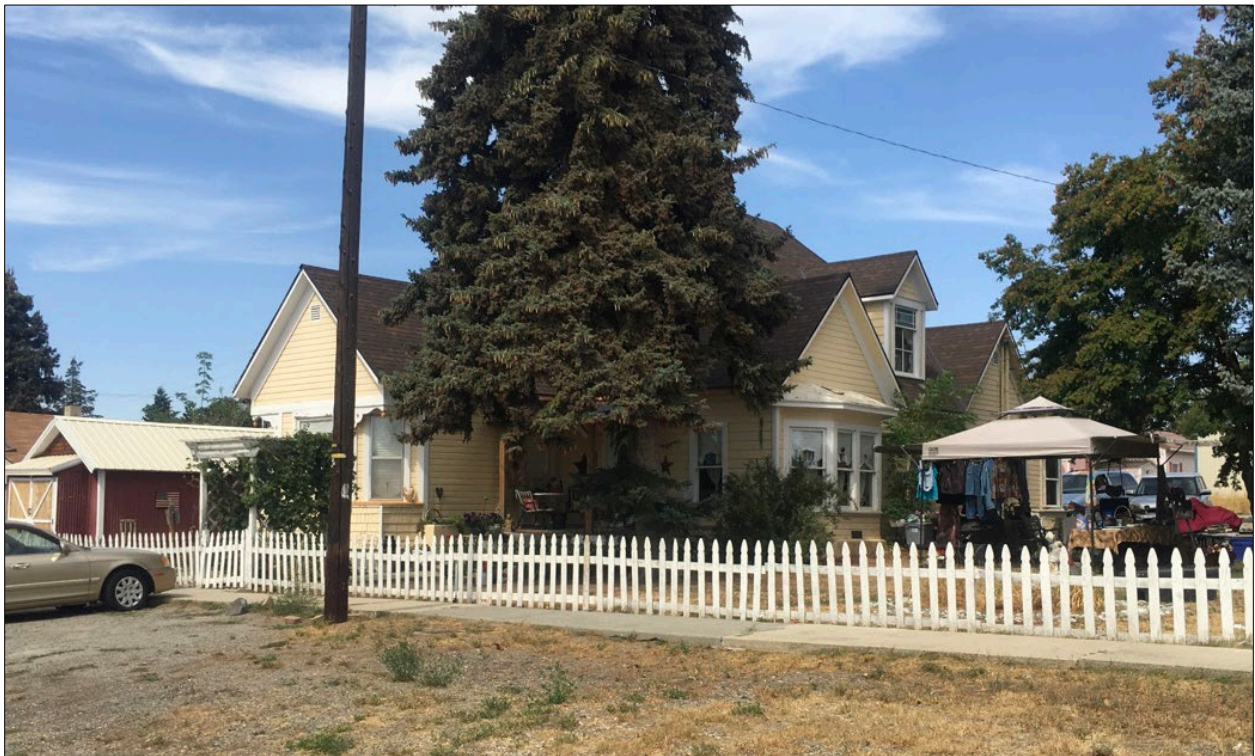
**Figure 9**  
A Queen Anne residence at 211 W Walnut Street (DAHP ID 578543)

Queen Anne style buildings are most notably defined by their complex, often sprawling forms and the use of highly elaborate decoration. Popular at the turn of the century, they are almost always two stories, have steeply pitched roofs and a large porch. Both massing and surface details are used to minimize any instance of smooth walls and often includes patterned shingles and towers. The most common subtype of the style is Spindlework, which is identified by its namesake ornamentation, sometimes known as gingerbread details. These buildings have delicate porch, roof, and windows decorations produced by machine lathes. Other, far less common styles are Free Classic (shares traits with Colonial Revival buildings), Half-Timbered (similar to Tudor buildings), and Patterned Masonry (containing decorative terracotta or stone panels); the latter two are rarely found outside of the East Coast. These building details could be shipped throughout the United States due to the emergence of the railroad, and builders incorporated them exuberantly. The Queen Anne building surveyed for this Project is located at 211 W Walnut Street (Figure 9).

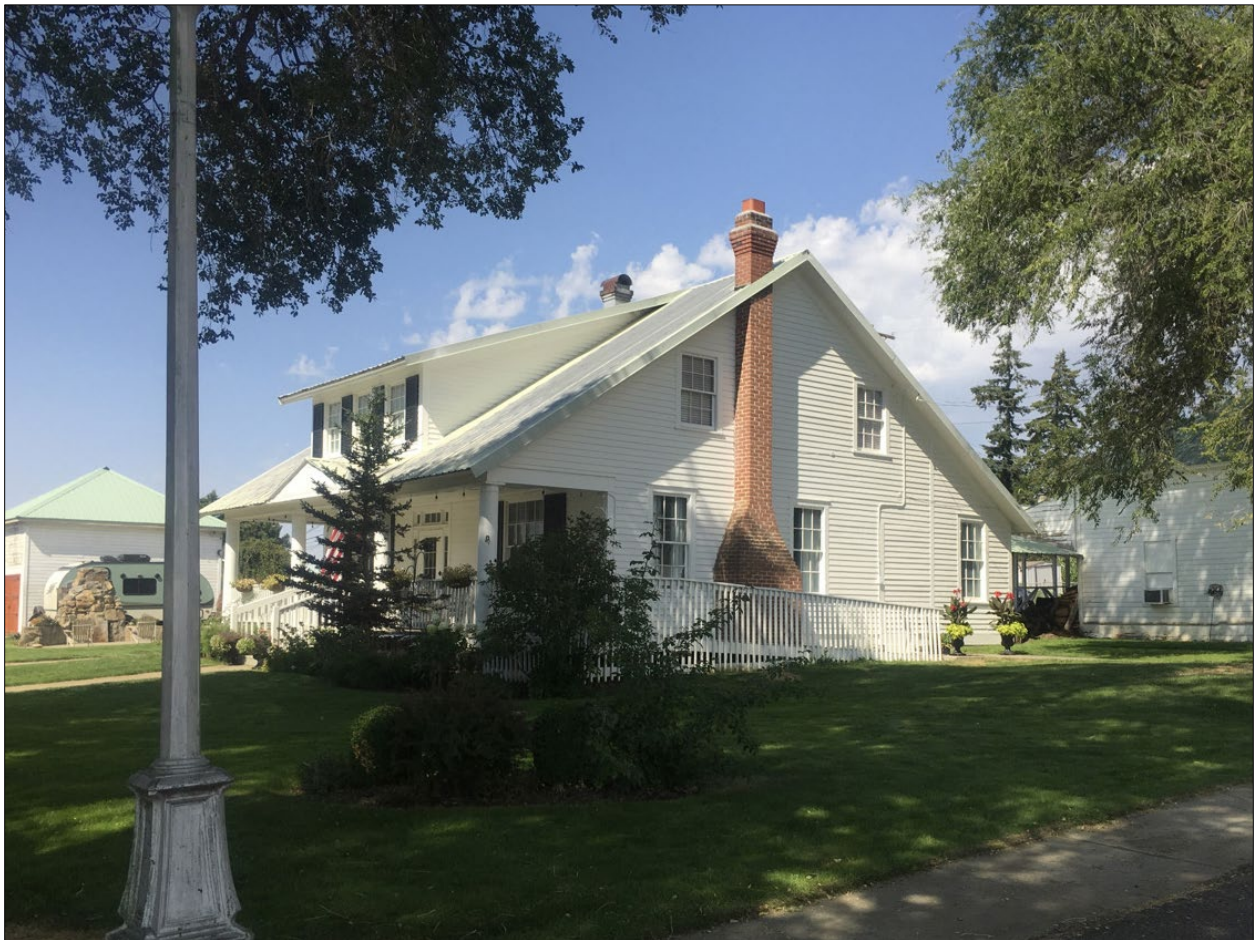
**Figure 10**  
A Colonial Revival residence at 303 E Locust Street (DAHP ID 578524)

Colonial Revival buildings first grew to prominence with the Philadelphia Centennial of 1876 and draw on the earlier Georgian, Dutch, and Federal styles. It was an overwhelmingly popular style in the first part of the 20th century; roughly 40% of buildings constructed between 1910 and 1930 were Colonial Revival. Unlike many other styles, it remained relatively popular through and after World War II, although post-war iterations were generally less elaborate than earlier designs. Colonial Revival buildings are often two stories, symmetric, and clad in brick or clapboard, with the front entry accented by a portico, typically a decorative pediment supported by columns or pilasters. Other common features include fanlight transoms, gable returns, and paired windows with multi-pane glazing. The one Colonial Revival building surveyed as a part of this Project is 303 W Locust Street (Figure 10).

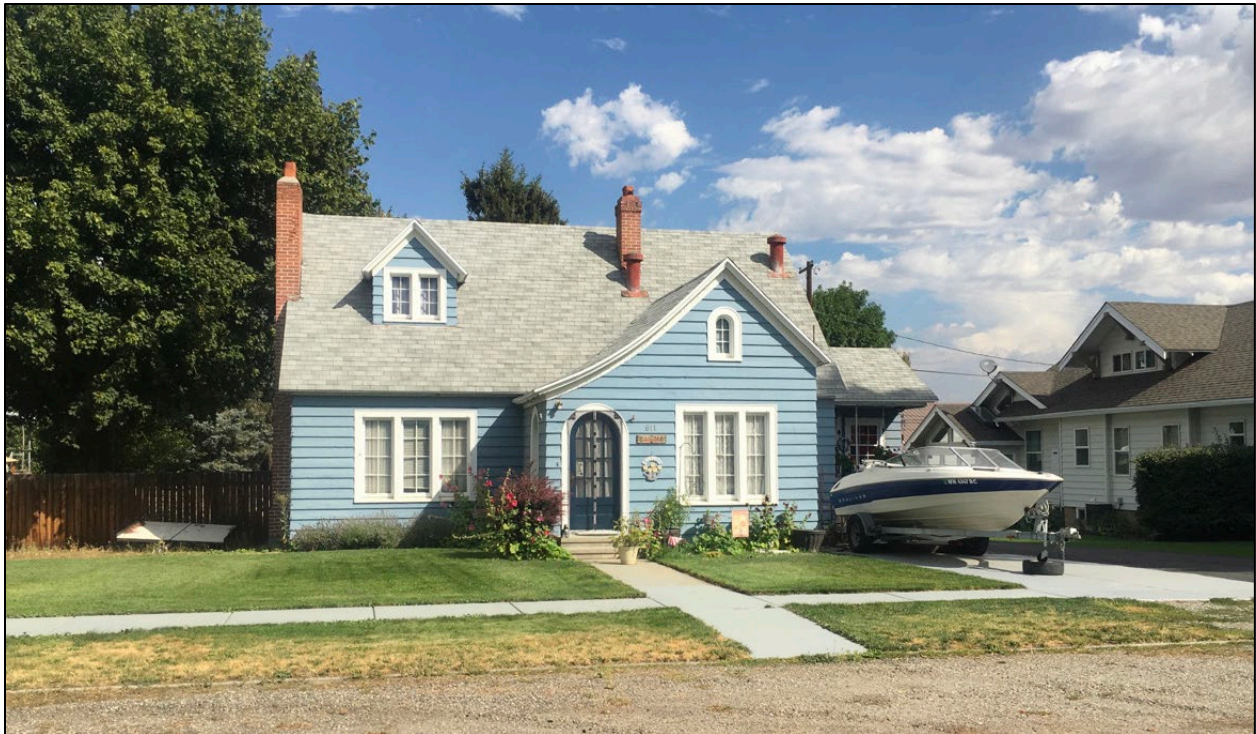
**Figure 11**  
A Tudor Composite residence at 611 E Locust Street (DAHP ID 578340)

Tudor Revival buildings draw on a wide range of early English building traditions that date from late Medieval to the early Renaissance. Despite this broad range of source material, Tudor Revival buildings are often highly identifiable by a steep, side facing gable, highlighted entries, and half-timbering, where wood “timbers” with wood or stucco infill cover the second story. Instead of half-timbering, some employ highly patterned brickwork. Traditionally, windows are grouped and have few details, although leaded glass is a common feature. Chimneys are also very common and can be large and/or elaborate. In the Pacific Northwest, many Tudor Revival (also known as Tudor Composite) buildings are more modest, and half-timbering is not always the norm. Many northwest buildings designed in the style, particularly those that are smaller in size, are faced in stucco or clapboard. These regional iterations of the style are occasionally referred to as “Northwest Tudor,” as the horizontal emphasis (as can be seen in Waterville example includes 611 E Locust Street, Figure 11) is rarely found in other places.

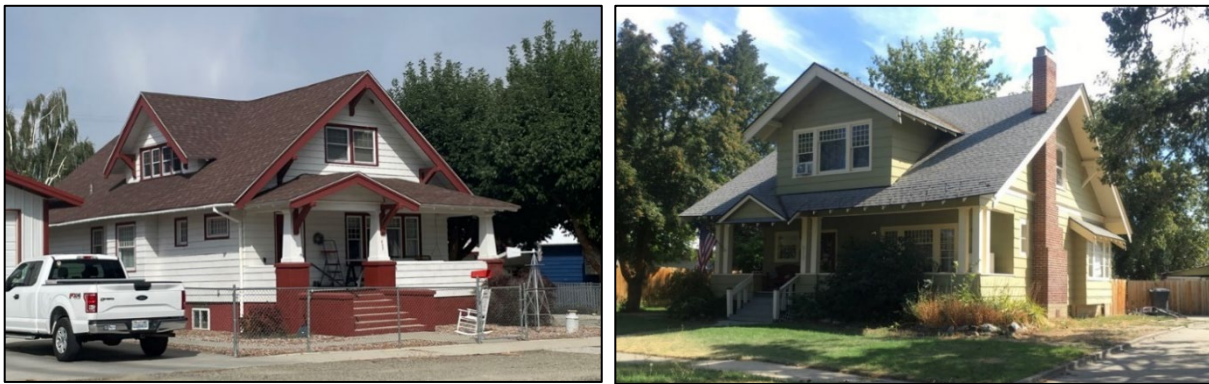
**Figure 12**  
Craftsman residences at 607 E Ash Street (DAHP ID 578277), left, and  
610 E Locust Street (DAHP ID 578336), right

Craftsman buildings were a very common style from roughly the turn of the century to the onset of the Great Depression. The style has its roots in the English Arts and Craft Movement, which viewed machine-made elements as impersonal and focused on all details, large and small, being handmade with careful attention (Walker 1996:178). Early, highly refined, buildings designed in the style were widely reported on in magazines. “As a result, a flood of pattern books appeared, offering plans for Craftsman bungalows; some even offered completely pre-cut packages of lumber and detailing to be assembled by local labor” (McAlester 2015:578). This dissemination of images, plans, and materials led to a booming popularity. Buildings designed in this style typically feature a low pitch roof with a deep overhang and exposed roof rafters, sometimes with brackets or braces. Full width porches with corner posts or battered posts are typical to the style as well. Originally, wood siding (typically wood shingles or clapboard) was the norm, although many have seen siding changes – perhaps most notably during the post-war period, when many were re-sided with asbestos shingles. Examples include 607 E Ash Street and 610 E Locust Street (Figure 12).

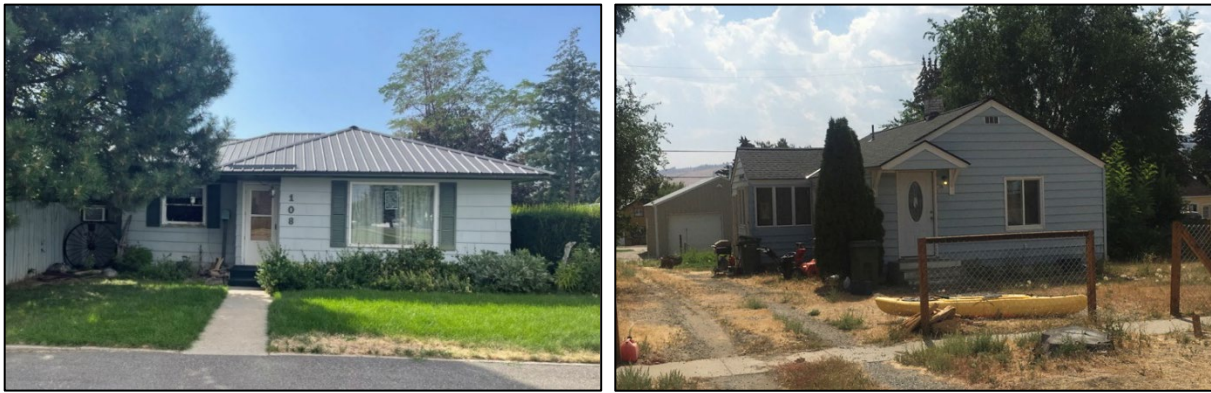
**Figure 13**  
Minimal Traditional residences at 108 N Adams Street (DAHP ID 578385), left,  
and 204 W Locust Street (DAHP ID 578517), right

During the latter half of the Great Depression (1935 – 1940) and through the end of the 1940s, Minimal Traditional buildings were overwhelmingly common. During that time, it was the Federal Housing Administration's (FHA's) preferred design and therefore more likely to be covered by FHA loans. In addition, the small houses could be constructed quickly, responding to housing needs to accommodate World War II production line workers and later to meet GI housing demands. The style eschewed nearly all decorations to maximize the visual size of the buildings, which were often less than 1,000 square feet. The focus was on the scale and proportion of doors and windows, and it was recommended that only one cladding material be used. They are almost exclusively one story, and the roof typically has little to no overhang. Examples of the style found in Waterville are located at 108 N Adams Street and at 204 W Locust Street (Figure 13).
