Title of Report: Historic Property Inventory in the Colfax Central Business District, City of Colfax, Whitman County, Washington.

Historic Property Inventory in the Colfax Central Business District

City of Colfax, Whitman County, Washington

AHA! Project 2016-010

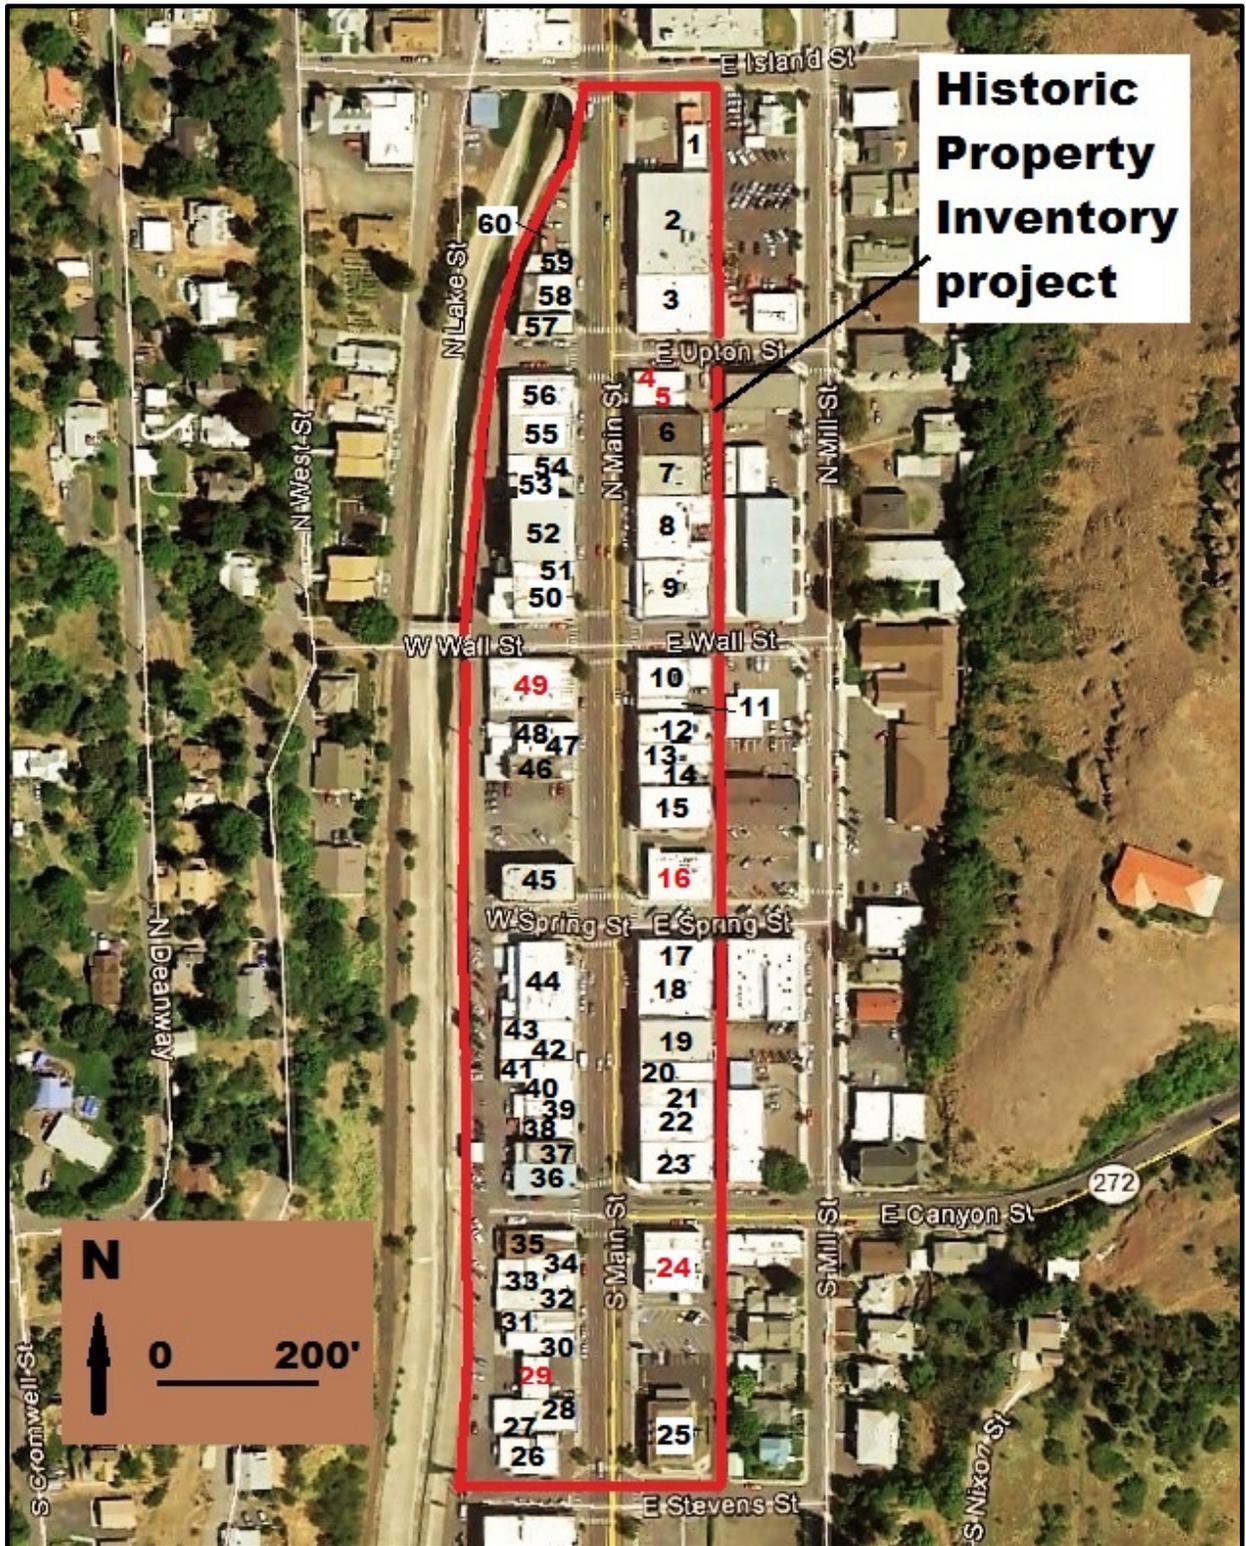
Figure 3. Inventory Area, showing building numbers assigned during the project; buildings 4, 5, 16, 24, 29 and 49 are modern (adapted from Google Earth aerial photograph, 2015).

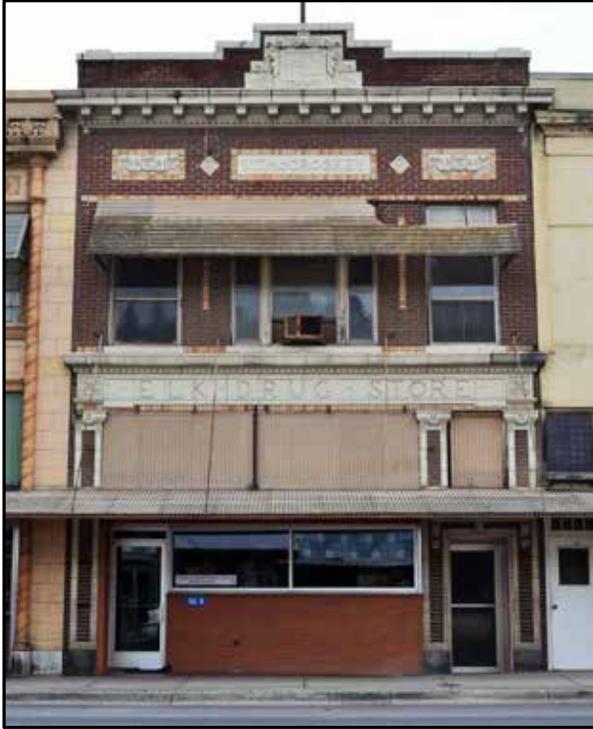
One building in the Inventory Area was constructed as a modest example of the Beaux Arts architectural style (Project Number 13) (Figure 27). This style of architecture was introduced to the United States in the late nineteenth century by American architects who had trained at the esteemed Ecole des Beaux-Arts in Paris. The Beaux Arts architectural tradition advocated formal classical-inspired buildings, embellished with lavish decorative detailing. Typical features of the style include masonry walls usually of light-colored stone; rusticated (accentuated) masonry joints on the first level; wall surfaces with ornate garlands, shields, and floral motifs; elaborate cornices with moldings, dentils, and modillions; classical quoins, pilasters, and columns; and strict symmetry. This style appealed to the wealthy industrial barons of the era, particularly for commercial or public buildings. By approximately 1930, however, economic times had changed and the style passed from fashion.

Figure 27. Beaux Arts style: 116 N. Main Street (Project Number 13), west/front elevation.

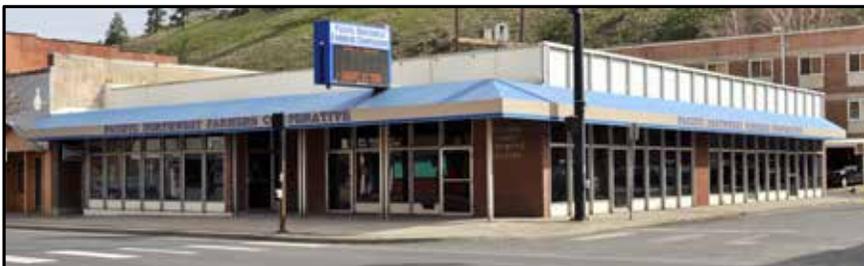
Three buildings in the Inventory Area were constructed in simple variations of the International style, a type of Modernist architecture generally reserved for commercial and public buildings (Project Numbers 25, 29 and 71) (Figure 32). The style is derived from European Modern architecture that arose during the immediate post-World War I period as a backlash against all things traditional, a rejection of the “old order” perceived as the cause of the era’s political instability and social turmoil. Closely allied with socialist causes, European Modernists sought to reduce class disparity by creating a universal architectural style using economical materials such as concrete and steel to create simple, utilitarian structures. In America, however, architects were more attracted by the clean, simple aesthetics of the new style than by its social implications. During the 1950s and 1960s American architects finally embraced Modernism’s fully developed International Style, with its flat-roofed asymmetrical geometric forms featuring smooth unadorned wall surfaces and bands of unembellished windows, and variations of the style remain popular today.

Figure 32. International style: 200, 204, 206 N. Main St., 109 E. Wall St. (Project Number 9), west/front and south sides.

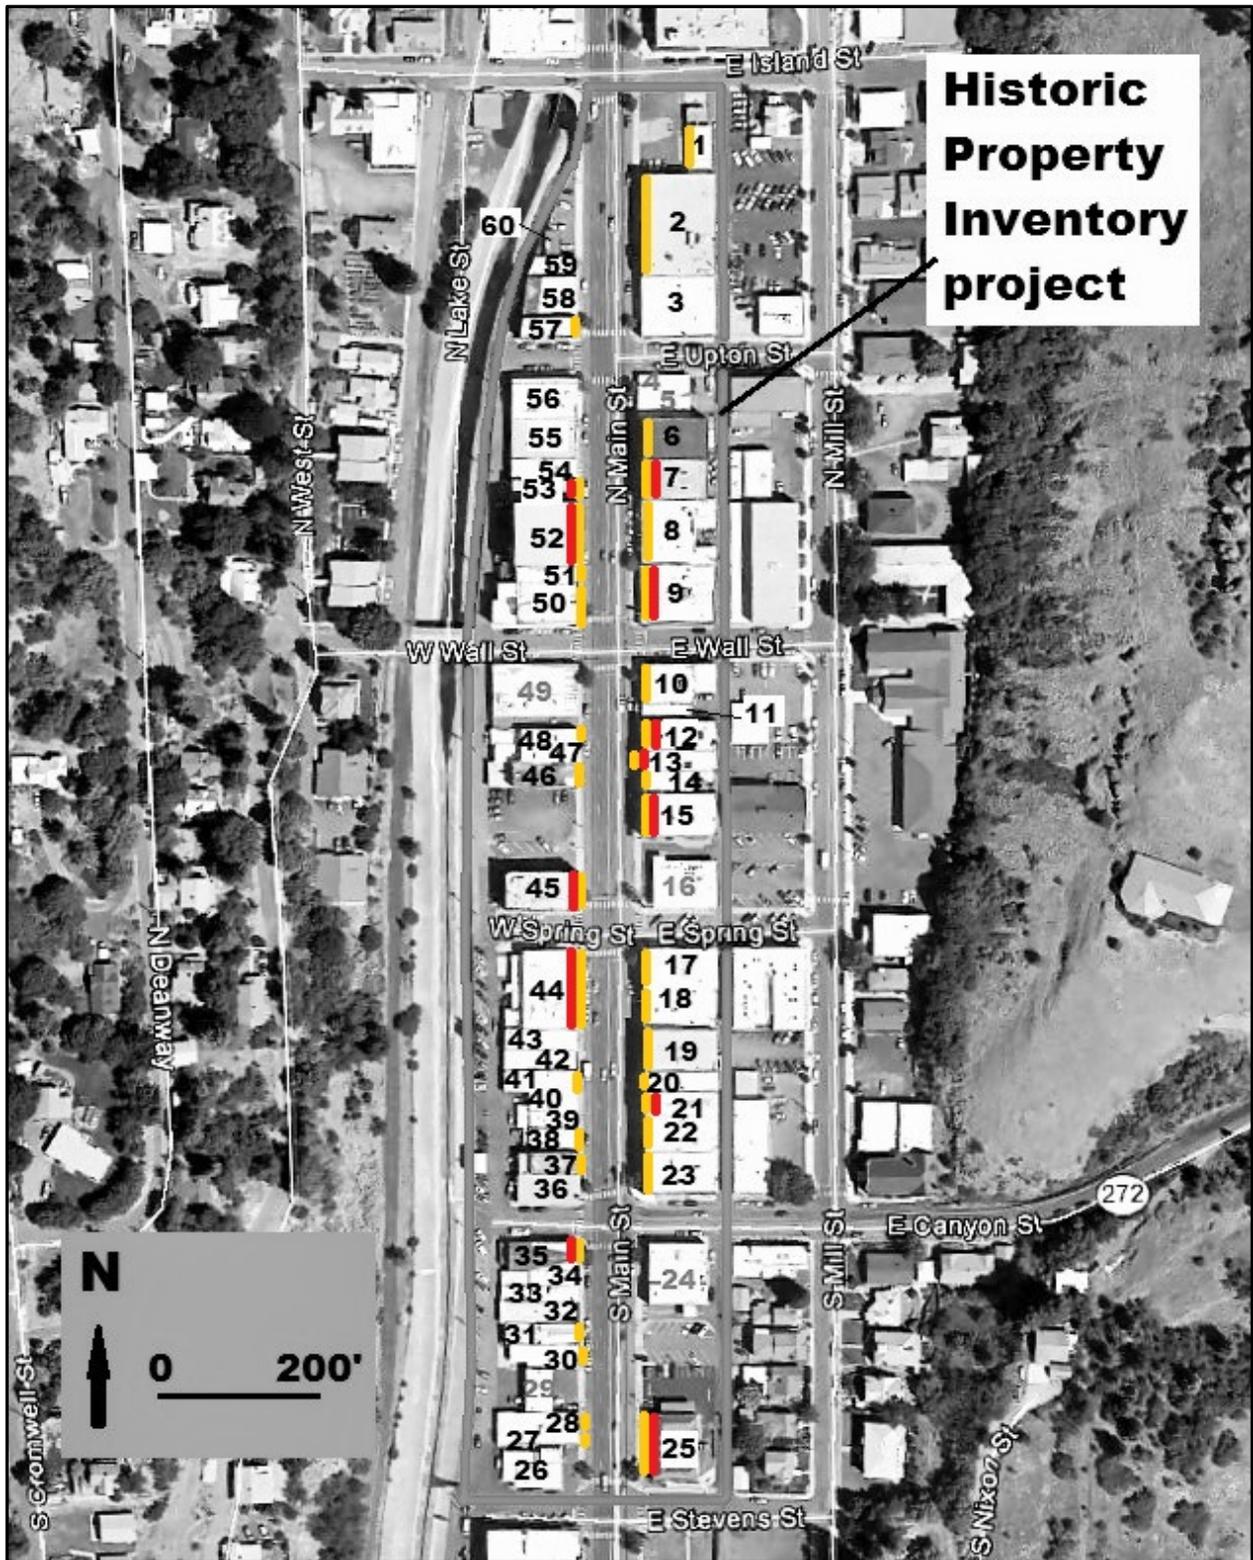
Map showing buildings recommended individually eligible for National Register of Historic Places listing (red) and buildings recommended contributing to a National Register of Historic Places Historic District or individually eligible for Colfax Register of Historic Places listing (yellow).

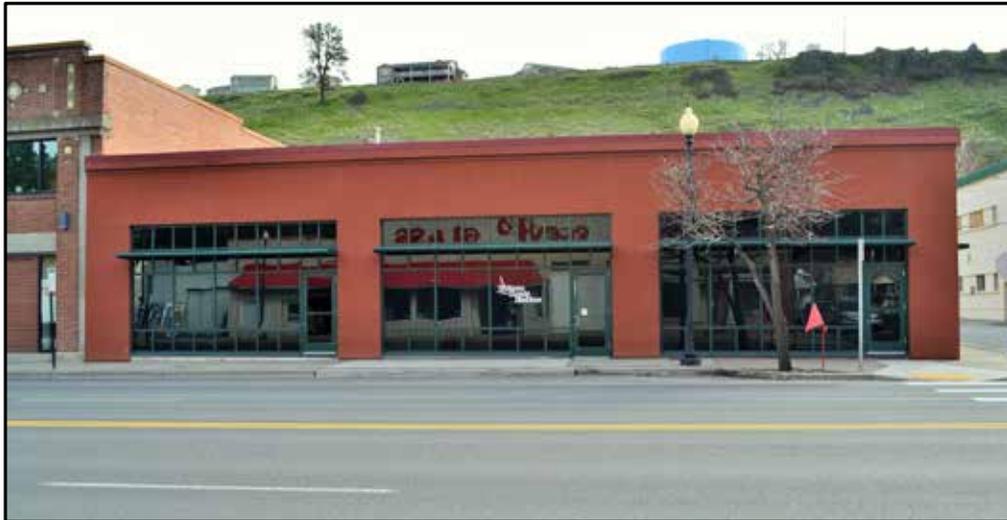
**Project Number 3. 304 N. Main St., 111 E. Upton St.
Whitman County Elections, Palouse Empire Fair; historic Moffatt Warehouse, built 1908**

Figure A-8. Whitman County Elections/Palouse Empire Fair, 304 N. Main St./111 E. Upton St., 2017; view to the east.

Remodeling of the building in the last ten years has resulted in the current Modernist structure. The building rests on a poured concrete foundation, is clad with smooth stucco painted a reddish brown, and features a flat parapet roof. The main façade is symmetrically arranged with three large rectangular banks of modern metal frame windows evenly spaced across the elevation. A single metal frame glass commercial door is incorporated into each window bank. A fourth, slightly smaller modern window bank is situated at the front of the south side. A modern metal louvered canopy extends from the upper part of each window bank, shading the windows below. Four segmentally arched openings, three windows and one door, open asymmetrically into the south wall to the rear of the window bank, with a rectangular vehicle door at the rear. All are now filled with modern metal frame windows or metal doors. Four more segmentally arched openings, three windows and a vehicle door, are asymmetrically arranged across the rear elevation, all also fitted with modern metal frame windows and a metal vehicle door.

The building is therefore recommended not eligible for listing in the National Register of Historic Places, either individually or as an element in a potential NRHP Main Street Historic District, and not individually eligible for listing in the Colfax Register of Historic Places.

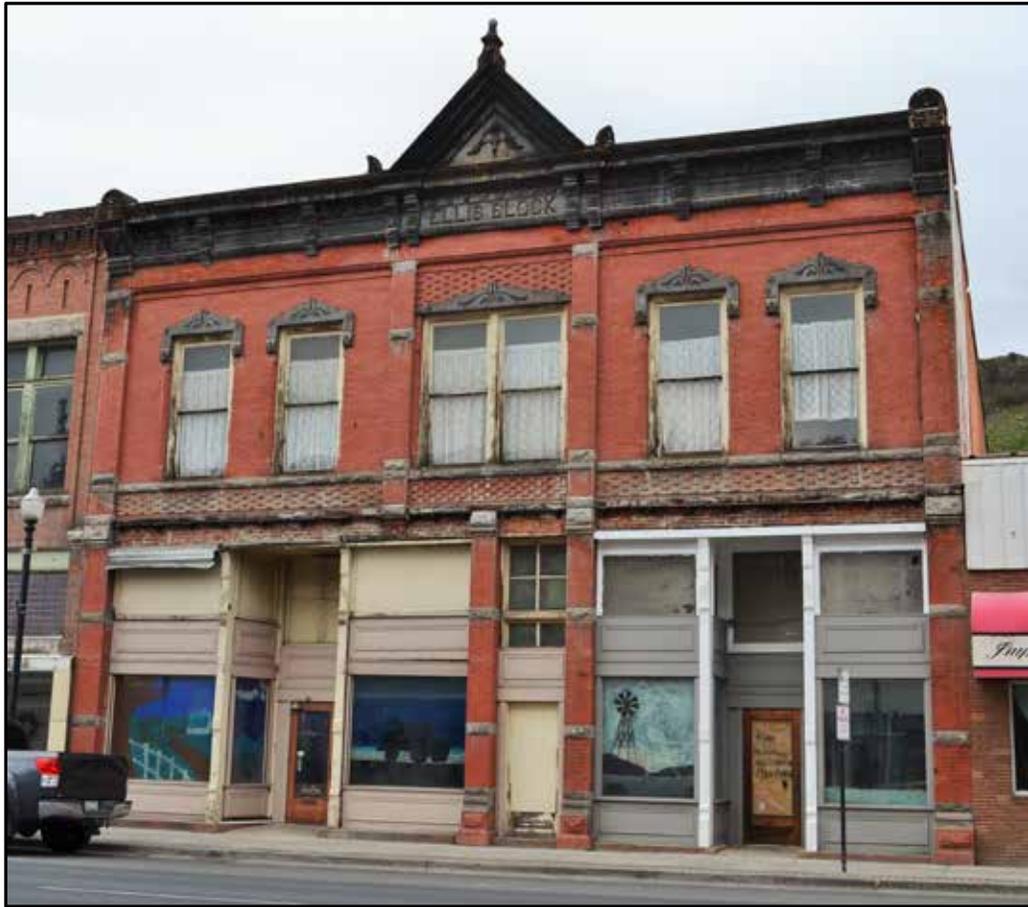
Figure A-14. Historic Ellis Block, 214, 216 N. Main St., 2017; view to the east.

This large rectangular two-story building faces west onto Main Street (U.S. 195) between Upton and Wall streets, one of the many adjoining commercial structures lining Main Street in the Colfax commercial core. The building is structural red brick in a common bond pattern with one header course for every six stretcher courses, while the main façade is veneered with a higher grade of red brick in a running bond pattern. The roof of the building is flat with a flat parapet, slightly stepped on the south side, and the foundation is presumably stone. A broad concrete sidewalk separates the building from the street and a paved alley borders the building on the rear. Although some alteration has occurred, the building retains much of its original form and fabric.

the north angled and the south rectangular—bordered by tall slender classical-inspired cast iron posts, a wood frame commercial door, and a wood sash transom band, now painted over. The narrow central bay contains the stairwell entrance, a modern replacement door with a wood panel transom and a six-light wood sash window at the level of the adjacent transom band. A feature appears to be missing at the junction of the first and second levels, perhaps an original cornice.

Four segmentally arched window openings are visible on the second level of the south wall. The rear elevation has two large round-arched doorways, with replacement doors and portions of the original wood sash transom lights, and several segmentally arched window openings of various sizes, most now filled with concrete blocks.
