National Register of Historic Places Registration Form

historic name **Burrows Island Light Station**

street & number **Far western shore of Burrows Island**

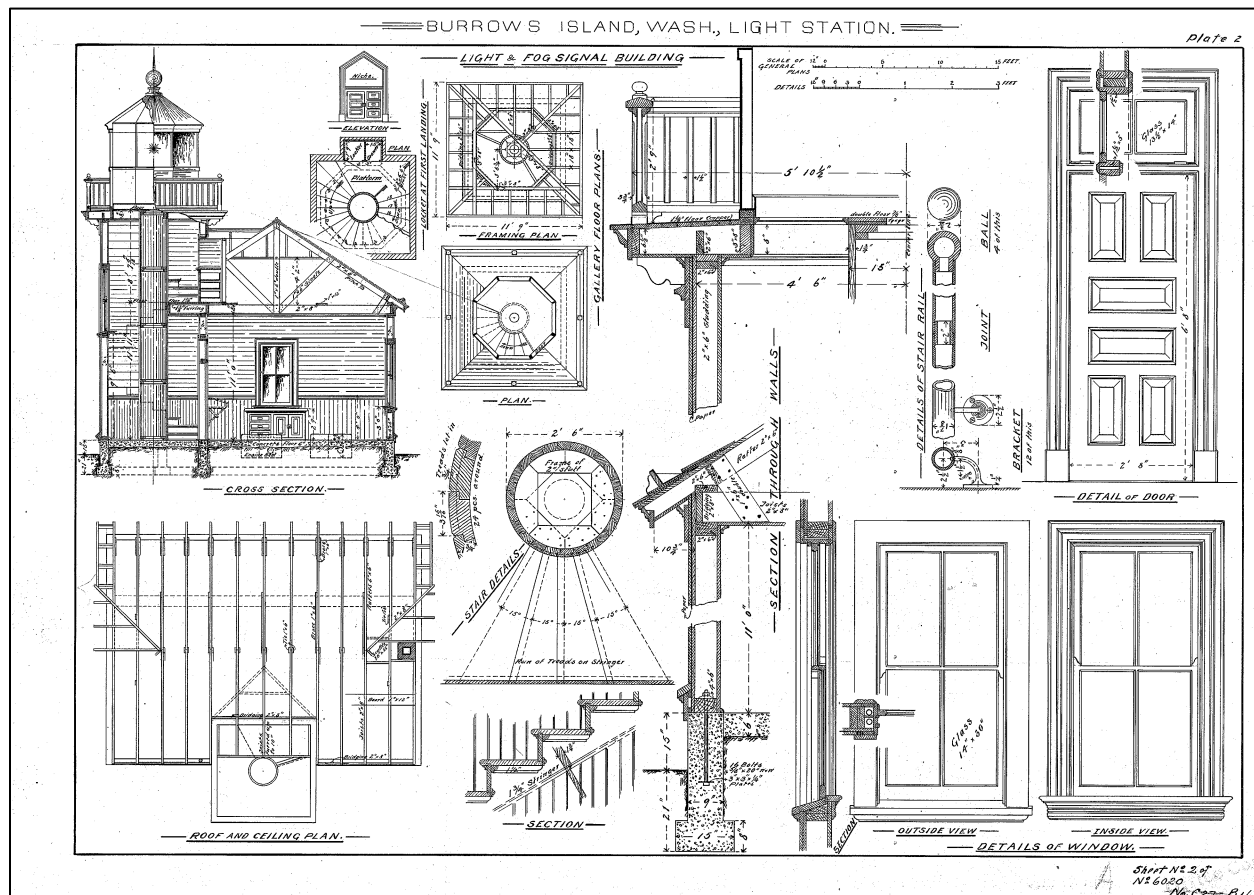
Figure 11 of 42: Architectural drawings by Carl W. Leick of the Light Tower and Fog Signal Building including a cross-section as well as door, window, and stair details, 1905.⁷²

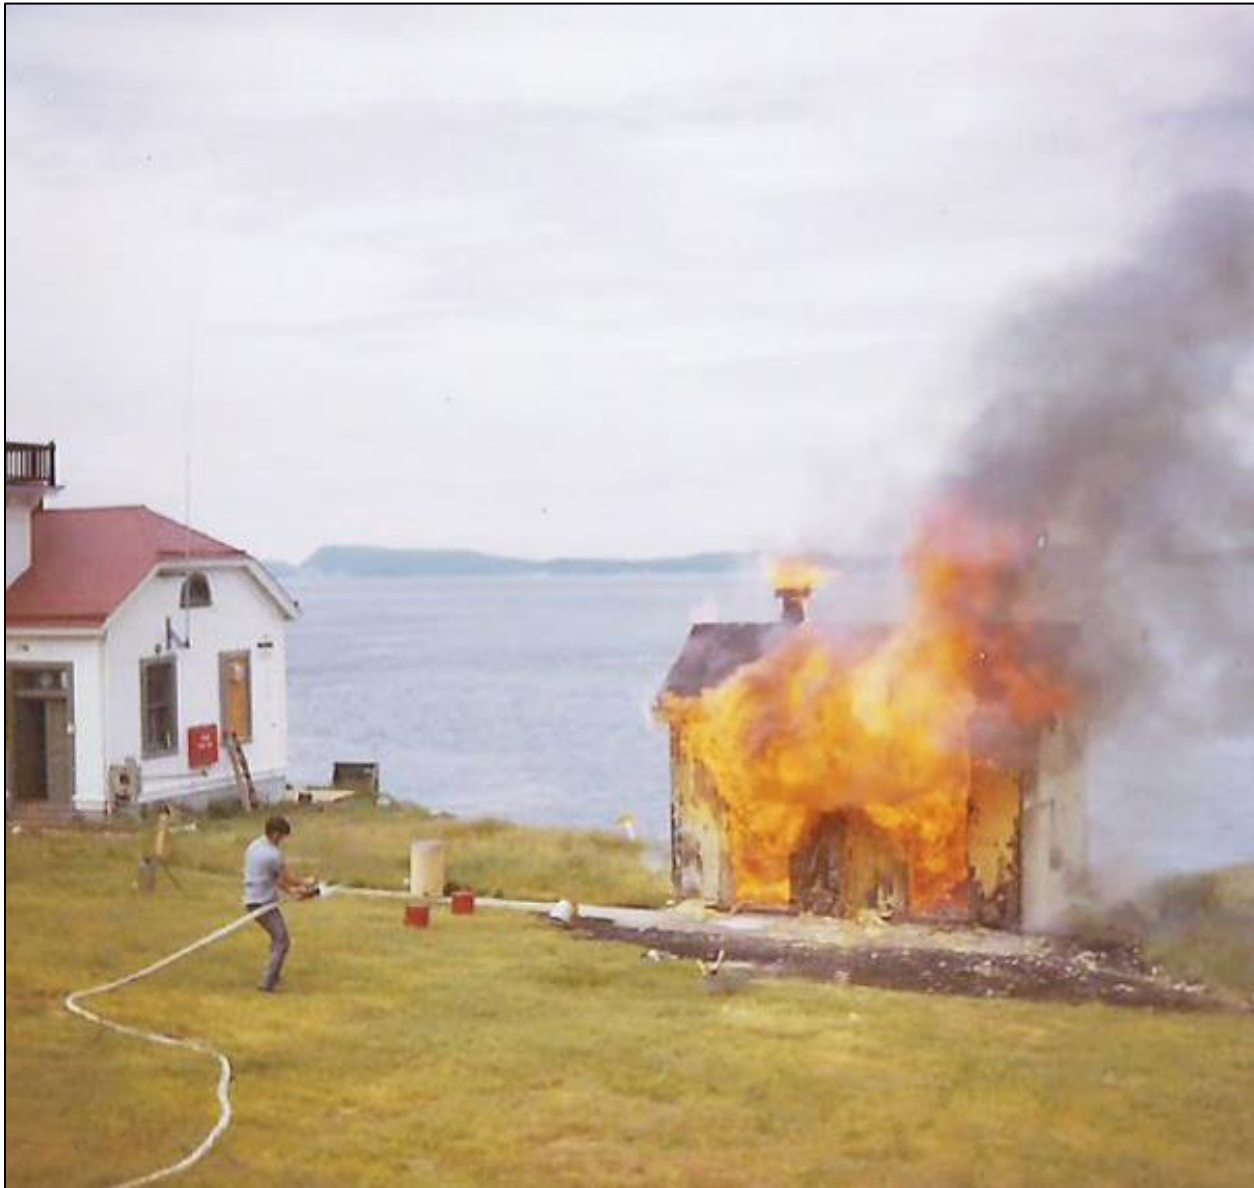
Figure 40 of 42: Burrows Island Light Station, Coal and Oil Storage Building engulfed in flames in 1971.¹⁰¹

The Coal and Oil Storage Building, built in 1906, was destroyed in a fire in 1971; the foundation remains.

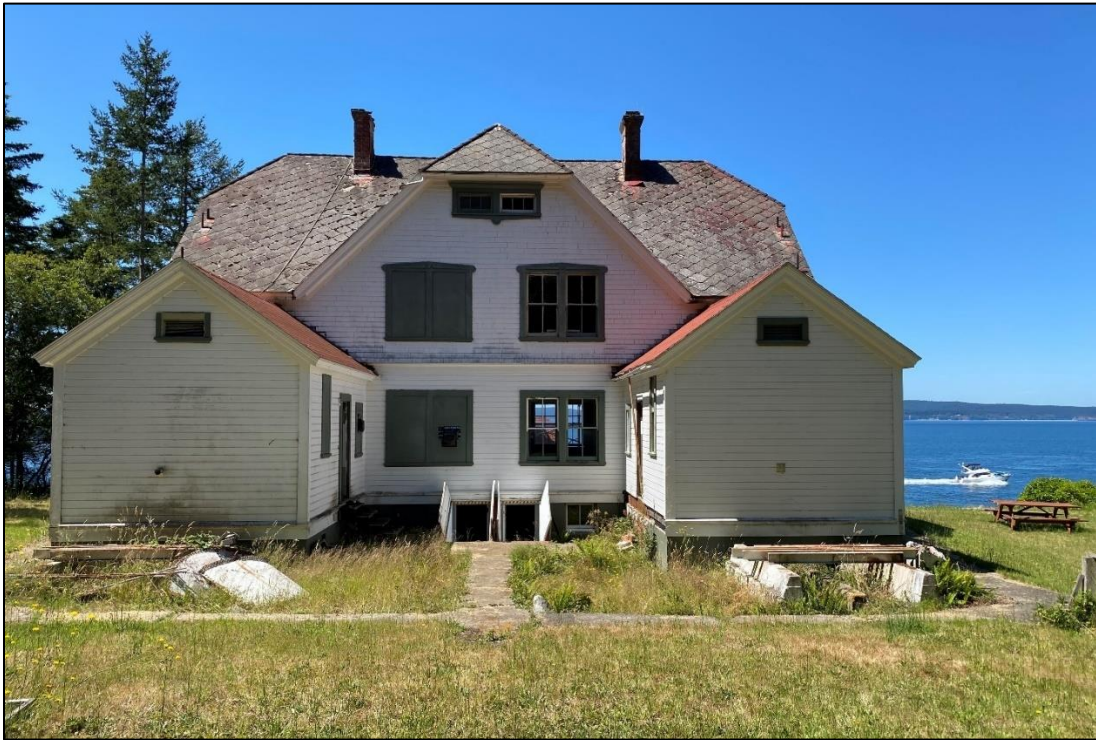
Photo 11 of 46 Keepers' Quarters east elevation; camera facing west.

The rear (east) elevation displays a missing concrete staircase on the north rear wing, facing south, and replaced cellar doors.

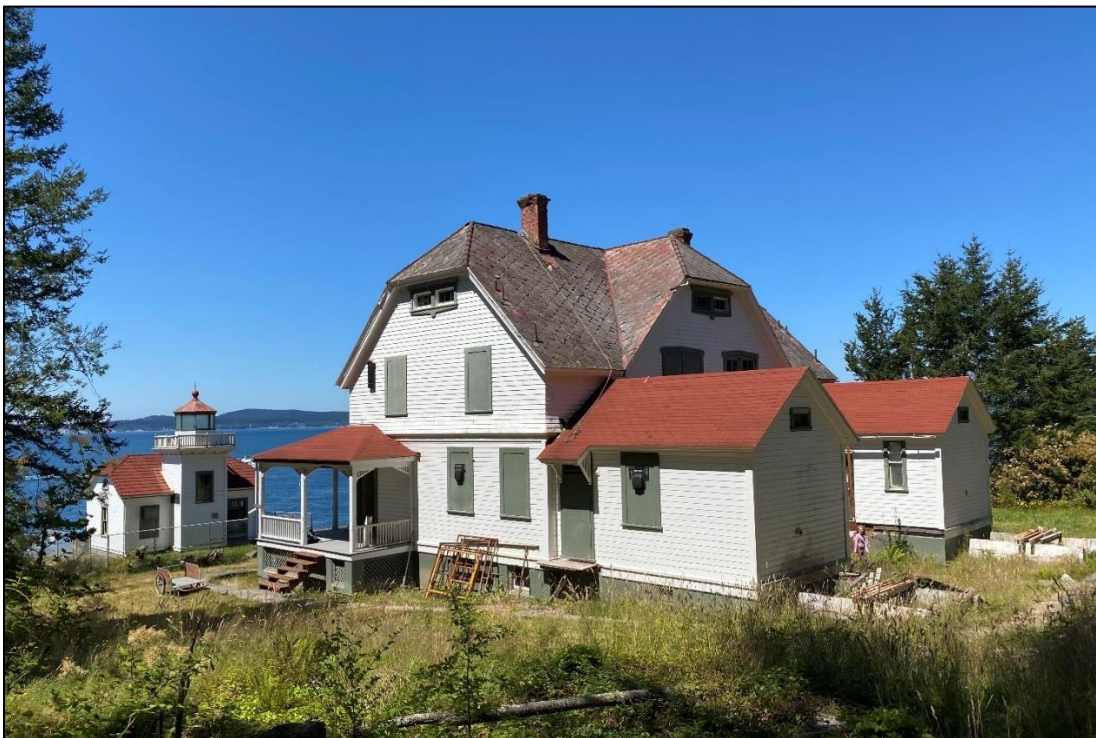
Photo 12 of 46: Keepers' Quarters south and east elevations; Light Tower and Fog Signal Building in the background (left); camera facing northwest.

The south elevation displays a boarded front door and a missing staircase; a modern staircase is installed at the porch entry. Portions of the porch railing are missing.

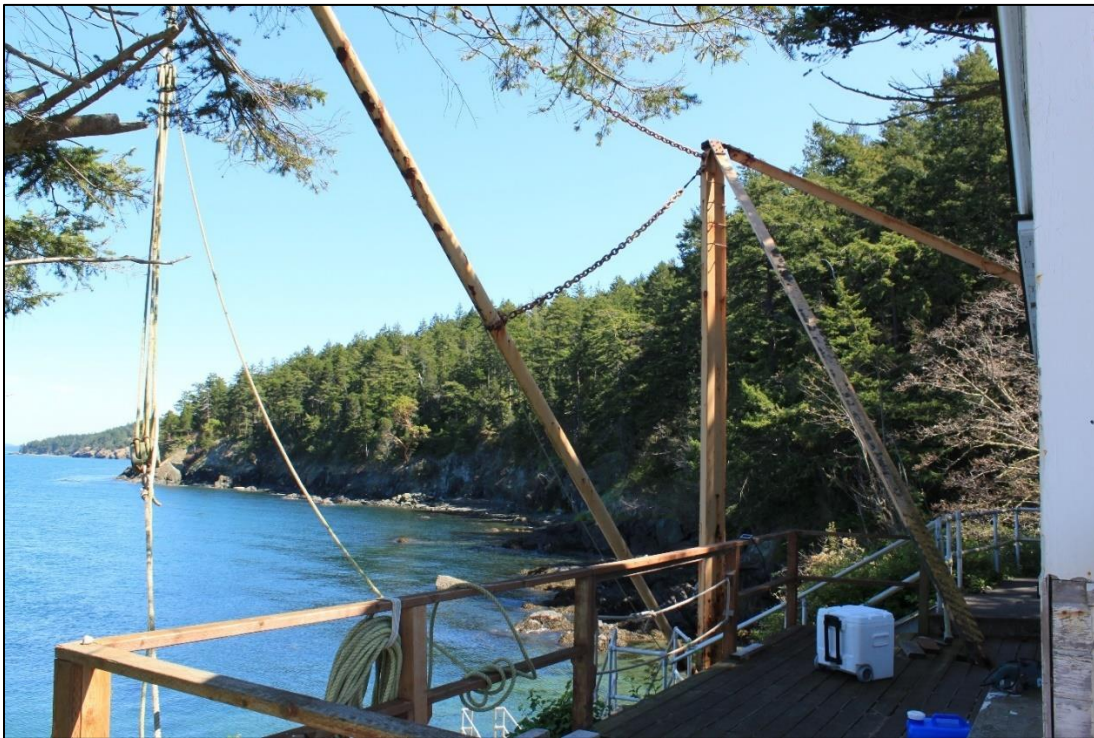
Photo 18 of 46: Derrick viewed from Boathouse deck; camera facing northeast.

that the Derrick was repaired by the NWSS in 2011 with maintenance activities and new ropes to make it functional once again.

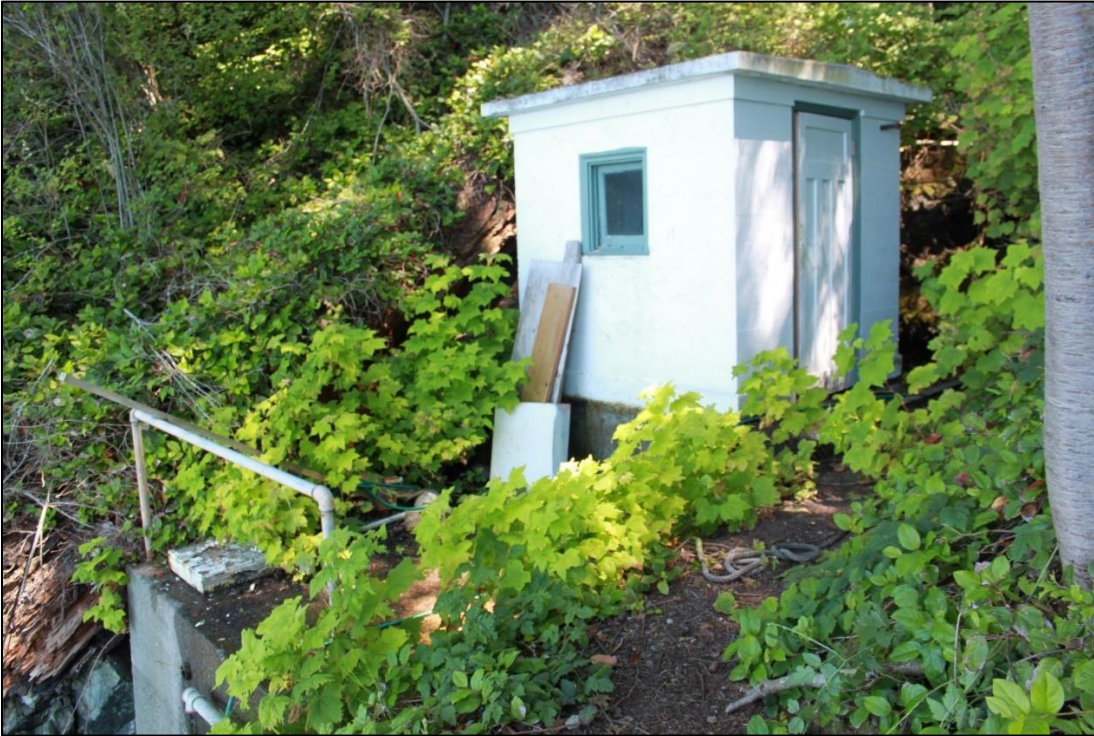
Photo 19 of 46: Pumphouse with cistern; camera facing northeast.

Built circa 1958, the Pumphouse is a single-story one-room concrete structure located on the west face of Burrows Island. Accessed by an earthen path northeast of the Boathouse, the building was constructed to house a spring pump and cistern that originally supplied water to the Burrows Island Light Station. The Pumphouse has a board-formed concrete foundation and a square plan, measuring 7 feet by 7 feet. The Pumphouse faces west, and a concrete pad with a metal pipe handrail borders the building on the western façade. The building is made of board-formed concrete with a roughly 3-foot-tall, board-formed concrete foundation. The building has a flat roof with a minimal overhang and a simple concrete cornice. The building is Utilitarian in design, void of any ornamentation. It is accessed by two concrete steps leading from the concrete pad on the western façade. The west façade has one centered square single-pane wood window. The north elevation is void of ornamentation. The east elevation is flush with the surrounding hillside and has one metal pipe protruding from the top center of the wall. The south elevation features a wood-paneled door. A single metal pipe protrudes from the southeastern corner of the southern elevation.

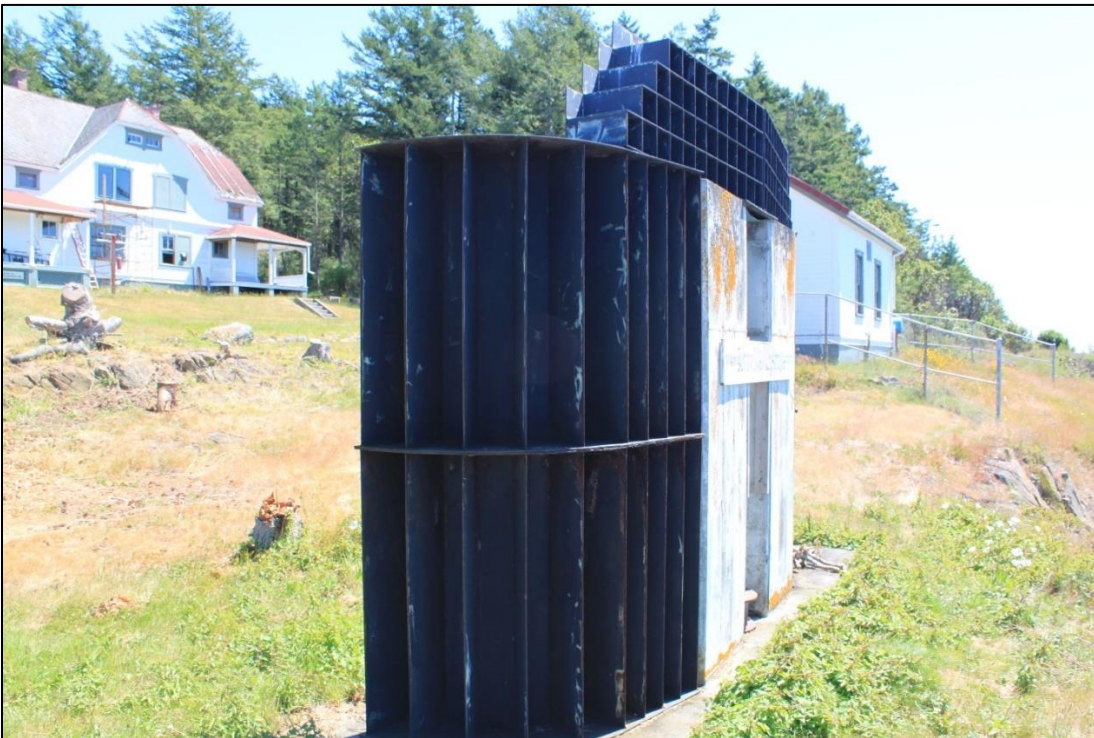
Photo 20 of 46: Foghorn sound baffle; Keepers' Quarters (left) and Light Tower and Fog Signal Building (right) in background; camera facing southeast.

Built circa 2000, the concrete and sheet metal foghorn sound baffle is north of the Light Station and Fog Building near the western edge of the lawn. The structure has a poured concrete foundation and consists of a concrete vertical base at the center flanked by fan-shaped curved metal baffles and topped with gridded metal baffles to muffle the noise emitted from the light station's foghorn. The foghorn, now removed, would have been installed on a base in a center alcove within the structure facing the water. A small horizontal wood sign with website information is attached to the structure facing the water.

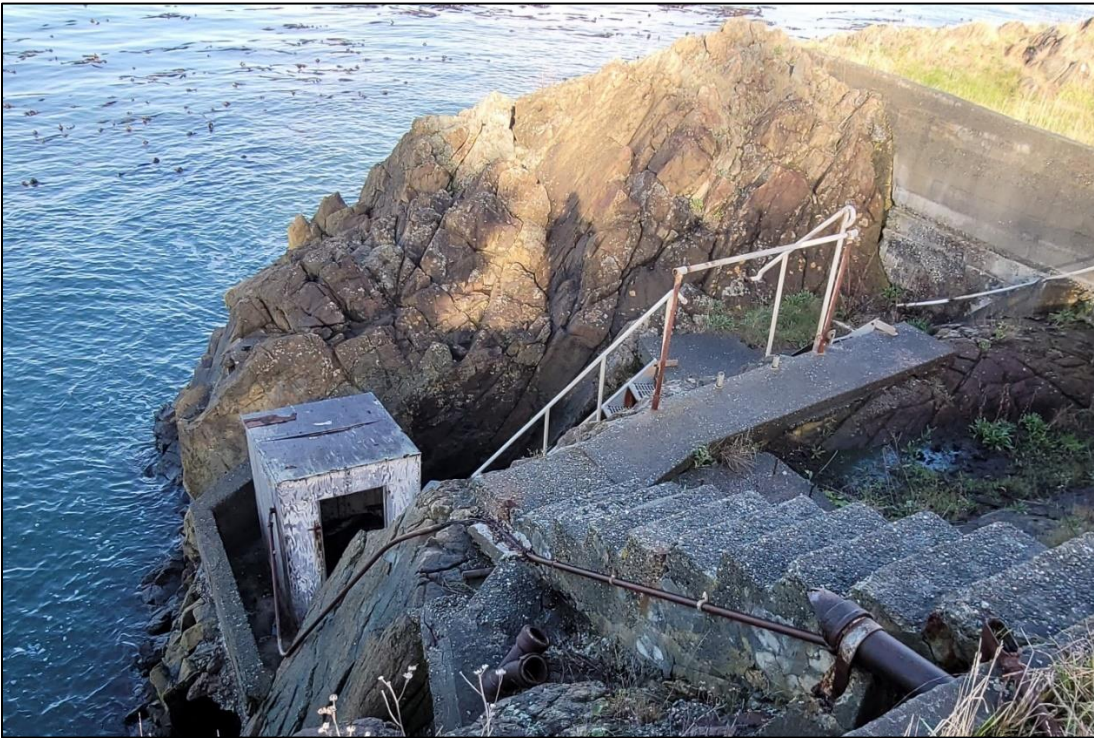
Photo 21 of 46: Saltwater intake; camera facing northwest.

The Saltwater Intake is located northwest of the Light Station and Fog Building along the rocky coastline near sea level. The intake structure, originally constructed between 1958 and 1961, has a concrete landing enclosed by a short concrete wall on the south side and is accessed by a set of concrete and modern steel-framed stairs. Remnants of metal piping in a variety of dimensions are visible along the concrete stairway and attached to the replacement pumphouse.

A review of historical drawings and photographs of the Saltwater Intake indicate it originally featured a concrete pumphouse which was demolished sometime after 1977. It was replaced by the extant plywood-framed intake structure at an unknown date. Although the concrete stairs to the pumphouse remain largely intact, new metal stairs with railings have been added, and the piping and other supporting utility elements appear to be only partially intact.

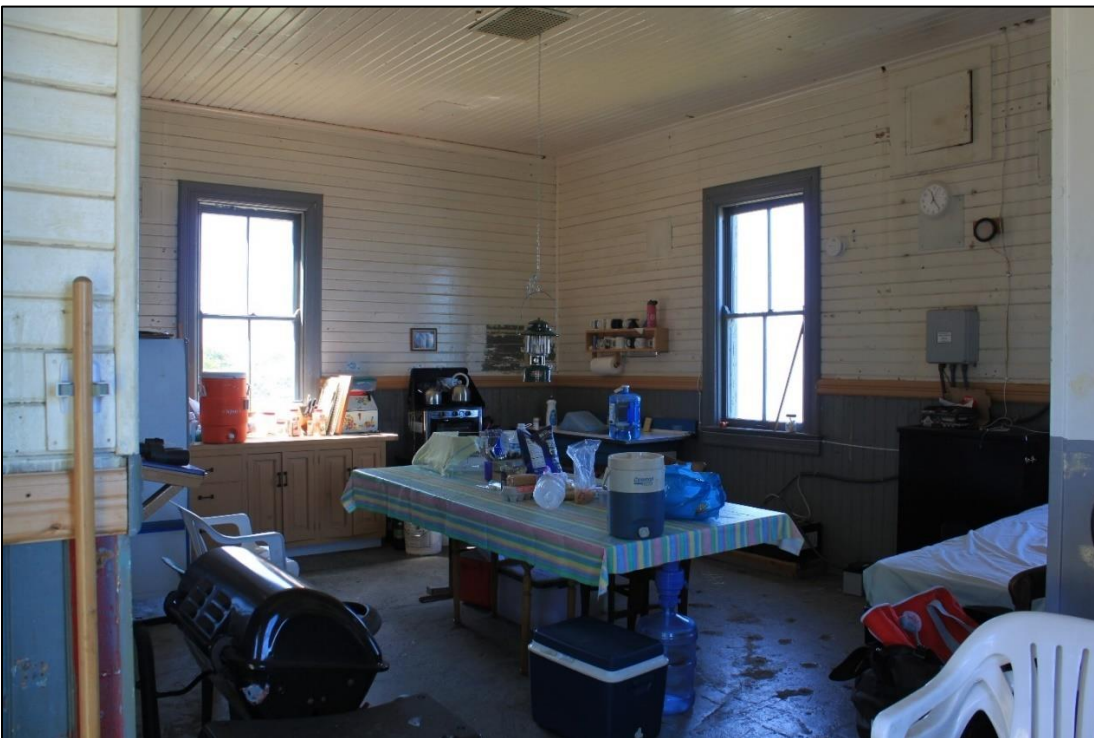
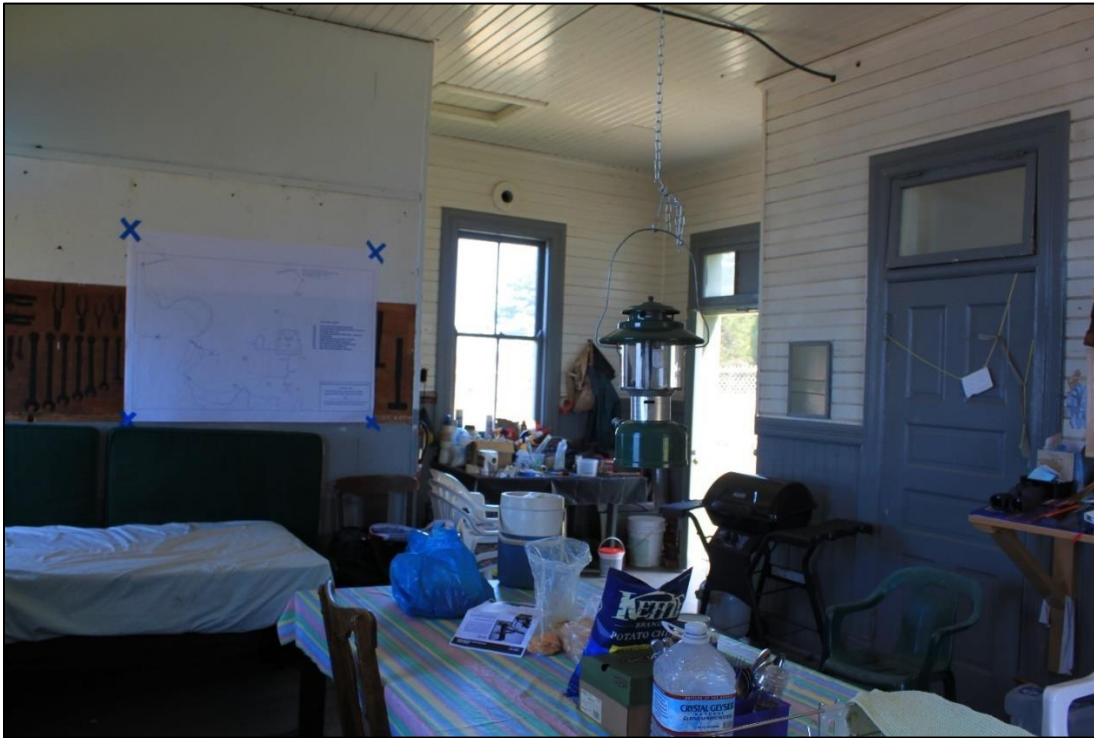
Photo 22 of 46: Light Tower and Fog Signal Building engine room.

Photo 23 of 46: Light Tower and Fog Signal Building engine room.

On the interior, alterations include the addition of a battery room in the northwest corner of the engine room. Architectural drawings suggest that the battery room was added in 1971, likely in anticipation of the building's transition to an automated aid to navigation in 1972. The engine equipment once housed within the building was removed at an unknown date, and the 4th-order Fresnel lens was replaced in 1972 (it is now on display at USCG Air Station Port Angeles in Port Angeles, WA). Despite these alterations, the building appears to retain its original flooring, wall finishes, fenestration, and wood millwork.

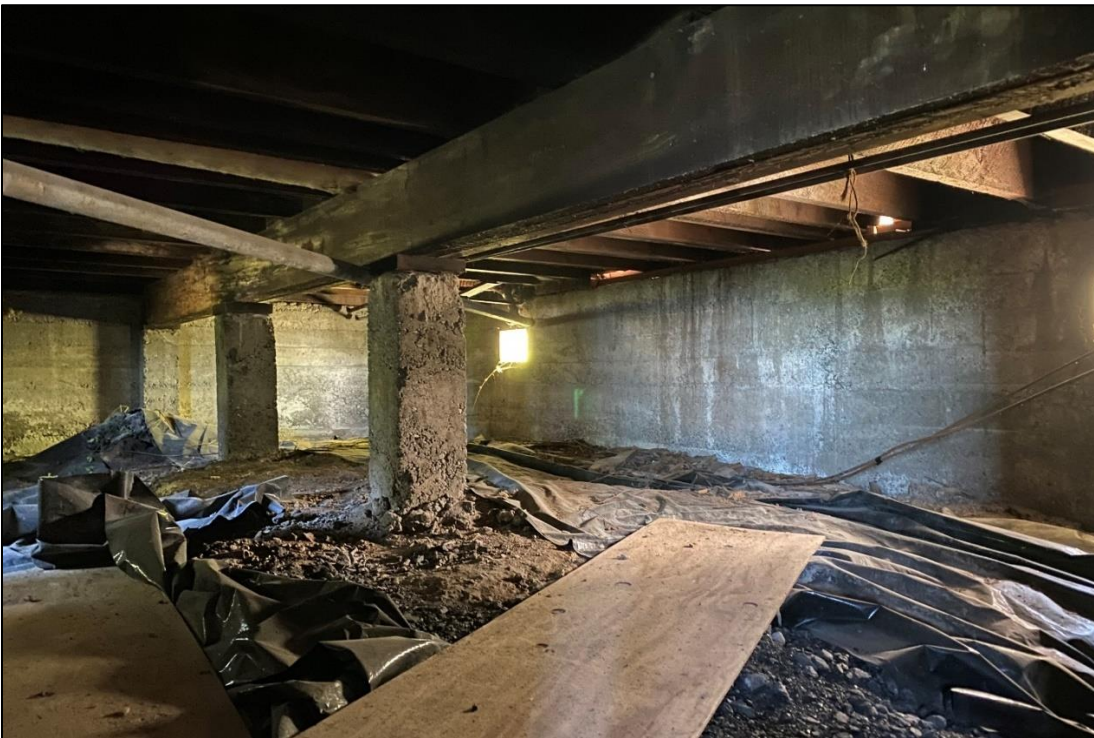
Photo 26 of 46: Keepers' Quarters crawl space under north unit showing square concrete posts that support the rear wing extensions.

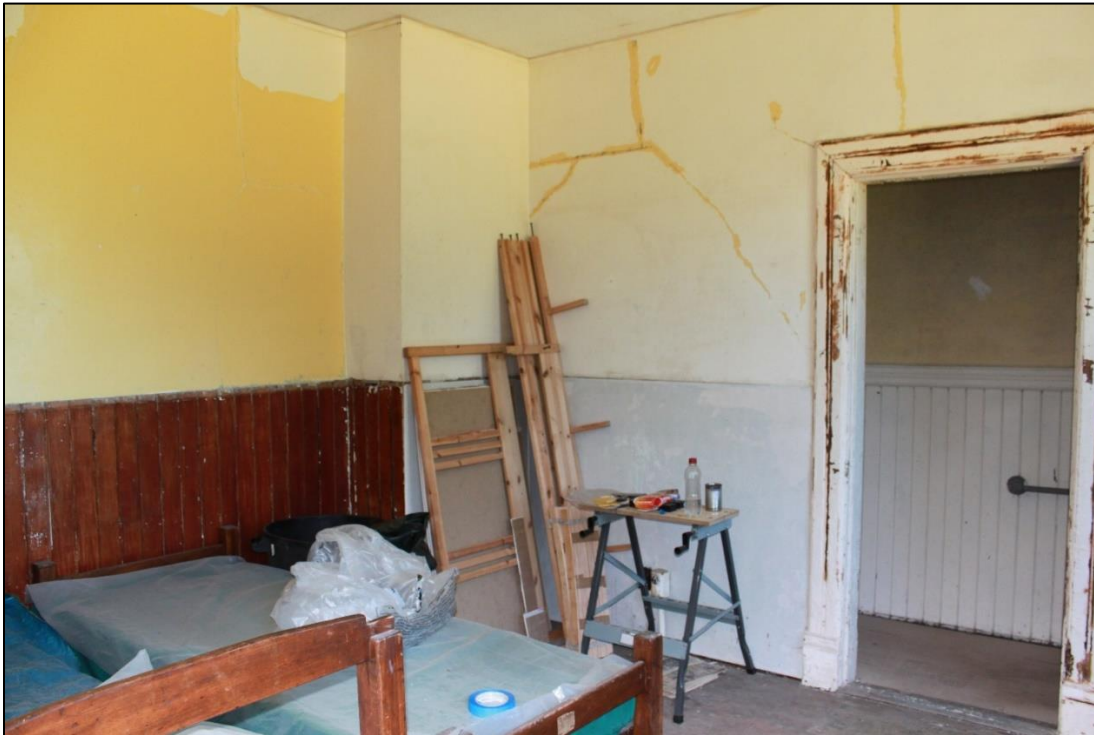
Photo 31 of 46: Keepers' Quarters north unit entry hall showing in-progress restoration work and retained plaster, flooring, and door surround.

The Keepers' Quarters is currently undergoing an extensive restoration project managed by the Northwest Schooner Society (NWSS) that includes a complete overhaul of all interior finishes and repairs to windows, doors, and porches. Restoration work is underway in the north residential unit with less focus presently in the south unit. The NWSS is coordinating its restoration efforts with the Washington Department of Archaeology and Historic Preservation (DAHP) for guidance on following the Secretary of the Interior's Standards.

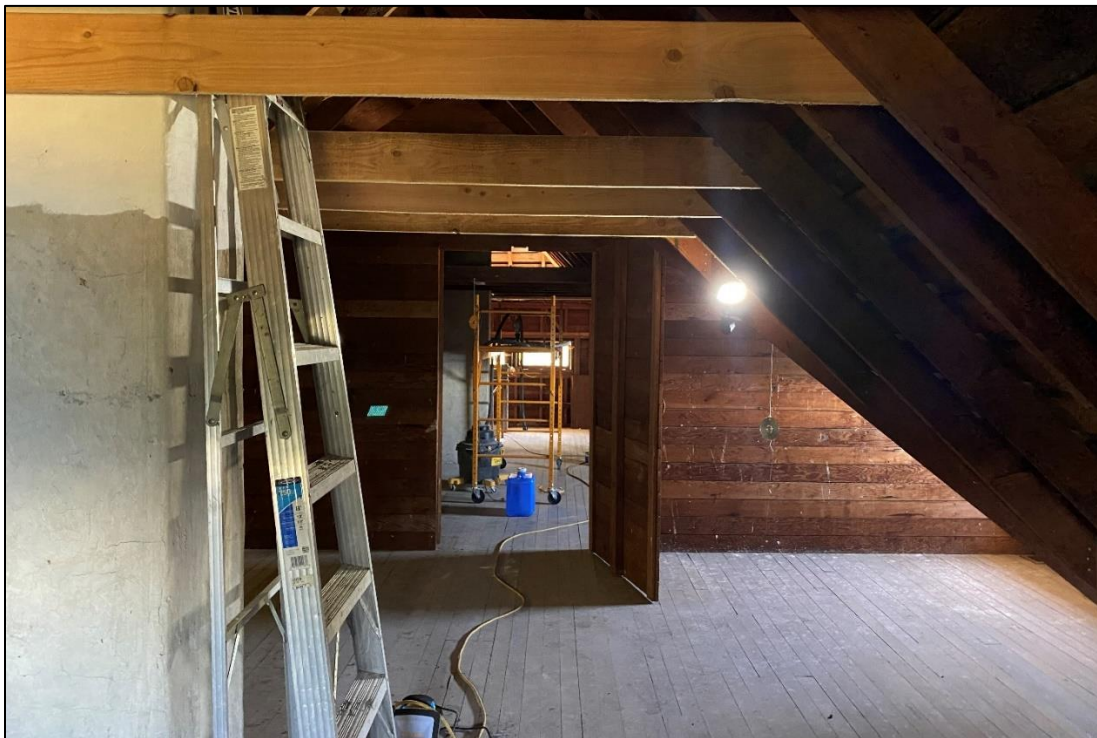
Photo 44 of 46: Keepers' Quarters attic, view from north unit looking into south unit.

The attic is accessed via a wood staircase from the second-floor hall. The attic extends the full width of the duplex and is divided by a rustic wood-framed wall with a simple, wood plank door. The room features original wood floors and exposed beams and rafters. The interior structures of two chimneys—one centrally placed in each residence—is visible within the attic but not on any of the other stories.
