HISTORIC THEATRES

STATEWIDE SURVEY AND PHYSICAL NEEDS ASSESSMENT

This report commissioned by the Washington state Department of Archaeology and Historic Preservation.

Published June 30, 2008

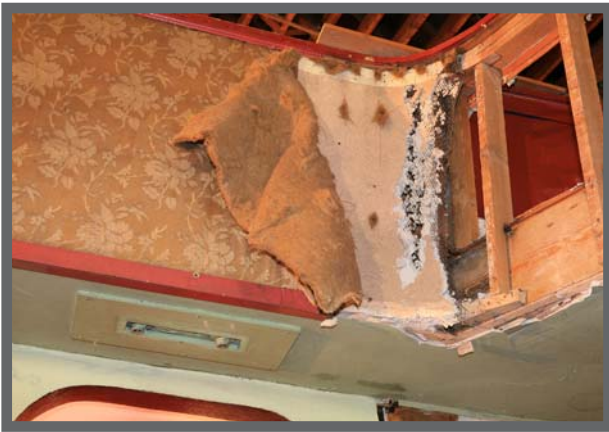
Detail of silk covered sound baffling which has deteriorated from moisture and coal dust saturation over many years. Source: Artifacts Consulting, Inc. 2008.

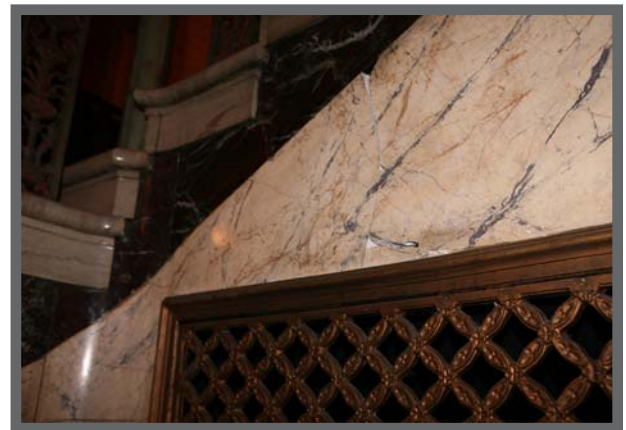
Detail of broken stone veneer lining a stairwell. Source: Artifacts Consulting, Inc. 2008.

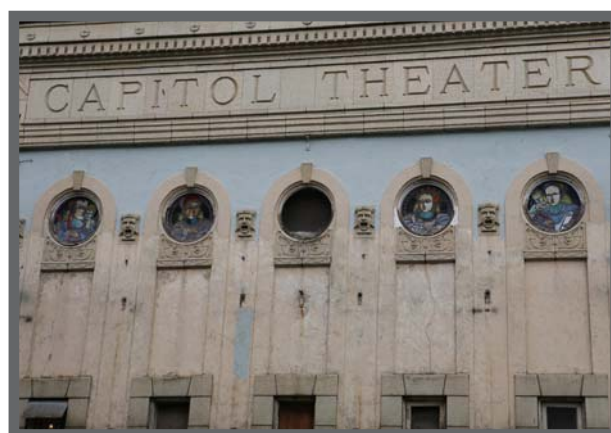
Facade detail showing missing stained glass window, damaged stucco. Source: Artifacts Consulting, Inc. 2008.

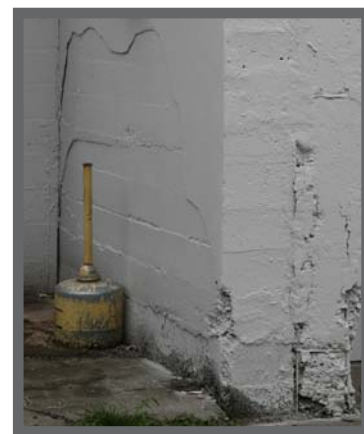
Example of shallow rebar, too large aggregate in early concrete work. Source: Artifacts Consulting, Inc. 2008.

Structural design defects occurred where the reinforcing steel is close to the surface of the exterior concrete wall. Corrosion of the reinforcing steel can occur and cause jacking (expansion of the steel), thus spalling the concrete surface covering. Another problem is the old steel fasteners left in the concrete walls. Over time, they have often corroded and jacked, thus causing sections of concrete to deteriorate. Water infiltration into a wall can also cause pieces of the concrete to be dislodged (spalling) when it freezes and expands. In order to prevent water infiltration, some of the buildings with exposed concrete were painted with vapor-proof paints or sealants. These paints often trap moisture behind the surface and cause further spalling.

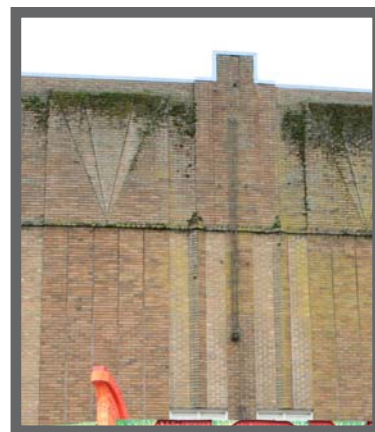
Detail of a mossy, exterior brick wall in need of cleaning/repointing.. Source: Artifacts Consulting, Inc. 2008.

The brick found in this survey can be divided into two types and uses. The first type is utilitarian, used as structure and infill. The second type is decorative, used as exterior cladding. Utilitarian brick is usually of a lesser quality than brick used for cladding. Fired at a lower temperature and consequently softer, utilitarian brick was often acquired from a local manufacturer and quality could vary greatly. Exterior brick, such as that used for cladding, was fired at a higher temperature. Often the surface is glazed or scored. In some cases, it was imported from manufacturers outside the region because of the decorative quality. The quality of both types of brick has been good for the most part. Failure is often not with the brick itself but with the mortar joints if repointing has been deferred for too many years.

Failing mortar joints have an increased potential to allow water into the wall behind. Where the walls are concrete with a brick veneer, this is a stabilization issue as metal ties that secure the brick to the concrete have often corroded. In those cases, the ties no longer function to hold the brick in place. Another form of failure is the location of fasteners in the brick rather than in the mortar joints. Often, these old fasteners were never removed once they became unnecessary. Many have begun to rust, and, with resultant water-borne corrosion “bleeding” down the face of the brick wall. At the worst, they are beginning to jack the brick surrounding them. In some cases, brick has been covered with a bituminous paint in an attempt to prevent water infiltration. This has done little and now presents additional work when repairing and repointing the brick. Finally, cases of spalling were discovered, but this was primarily on the softer brick used on the sides or backs of buildings. Most of the spalling to the decorative brick is at the pedestrian level where it was damaged, thus allowing water behind the glazed surface.

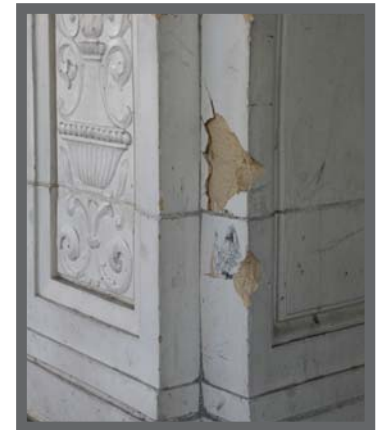
Detail of damaged terra cotta. Source: Artifacts Consulting, Inc. 2008.

Terra cotta was possibly the most consistent masonry product of that era. It was manufactured by only a few regional companies that had perfected the process and quality. The greatest problems found in the terra cotta facades originate either from water infiltration in mortar joints (most often in the skyward facing joints) or where the glazed surface has been damaged. Water infiltration behind the glazed surface is leading to spalling. Water infiltration into the skyward facing joints corrodes the steel hangers that attach the terra cotta to the building structure, eventually resulting in the terra cotta dislodging from the building. Many of the buildings with terra cotta cladding and ornament have had various metal fasteners installed through the terra cotta. In many cases, this has been done with no thought given to properly locating the fasteners or to removing the fasteners and patching the holes once the fasteners are no longer necessary. Consequently, metal fasteners have begun to rust and “bleed” down the face of the terra cotta. In the worst examples, the fasteners are beginning to jack out the terra cotta surrounding them. Another problem found during the survey

is damage to terra cotta cladding at the pedestrian level, where it is typically broken on the edges or corners. Broken surfaces allow water to penetrate the clay and deteriorate the terra cotta.

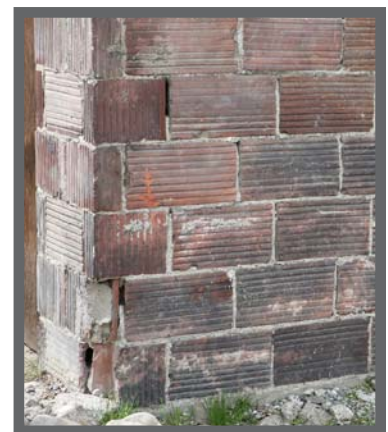
Detail of a hollow clay tile exterior clad wall. Source: Artifacts Consulting, Inc. 2008.

Hollow clay tile is the most utilitarian masonry used in the buildings of the era and often used as an inexpensive infill material between structural elements. It was recorded on the exterior of several theaters but more commonly used for interior walls. Generally, theaters used hollow clay tile where fireproofing was required, such as walls to divide projection rooms from the auditorium. It is relatively fragile and difficult to repoint, but it holds up well when treated carefully. Some limited damage was noted where the tiles were struck with equipment or impacted by earthquakes.

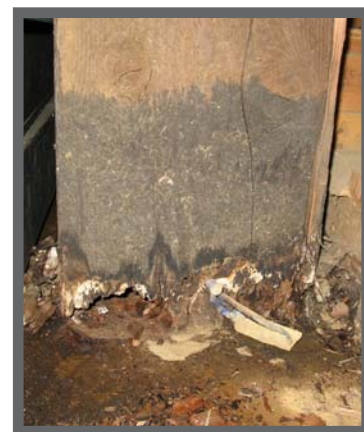
This survey had a certain limitation—time. Making a full determination on the condition of structures requires an in-depth survey in cooperation with a structural engineer. From the brief survey visits, the great majority of structural systems encountered appear to be in good condition. During the survey, the following causes of deterioration were investigated: water infiltration (usually from roofs); infestation of animals or insects; and, stress caused by settlement or earthquakes. Water infiltration was the most common problem, usually because the roofing was or had been in poor repair. Enclosed space allows mold and rot to occur, but these problems appear to exist in only one of the wood frame buildings. Animals can be difficult to control, and there was often evidence of rats, bats, and birds in the buildings. However, these types of animals, all of which most often inhabit attics or basements, have caused only minor damage compared to that done by insects, such as termites. The wooden footings of one building in particular have become compromised because of termites. Little seismic damage was noted, and a few composite structures have been seismically reinforced.

Deteriorated wood post. Source: Artifacts Consulting, Inc. 2008.

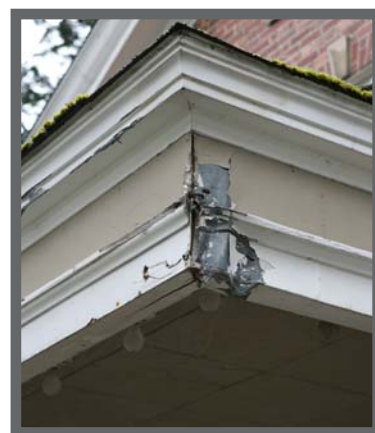
Damaged metal entrance canopy. Source: Artifacts Consulting, Inc. 2008.

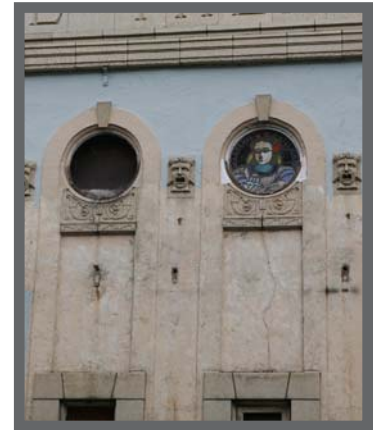
Missing stained glass. Source: Artifacts Consulting, Inc. 2008.

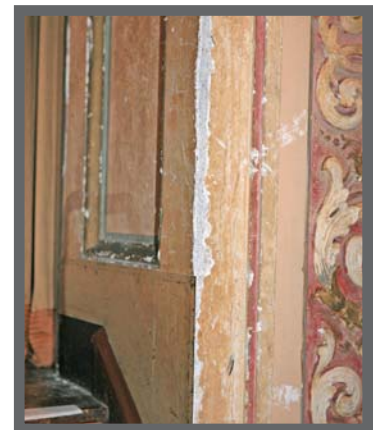
Damaged proscenium arch plaster. Source: Artifacts Consulting, Inc. 2008.

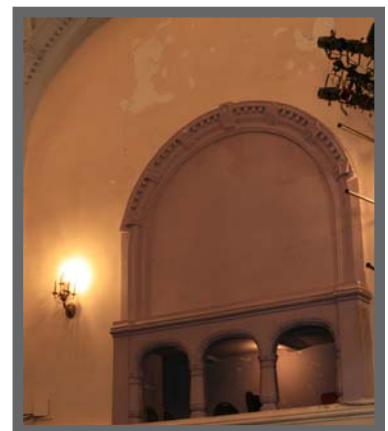
Peeling interior paint. Source: Artifacts Consulting, Inc. 2008.

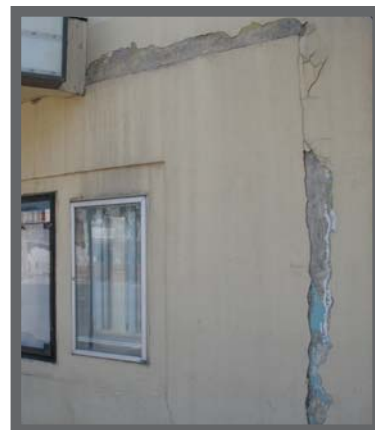
Stucco needing repair. Source: Artifacts Consulting, Inc. 2008.

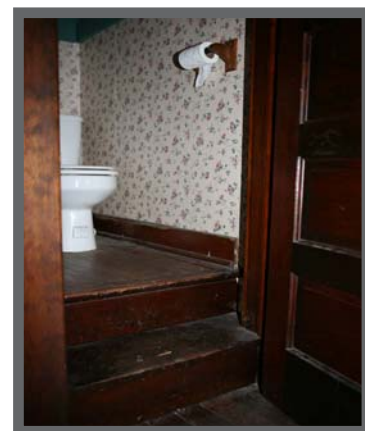
Non-ADA compliant restroom. Source: Artifacts Consulting, Inc. 2008.

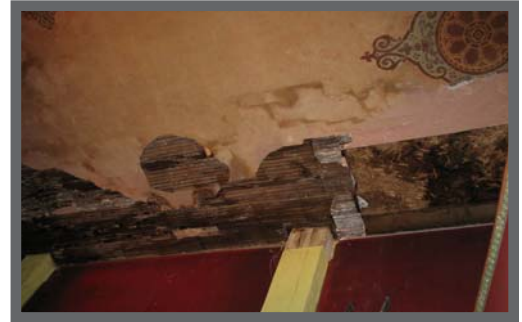
Stabilization of interior plaster ceiling needed. Source: Artifacts Consulting, Inc. 2008.

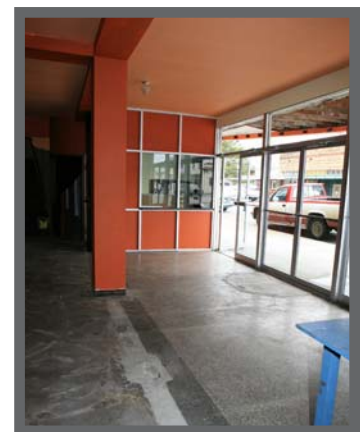
Example of a lobby which was expanded in the past; note change from concrete to terrazzo floor, shadow of former ticket booth near modern glass doors. Source: Artifacts Consulting, Inc. 2008.

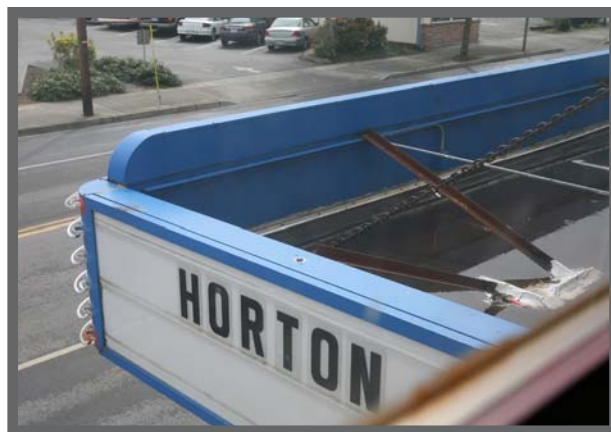
Detail of a canopy marquee with standing water. Source: Artifacts Consulting, Inc. 2008.

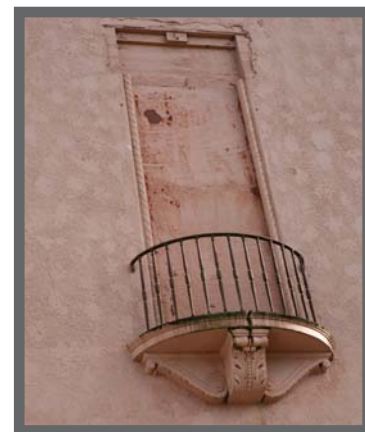
Restoration of various facade elements needed (missing shed roof, rusting metal rail, boarded over windows). Source: Artifacts Consulting, Inc. 2008.

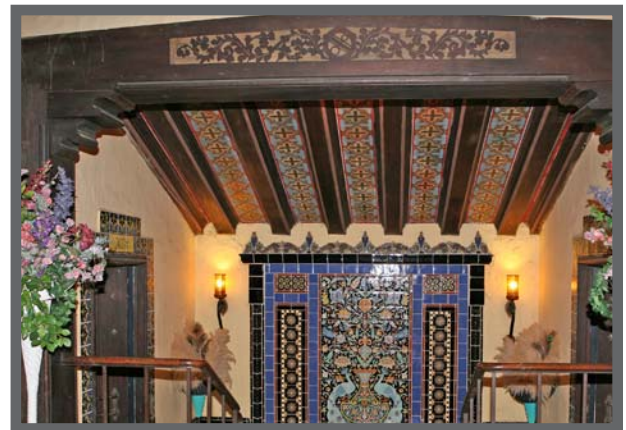
This ornate lobby fountain could operate again with restoration assistance. Source: Artifacts Consulting, Inc. 2008.

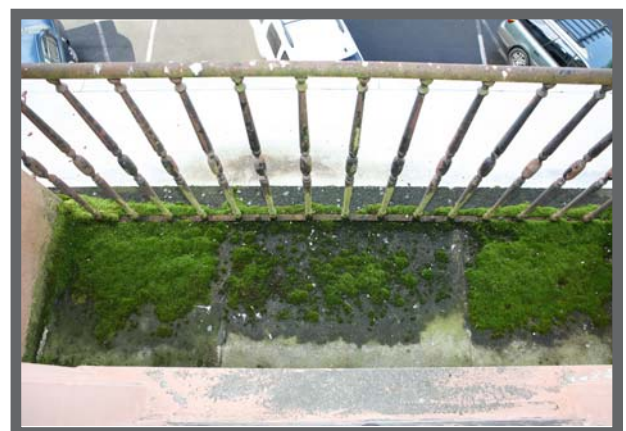
Looking down at an exterior balcony covered in moss. Source: Artifacts Consulting, Inc. 2008.

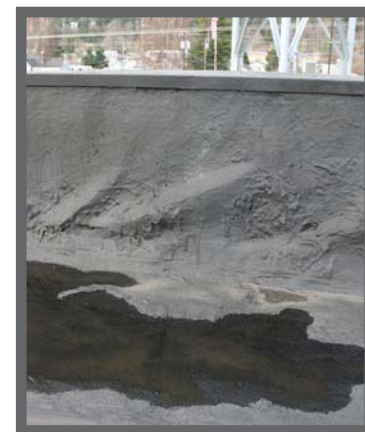
Roofing with holes and pools. Source: Artifacts Consulting, Inc. 2008.

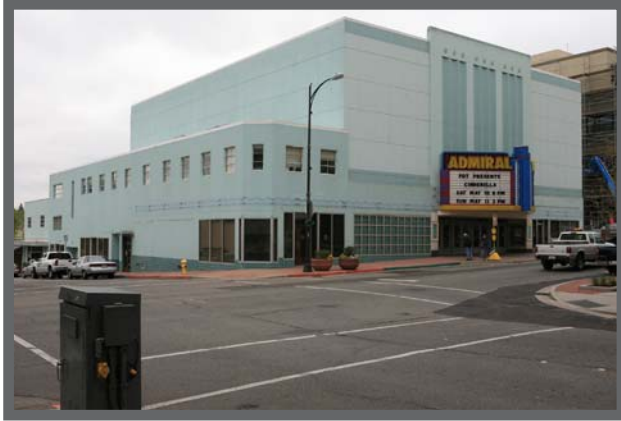
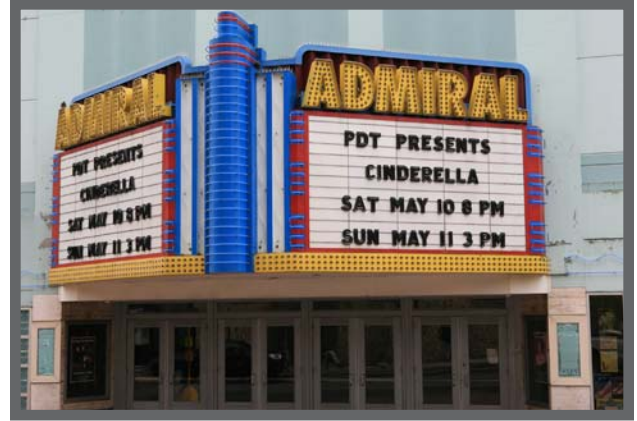
ADMIRAL THEATRE (BREMERTON)

Condition Issues: Not surveyed on the interior, and no exterior condition issues noted. Integrity has not been evaluated because the interior was not accessed.

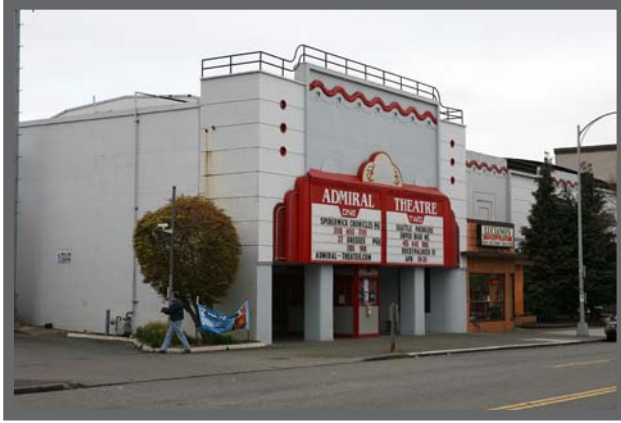
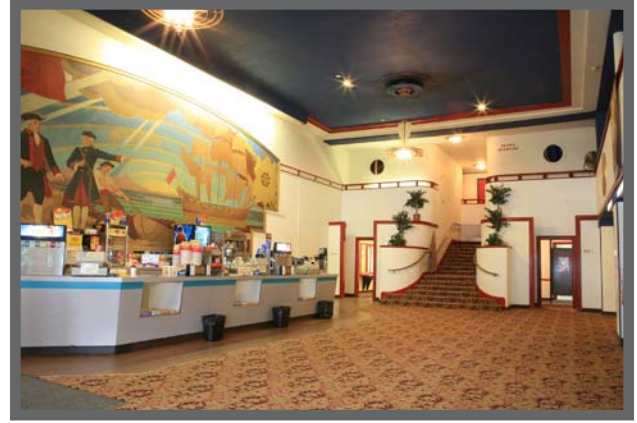
ADMIRAL THEATRE (SEATTLE)

Condition Issues: Overall, moderate integrity and good condition. The most pressing physical concern is the facade. The exterior is painted concrete. In some places, water has infiltrated between the concrete and paint, lifting paint away from the substrate. A car wash abuts the building and may be causing water problems both on the exterior and interior of the building. There are some large cracks in the south corner of the building. There are also vertical and horizontal cracks in the front facade which seem to have happened during the Nisqually earthquake. As far as potential restoration priorities, the 1973 alterations could be reversed to increase the theater's integrity. In that year, a metal stud sheet rock wall was installed, dividing the auditorium in two. The interior faces of the two exterior walls, which have undersea murals, were covered with fabric. The auditorium ceilings had a lay-in acoustical panel ceiling installed. General wear has caused minor damage to interior plaster walls and the lobby mural. Entry doors are original and in good condition. The building has not been seismically upgraded. The building does not have a fire suppression system (fire sprinklers).

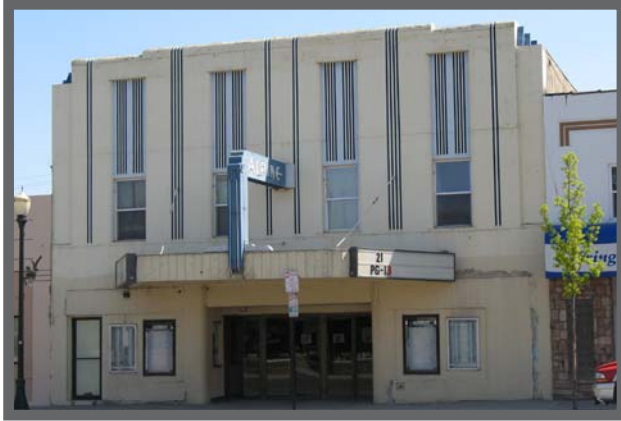
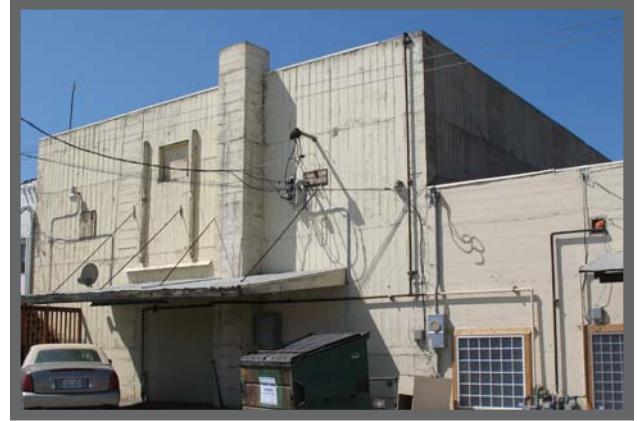
ALPINE THEATER

Condition Issues: Not surveyed on the interior, but recent communication with the owner has provided some understanding of the interior physical concerns. A severe rain storm 3-4 years ago caused water to enter the building from under the roof flashing, resulting in damage to the ceiling plaster and stenciling. The owner would like to repair and restore damaged ceiling areas. The exterior of the building needs repainting. A 1994 renovation changed out the projection equipment, with the old going to the Auto Vue Drive-In and new equipment being installed at the Alpine. Integrity has not been evaluated because the interior was not accessed.

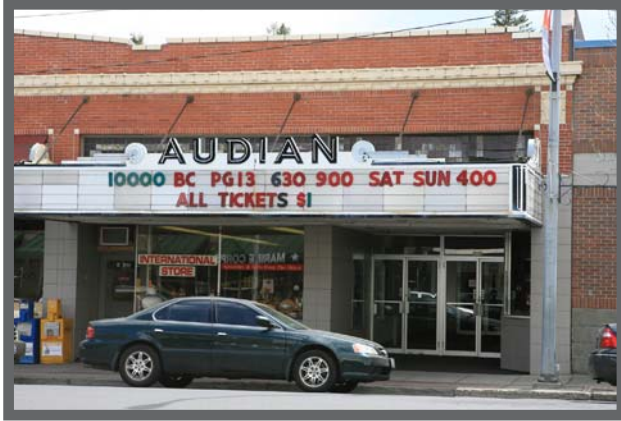
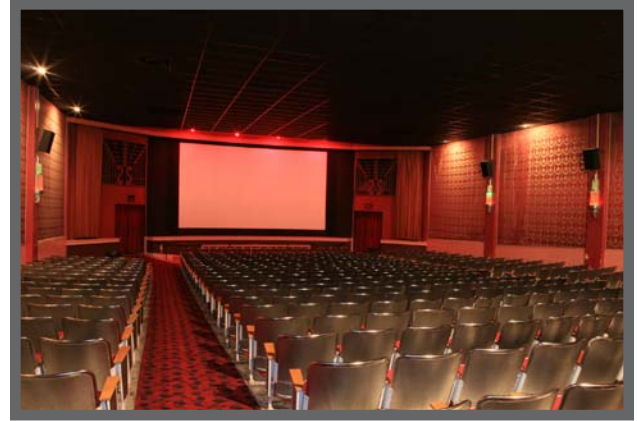
AUDIAN THEATRE

Condition Issues: Overall, moderate integrity and fair condition. The most pressing concerns are interior plaster, the electrical system, glass transom panels, and lobby floor structure. Overall, the theater maintains much of the original 1930 structure despite the 1936 remodel and subsequent changes. It is difficult to determine present layout in relation to the original. The plaster walls and ceiling show a good deal of damage. In the lobby, shingles have been installed over the original finish. Except for the projection booth, the wiring system is from 1936. The transom above the canopy is made up of four-by-four leaded glass; the comes are failing, and the glass is falling out. The floor structure is reported to be two-by-twelve's that are rotting. Tile has been installed on the front facade in a poor attempt to unify the storefronts. It is not known if the original facade is intact behind the tiles.

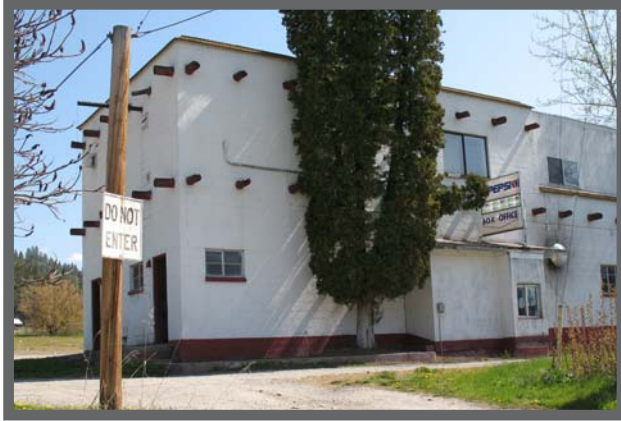
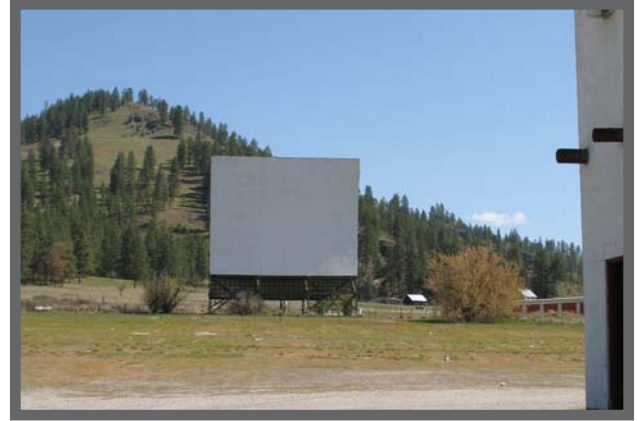
AUTO VUE DRIVE-IN

Condition Issues: Not surveyed on the interior, but recent communication with the owner has provided some understanding of the interior physical concerns. Restrooms are in extreme need for rehabilitation. Movie screen was never coated, so it is in bad shape. Screen repairs were done about 10 years ago but it is time for more help. On the main building, there are varying degrees of deterioration in the wooden faux vigas. Integrity has not been evaluated because the interior was not accessed.

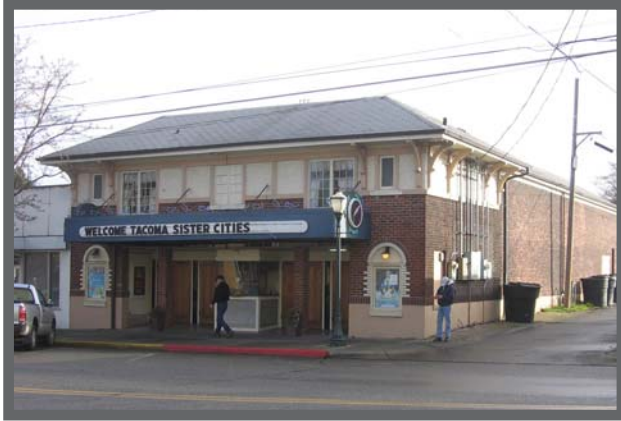
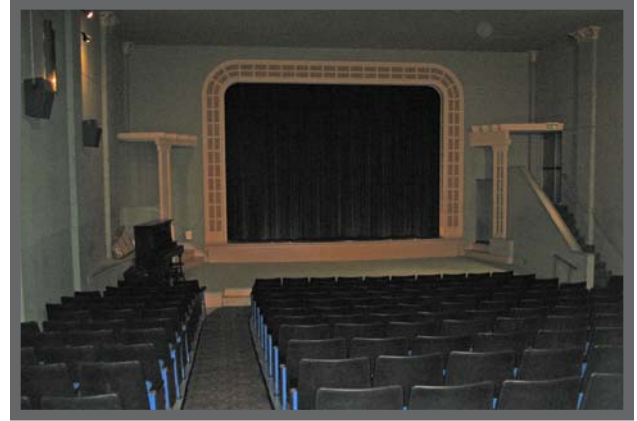
BLUE MOUSE THEATER

Condition Issues: Overall, high integrity and excellent condition. The most pressing physical concern is the leaking roof. The perimeter foundation is poured-in-place concrete. There are several small cracks in the foundation along the side walls, possibly caused by slight settlement. The cracks do not extend higher into the brick wall above. In places, the reinforcing steel is exposed but does not seem to be causing problems for the foundation wall. The exterior walls appear to be in good condition. A terrazzo entry off the side walk is in good condition as are the entry doors. Recently an ADA restroom has been added. There is no fire suppression system in the building. The building has not been seismically upgraded.

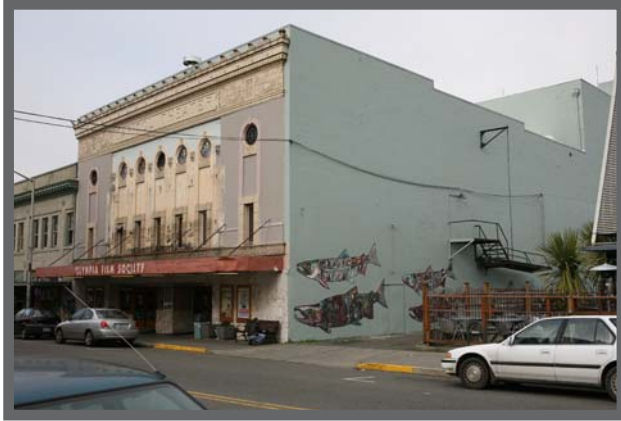
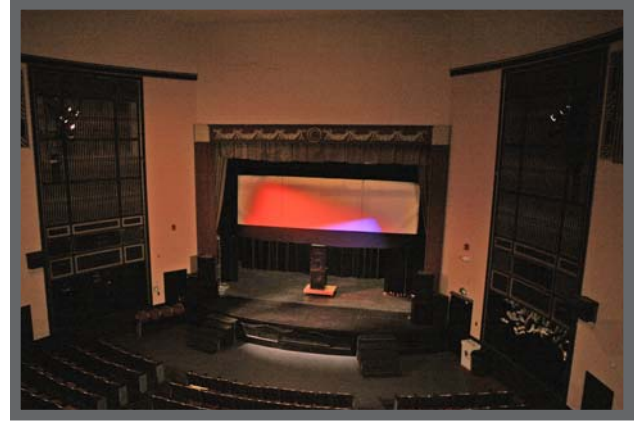
CAPITOL THEATER (OLYMPIA)

Condition Issues: Overall, moderate integrity and good condition. The most pressing physical concern is the facade. The terra cotta needs repointing, repair and cleaning. The building has not been seismically upgraded. The balcony is not ADA accessible. The building does not have a fire suppression system (fire sprinklers).

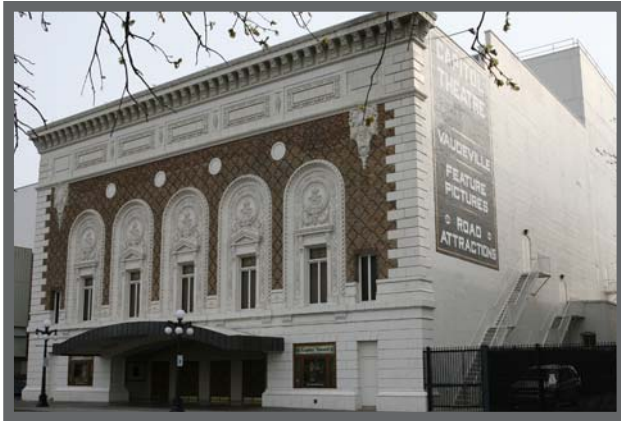
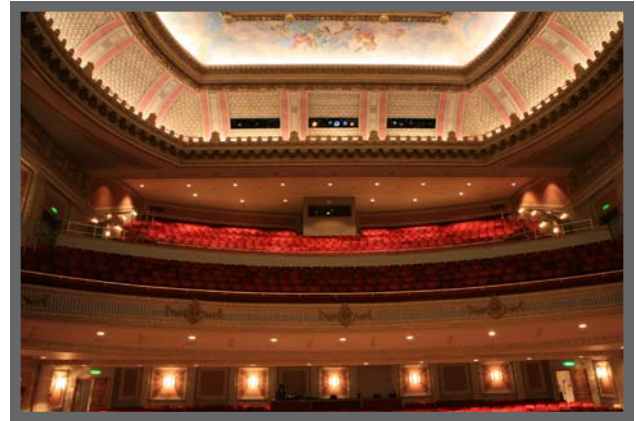
CAPITOL THEATRE (YAKIMA)

Condition Issues: Overall, high integrity and excellent condition. The most pressing physical concern is water damage to the plaster walls and paint. The walls and ceilings need cleaning to bring back the clarity of the decorative paint and gilding. The theater was largely rebuilt following a fire in 1975. No stabilization needs were noted. Great pains were taken to replicate the original look of the original surfaces, sometimes with modern materials. Where the exterior walls were extensively damaged or destroyed during the fire, concrete block was used as a backing material. The painted brick side walls appear to be in good condition. Since the fire, the building has been fully sprinkled and is largely ADA accessible.

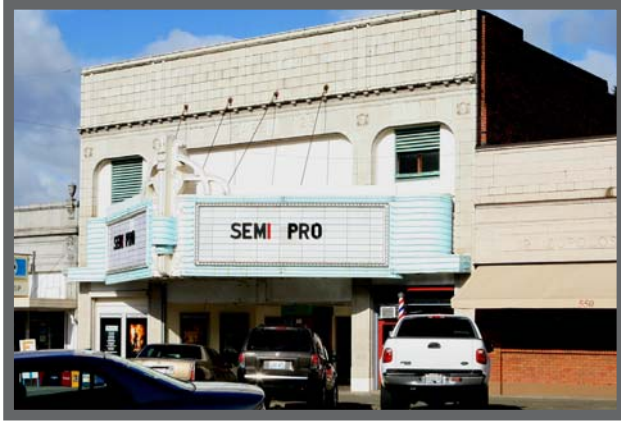
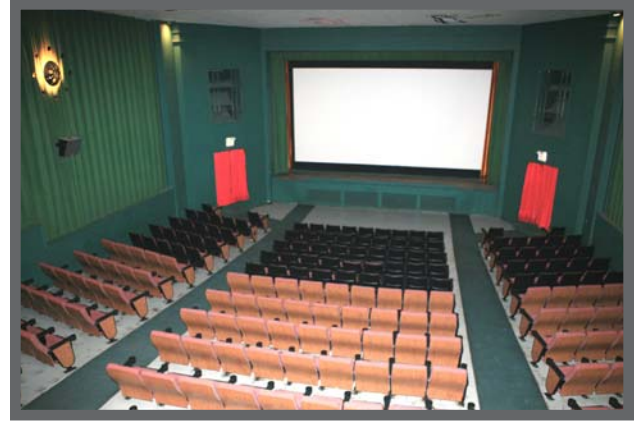
CHEHALIS THEATRE

Condition Issues: Overall, high integrity and excellent condition. The most pressing physical concern is the damage to the terra cotta cladding. There is a minor amount of damage to the terra cotta, but overall it is in good condition. Portions of the terra cotta wall need repointing. The old boiler and radiators need maintenance and restoration. The building has not been seismically upgraded, and it does not have a fire suppression system (fire sprinklers). The building does not meet ADA requirements for restrooms.

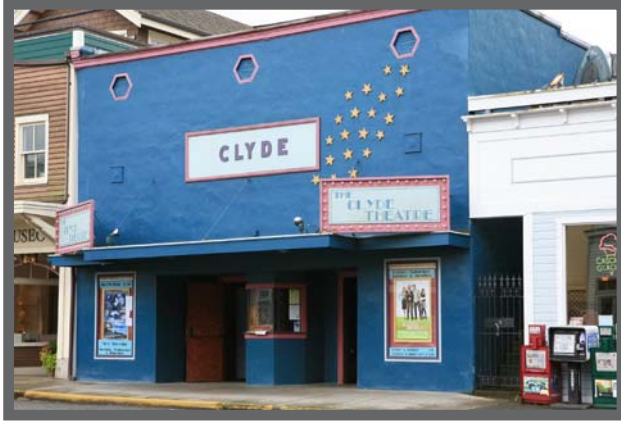
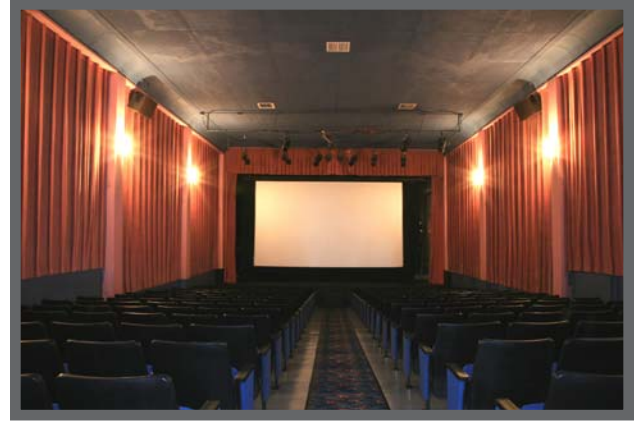
CLYDE THEATER

Condition Issues: Overall, good integrity and good condition. The most pressing physical concern is the leaking roof. The roof does not drain properly and needs to be properly sloped to drain. The roof slopes five feet in one hundred feet, which is inadequate to drain it properly. The current roofing also dates from 1971, so it needs replacement anyway. The owner has been making attempts over the years to make the building handicapped accessible; however, the building's footprint is small and does not allow for increased space for restrooms. The owner installed a redundant seismic structural system in 1992. Designed by a structural engineer, the system ties the roof, walls and foundation together. Electrical and heating/ventilation systems were replaced in the 1980s.

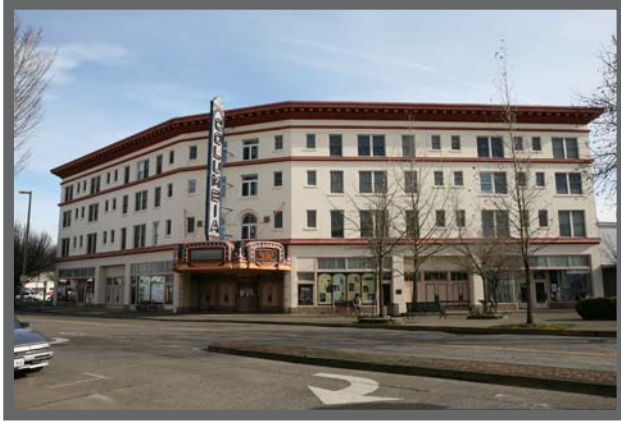
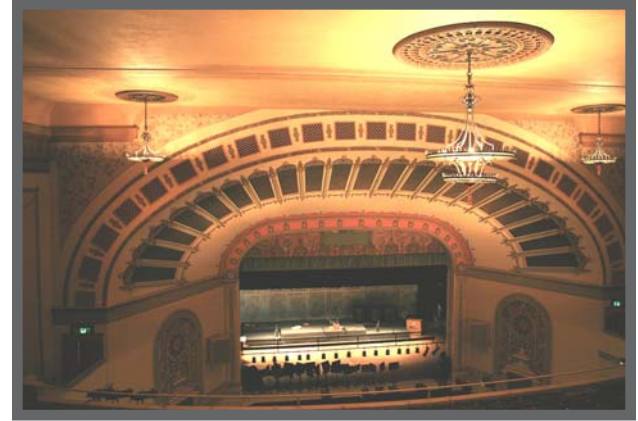
COLUMBIA THEATRE OF THE PERFORMING ARTS

Condition Issues: Overall, high integrity and good condition. The most pressing physical concerns are to be addressed under planned 2008 renovations, but interior plaster and decorative element repair are not budgeted. The 2008 renovation will repair the historic vertical marquee, refinish the auditorium and lobby floors, update heating and mechanical systems, and make the stage and orchestra pit ADA accessible. Also, the 1940s seats will be replaced with enlarged replicas of the originals. Condition concerns which do not fall under the planned renovation are the areas on various roof levels where water pools, with at least one spot collecting detritus and harboring vegetation growth. Some plaster damaged walls and ornament could use repair. The building has been seismically reinforced. DryVit cladding added in 1999 is intact. The canopy marquee has been replaced.

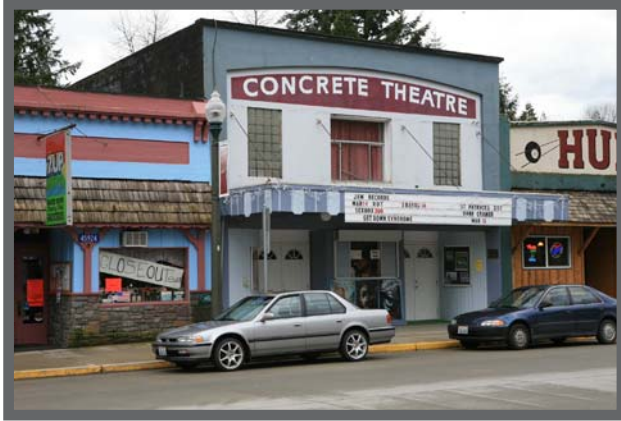
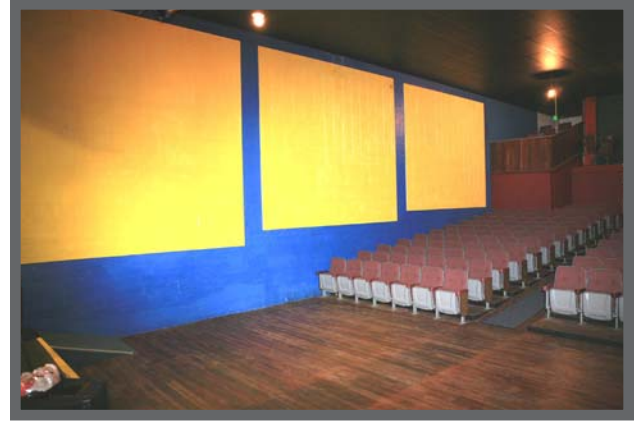
CONCRETE THEATER

Condition Issues: Overall, moderate integrity and good condition. The most pressing physical concern is the leaking roof. Also, the foundation may be leaking. The building has not been seismically upgraded, and it does not have a fire suppression system (fire sprinklers). The lobby restrooms do not meet ADA codes; however, any attempt to enlarge them would greatly impact the historic layout of the building. The theater does not meet exiting code. There are no side exits; there is only an exit from the back of the stage, and it is not equipped with panic hardware. The original wood auditorium floor has recently been refinished and is in excellent condition.

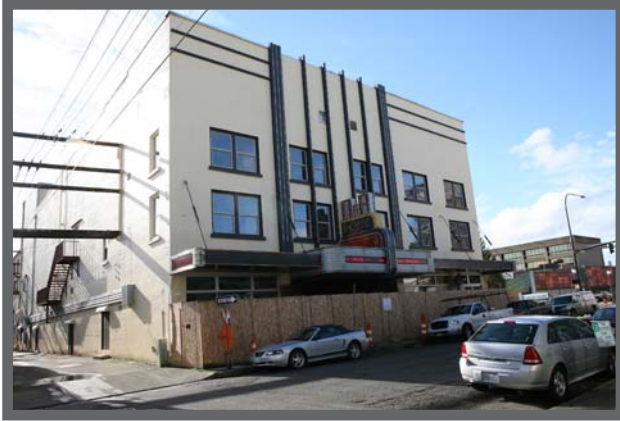
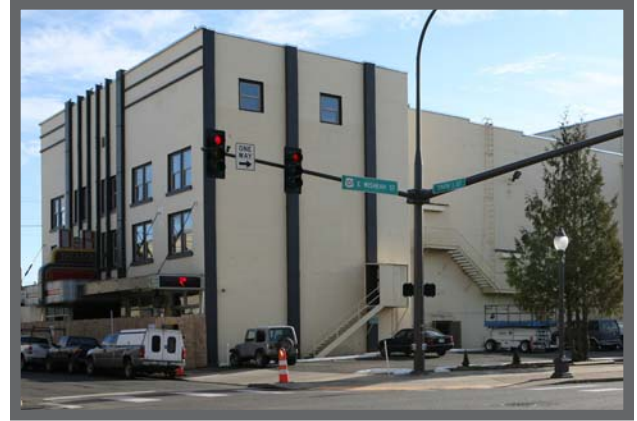
D & R THEATER

Condition Issues: Not surveyed on the interior, so integrity has not been evaluated. No physical concerns noted on the exterior.

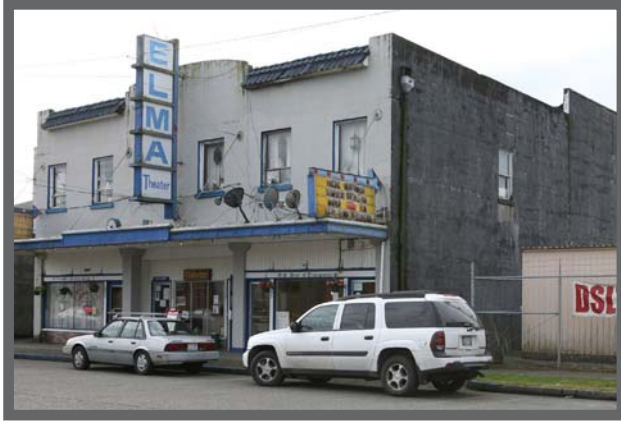
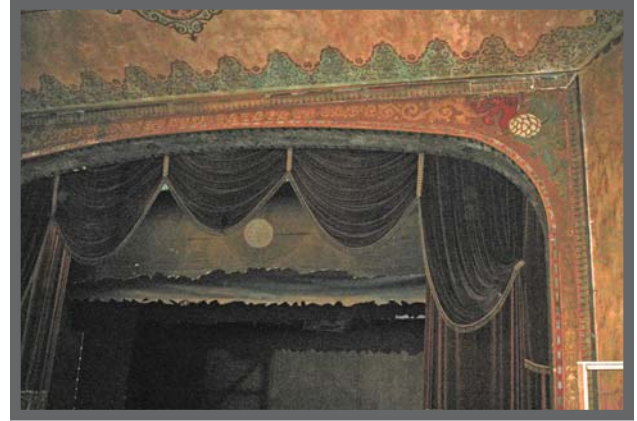
ELMA THEATER

Condition Issues: Overall, moderate integrity and poor condition. The most pressing physical concerns are the roof, interior plaster, interior paint and decorative stenciling, and electrical and mechanical systems. However, this theater has many restoration and updating needs apart from the stabilization priorities. A closer inspection is necessary, but there appears to be several layers of roofing material over the wood trusses, joists and decking. In addition, the roof has been patched many times, both with sheet material and liquid. There is water pooling, the surface is bubbling and cracking, and there are large areas around the parapet flashing where water is entering the walls, resulting in severe and ongoing damage to the plaster ceiling in the auditorium. Large sections of exposed lath are visible where plaster has fallen and beautiful painted ornamentation is being lost. The theater was closed by the local building officials just prior to the survey for a number of code violations. Presently, the building is being heated with wood pellet stoves; the existing mechanical system is not working. This is inherently unsafe and inadequate. The electrical system is a patched together affair and is responsible for several of the safety citations by the code officials. Existing plumbing is inadequate and in poor condition. Vertical cracks are obvious in the exterior poured concrete walls. Lighting is insufficient. Restrooms should and could be made to meet the ADA requirements. The building has not been seismically upgraded and does not have a fire suppression system (sprinklers). Original glass transom blocks are covered up on the exterior above the theater and the two retail space entries. The lobby has been highly altered, but most changes may be reversible.

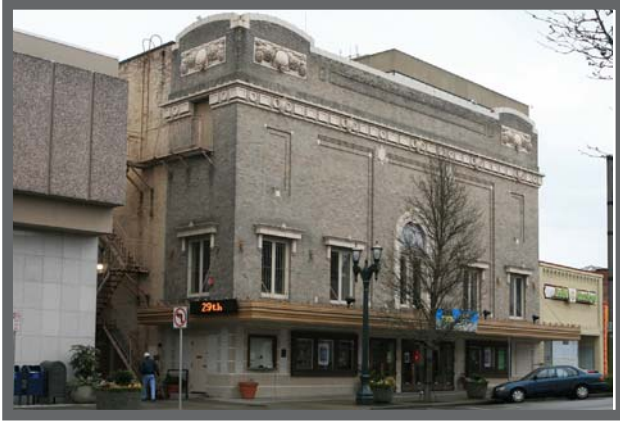
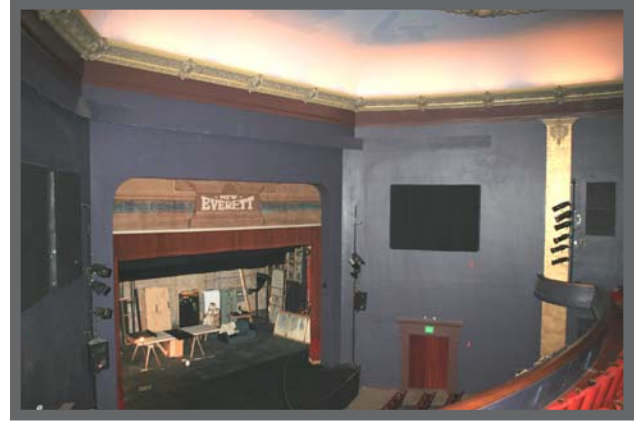
EVERETT THEATRE

Condition Issues: Overall, moderate integrity and excellent condition. The most pressing physical concern is the side and back walls need cleaning and repointing. The brick and terra cotta on the front of the building have recently been restored, repointed, and cleaned. However, the sides and back walls have not been cleaned or repointed; these walls have several layers of peeling paint over the brick. The mortar joints may be failing, allowing water infiltration. There appears to have been no seismic upgrade to the building during the recent restoration, but brick ties have been added to the back wall sometime in the past. The theater has three different heating systems. The exterior walls have been modified over the years, and there is evidence of in-filled windows and doors. There is a fire escape attached to the north side of the building. The building meets ADA codes and has a fire suppression (sprinkler) system. In 2001, electrical systems were updated.

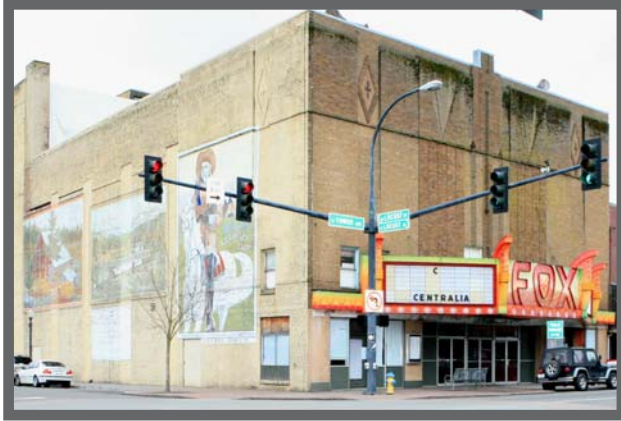
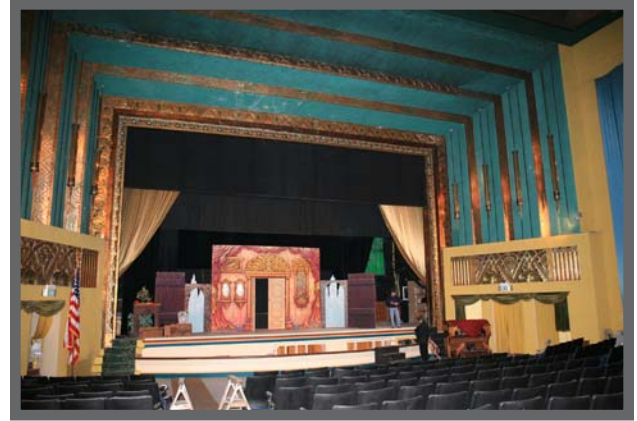
FOX THEATRE (CENTRALIA)

Condition Issues: Overall, high integrity and poor condition. The most pressing concerns are the leaking roof, the brick cladding, and the interior plaster. The theater has been closed for a number of years and has fallen into disrepair. Water infiltration has damaged the interior plaster walls and ceilings. Now owned by the City of Centralia, there are plans to reroof the Fox by the end of 2008. On the south side, the brick cladding needs to be reattached to the structure. All exterior brick needs to be repointed and cleaned. The interior plaster walls and ceilings need to be stabilized, repaired, cleaned, and painted. Also, some other system of preventing water infiltration into the fly loft wall needs to be explored other than the present single-ply membrane roofing draped over it. The reinforcing steel in the concrete back wall has begun to corrode and jack concrete. Also, old steel fasteners that were left in the concrete walls have corroded and are jacking sections of concrete. The restrooms do not meet ADA requirements. The theater needs a new mechanical and electrical system. The building has not been seismically upgraded and does not have a fire suppression system (fire sprinklers).

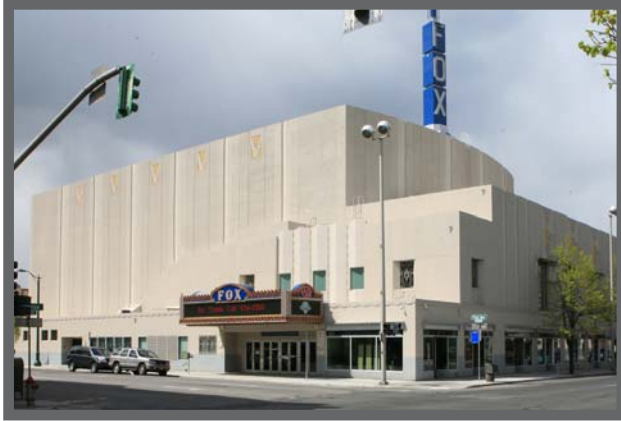
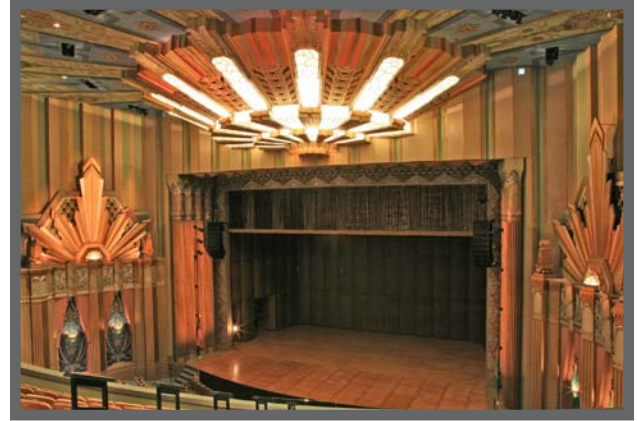
FOX THEATER (SPOKANE)

Condition Issues: Overall, high integrity and excellent condition. There are no pressing physical issues identified. The Fox has recently undergone an extensive renovation and reopened in the fall of 2007. The theater is ADA compliant.

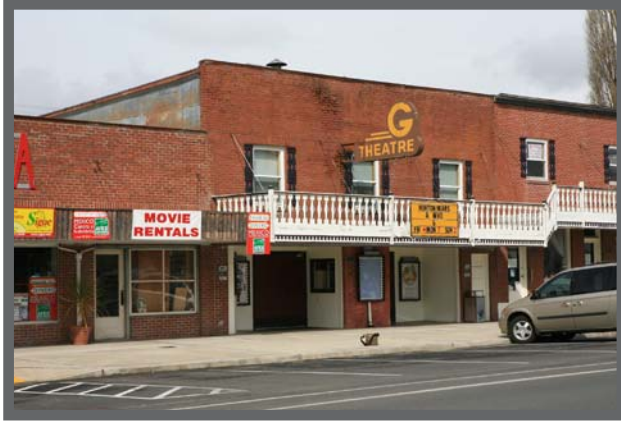
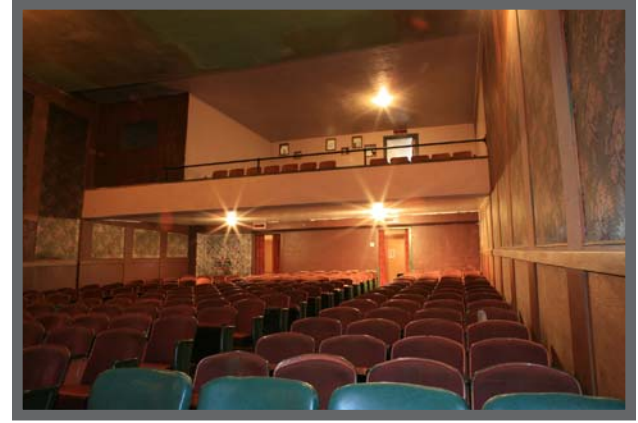
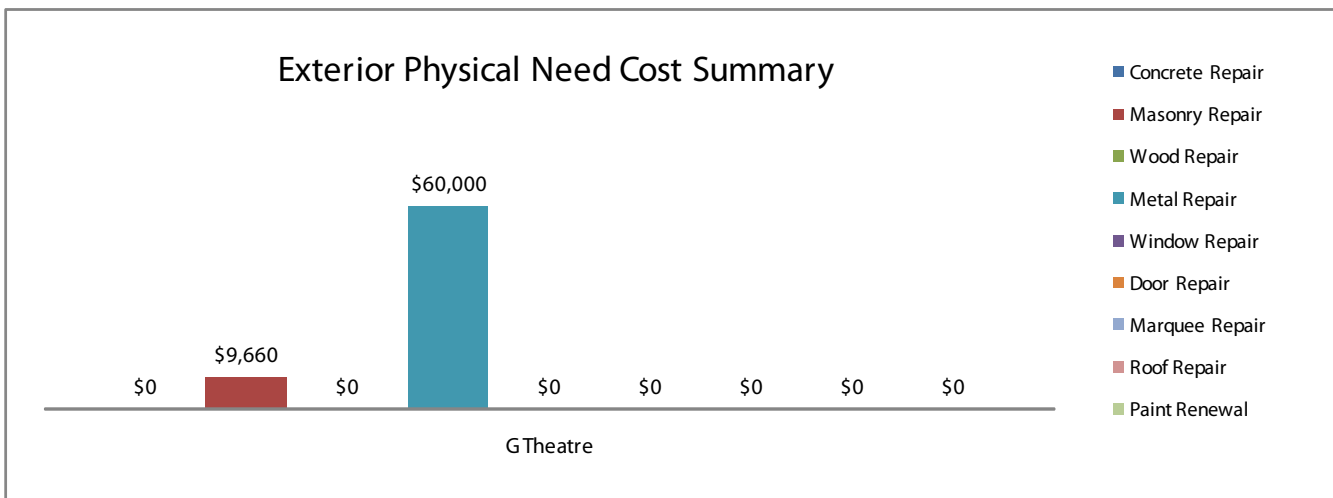
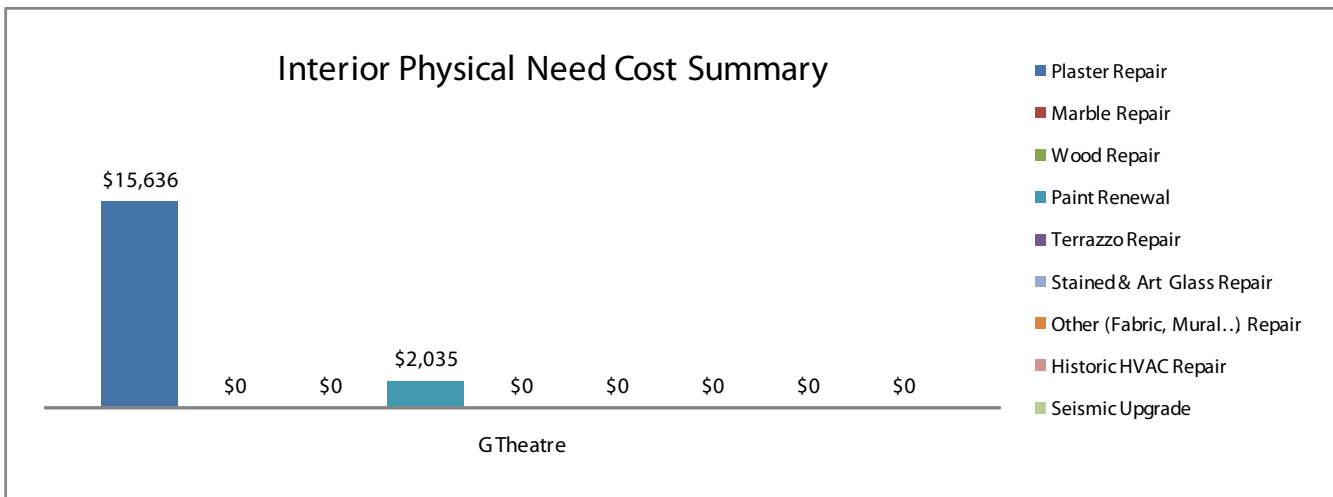
G THEATER

Condition Issues: Overall, moderate integrity and good condition. The most pressing concerns are the marquee, the facade, interior plaster, building systems, and seating. Specifically, the marquee is in poor condition and needs stabilization. The internal structure is corroded and many of the exterior metal panels are beyond repair. For general building preservation, the brick facade needs repointing and cleaning. A small amount of interior plaster is water damaged and requires repair. The electrical system is inadequate in the auditorium. Seats are in fair to poor condition. Restoration efforts should address the metal canopy, which has been obscured by a wood railing applied over it. Vinyl windows have replaced the original ones. The building has not been seismically upgraded and does not have a fire suppression system (fire sprinklers).

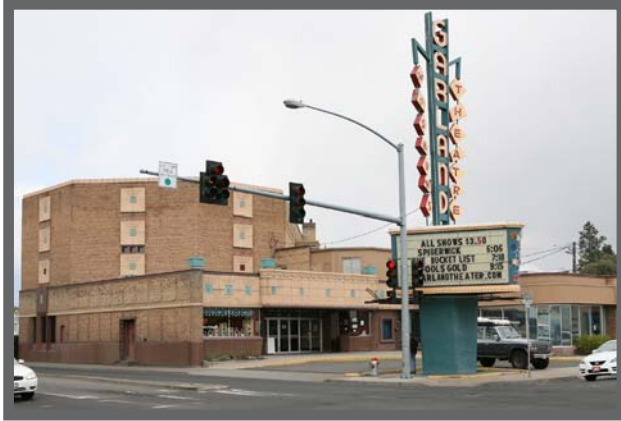
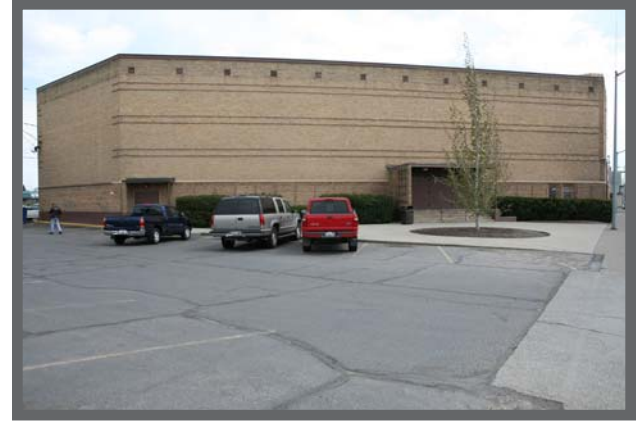
GARLAND THEATRE

Condition Issues: Not surveyed on the interior. There is some water damage to the underside of the entry canopy. The material appears to be stucco or simply exterior plaster. However, without the owner's permission, a close examination was not performed. Exterior cladding appears to be in good condition. Integrity has not been evaluated because the interior was not accessed.
