HISTORIC THEATRES

STATEWIDE SURVEY AND PHYSICAL NEEDS ASSESSMENT

This report commissioned by the Washington state Department of Archaeology and Historic Preservation.

Published June 30, 2008

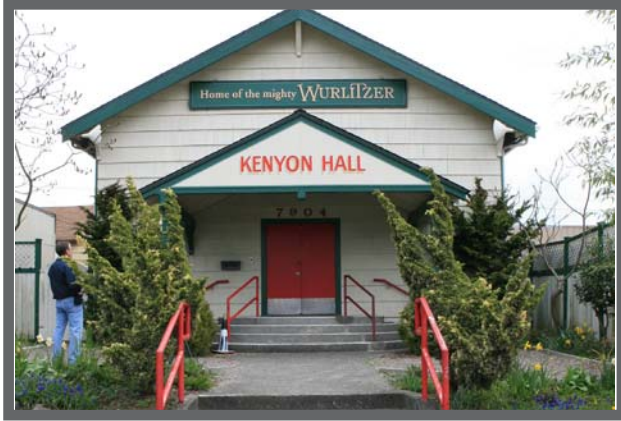
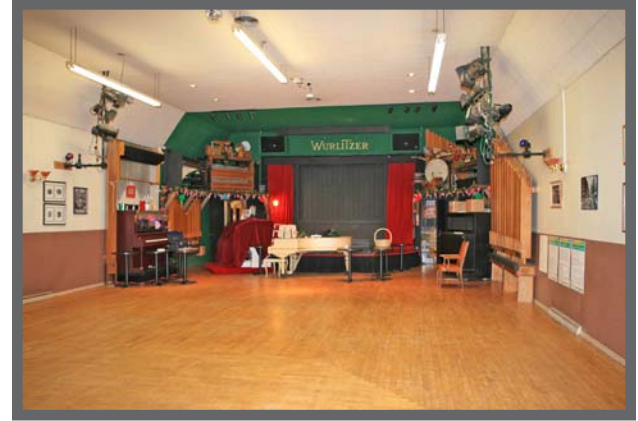
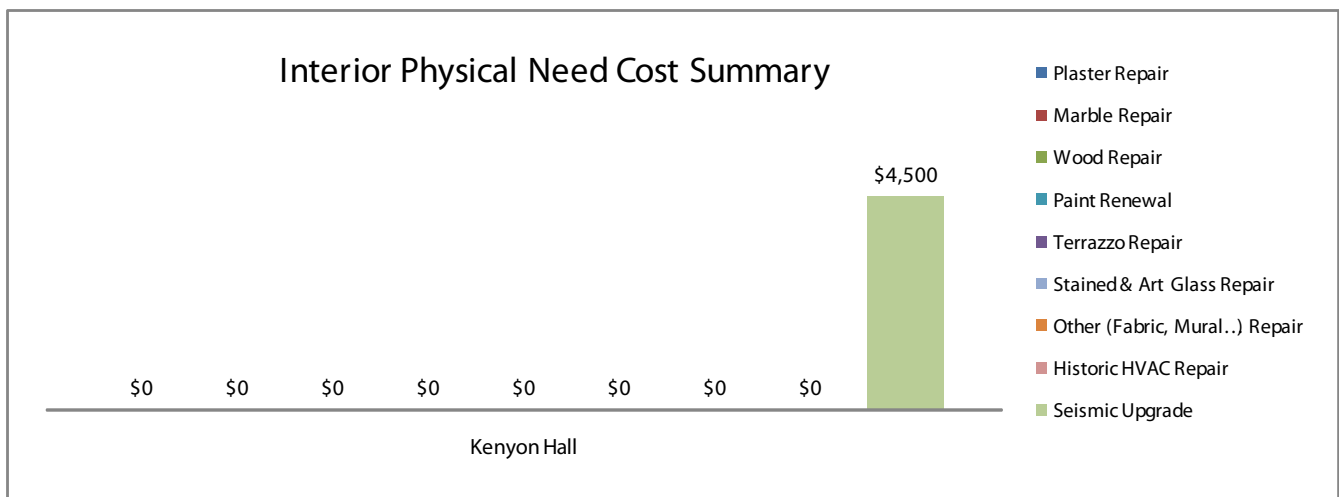
KENYON HALL

Condition Issues: Overall, low integrity and excellent condition. There are no pressing physical concerns. It is in good condition and functioning quite well as a small neighborhood performance venue. The building has not been seismically upgraded and does not have a fire suppression system (fire sprinklers).

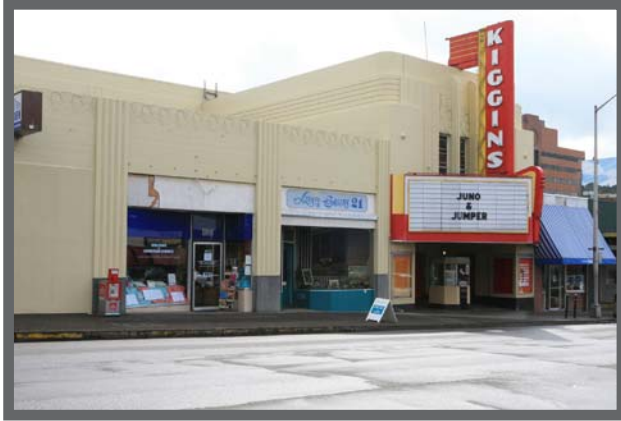
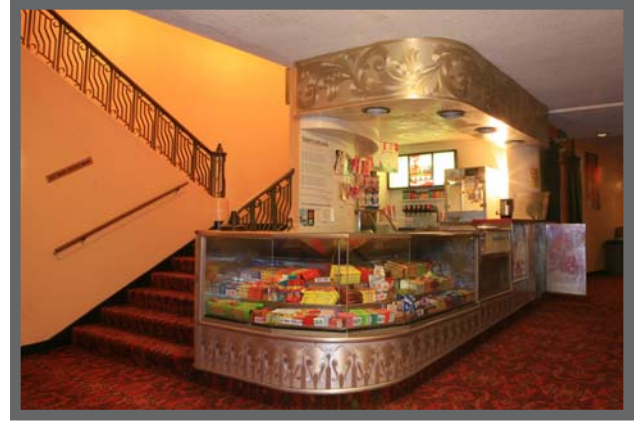
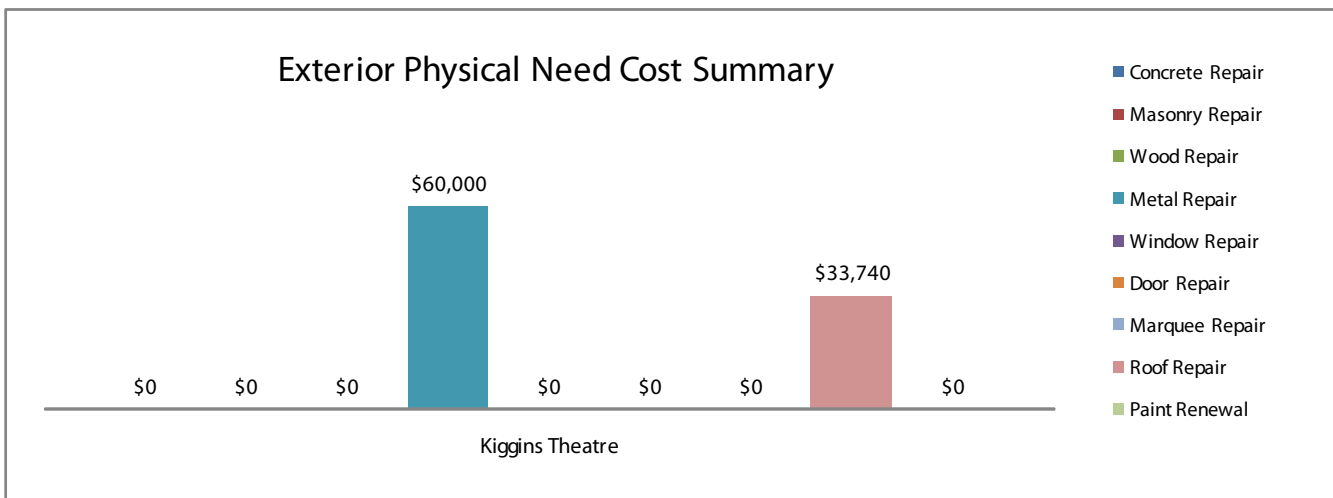
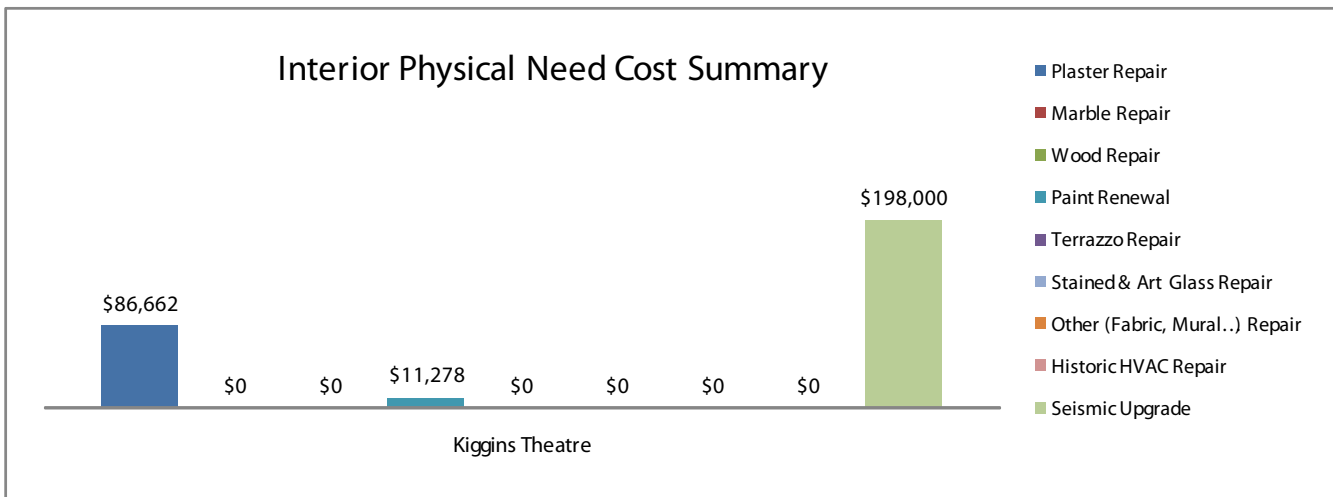
KIGGINS THEATRE

Condition Issues: Overall, high integrity and good condition. The pressing issues are the marquee, interior plaster, bathrooms, seating, and the front facade. The marquee needs extensive repair. Interior plaster walls and ceiling show a fair amount of water damage throughout. Upstairs restrooms need a change of wall covering (fake fur currently) in the vestibules and repair of the broken wall plaster. Restroom capacity is insufficient for large audiences. Auditorium seats show a range of conditions, from fair to completely broken. On the facade, four-by-four inch tiles have been added up to the marquee level. A drinking fountain in the front part of the lobby is missing but a floor shadow indicates its original location. Electrical systems were updated in February 2008. Floor plan, light fixtures, interior signage, doors and windows are intact with high integrity. The building seems structurally sound with no major issues. The roof is only ten years old.

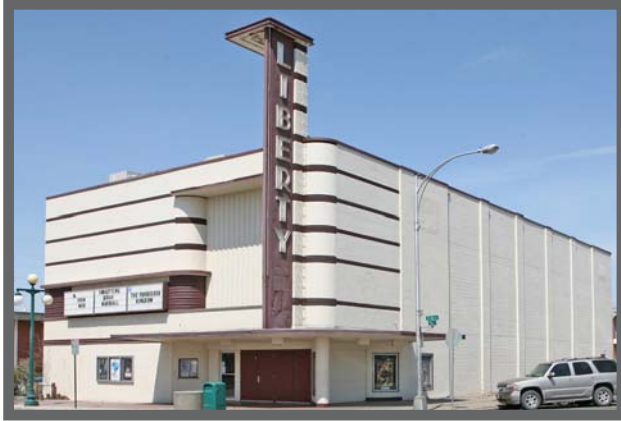
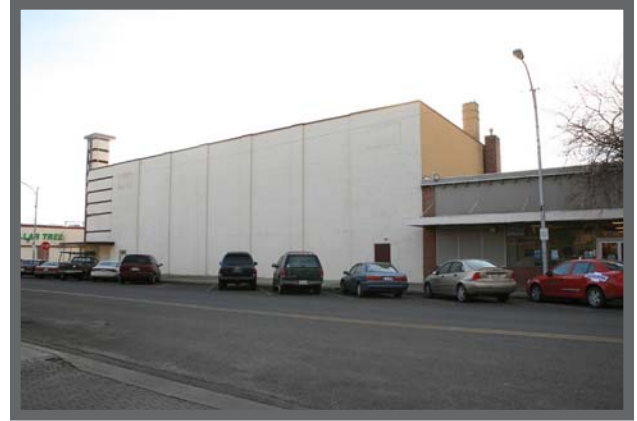
LIBERTY THEATER (ELLENSBURG)

Condition Issues: Not surveyed on the interior. Exterior condition issues include some cracking in the concrete walls and spalling on the edge of the upper concrete overhang. Two vertical cracks in the exterior walls appear to transfer from one side of the theater to the other. Integrity has not been evaluated because the interior was not accessed.

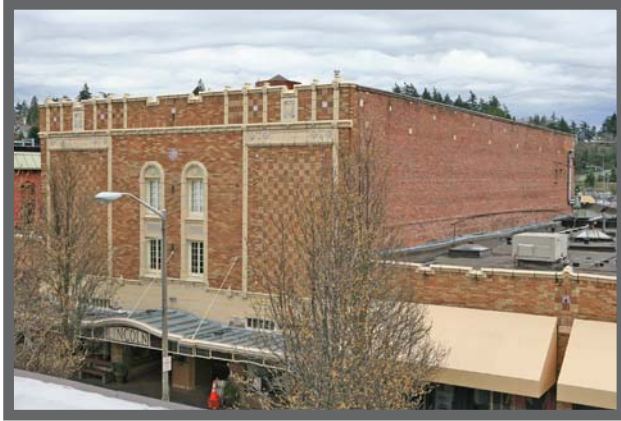
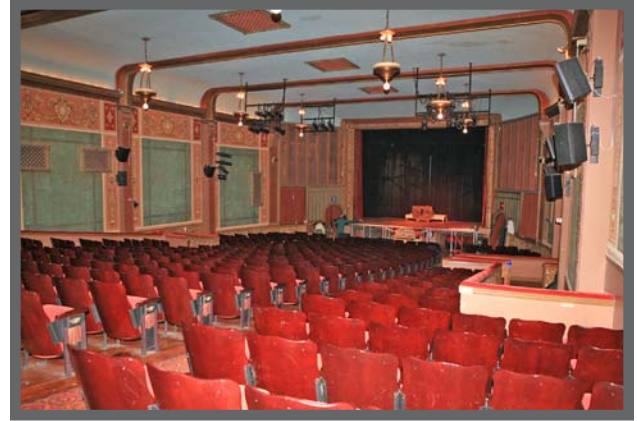
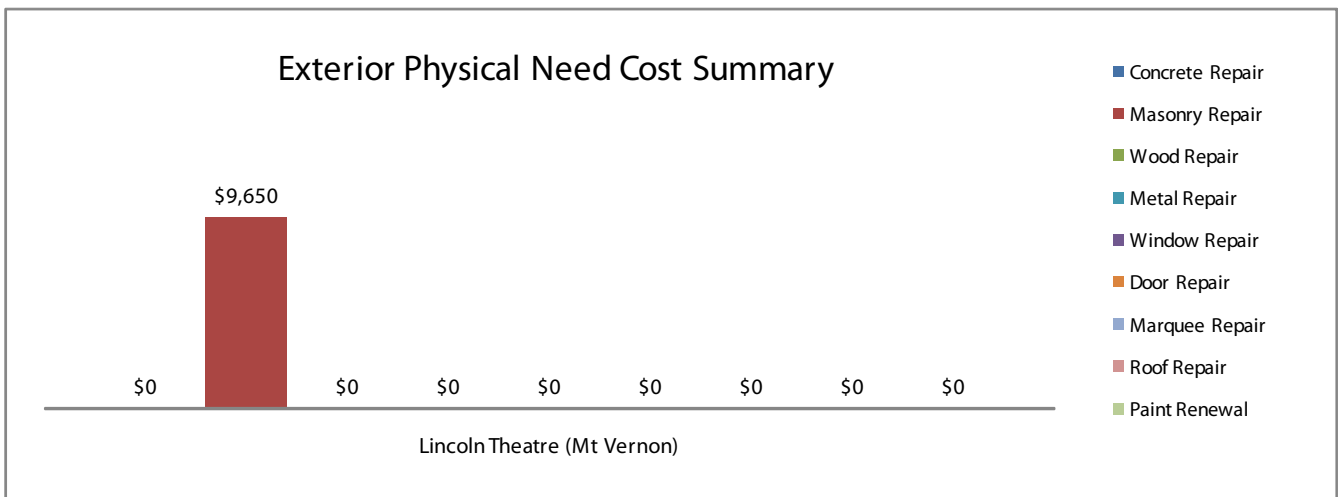
LINCOLN THEATRE

Condition Issues: Overall, high integrity and excellent condition. The most pressing physical concern is the exterior brick that needs repointing and cleaning. Abutting the Lincoln Theatre is a one-story structure built in the same manner, with the same materials, and possibly at the same time as the theater. This neighboring structure is in poor condition, and its deterioration could threaten the Lincoln. The Lincoln has not been seismically upgraded and does not have a fire suppression system (fire sprinklers), just a fire hose.

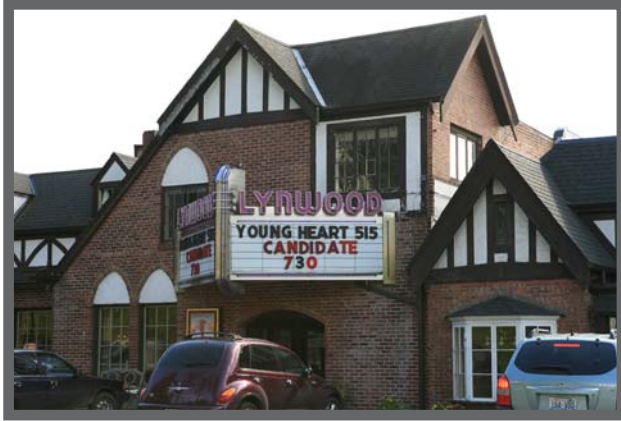
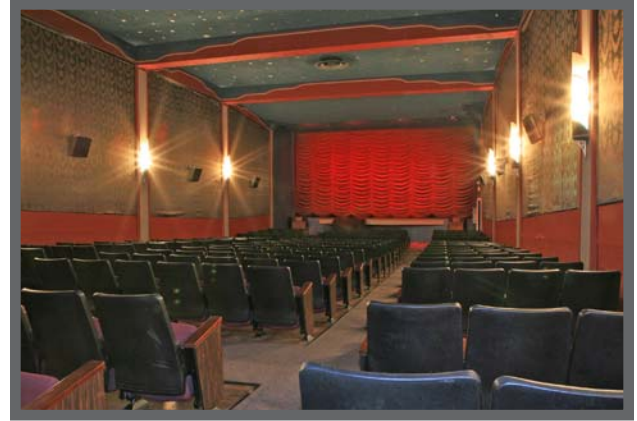
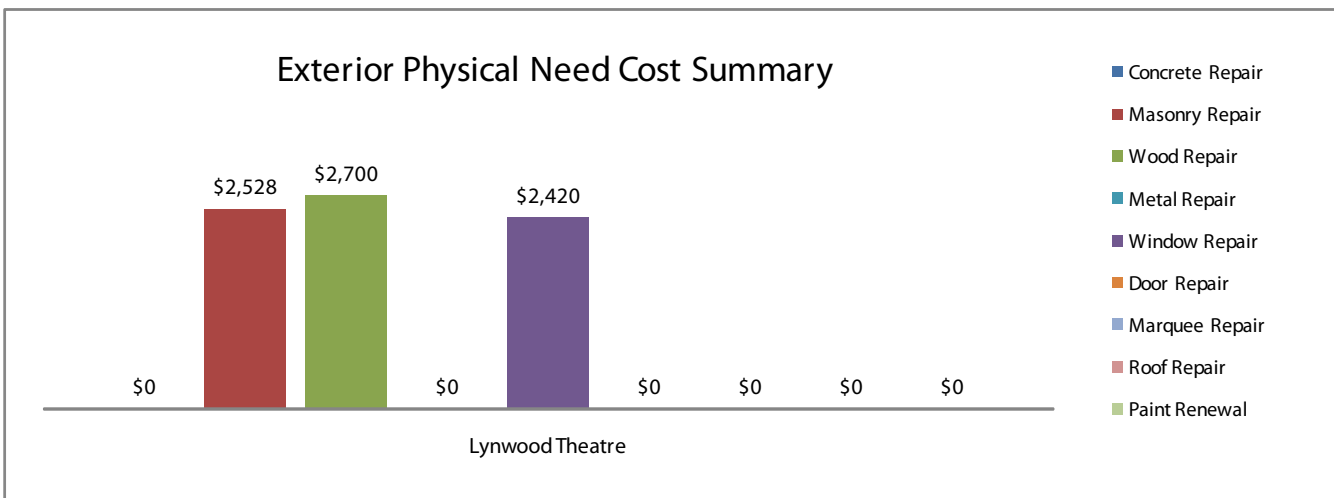
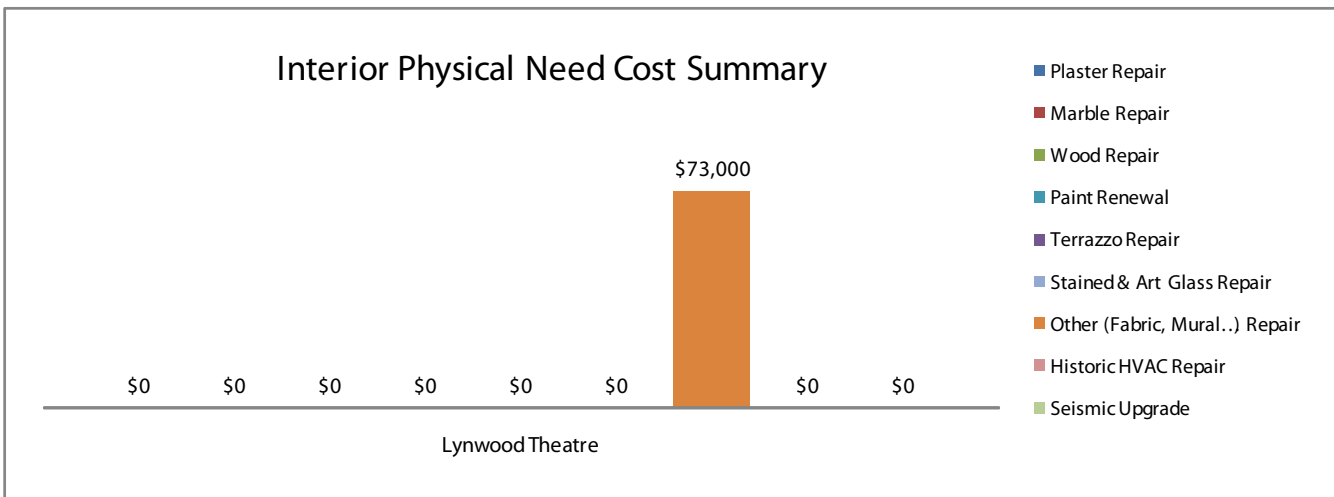
LYNWOOD THEATER

Condition Issues: Overall, high integrity and excellent condition. The most pressing physical concerns are the windows, facade and interior finishes. Specifically, these are all preservation level efforts. The projection room level wood windows need attention, the brick facade needs cleaning, the exterior stucco and wood trim need painting, and the interior wall fabric needs cleaning and repair from past water damage. The front doors are slightly weathered and need to be refinished. The theater and the abutting buildings have not been seismically upgraded and a fire suppression system has not been installed in the theater. The marquee is new, but it is a good replica of the original.

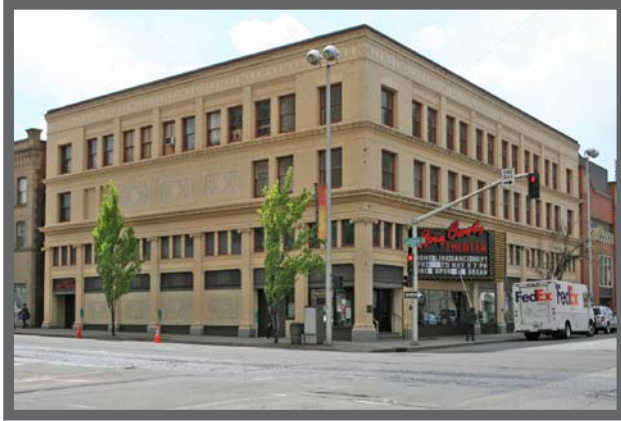
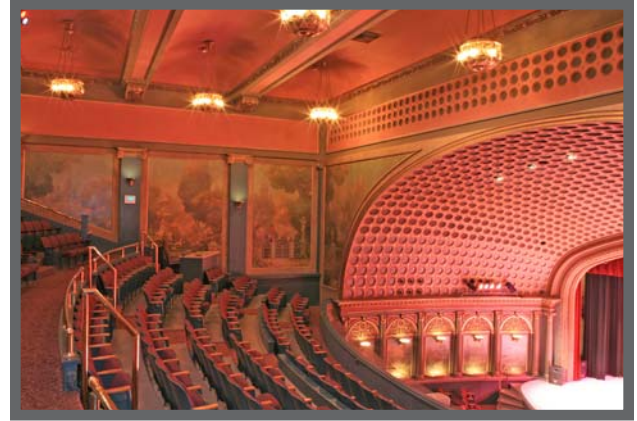
METROPOLITAN PERFORMING ARTS CENTER (MET)

Condition Issues: Overall, high integrity and good condition. The most pressing physical concerns include the roof, facades, and interior plaster. The roof needs replacing; it is leaking and causing damage to the interior surfaces. Both the brick and terra cotta need some repair. Rust stains indicate that the terra cotta metal hangers are corroding and need repair. All the wood windows need to be removed, repaired, glazed, painted, weather stripped, and reinstalled. Portions of wall plaster are damaged and in need of repair and painting. Wall murals in the auditorium are water-damaged and require restoration. The building has a fire sprinkler system for the stage and dressing rooms, but not the auditorium or lobby. Furthermore, it has not been seismically upgraded. The storm water overflow sometimes allows water to infiltrate the building. The building is clad with a combination of glazed brick and terra cotta. Both the brick and terra cotta are in good condition but need some repair and repointing. The lobby was remodeled to give it more space, but the majority of the building has historic finishes. The first floor is ADA accessible, including the restrooms, but the balcony is not.

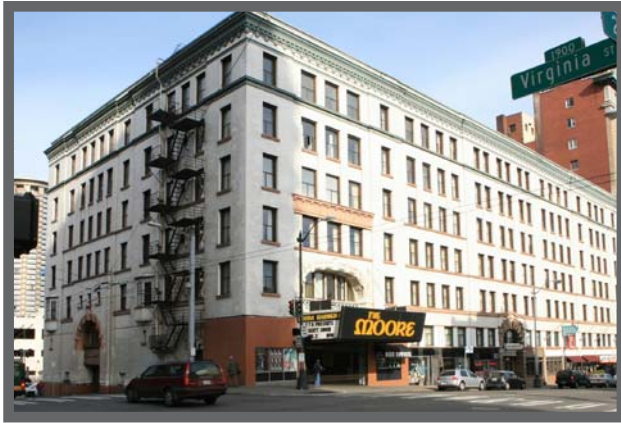
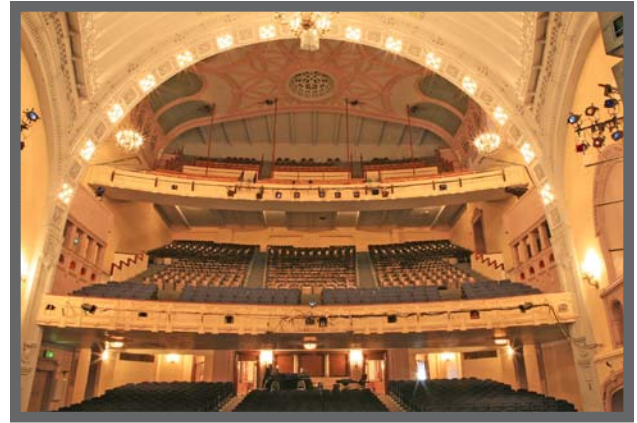
MOORE THEATRE

Condition Issues: Overall, high integrity and fair condition. The most pressing physical concerns are damaged plaster, marble, and stained glass. All the interior surfaces need cleaning, repair, and restoration. The interior needs to be painted. The theater has a wet sprinkler system in the halls but not in the auditorium. Because it is located within a larger building, the theater shares many of its systems and services, which are outdated. Also, the theater does not control the condition of the exterior facade, which needs restoration. The building has not been seismically upgraded. The lobby, main house floor and first balcony are ADA accessible.

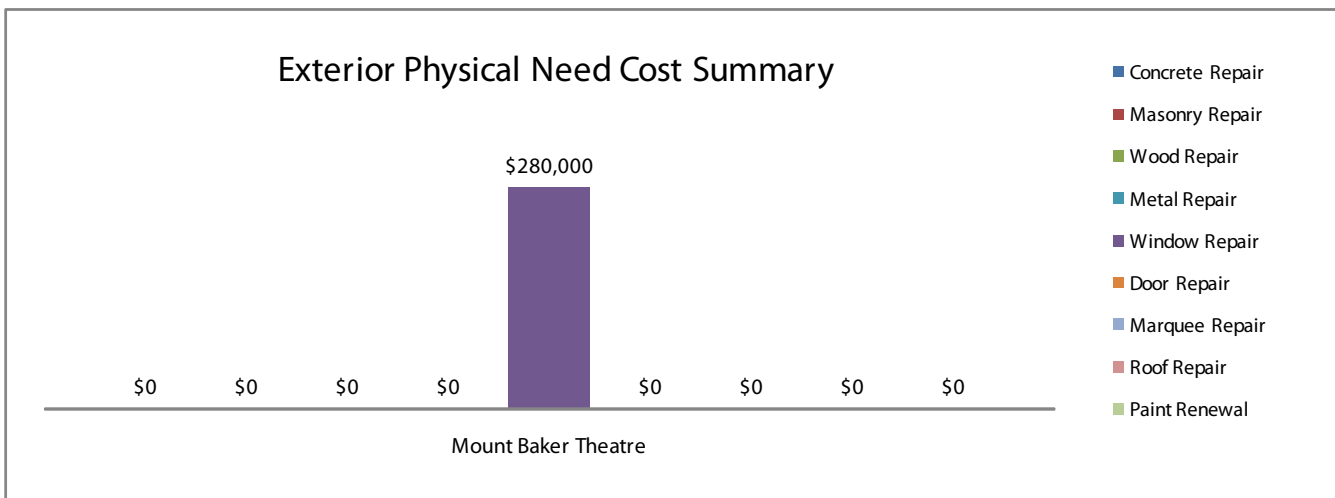
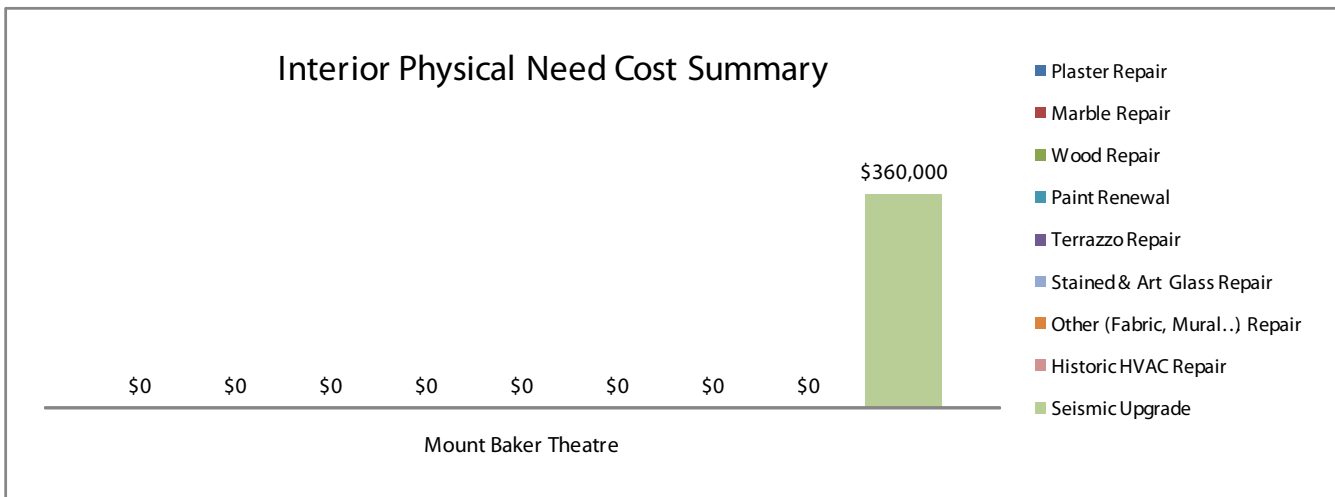
MT. BAKER THEATRE

Condition Issues: Overall, high integrity and excellent condition. The most pressing physical concerns are the weathered wood windows and the storefronts adjoining the theater. The windows need preservation, while the storefronts need restoration. The electrical and mechanical systems throughout the building are a combination of old and new. There is no fire suppression system in the portion of the building that includes the lobby, auditorium, and fly loft, but there is in the surrounding storefronts. The building has not been seismically upgraded. There is ADA access to the first floor and restrooms but not the balcony.

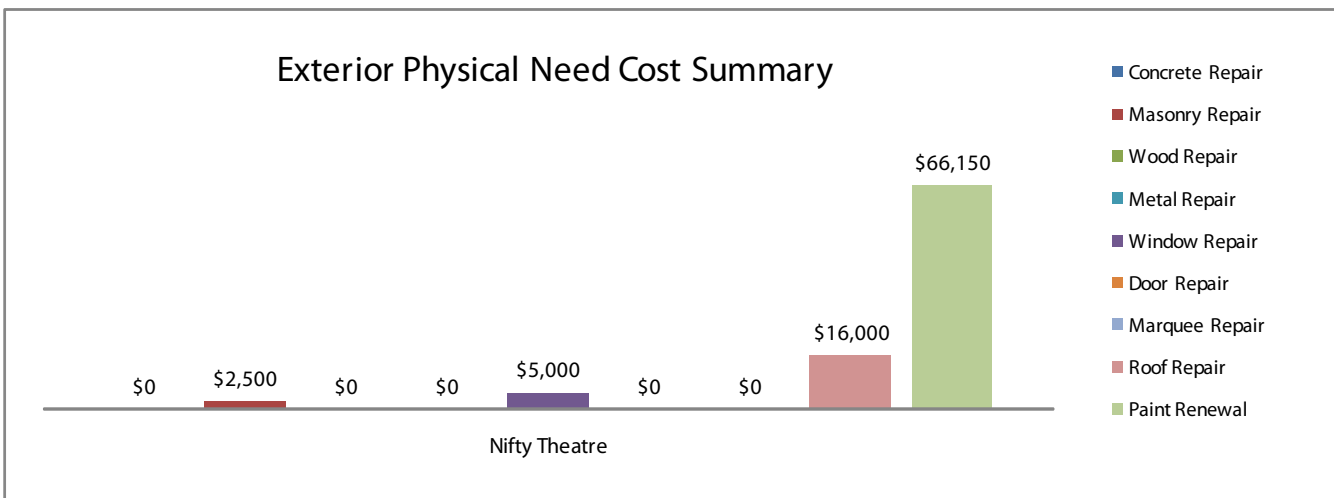
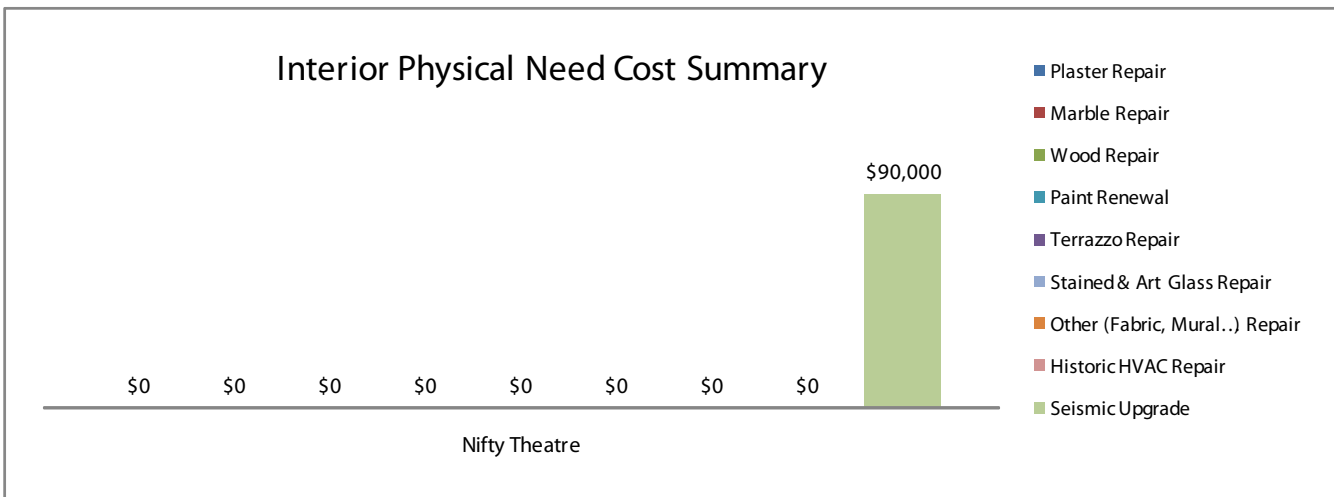
NIFTY THEATRE

Condition Issues: Overall, high integrity and good condition. The most pressing physical needs are the roof, the exterior facades, and the windows. Before anything else, a new roof is needed. The drop-siding needs painting. The front facade stucco is cracked and broken in places, requiring repair in the near future. The wood windows need to be restored. A small portion of the interior plaster is damaged and requires repair. The building is balloon framed and, according to the owner, was burned during construction. Portions of the stage framing and exterior walls are charred. Despite the charred framing, the structure appears to be in good condition. There is no fire blocking in the walls. The restroom appears to be original and not ADA accessible. To install an ADA accessible restroom would alter the interior, specifically to the detriment of the historic fabric. The front entry is not ADA accessible. Installing an ADA ramp would greatly alter the historic character of the front facade. The building has had no seismic upgrade nor does it have a fire suppression system (fire sprinklers).

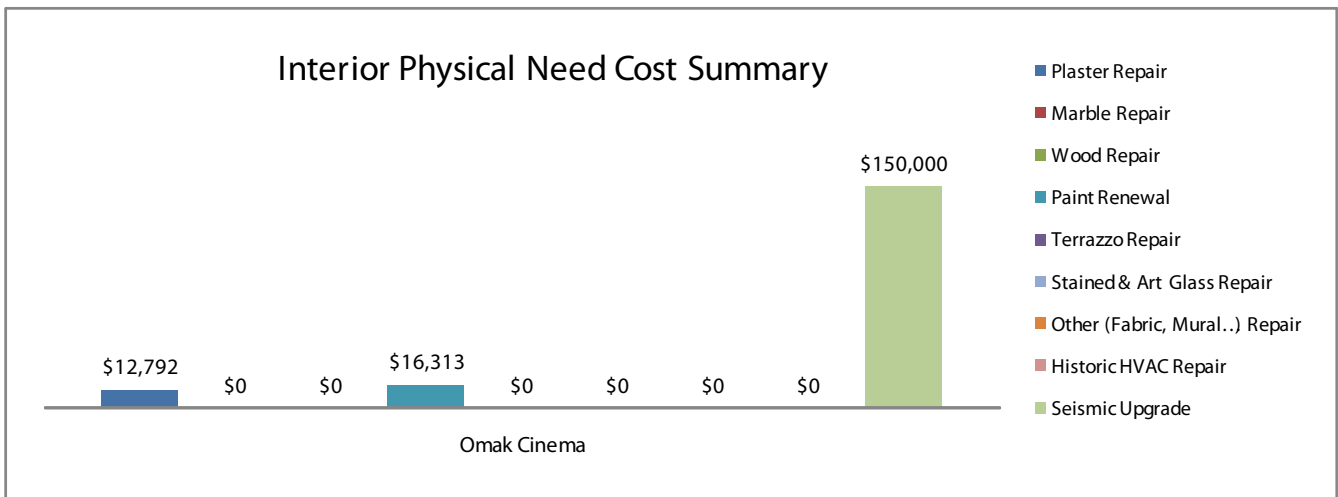
OMAK CINEMA

Condition Issues: Overall, high integrity and excellent condition. There are no pressing physical concerns, but the auditorium ceiling stencil work needs cleaning and restoration. The building has not been seismically upgraded. The roof is two years old and in good condition. The original exterior wood windows and tile cladding are both in good condition. The marquee may not be original, but it appears to be in good condition.

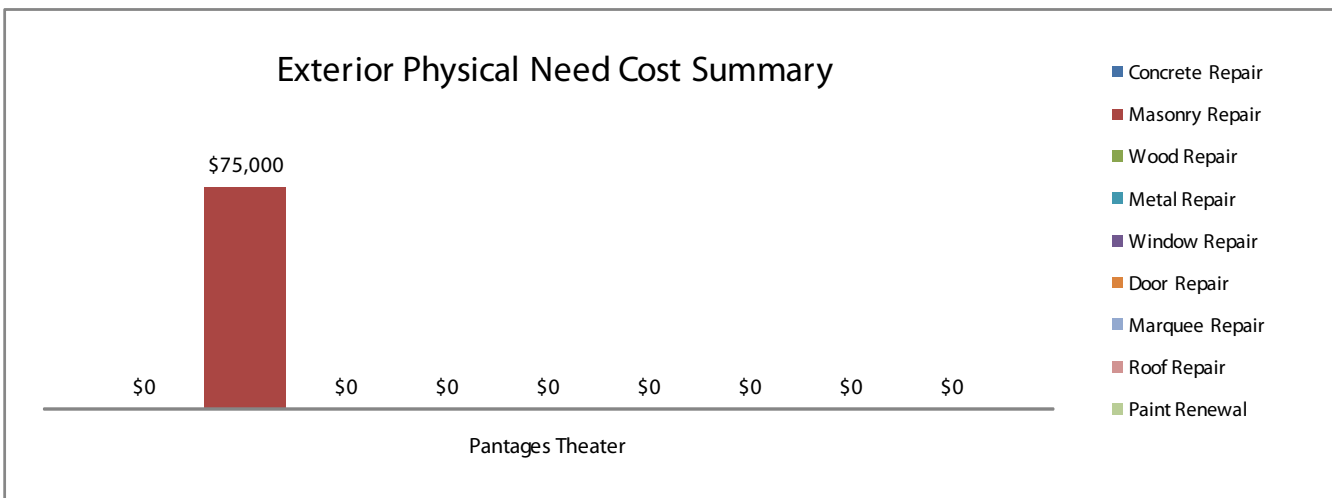
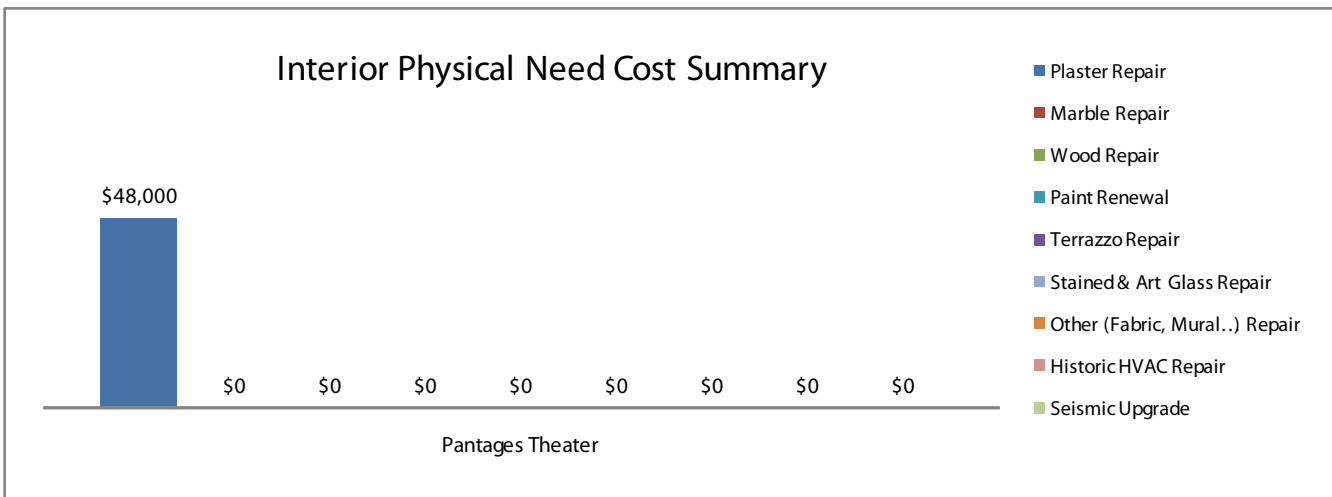
PANTAGES THEATER

Condition Issues: Overall, high integrity and excellent condition. The most pressing physical concern is portions of the terra cotta cladding are damaged and need repair. A small portion of the interior plaster needs repair. The interior walls and ceilings need cleaning as does the stained glass. The theater lobby was renovated and enlarged recently. The exterior cladding (fiber glass panels) was installed, matching the existing terra cotta panels. The interior walls, ceiling, and columns were also clad in the same fiberglass panels. During this renovation, a fire suppression system was installed in the hall and lobby; smoke detectors were also installed in the auditorium. The building was seismically retrofitted in the 1981 renovation. The building's steam heating system is ineffective and needs overhaul.

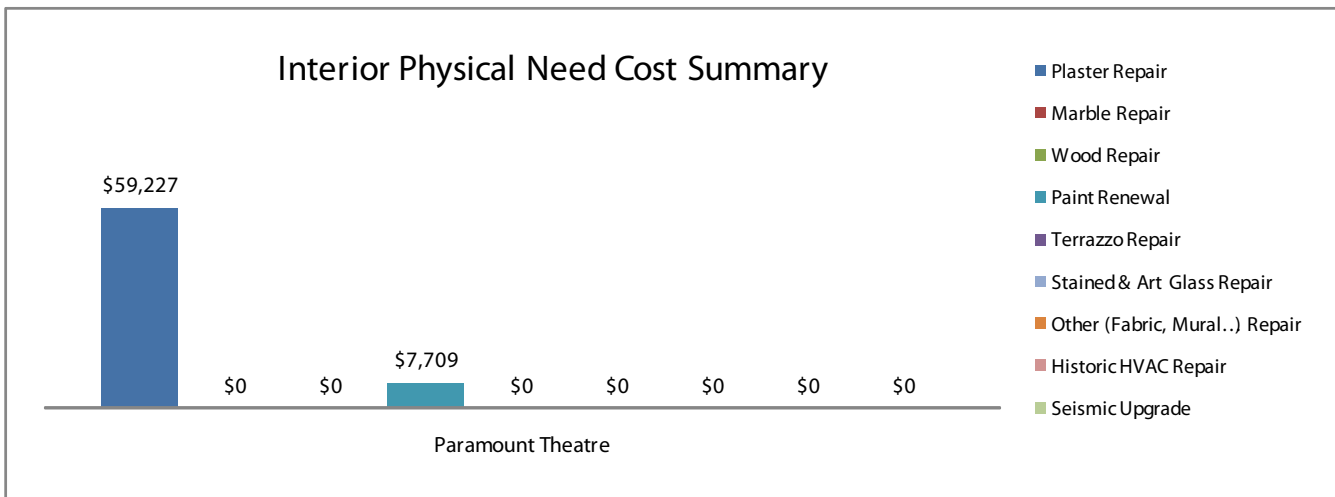
PARAMOUNT THEATER

Condition Issues: Overall, high integrity and excellent condition. The most pressing physical concern is the damaged interior plaster. The Paramount was restored and remodeled recently. The main floor seating was remodeled about ten years ago. The light fixtures were cleaned during the renovation. The exterior of the building was cleaned and the brick repointed about ten or twelve years ago. The roof was replaced about one year ago. The building has a fire suppression system backstage but not in the auditorium or lobby.

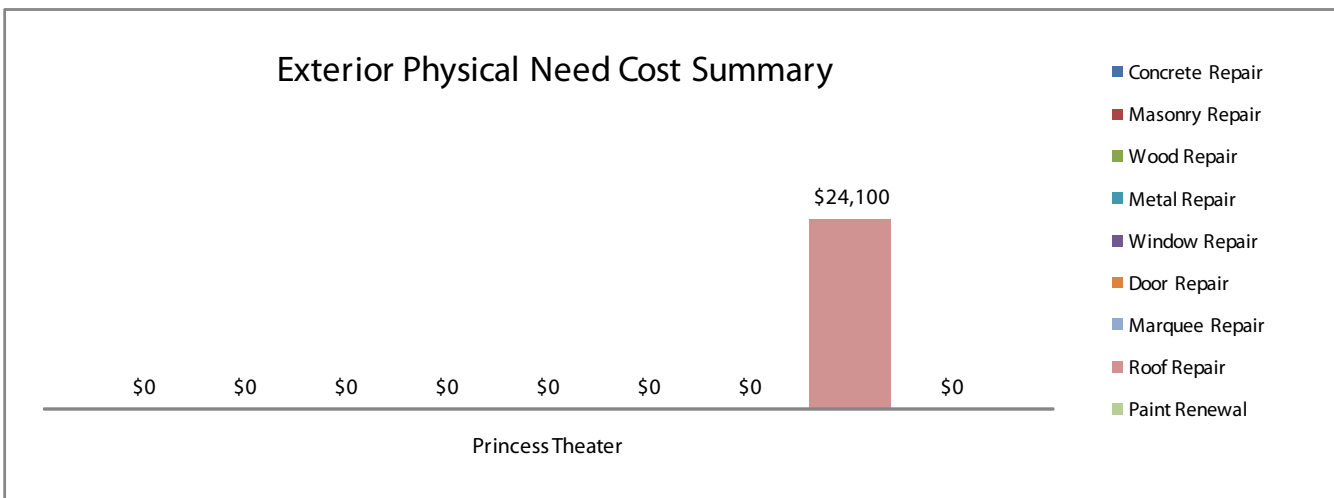
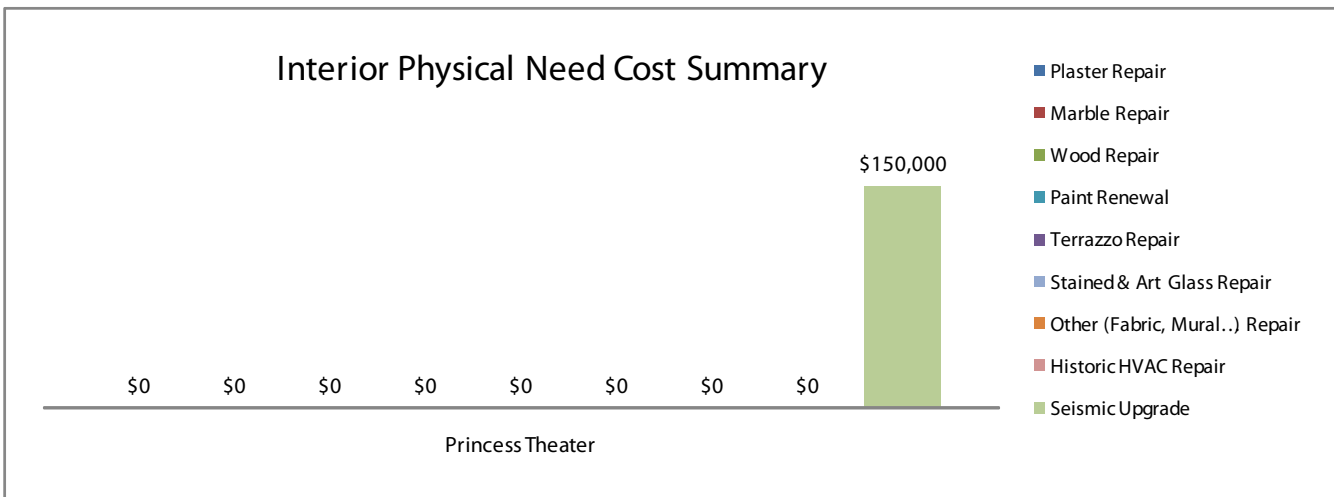
PRINCESS THEATER

Condition Issues: Overall, low integrity and excellent condition. The most pressing physical concern is the roof, which needs repair or complete replacement. The building was heavily remodeled in 2006 - 07. Interior doors were added, and the exterior doors are not original. The walls have been fastened to the concrete exterior walls. There is a large crack in the exterior concrete of the wall of the building; the crack runs the full height. Several large steel plates have been fastened on each side of the crack. Oval holes for the plate fasteners allow the plates to move with the wall. There are the remains of roof or floor joist pockets in the exterior of the concrete wall.

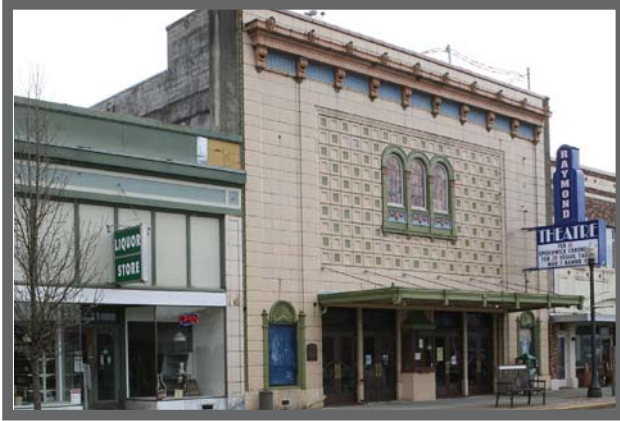
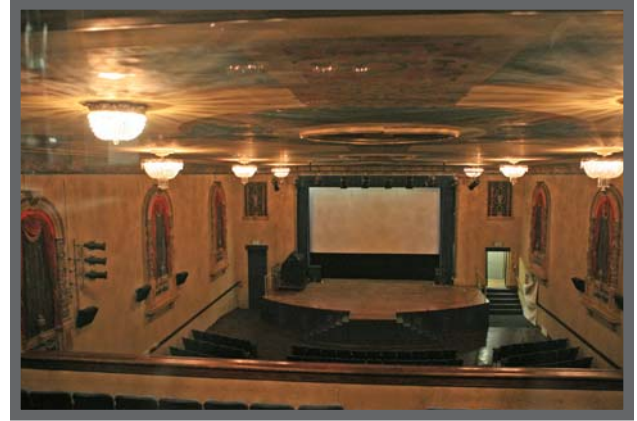
RAYMOND THEATRE

Condition Issues: Overall, high integrity and good condition. The most pressing physical concerns are damage to the terra cotta, water damage to the brick back wall, and the canopy's corroding structural steel beams. There are also areas of water damage to the interior plaster walls and ceilings. The Raymond Theatre was renovated several years ago. At that time, it was seismically upgraded, but the building is not equipped with a fire suppression system (fire sprinklers). The building may be experiencing settlement, as evidenced by cracks on the east corner of the front wall.

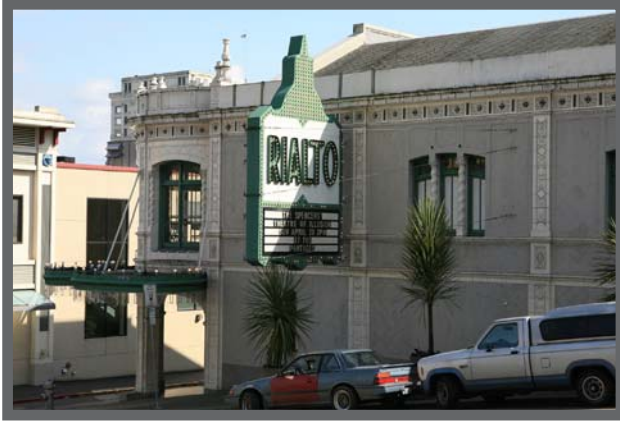
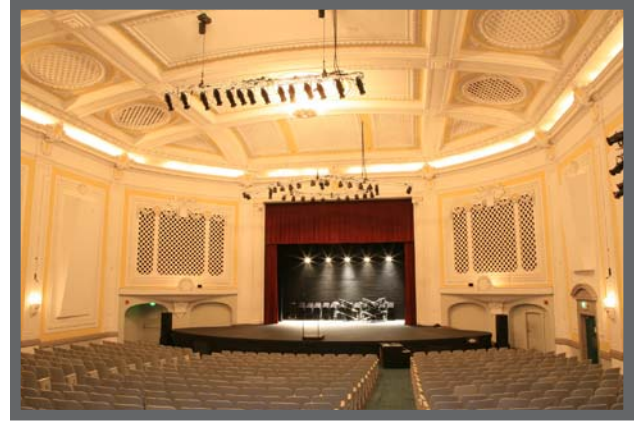
RIALTO THEATER

Condition Issues: Overall, high integrity and good condition. The most pressing physical concerns are the damaged terra cotta and stucco exterior finishes. Historic lighting fixtures need renovation and repair, and the second floor rotunda walls and ceiling need to be repaired and painted. The terra cotta along the parapet needs to be restored and the missing decorative lights installed. The city has the terra cotta replacement parts but not the money to install them. In addition, the few leaks into the building are thought to be coming from the exterior parapet lights. For future preservation efforts, the interior needs to be cleaned. There is no air conditioning or heating in the lobby. A 1991 renovation structurally reinforced the building with a steel and concrete frame inside the historic envelope. The building is ADA compliant. The auditorium is fully sprinkled.

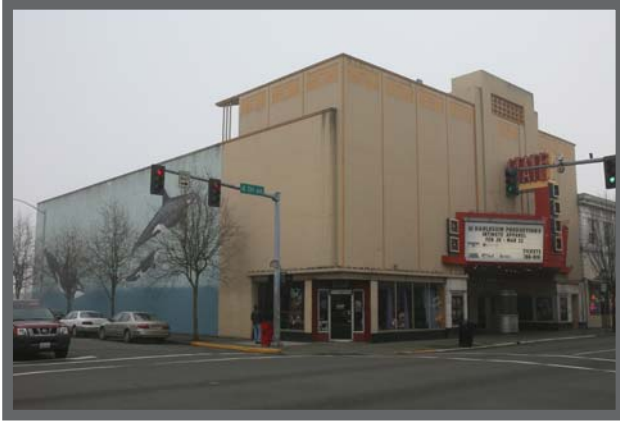
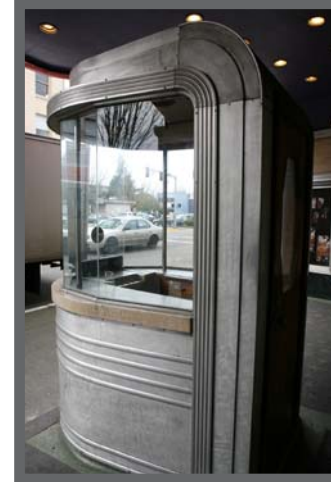
STATE THEATER

Condition Issues: Overall, moderate integrity and good condition. The most pressing physical concern is the roof. It is leaking despite being only fifteen years old. Several of the leaks appeared when the new HVAC system was installed in the summer of 2007. The entry doors are original, but they are weathered and need restoration. Sprinklers were added to the building in 1998, and the electrical system was upgraded in the same year. The building has not been seismically upgraded, but it was originally designed and constructed to withstand seismic activity. The building is ADA accessible, including the restrooms.

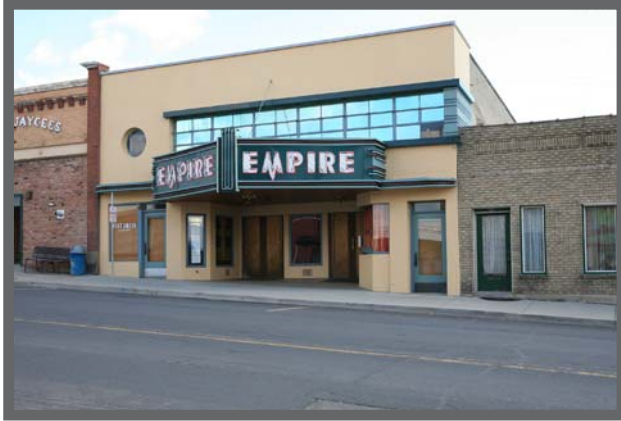
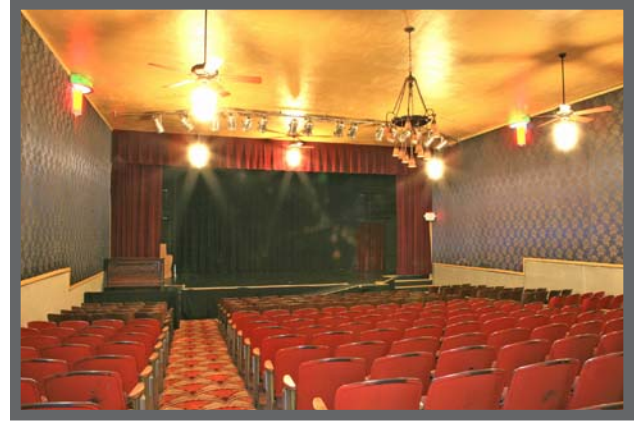
TEKOA EMPIRE THEATER

Condition Issues: Overall, high integrity and good condition. The most pressing physical concerns include several items. The entry doors appear to be original, but they are water-stained at the bottom and need to be removed and completely restored. The old squirrel cage fan is in need of a new electric motor, axle bearings, and cleaning. The wood floors need to be refinished. The original historic wall fabric needs to be repaired and cleaned. Carpeting is torn and needs replacement. The building has not been seismically upgraded and is not equipped with a fire suppression system (fire sprinklers). The theater is not ADA compliant for the auditorium seating or restrooms. The electrical systems have been recently upgraded. The roofing material was replaced in 2007.

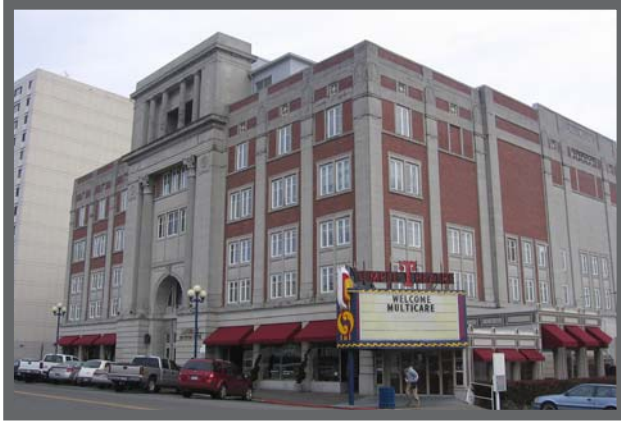
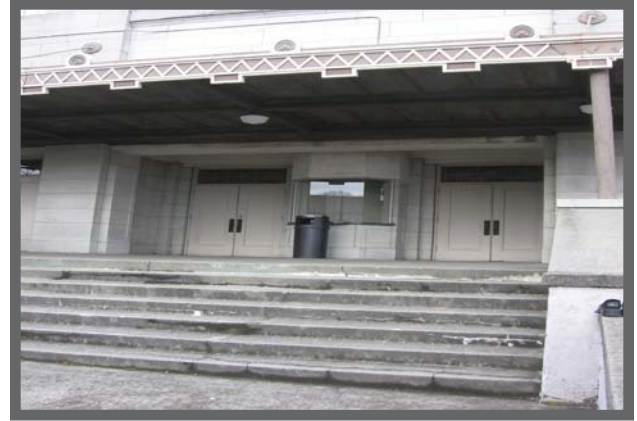
TEMPLE THEATER

Condition Issues: Not surveyed on the interior. Exterior condition issues include the cracked sandstone on either side of the west entry for the main building (not the corner theater entrance). On the rear (east) facade, there are some cracks that run up a good portion of the wall as well as some shorter cracks. Seismic activity is likely responsible for some of the cracks. Integrity has not been evaluated because the interior was not accessed.

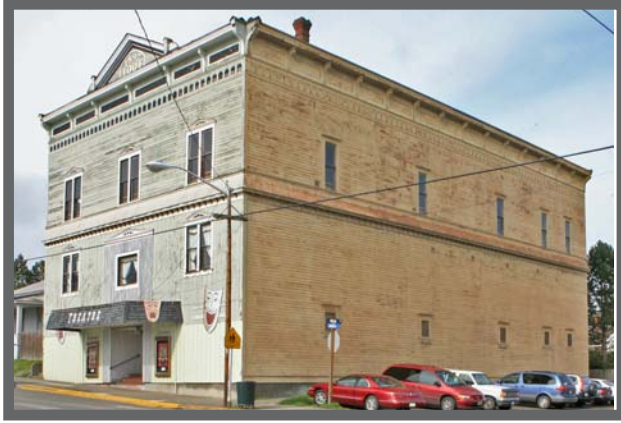
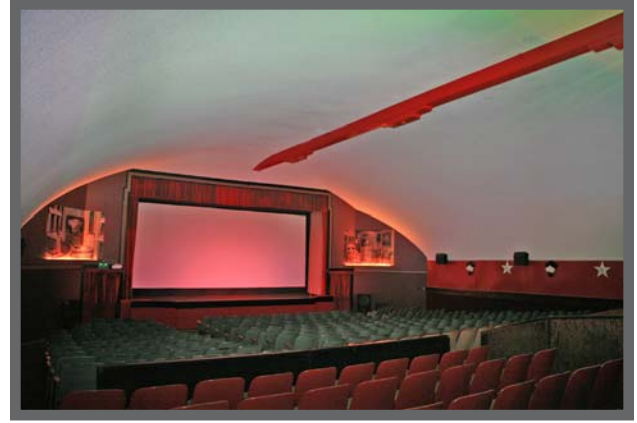
UPTOWN THEATER

Condition Issues: Overall, high integrity and good condition. The most pressing physical concern is the cladding. A leaking leader box or downspout is getting the siding wet on the west side of the building. All siding needs painting, especially on the alley side (rear). Some nails are bleeding and some portions of siding are broken or damaged. There are several double hung wood sash windows that are original to the building and appear to be in restorable condition. There has been no seismic upgrade to the building. Since the building has an unusual structural system (second floor is supported off a beam running the length of the building), tying this structure together would protect this unique architecture from damage or possible failure during a seismic event. The electrical system is being updated as time and money allows. Presently the building does not meet ADA codes for restrooms, exiting or seating. To install handicapped accessible toilets would greatly alter the historic interior, but creating handicapped seating would only require the removal of a few seats. The building is not sprinkled. The roof is only seven years old and is not leaking.

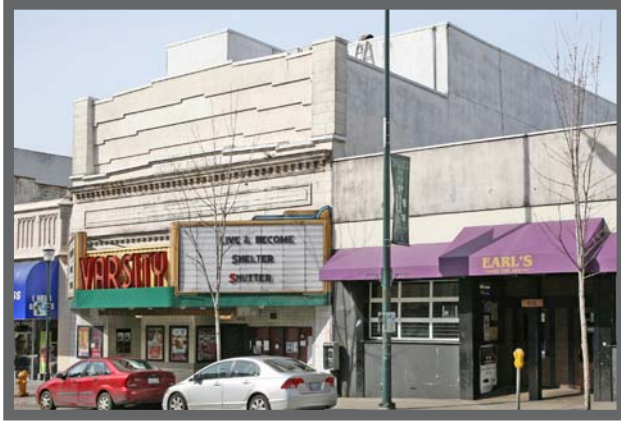
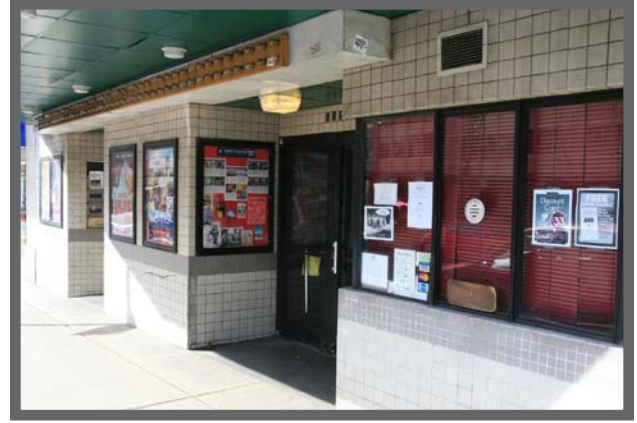
VARSITY THEATER

Condition Issues: Not surveyed on the interior, and no exterior condition issues noted. Integrity has not been evaluated because the interior was not accessed.

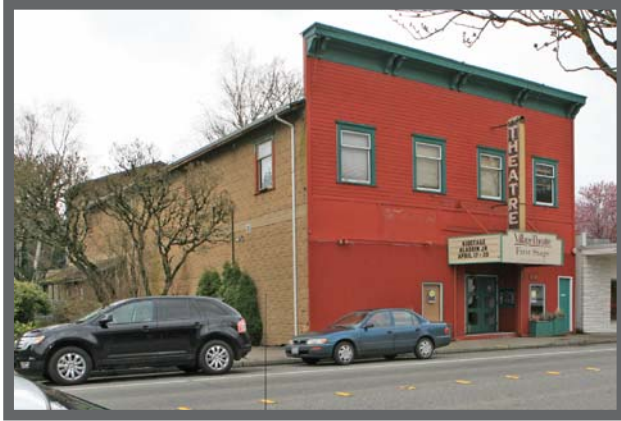
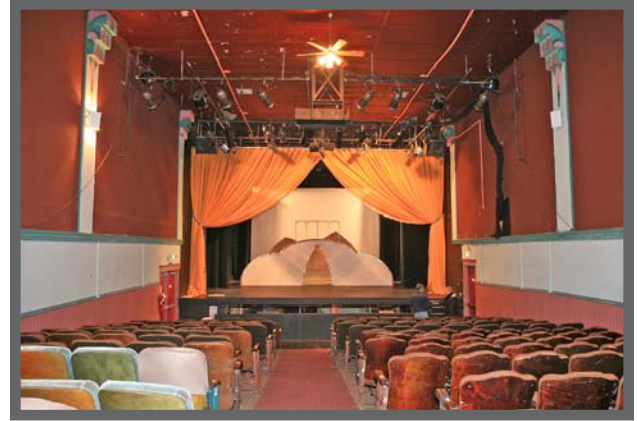
VILLAGE THEATER

Condition Issues: Overall, moderate integrity and poor condition. The most pressing physical concerns are the foundation, exterior walls, and roof. The building needs a perimeter foundation and drains. Sections of the extant wood sill are deteriorating from pests and water exposure. Interior footings for the floor need to be reinforced. All exterior walls need restoration. Drop-siding needs to be repaired, restored, and painted. New roof gutters and downspouts should be installed and tied to the storm drains. The windows and doors need to be stripped and painted, and the interior needs a complete restoration, including the second floor. The building has not been seismically upgraded, and there is no fire suppression system (fire sprinklers). There is an ADA entrance/exit ramp and restroom.
