HISTORIC THEATRES

STATEWIDE SURVEY AND PHYSICAL NEEDS ASSESSMENT

This report commissioned by the Washington state Department of Archaeology and Historic Preservation.

Published June 30, 2008

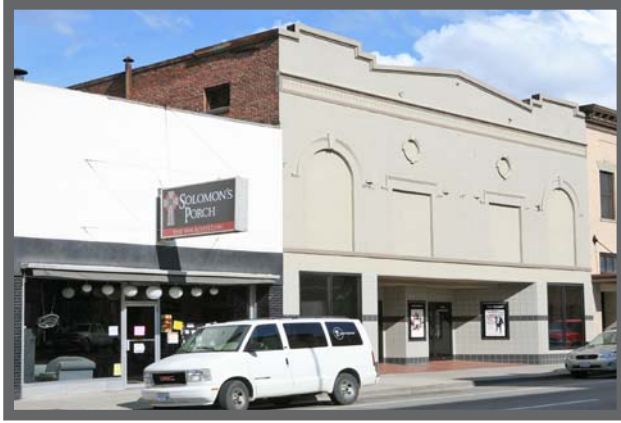
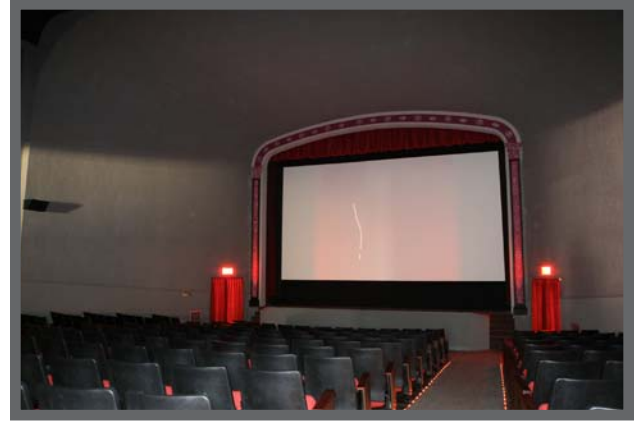
LIBERTY II

Condition Issues: Overall, moderate integrity and excellent condition. There are no pressing physical concerns. The auditorium was duplexed in 1984. Portions of the exterior have been changed, but there is integrity, such as the varied window moldings above street level and the shaped parapet. The front facade retains its stucco above the non-historic tiled entry. Upper level windows have been infilled, leaving only non-historic, aluminum-framed shop windows at street level. There is no fire suppression (sprinkler) system. The first floor is ADA accessible, including the restrooms. The roof was redone in 1991.

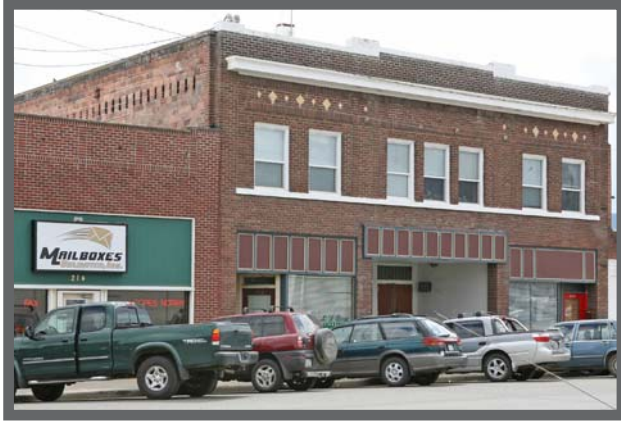
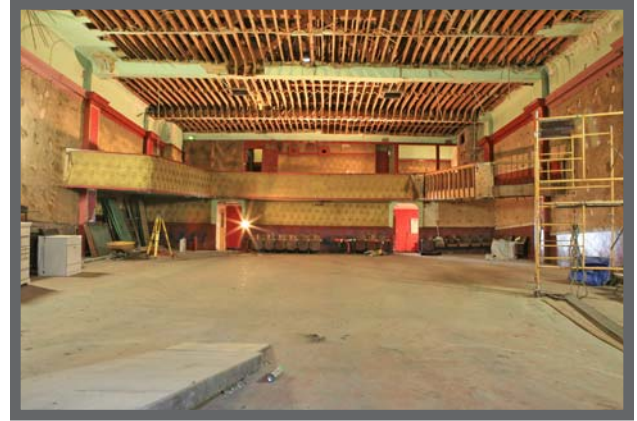
VOGUE THEATER

Condition Issues: Overall, moderate integrity and fair condition. The most pressing concerns are being addressed by renovation efforts in 2008. However, the renovation itself is also a cause for loss of integrity as historic material is being removed. Interior plaster and lath has been removed from the ceiling and walls. Oval shaped auditorium walls (inset from the brick exterior walls) have also been removed. All seats have been removed from the auditorium although a few remain stored inside the building. It is reported that this demolition was necessary because of the water damage caused during the years the building was unoccupied. Wall coverings, which appear to be of fibrous material covered by silk, are being removed because of their water damage and coal dust saturation. Brick walls need repointing. There is no heating system now. There is no canopy or marquee remaining. The wood floor of the balcony is in good condition but the status of the balcony support mechanisms is unknown. Renovation plans call for the balcony to remain but with modifications. The concrete main floor is exposed but in good condition. A new roof was recently installed. At this level of renovation, it must be assumed that the building will have to be brought up to existing building and safety codes.

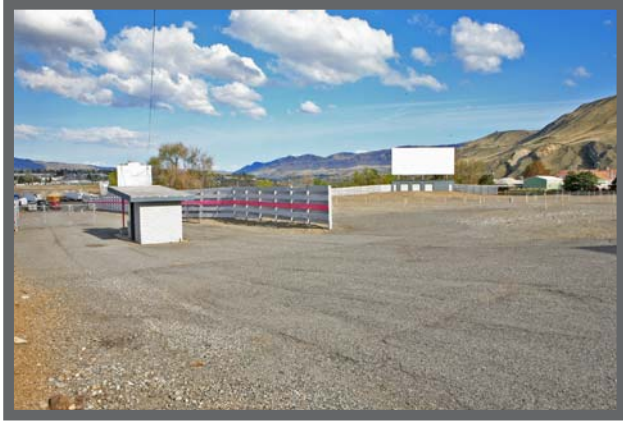
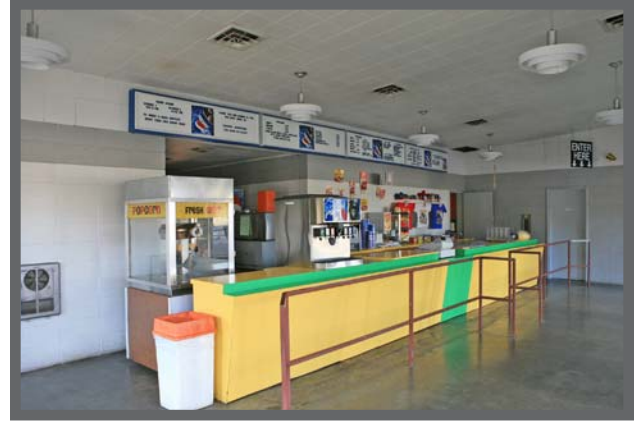
VUE DALE DRIVE-IN THEATER

Condition Issues: Overall, high integrity and excellent condition. No physical concerns noted.

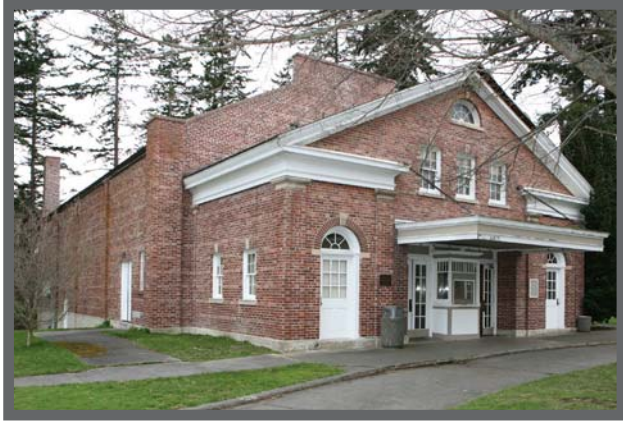
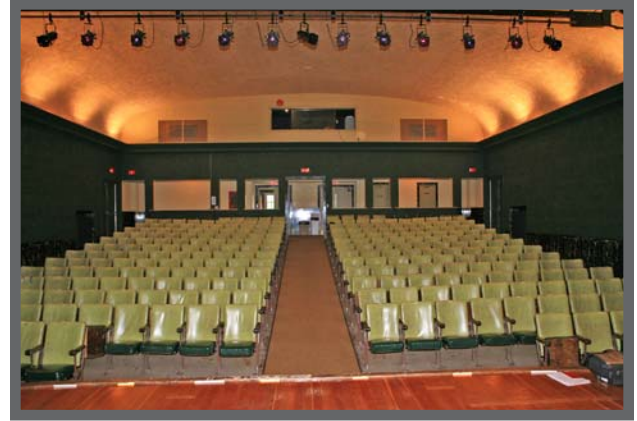
JOSEPH F. WHEELER THEATER

Condition Issues: Overall, high integrity and excellent condition. The most pressing physical concerns are damage to the pediment trim over the entry, building systems, and a damaged canopy. The gable end pediment is missing a piece of wood trim. The mechanical system is old, as is the electrical system; both need upgrading. Inset radiators are spaced along the walls; these are also original and need to be serviced and restored. A passing truck banged the entry canopy on one corner. The building has not been seismically upgraded, and it does not have a fire suppression system (fire sprinklers). The structural system appears to be in excellent condition.
