CURRAN HOUSE HISTORIC STRUCTURE REPORT

Published May, 2010

Charles and Mary Louise Curran Residence

4009 Curran Lane

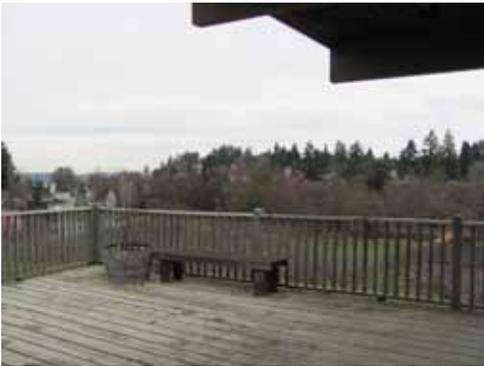
View of deck, looking north. Source: Artifacts Consulting, Inc.

The critical maintenance issue from a safety standpoint is the deck, which is currently unstable. Deterioration of the wooden structural system makes the deck currently unusable and a potential safety hazard.

- Remove the deck and replace with one of similar plan (footprint), but a stronger support system is needed. Framing members which are in good condition may be considered for reuse.

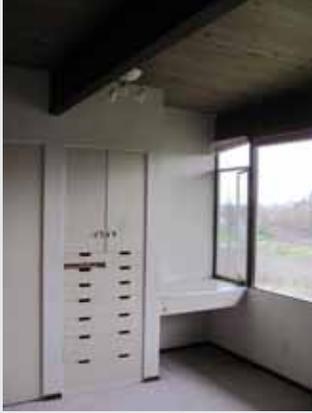
<p>Bedroom 3</p>	<p>This is the smallest of the three main floor bedrooms, located at the south corner of the house. Windows face southwest, sharing a wall with the main entry and facing Rock Road West and the driveway. This bedroom provided dedicated sleeping space for one of the Curran daughters. Original finishes included dark stained textured plywood wall paneling on the southeast wall, gypsum board for remaining walls, asbestos tile flooring, and stained wood beams and decking as ceiling. Alterations include added wall-to-wall carpet. Casement window is broken.</p>	<p>Secondary</p>

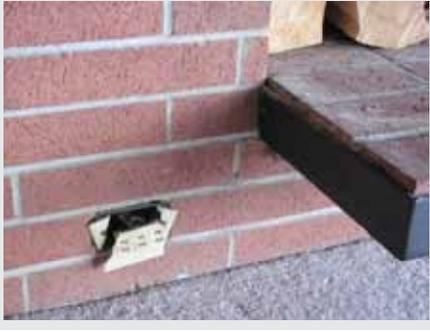
<p>Outlet Covers</p>	<p>Small outlet covers are located on the interior walls and on the main floor fireplace. Some outlet covers are broken or missing.</p>	<p>Minimal</p>

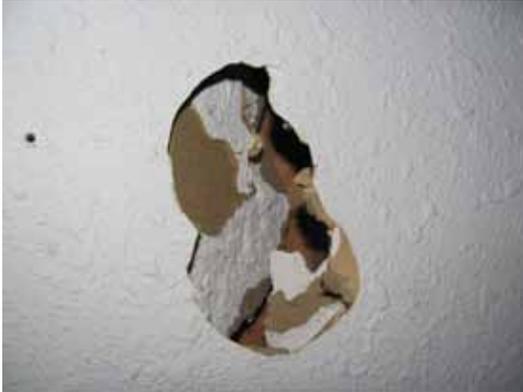
Detail of hole in wall of basement family room. Similar hole evident in bedroom #3. Source: Artifacts Consulting, Inc. 2010

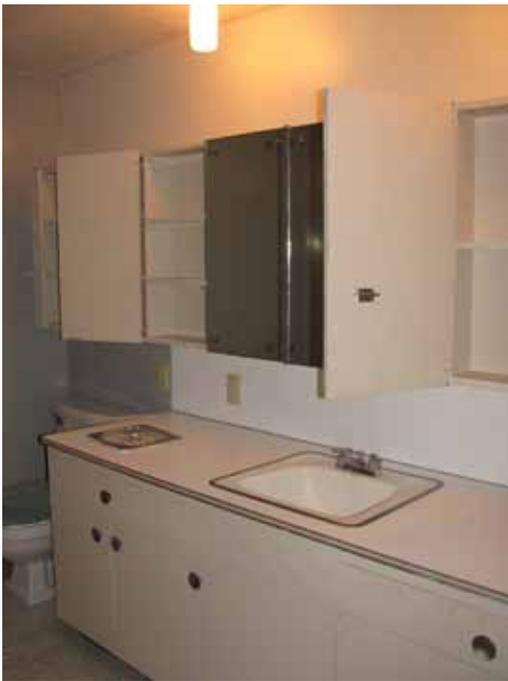
Intact cabinets, counter, sink and light fixture in bathroom #2. Source: Artifacts Consulting, Inc. 2010

Bath #2 – original flooring, sink, light fixtures, shelves, and cabinets. The toilet, tub, fan cover (detached, on counter) and hardware, including toilet roll holder, faucets, and taps, have been replaced. The towel rack is missing except for one bracket. Cabinets and shelves are intact.
