DOWNTOWN EVERETT HISTORIC BUILDINGS
ASSESSMENT & TOOLKIT

Prepared for:
The City of Everett

BOLA Architecture + Planning

July 21, 2017

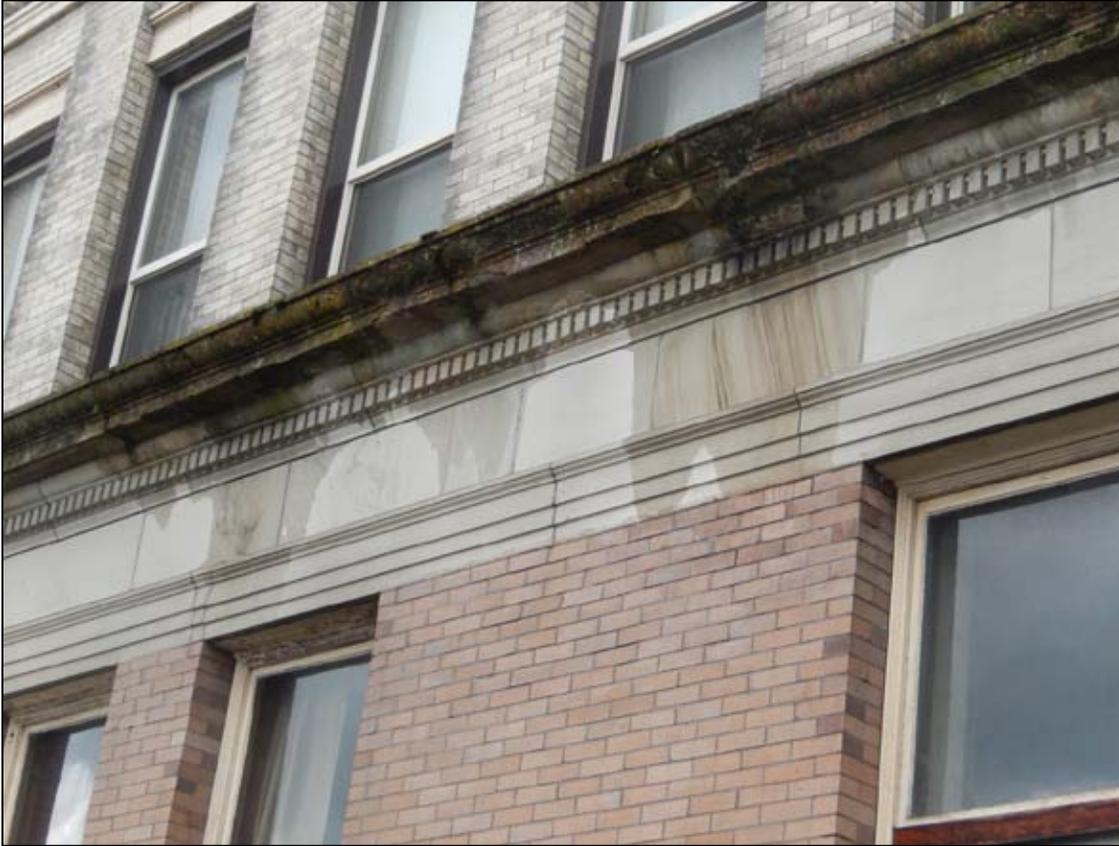
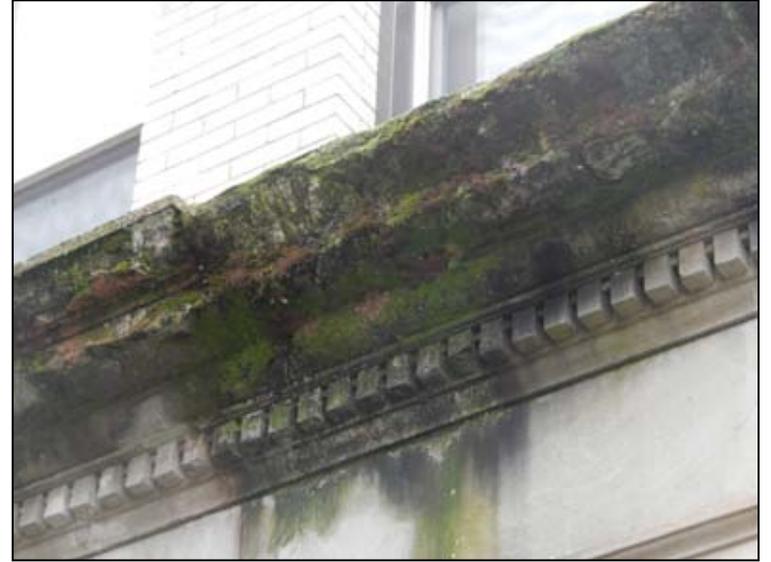
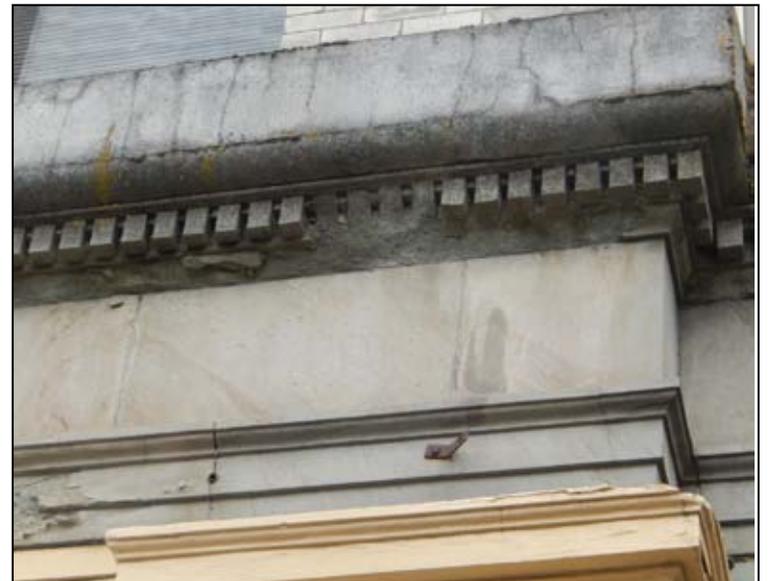
STONE

Stone trim and details introduce another color and texture to a building façade. Stone is often used as a window sill or lintel, string course, or cornice. The examples pictured here are showing problems resulting from water damage.

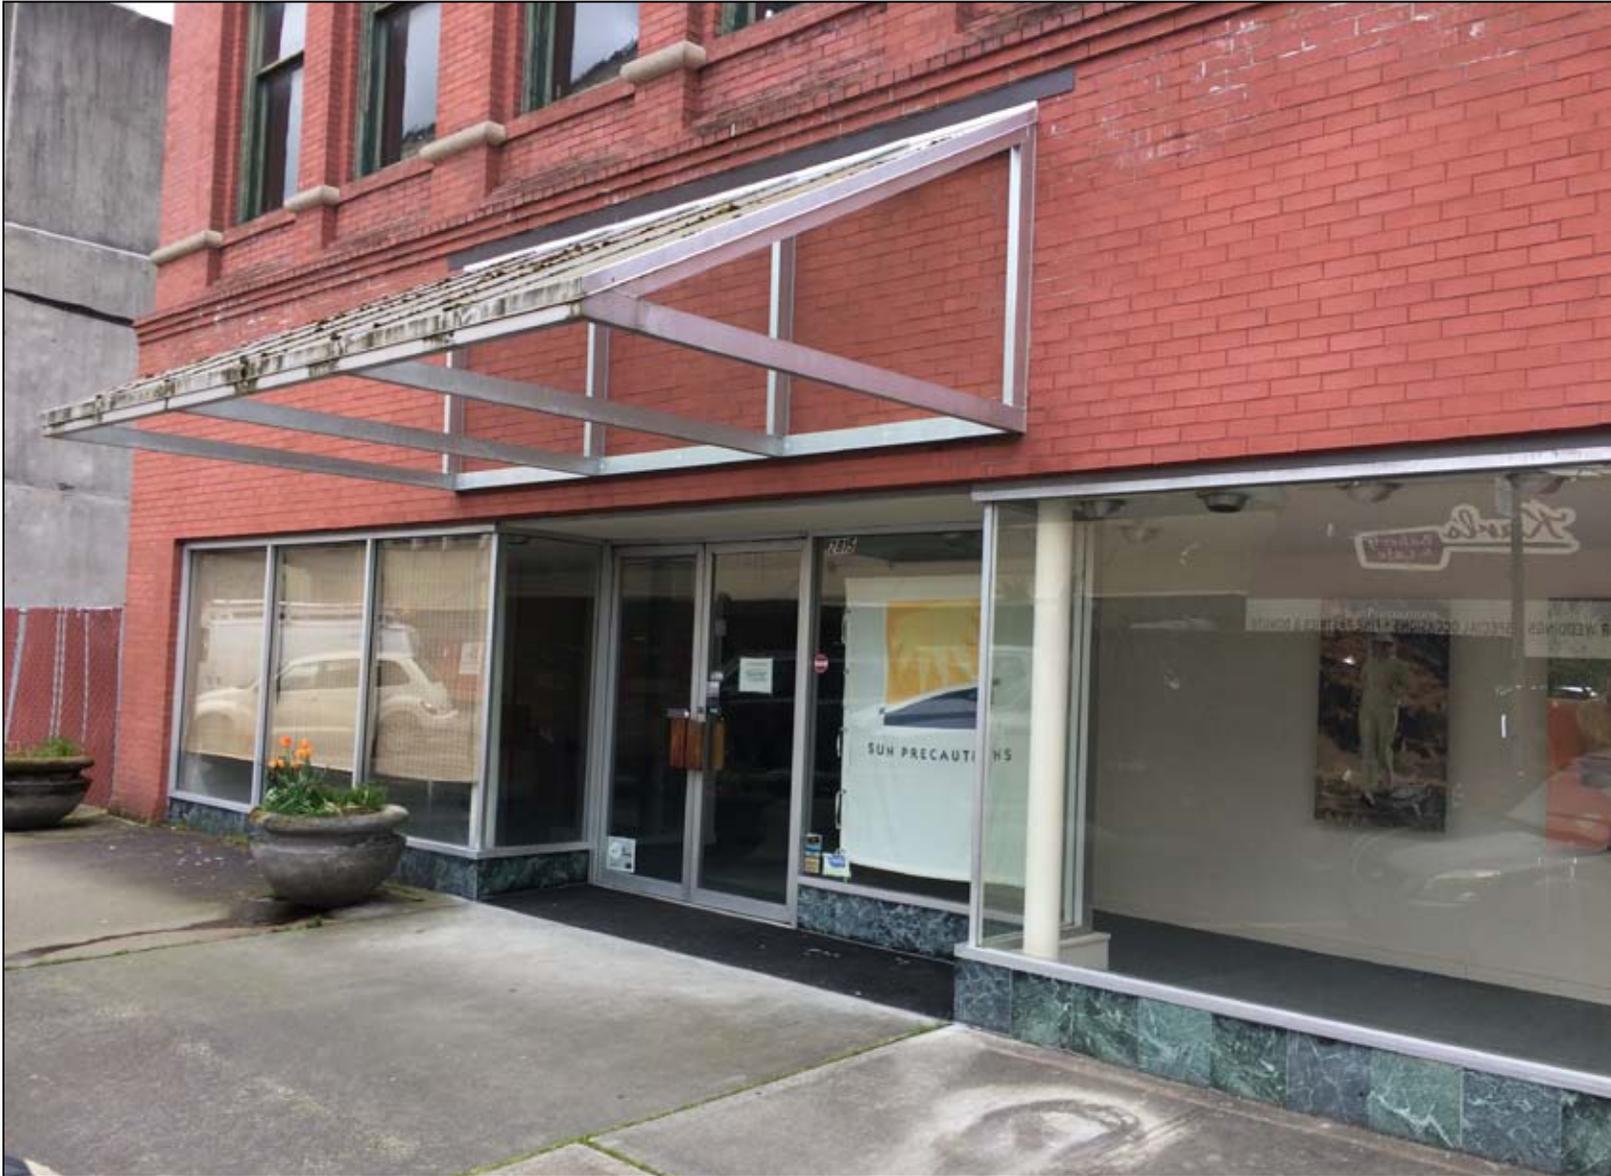
In each of these three examples, the original storefront assembly was replaced with a contemporary version that is not harmonious with the building's historic character. The proportions and materials are out of place. The alterations to the Horseshoe Saloon also resulted in a loss of visual transparency.

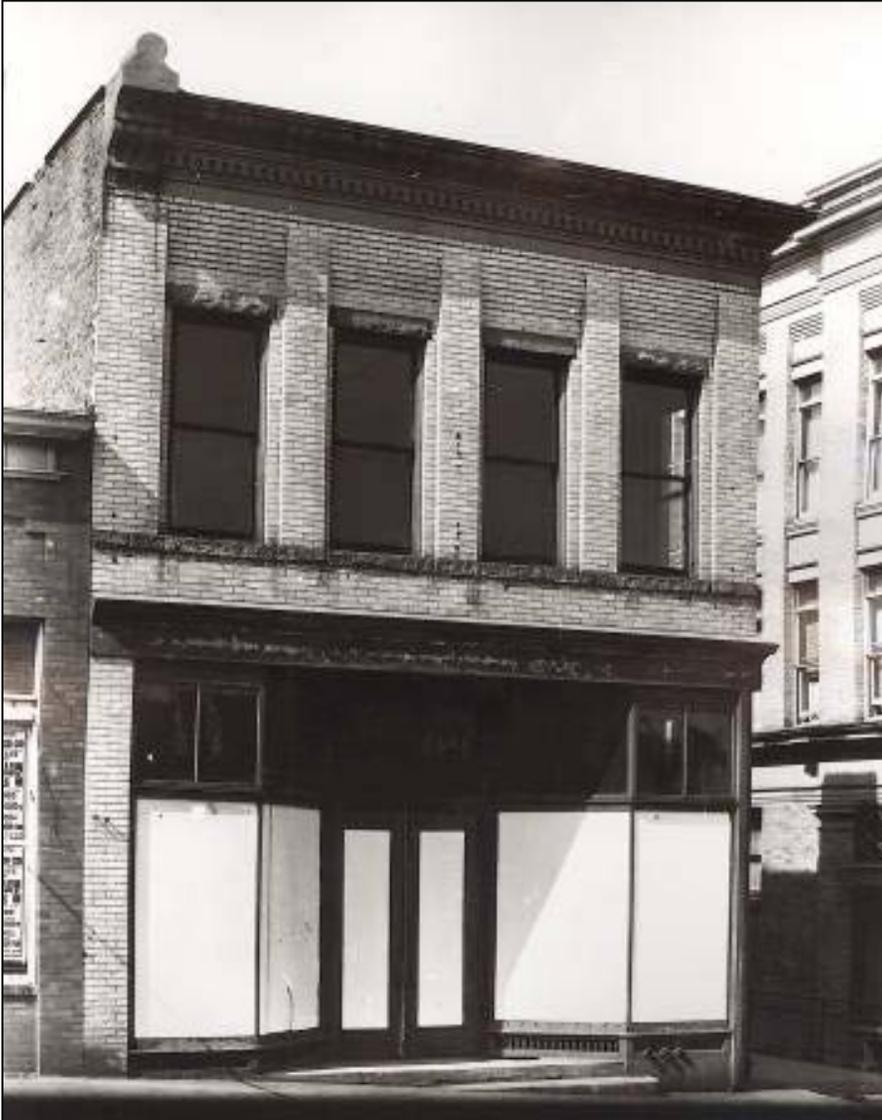
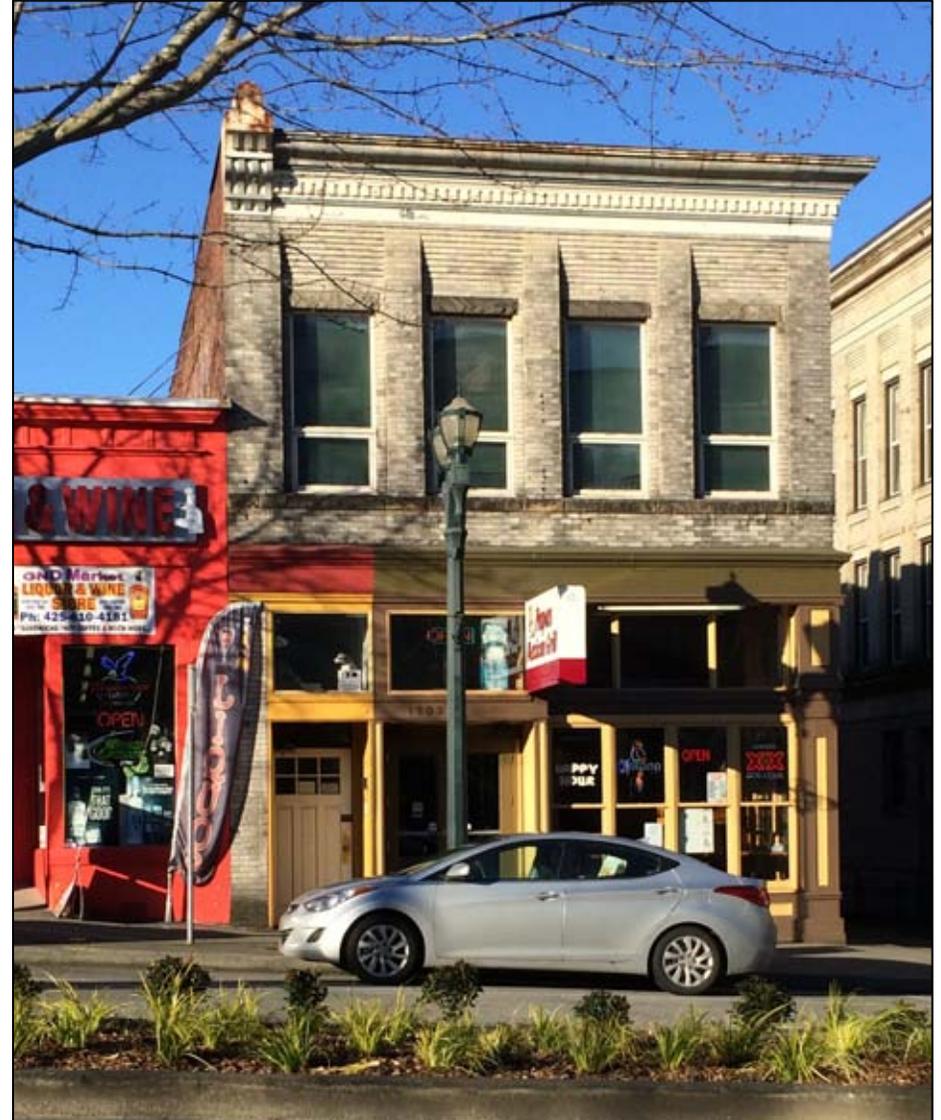
EVERGREEN BUILDING (1902) • 1909 HEWITT AVENUE

- Face brick is generally in good condition, although at the sign band level there are holes in the brick, likely from signage installed and removed over time. There are some areas of missing mortar/open joints in the brickwork. Brick, along with stone details, should be inspected by a qualified mason, cleaned, repaired and repointed where needed.
- Consider replacing non-original second-floor windows with single-hung wood windows that better match the originals, visible in the historic photo.
- The sheet metal cornice should be inspected to verify condition and confirm that it is properly attached to the building. Based on a cursory view from the sidewalk, it appears there are areas of missing paint. At a minimum, the cornice should be cleaned, properly prepared, and repainted.

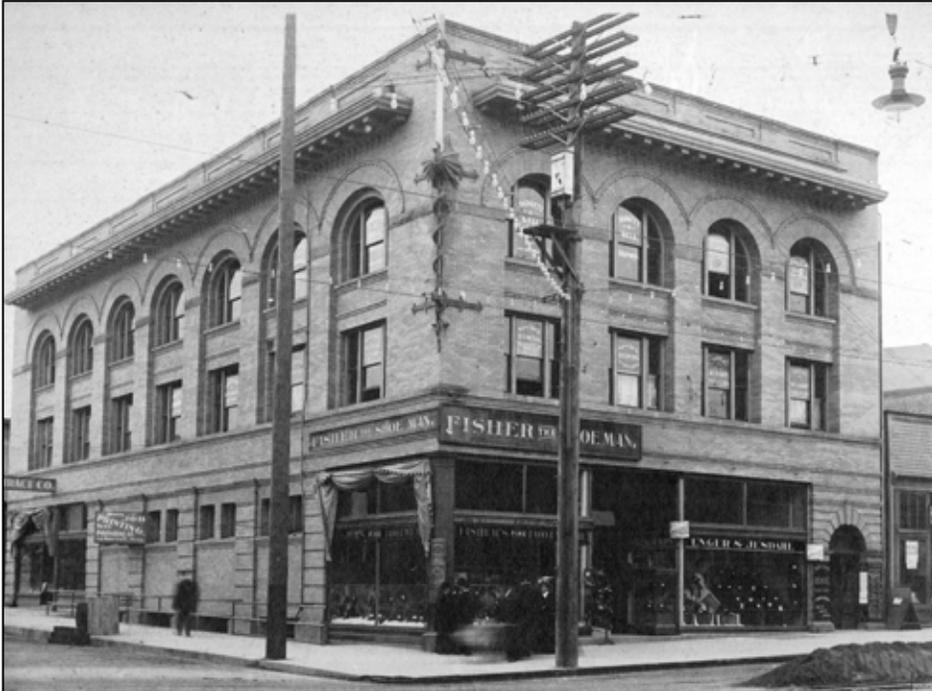
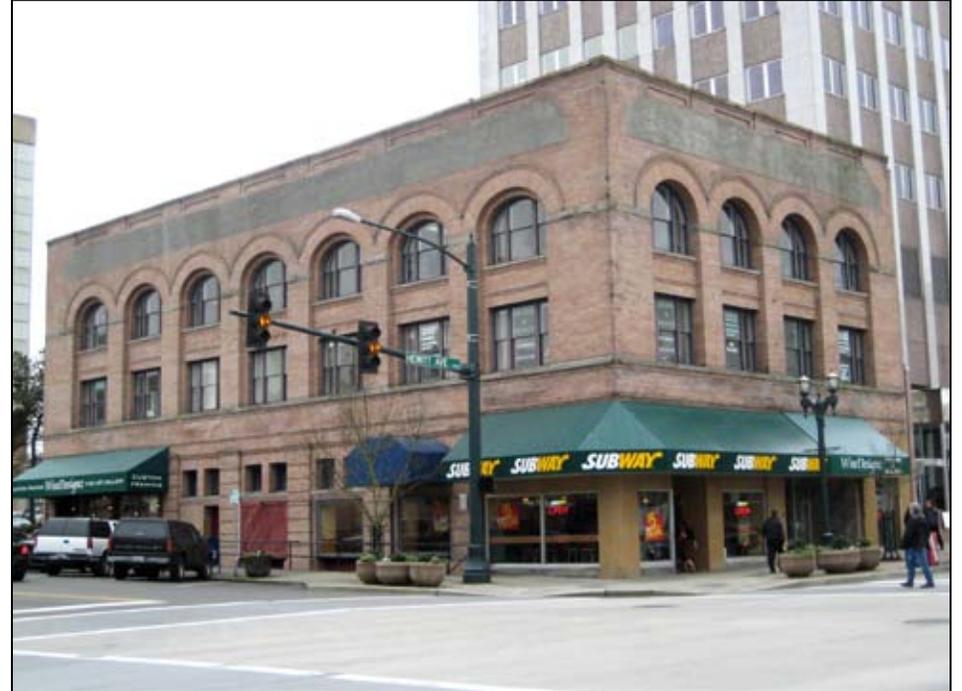
GREENBERG BLOCK (1903) • 1620 HEWITT AVENUE

- There is evidence of extensive water infiltration, indicated by staining and plant growth.
- Sandstone trim is in poor condition, with spalling, cracks, and biological growth.
- Face brick is generally in good condition, although at the sign band level there are numerous holes in the brick from signage installed and removed over time. There are some areas of missing mortar/open joints in the brickwork. Brick should be inspected by a qualified mason, cleaned, repaired and repointed where needed.
- Second- and third-story original wood windows appear from the sidewalk to be in fairly good condition, although the sills were not visible and may be deteriorated.
- Consider reconstructing the original projecting cornice, which has been removed. Brace the tall parapet.
- Storefronts have been remodeled, most extensively on the north and northeast corner.

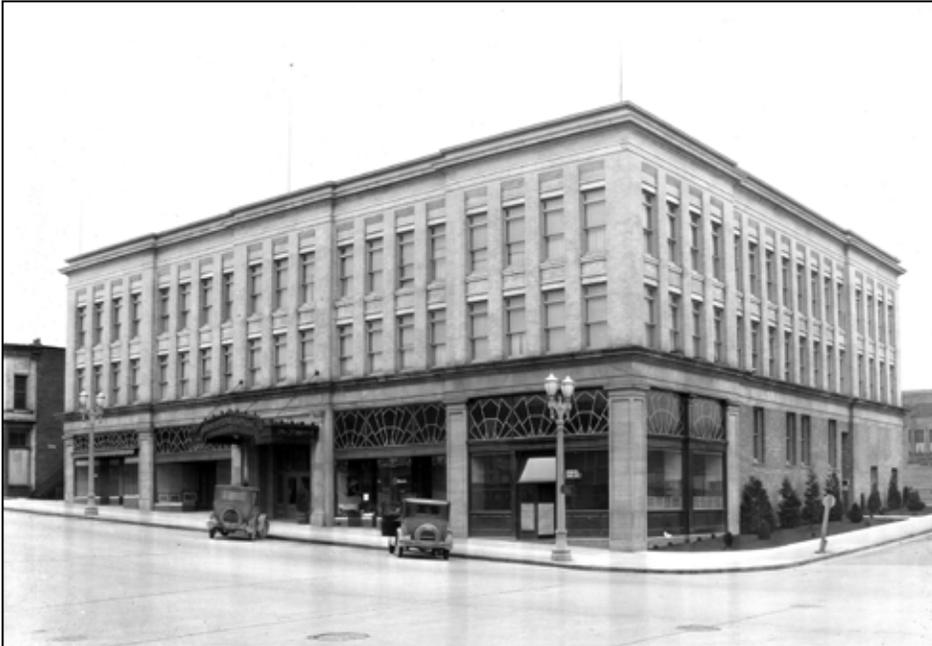
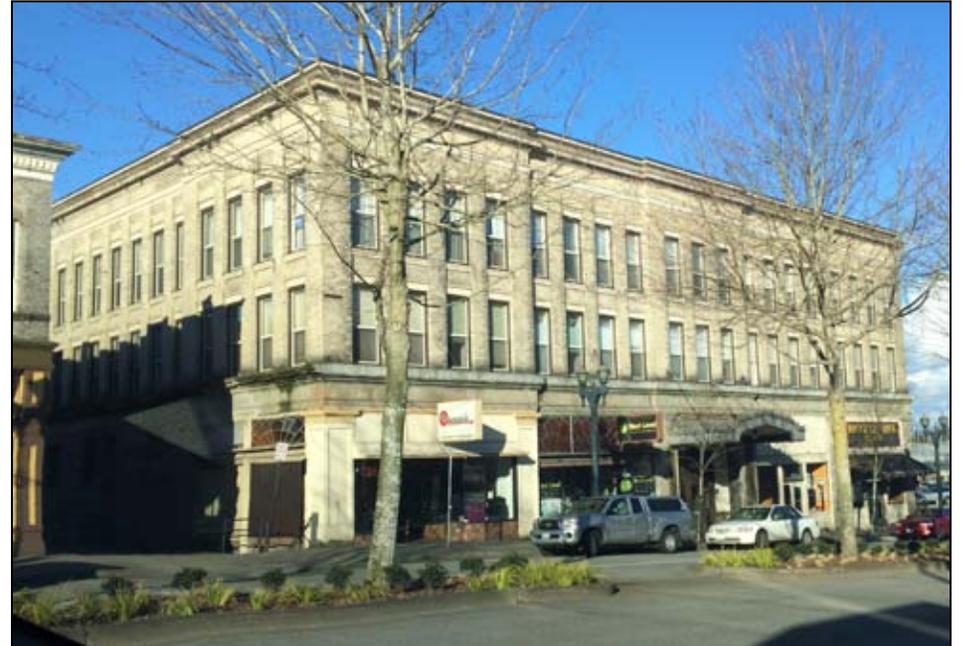
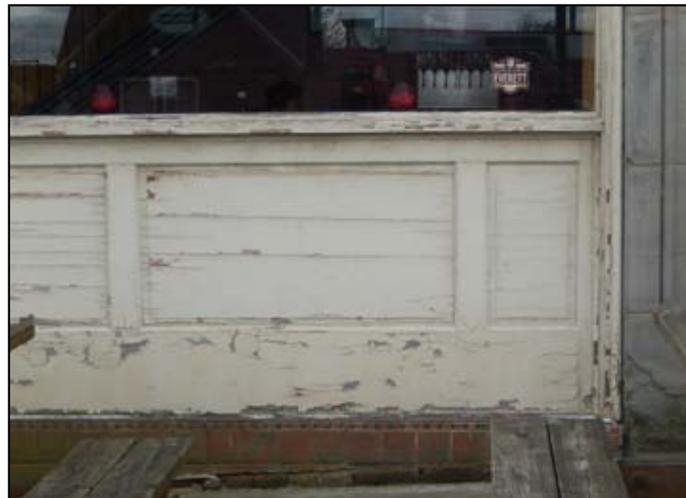
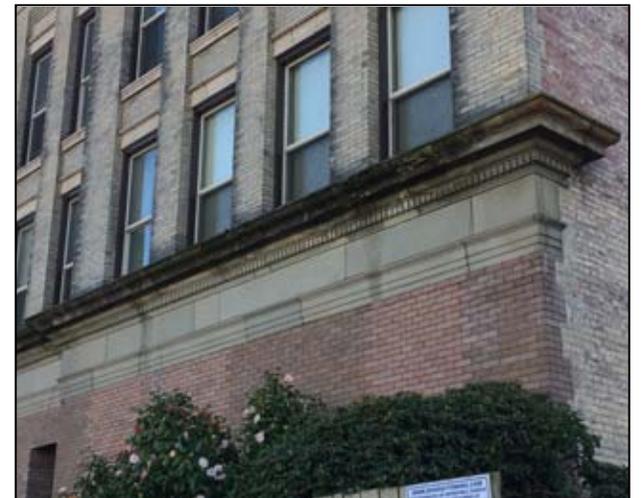
MITCHELL HOTEL/CASCADIAN APTS (1903) • 915 HEWITT AVENUE

This building has very good integrity but suffers from some significant deterioration. Water infiltration is evident, indicated by staining and areas of moisture, particularly on the sandstone, and extensive biological growth.

- Sandstone trim is in very poor condition in some areas, and the projecting cornice and intermediate cornice (below the second floor line) may be a safety hazard. It should be immediately inspected by a stonemason for further steps.
- The face brick and terra cotta trim appear to be in relatively good condition but should be inspected by a qualified mason. Brick should be cleaned and repointed where needed.
- The tall brick chimney should be repointed as needed and braced.
- The building has a tall parapet, which should be braced.
- The metal awning/marquee over the central south entrance should be inspected, cleaned, and repaired as necessary.
- Scrape, prime, and repaint wood storefronts, bulkheads, and doors.

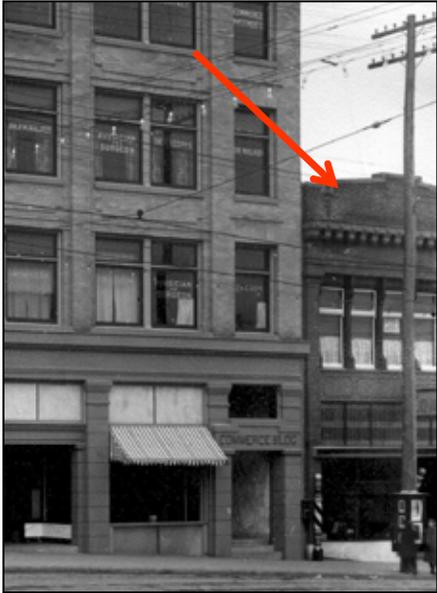
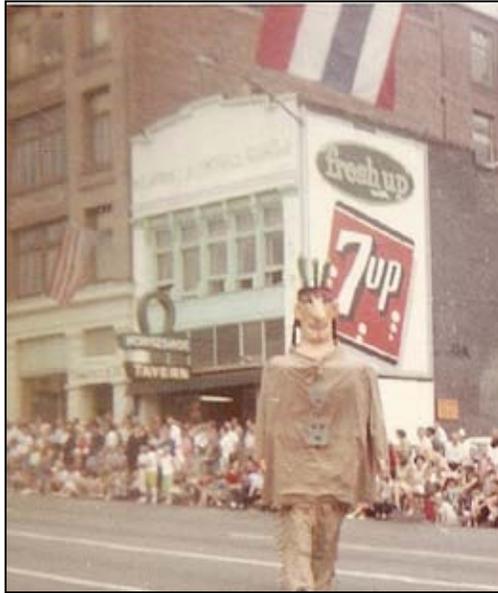
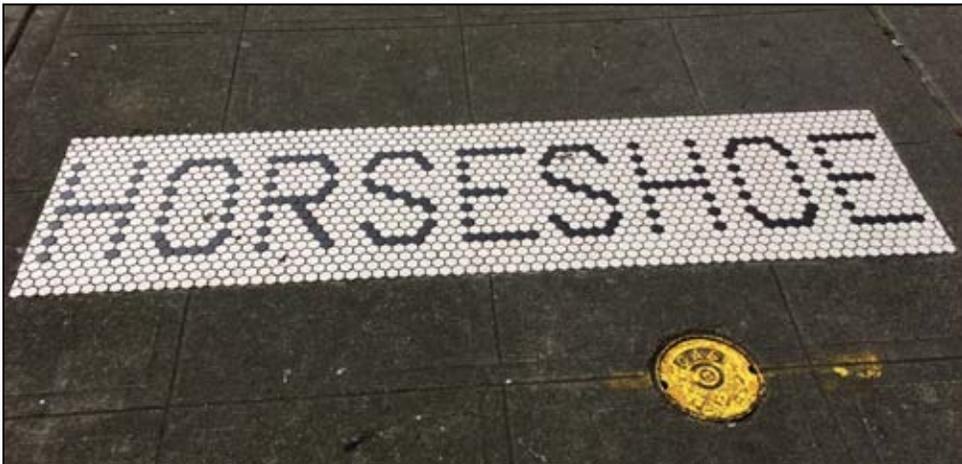
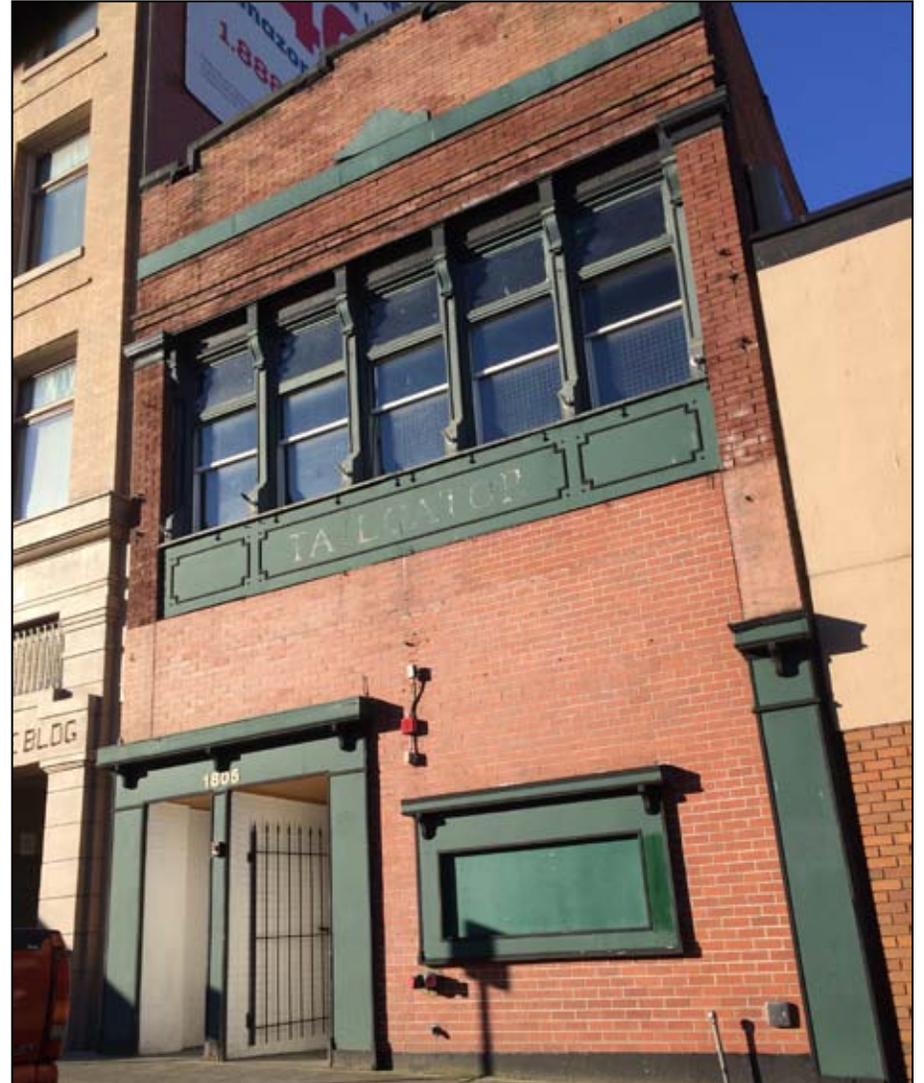
HORSESHOE SALOON (1909-10) • 1805 HEWITT AVENUE

- Some of the original brick appears to be deteriorating. The brick should be inspected by a qualified mason, cleaned, repaired and repointed where needed.
- Scrape, prime, and repaint wood trim.
- Consider replacing non-original second-floor windows with single-hung wood windows that better match the originals, visible in historic photos.
- Consider reversing the extensive alterations at the first story and restoring a historically appropriate storefront.
- Consider reconstructing the projecting cornice to provide physical water repellency for surfaces below.

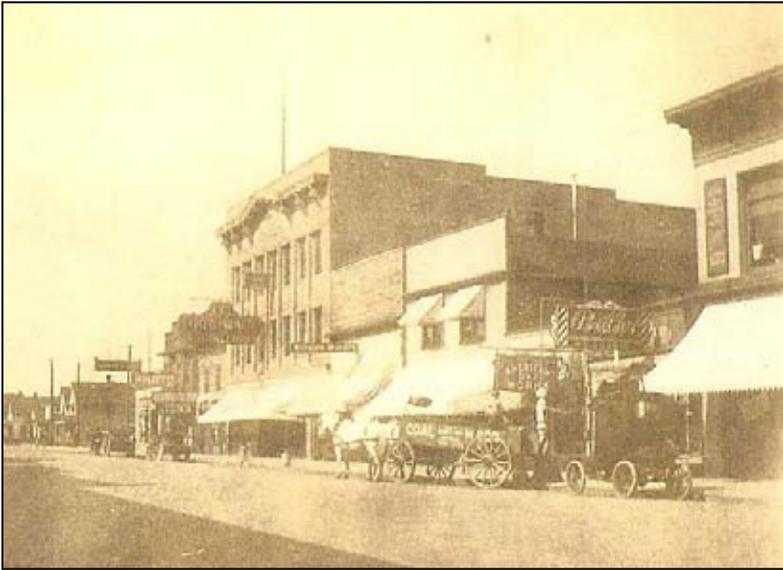
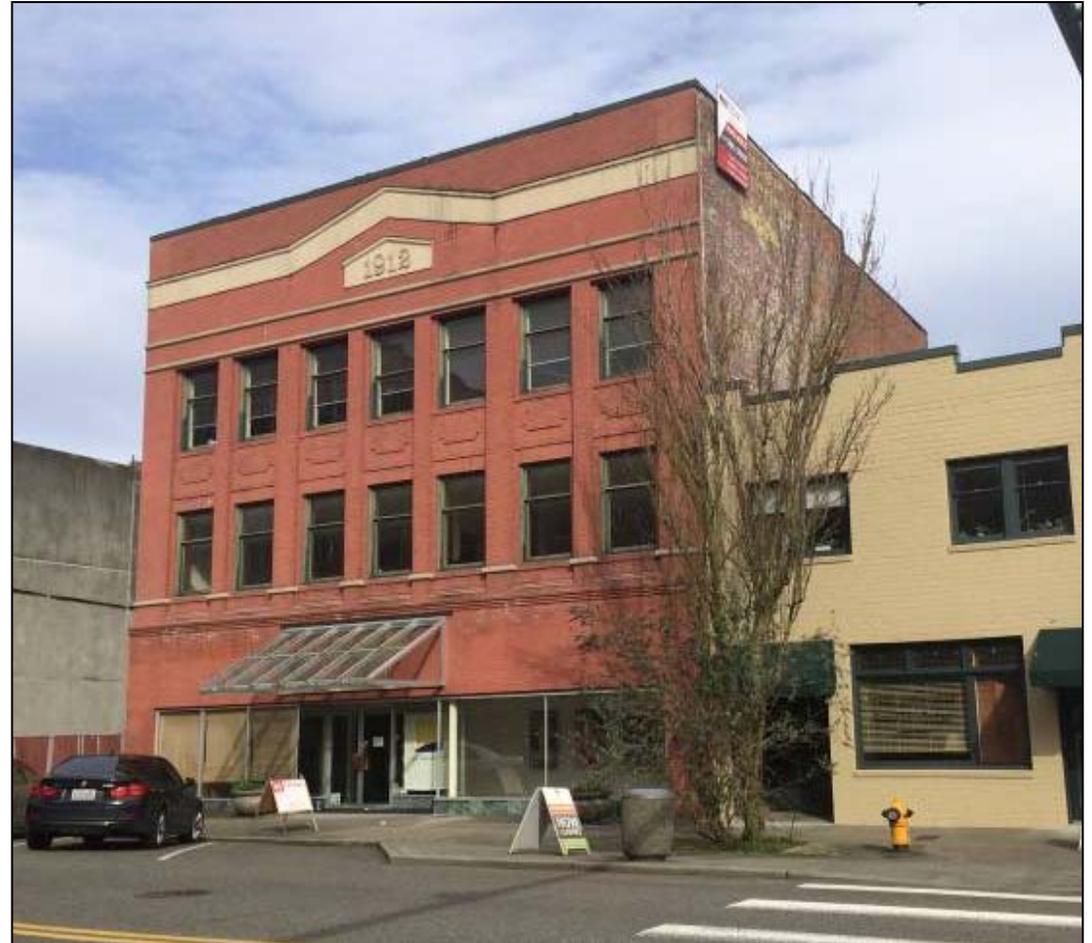
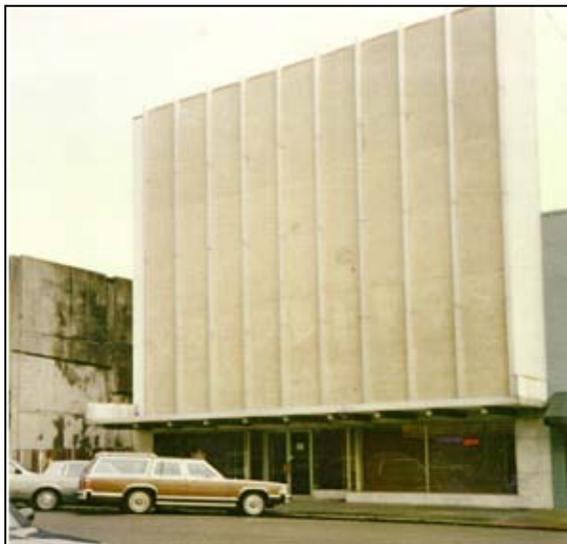
IOOF HALL (1912) • 2815 WETMORE AVENUE

- Reconstruct the projecting cornice.
- Remove the non-original glass awning, which is incompatible with the historic character of the building. Consider an awning more sensitive to the building. Consider restoring the storefront to the original, taller height.
- The original wood windows appear to be deteriorating. Undertake a window survey to determine their condition and necessary repairs; repair the windows.
- The brick should be inspected by a qualified mason, cleaned, repaired and repointed where needed.

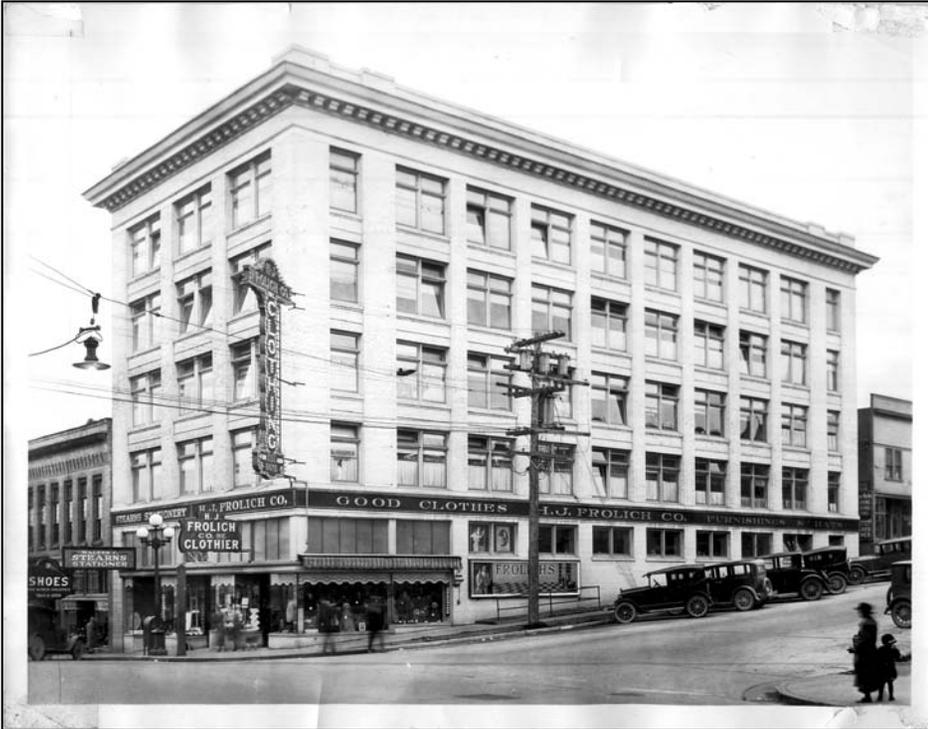
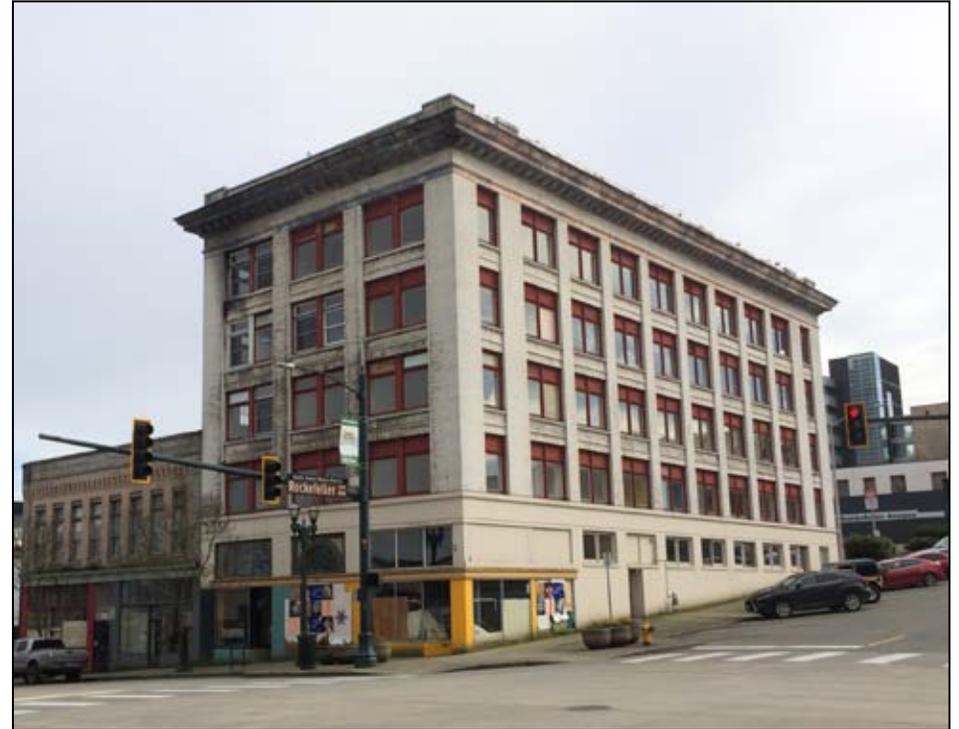
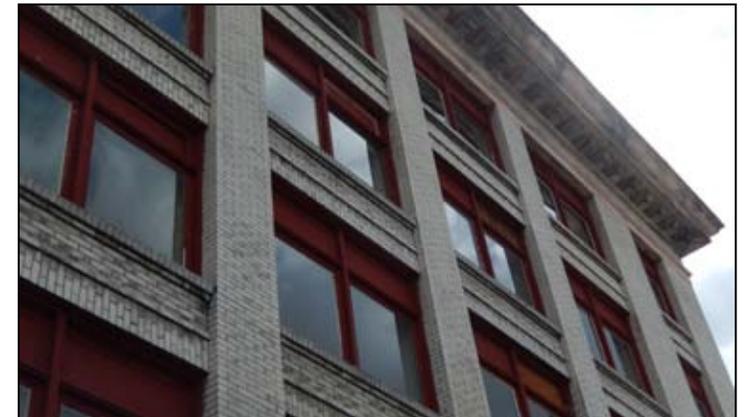
HODGES BUILDING (1923) • 1804 HEWITT AVENUE

- The face brick is stained in many areas. The brick should be inspected by a qualified mason, cleaned, repaired and repointed where needed.
- Scrape, prime, and repaint wood trim.
- The sheet metal cornice should be inspected to verify condition and confirm that it is properly attached to the building. Based on a cursory view from the sidewalk, it appears there are extensive areas of missing paint and some rust. At a minimum, the cornice should be cleaned, properly prepared, and repainted.
- Consider reversing the alterations at the first story and restoring a historically appropriate storefront, including transom windows.

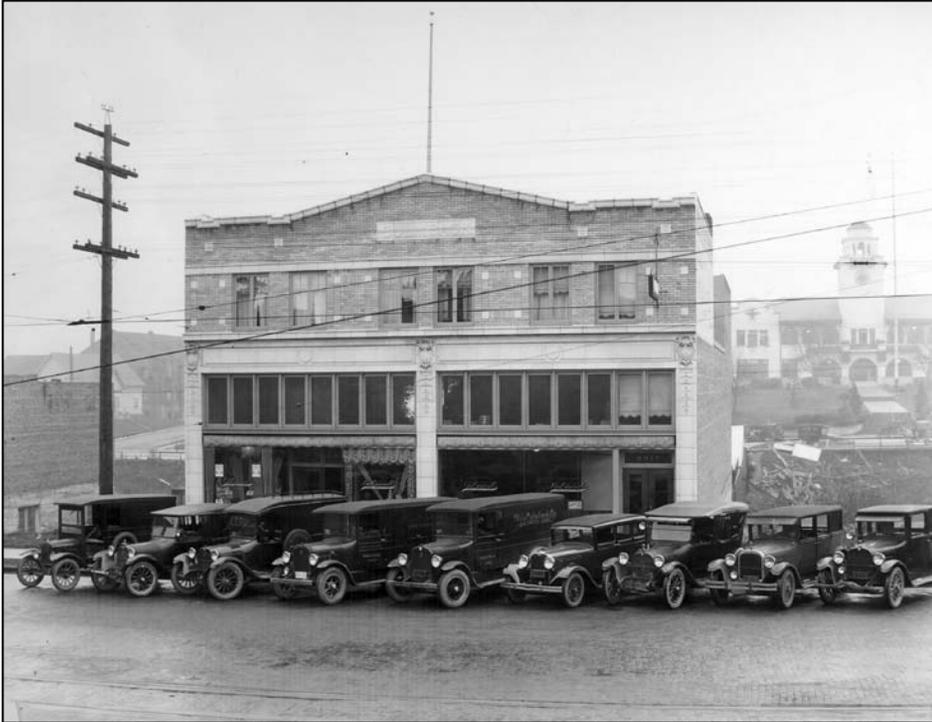
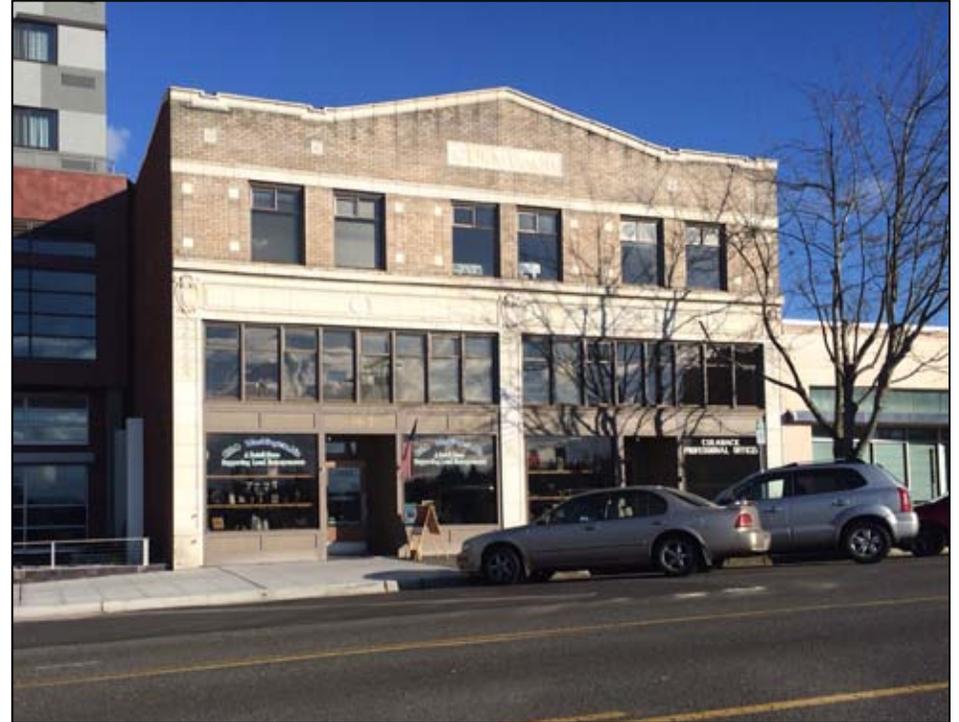
CULMBACK BUILDING (1924) • 3013 COLBY AVENUE

- The common red brick that is exposed on the north side of the building was likely intended to be covered by an adjacent building and not meant to be exposed as exterior brick. It has some efflorescence, as well as missing mortar and evidence of former ivy growth. The face brick on the primary west façade appears to be in good condition. The terra cotta has some spalling, some open joints, and areas that have been previously painted. The brick and terra cotta should be inspected by a qualified mason, cleaned, repaired and repointed where needed.
- Consider replacing non-original second-floor windows with wood windows that better match the original casement windows, visible in historic photos.

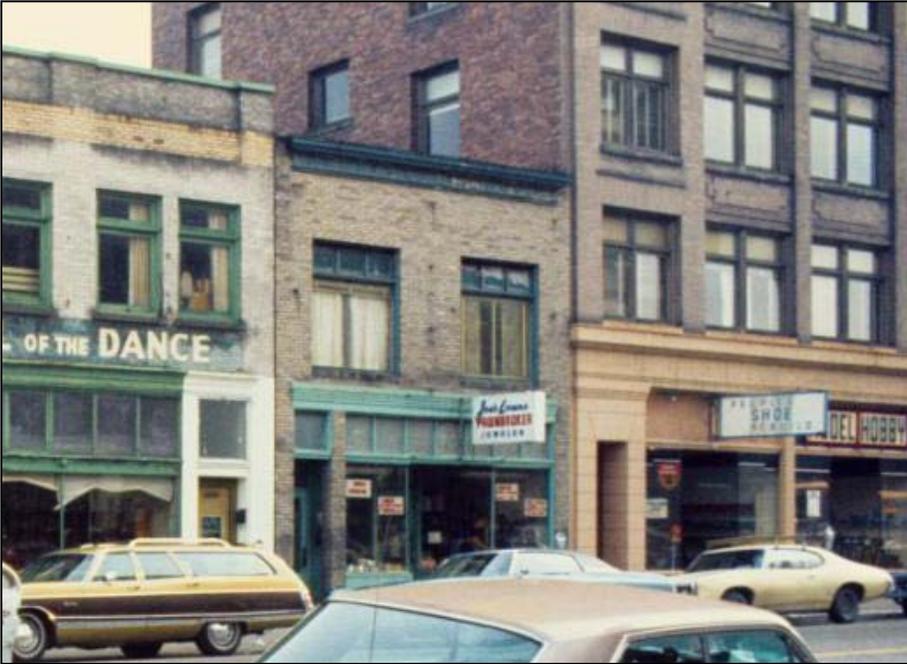
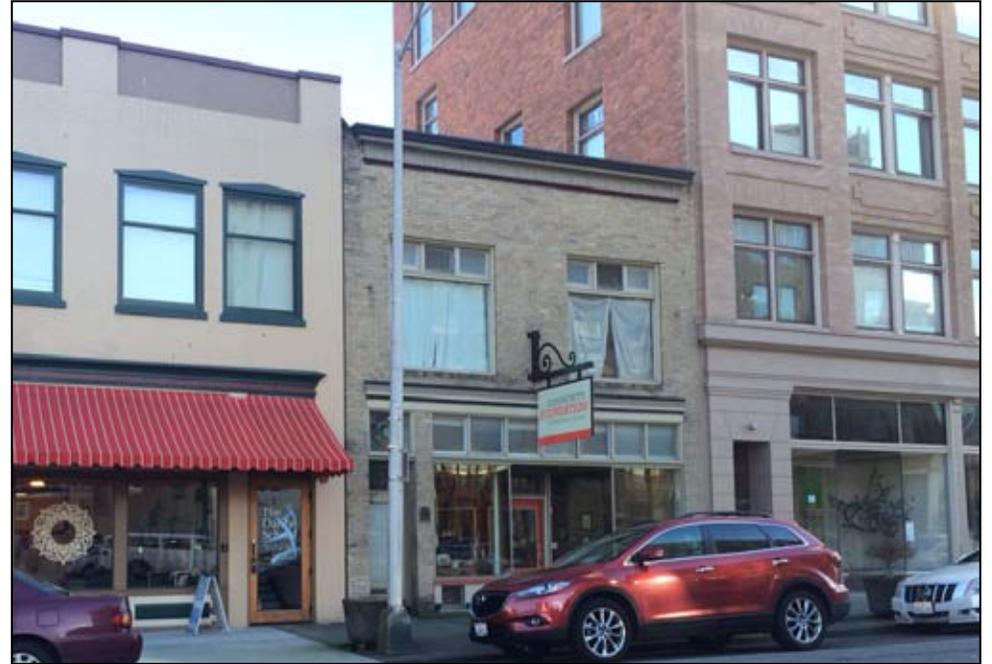
MORROW BUILDING (1925) • 2823 ROCKEFELLER AVENUE

- The brick appears to have been repointed in some areas, and original mortar is showing areas of failure. The brick should be inspected by a qualified mason, cleaned, repaired and repointed where needed.
- There is some missing trim along the bottom of the display window at the storefront, resulting in exposed wood. Add trim.
