HENDERSON HOUSE

HISTORIC STRUCTURES REPORT

Published: May 6, 2014.

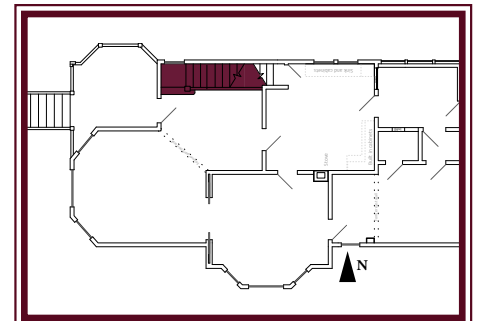
Condition:

- Split and damaged baseboard

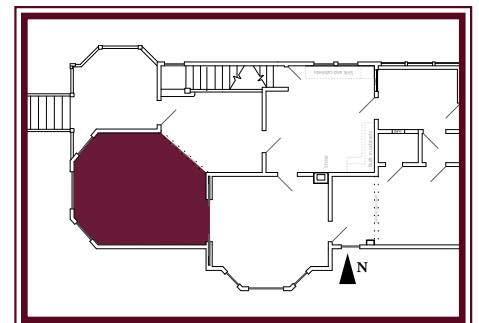
Condition:

- Overall good condition but with a few issues, including:
- A couple holes in windows
- Minor damage to window sashes
- Chatter marks on casings
- Baseboard pulling away from west wall, behind the radiator

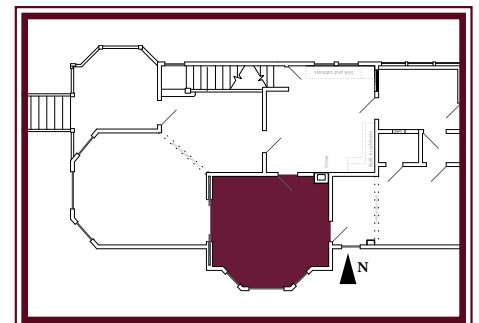
Condition:

- Baseboards pulling away from each other at southeast corner of bay window
- Base block in northwest corner pulling away from wall
- Apron below center bay window discolored behind radiator
- Portions of wallpaper discolored and cracked
- Chimney chase still used as ventilation as wall is warm to the touch

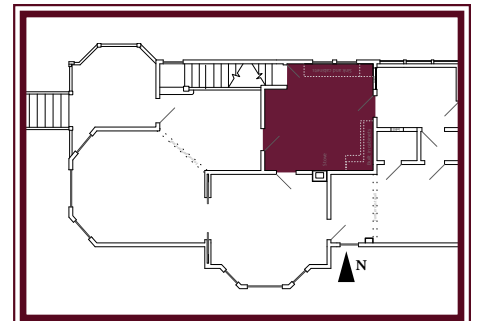
Condition:

- General wear and tear

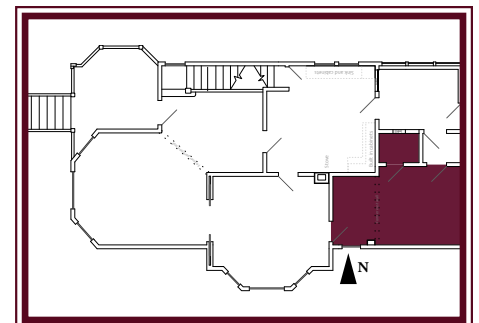
Condition:

- Baseboard on west wall bowing out away from wall
- Section of baseboard cut beneath window on south wall
- Cracked glass and holes in east window glazing
- Cracked wallpaper

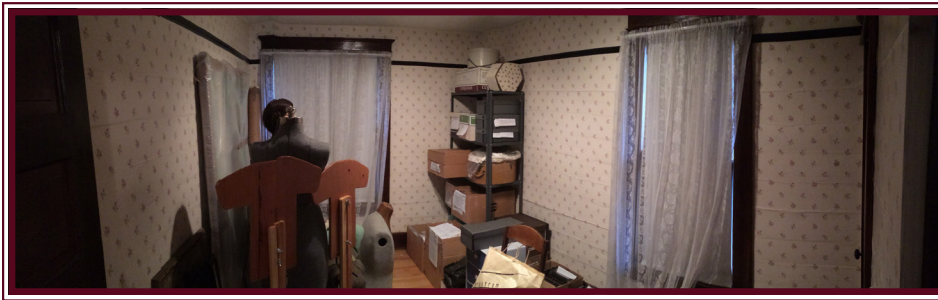
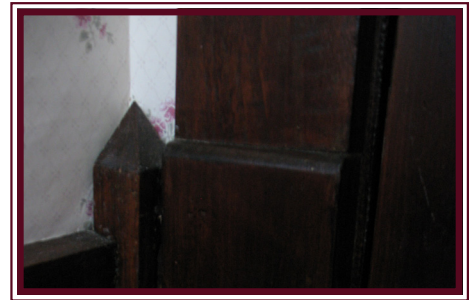
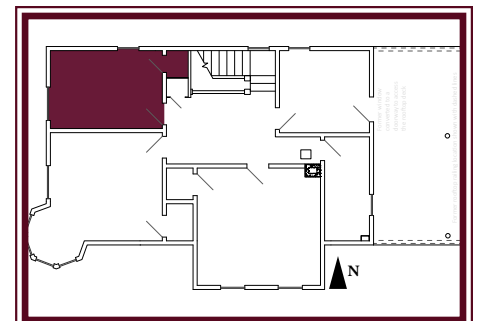
- Overall good condition. Cosmetic crack in stool of west window and cosmetic split in baseboard behind door, likely from when the flooring was redone.

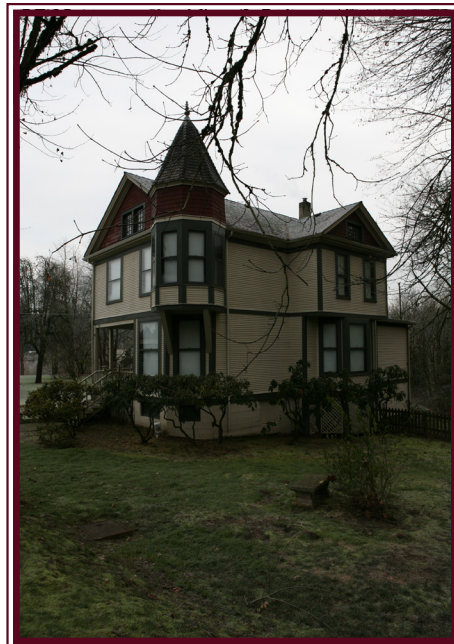
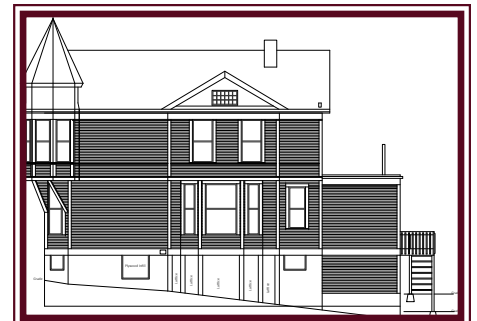
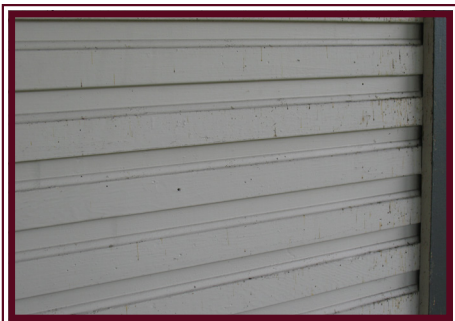
- Good condition overall
- Paint failing along portions of the facade
- Some deteriorated wood and failed paint along the bottom of the lattice at the bay window
- Deteriorated wood and failed paint at the base of the posts at the front porch; this occurs most prominently at the outer west post having the greatest exposure to the elements
- Some damaged concrete edges along the window openings and a thin (< 1/16 inch wide) crack off the lower east corner of the plywood in filled basement window.

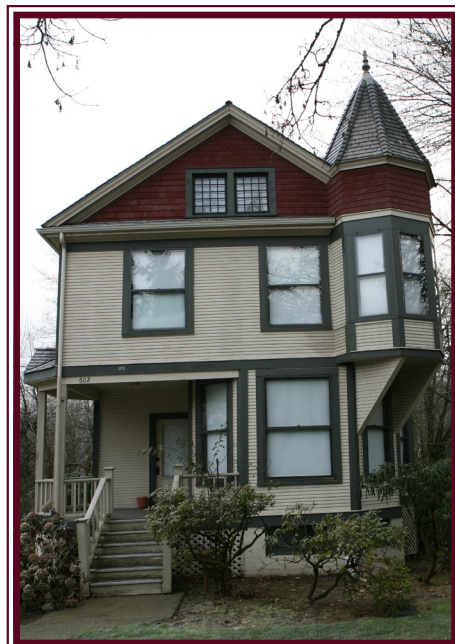
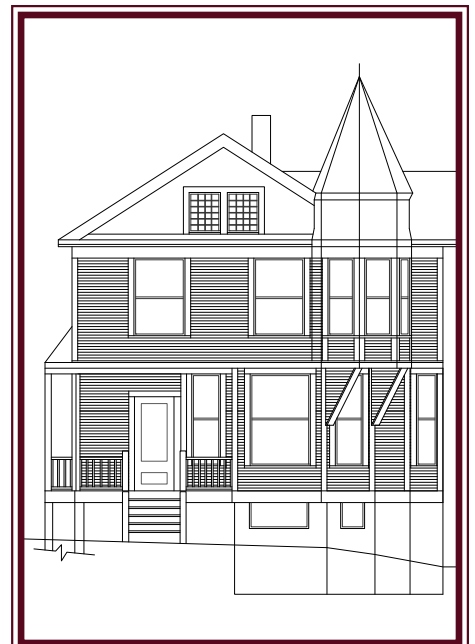
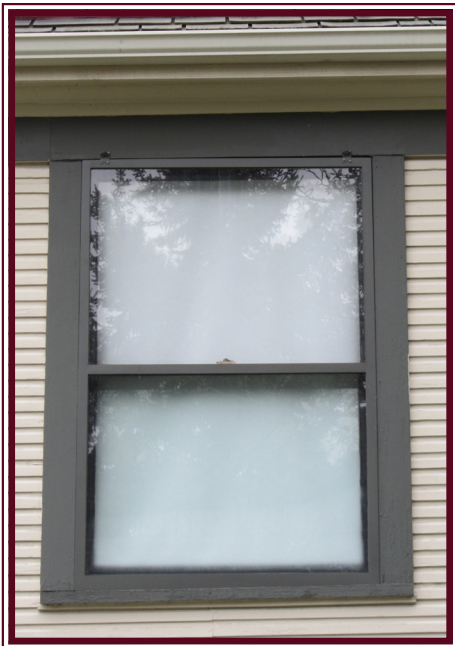
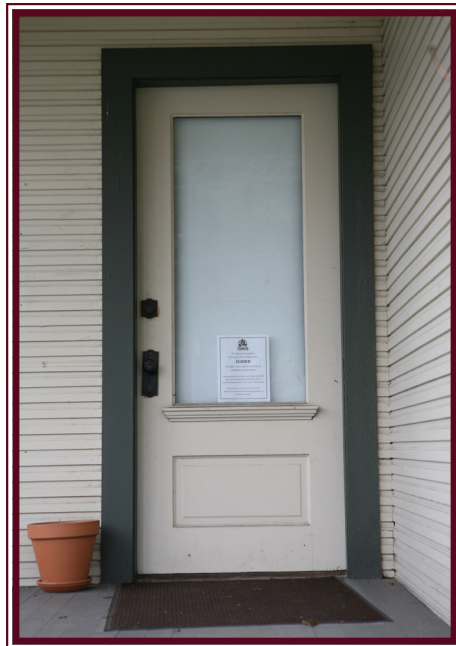
- Good condition overall
- Paint failing along portions of the facade
- Some deteriorated wood and failed paint along the bottom of the lattice at the bay window
- Deteriorated wood and failed paint at the base of the posts at the front porch; this occurs most prominently at the outer west post having the greatest exposure to the elements
- Some damaged concrete edges along the window openings and a thin (< 1/16 inch wide) crack off the lower east corner of the plywood in filled basement window.

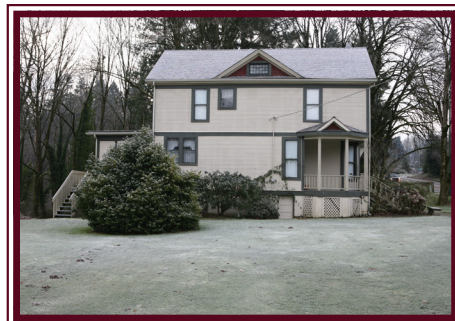
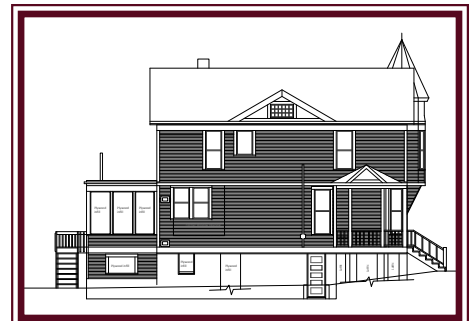
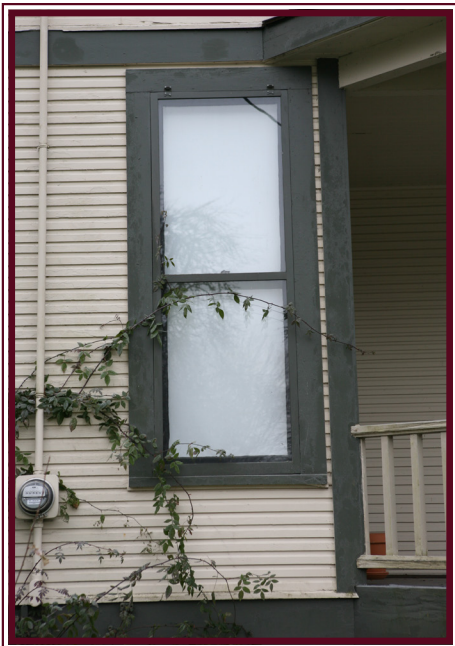
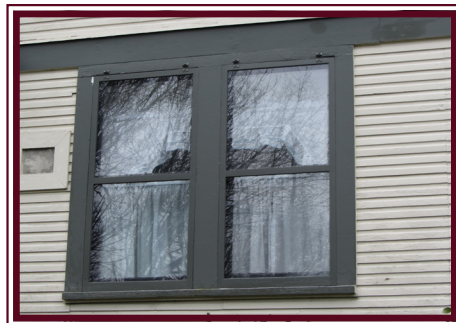
- Good condition overall
- Paint failing along portions of the facade, particularly below the kitchen windows
- Deteriorated wood and failed paint along the bottom of the lattice at the porch; some portions of the lattice had been in contact with the ground, accelerating their deterioration
- Deteriorated wood and failed paint at the base of the posts at the front porch; this occurs most prominently at the outer west post having the greatest exposure to the elements
- Previous damage at concrete foundation around door and window openings, consisting of broken off sections

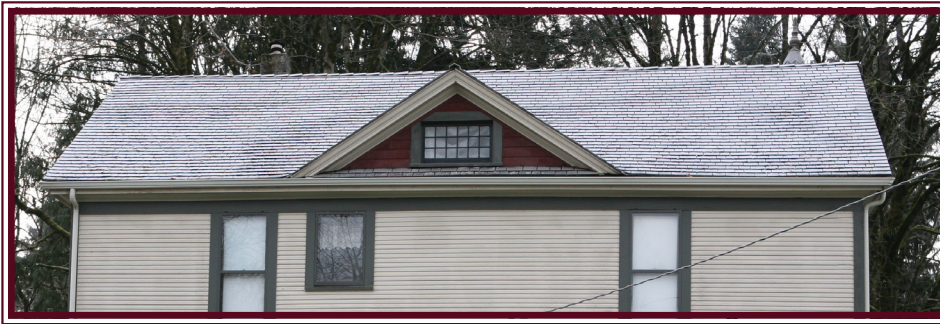
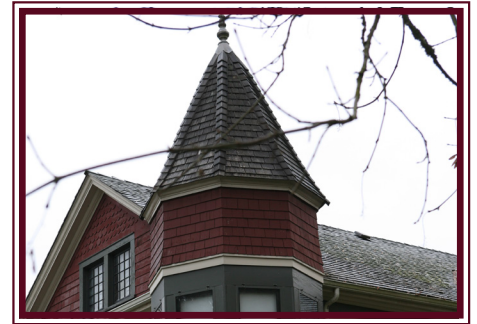
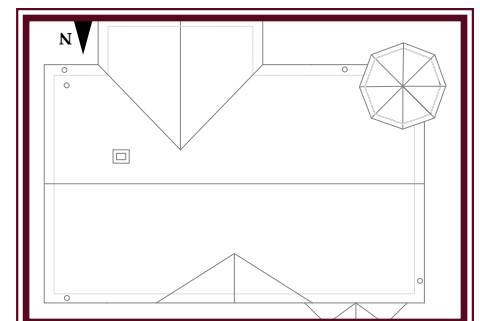
- Good condition overall
- Gutters on the south facade are filled with debris from the adjacent trees
