HISTORIC STRUCTURE REPORT

ST. EDWARD'S SEMINARY KENMORE, WASHINGTON

Prepared by Bassetti Architects

DRAFT September 28, 2007

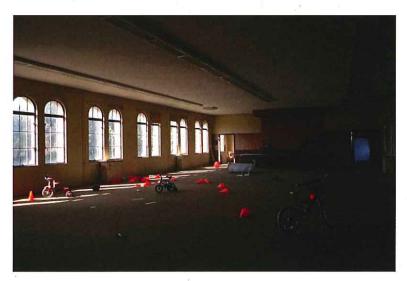
The Chapel was moved from the first floor to this space, perhaps in the 1950s, when the student body became too large for the First Floor Chapel. It has a simple wooden reredos where the altar was, with small rooms added behind it for use as a Sacristy.

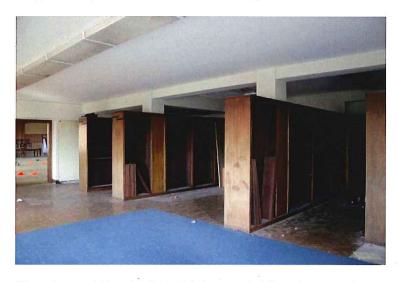
Library: The Library consists of two adjoining rooms with book shelves, in a favored location in the center of the second floor below the bell tower. The larger room was the primary student library, while the smaller room may have been reserved for priests and more advanced students.

The finishes are simple: the floor linoleum, the walls and ceiling painted plaster and the trim mahogany. It simple mahogany shelves line the perimeter, except on exterior walls and continue, forming dead end isles, into the middle of the room. The only additional ornament is a plaster niche for statuary.

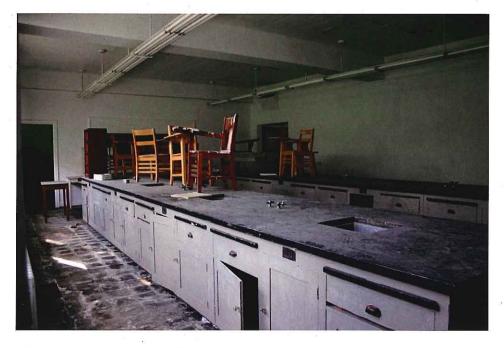
Chemistry & Physics Lab, Biology Lab: The Chemistry/Physics and Biology Laboratories were on the Ground Floor. Each has three adjacent rooms, used for photography, lesson preparation and storage. The finishes are utilitarian: linoleum floor, painted plaster walls and ceiling and painted fir trim. The most significant feature of these spaces are the built in chemistry tables, which contain a lot of seminary era student graffiti.

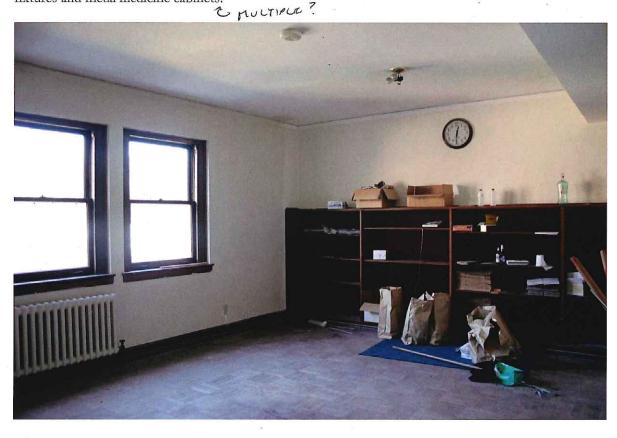
Priests' Quarters: Priests had suites of rooms, featuring a Study with bookshelves, a small Bedroom and a private Bathroom with a tiled shower. There were ten of these suites, located strategically at each end of the residential floors, with two on the Second Floor, and four each on the Third and Fourth Floors. The Second Floor also had two priest's rooms without Studies.

The Priests' Quarters are simple, but grand relative to all other residential areas. Each Study is finished with an oak parquet floor and contains mahogany built-in bookshelves and mahogany trim. The Bedrooms are finished with carpeted floors, painted fir trim and a Clothes Closet. The Bathrooms each contain a shower, toilet and sink and are finished with hex tile floors, subway tile wainscot, wall hung fixtures and metal medicine cabinets.

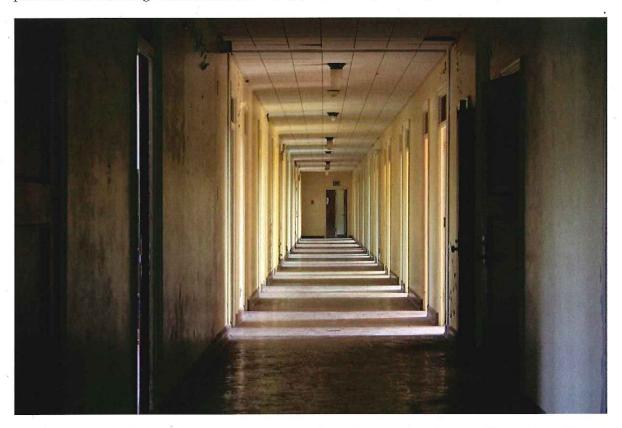
Student Bedrooms and Common Bathrooms: Students lived in small Bedrooms, each with a single window, a wash basin and a Closet with built-in drawers. These were originally intended to be private rooms, with only one occupant, but when the school came to be more crowded, younger students evidently slept in bunk beds. There are 113 rooms, located on the second, third and fourth floors. Students on each floor shared a common Bathroom.

All student areas are plain in their ornament. Linoleum floors, painted plaster walls and ceilings and painted fir trim are typical. The Toilet Rooms have terrazzo floors, subway tile wainscot, marble partitions and wall hung fixtures. Each common bath contained one shower stall

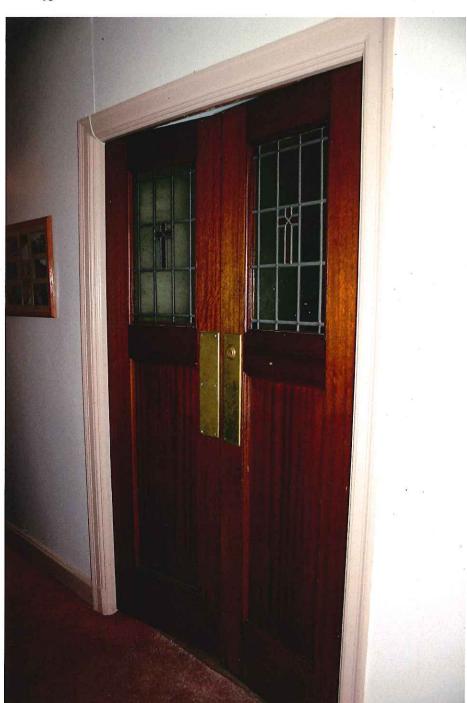
Sisters' Quarters: The most specialized residential area was the "Nuns' Quarters" or Convent, a sequestered area on the Second Floor of the East Wing, above the Kitchen. Here, the nuns who managed the Kitchen had individual Bedrooms, a Community Room, a common Bathroom and a private Chapel with Sacristy. A private stairway led down to their Parlor and Dining Room behind the Kitchen.

All Sisters' areas are plain in there ornament. Linoleum floors, painted plaster walls and ceilings and painted fir trim are typical. The toilet rooms have terrazzo floors, Keene's cement wainscot and bathtubs, instead of showers typical of the male residences.

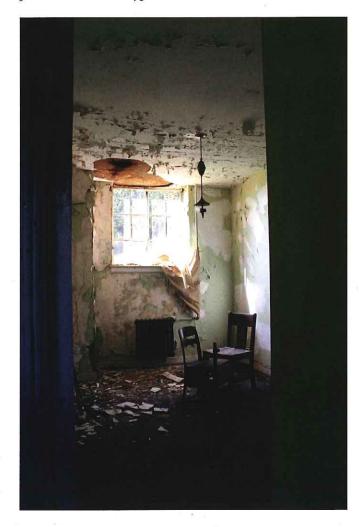
Helps' Quarters: Similar quarters at the South End of the Ground Floor housed male workers who performed janitorial, mechanical and gardening tasks to maintain the facility. Their quarters included small individual Bedrooms, a Living Room and a Bathroom. Their Dining Room was located at the other end of the floor, below the Kitchen.

All Helps' areas are plain in there ornament. Linoleum floors, painted plaster walls and ceilings and painted fir trim are typical.

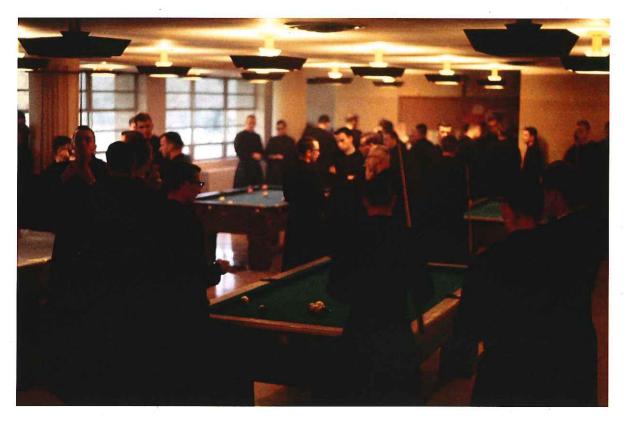
The least information is available about the Seminary's recreational spaces. The designated Recreation Room was below the Dining Hall. It contains the building's only fireplace and early student accounts indicate that it was used for student gatherings such as listening to radio programs, and probably for student activities and presentations.

It is unclear whether there was indoor space for active recreation such as basketball. Student accounts indicate that the original trunk storage room adjoining the recreation room was sometimes used for basketball in early years. Reportedly, it was later used as a barbershop, which probably put the built-in concrete bench to good use. From the beginning, much recreational activity was outside and extensive sports facilities were added over time. In 1951 a Gymnasium/Auditorium was constructed and became the primary focus of indoor sports and recreation. A significant number of activities and gatherings that were once in the main building were probably moved to the new building.

The recreation room is simple but contains some notable details. Walls are painted plaster and employ the textured paint used on all other public spaces. The trim is mahogany. The original floor was asphalt tile. Because the ground floor is partially below grade the windows sills are relatively high and the total window area smaller than on upper floors. The ceiling height is lower than on upper floors. The room has a cozy, rather than grand, feel despite the size of the footprint. It's most notable feature is the fireplace - the surround is cast stone set just proud of the plaster. The sides are detailed as quoins, with a staggered edge. To either side, at the transition to the fire box, a cast stone imbedded column contains geometric patterns on its shaft and is Romanesque in proportion and ornament. The mantel is simple flat panel with a peaked top bearing a Latin inscription, ECCE QUAM BONUM ET QUAM IVCUNDUM HABITARE FRATRES IN UNVM - Behold how good and how fitting it is for brothers to dwell as one.

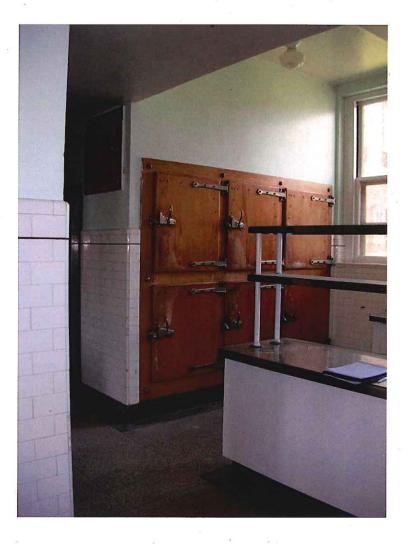
The Kitchen is large – it ceams to have been sized to serve even if the Seminary complex grew. It has a terrazzo floor and base with integral cement bases (finished in terrazzo) for working and serving islands. Continuous subway tile wainscot extends around the full perimeter with plaster walls and ceiling above. The Kitchen is notable for its very intact arrangement of original cooking appliances. Original stoves with a large hood anchor the center. Large steamer pots share the hood. A serving counter is located adjacent to the dining room with a dish room to its North. Multiple refrigerated compartments, one walk in sized, are arrayed to the North with prep counters adjacent. A separate Bakery and Butcher shop are located to the East. Additional counters, sinks and equipment are installed along the South wall. In all, the kitchen suite contains 8 refrigerated compartments and 51 separate pieces of equipment from a vegetable peeler to fish chest.

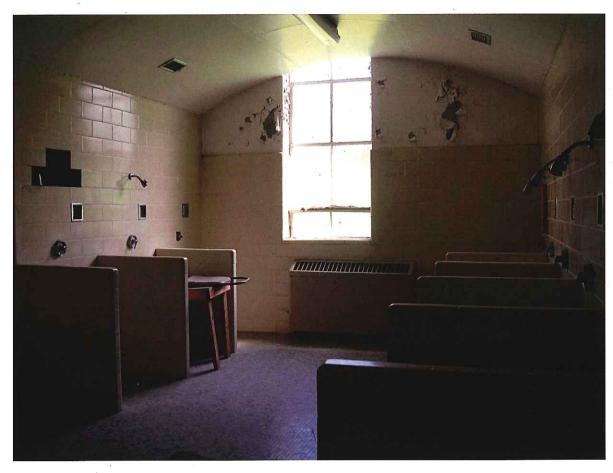
Below the Kitchen are the Laundry and the Boiler room, both of which retain much of their early character and equipment. They are surrounded by Storage and Mechanical areas, as shown in the original plans.

The major Bathroom, Shower Room and Locker Room are located in the center of the Ground Floor. Storage Rooms and Utility Closets are located throughout the building.

These spaces have typical institutional finishes of the period: The Toilets contain terrazzo floors, marble wainscot, marble partitions with wood doors and wall hung fixtures; the Locker Room has a terrazzo floor and base with integral terrazzo bases for the lockers; the Shower Room contains 13 stalls in a common space with terrazzo floor, tiled stalls and an arched cement plaster ceiling to accommodate ventilation.

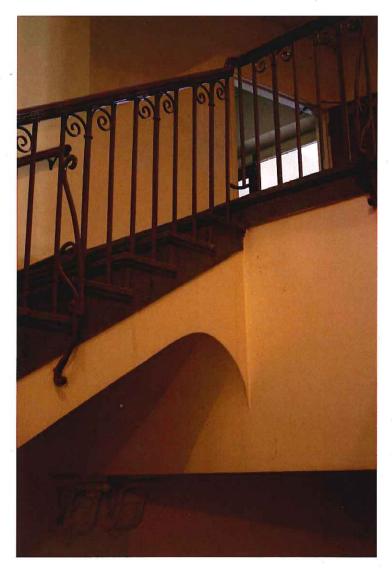
The level of detail and finish are consistent with the important adjacent spaces. At the First Floor, the Stair Hall defined by a decorative arch at the ceiling supported on plaster corbels. The arch and corbels do not cover any structure they are simply design elements. Beyond the arch, all changes in ceiling plane have large plaster coves to visually ease the transitions and reinforce the Romanesque impression of a load bearing masonry structure. The stair treads, risers and base are terrazzo. The terrazzo also forms the stringer with a plaster fascia below.

One of the most notable features is the layout. The stair is wrapped around an open well, about 5½2x8, extending from the first to fourth floor. The visual effect of the dark terrazzo stair, offset by the buff plaster, rising up through this well is strong. The picture is completed by the decorative iron railing capped with a mahogany handrail. One curved iron bracket per section of railing ads structure and visual depth. Overall this stair's details reinforce the visual themes of the building. A mix of Romanesque and Deco influence with a spare elegance.

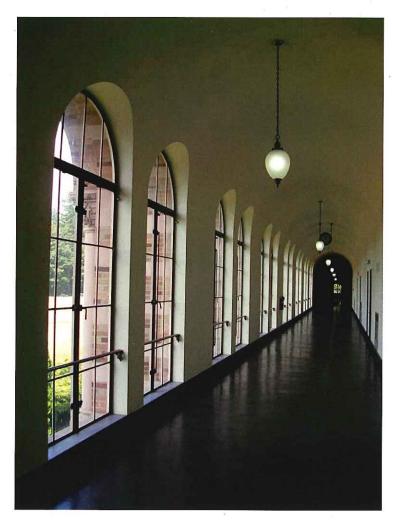
Plaster detailing, in public spaces, is consistently used to reinforce the Romanesque impression of being a load bearing masonry structure. Intersecting arches where window arches meet the continuous vault of the corridor, in the First Floor; create beautiful architectural form, give the exterior wall a greater sense of depth and reference European Monastic Buildings. Trim at door and window jambs, within the public spaces, is consistently inset within a plaster jamb. The transition between the face of plaster wall and the plaster jamb is detailed with a hidden metal corner bead allowing for a very tight seamless edge. The wood trim at jambs is simple in profile and its projection into the opening minimal. All of these detailing choices reinforce the weight and substance of the walls and reflect the more precise and finer detailing of the Deco period. Plaster cornices and corbels are used to define the important public spaces. The iconography of their ornament, however, does not appear to have specific significance.

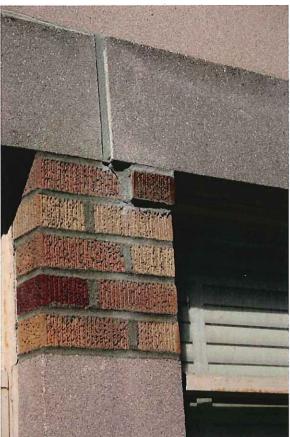
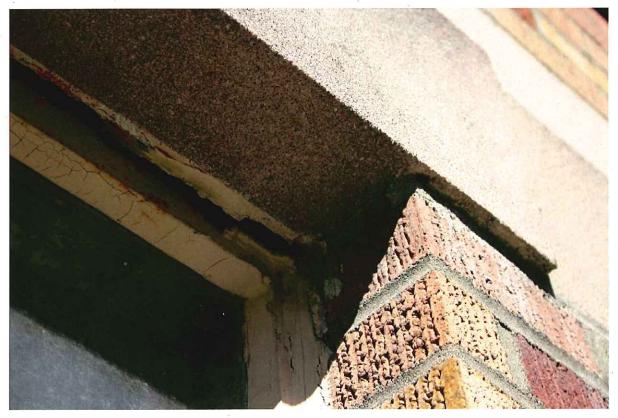
Where unaffected by water, the masonry is in good condition. The original tapestry brick is solid and the pointing in good condition. The cast stone is generally sound and details remain crisp. The exceptions are areas where water has migrated. In these areas a broad area of efflorescence occurs with a smaller region of black biological growth within it. In larger joints and crevices and in less sunny areas the biological growth includes moss, fern or other plants. In limited areas some displacement of the facade cladding occurs. These are most notable at window heads and narrow pilasters where the cladding is not as supported by the adjacent fabric. These displacements are likely early signs of failure in the ties between the structural wall and cladding

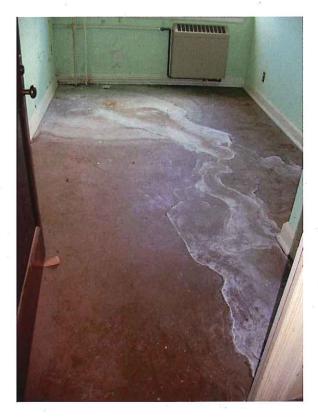
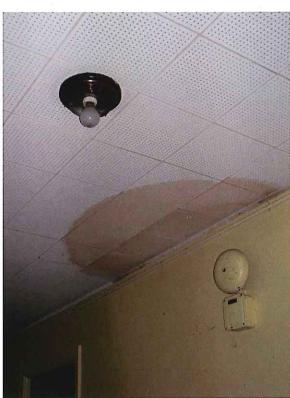
Water infiltration, both exterior sources and interior plumbing have caused the greatest amount of interior damage. In affected areas staining, plaster deterioration and loss is typical. Rust stains, from metal lath are evident on plaster finishes. Rot and material loss is occurring on wood finishes. Rubber tiles are cupped and delaminated from the floor. Linoleum is stained. And, stone stools and bases are showing displacement, presumably from expansion of underlying materials.

Seismic events have resulted in damage to finishes. These cracks are the result of finish materials that are more brittle than the structure and are not necessarily indicative of structural damage. Cracks are typically small and appear in the same pattern or formation room after room especially, on upper levels of the South Wing. The kitchen also has several cracks in tile finishes. Particularly notable is surface damage associated with seismic movement at the expansion joint between the building center and South Wing. The joint is visibly displaced by a couple inches, especially on upper floors.

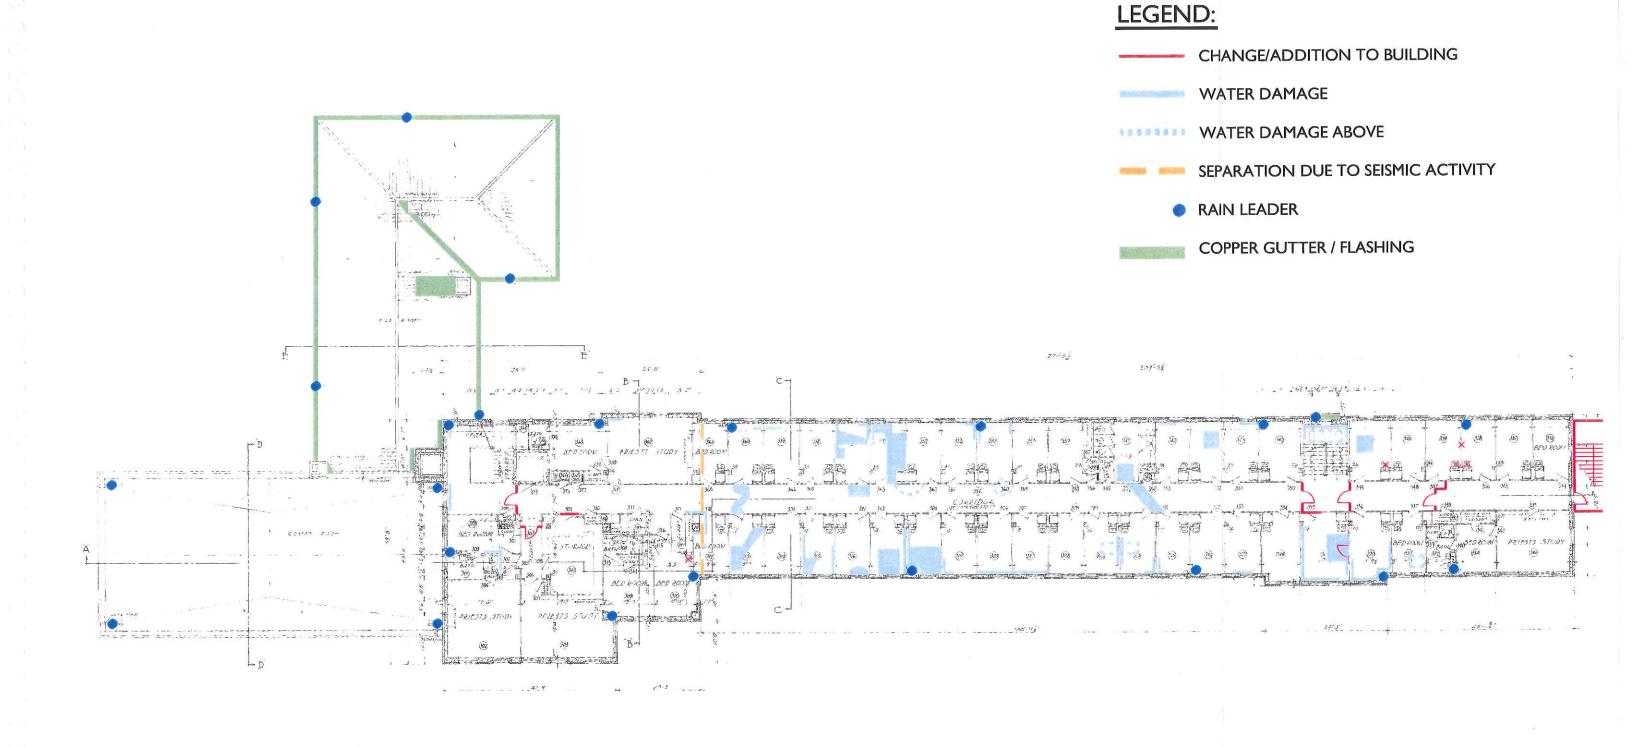
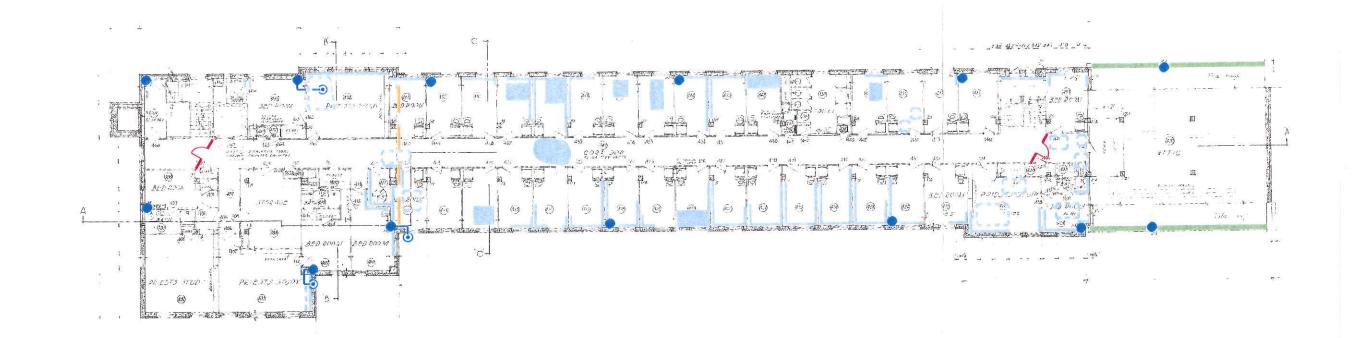
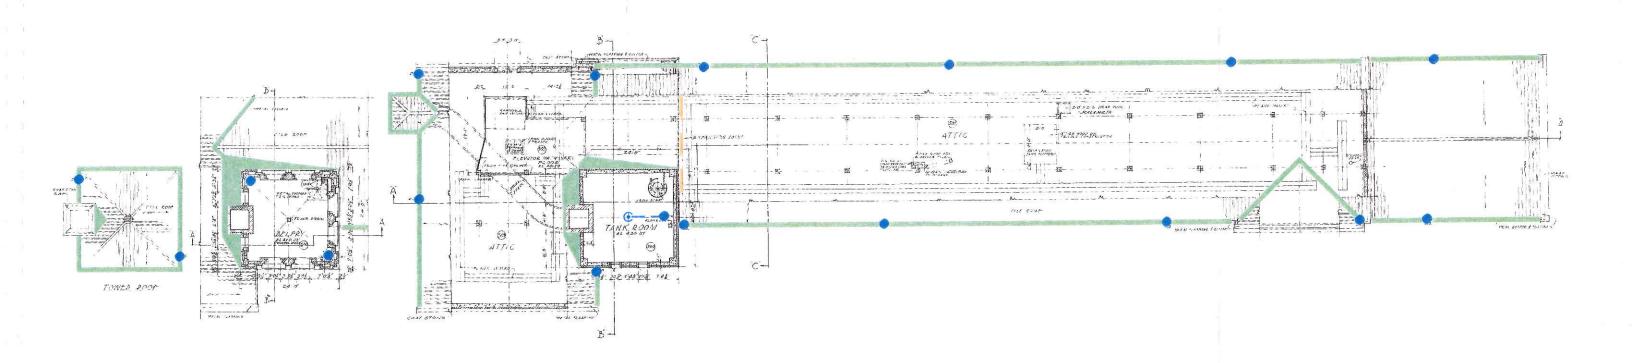
See the following interior condition drawings for locations of water migration in the building, seismic damage to finishes and areas of subsequent work. These drawings are based on field observation but an exhaustive condition survey.
