# Window Repair and Weatherization Guidebook

***A Handy Guide for Owners of Portland, Oregon Homes***

**Bosco-Milligan Foundation/Architectural Heritage Center  
With support from the Irvington Community Association  
Portland, Oregon**

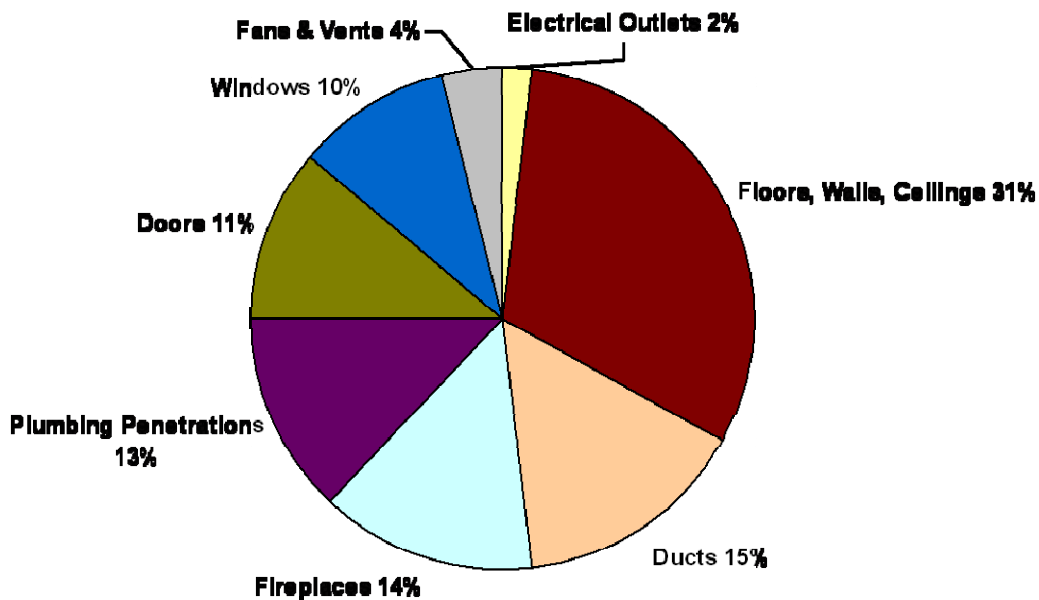
Figure 1.

### Areas of Typical Energy Loss

Source: U.S. Department of Energy

For more than two decades, original single paned wood windows have been cast as the enemy when it comes to heat loss and energy consumption in our homes. But the fact remains that windows are not the sole or even the primary culprit in this regard. In fact **there are several other factors that need addressing before window replacement should even be considered**. This is especially true in our historic districts, where windows are often considered as defining features of houses built prior to the 1960s. The fact that windows are significant to the architecture of a home frequently leads to contentious battles between well-meaning homeowners and local landmarks commissions that review exterior alterations to historic properties. Simply put, window replacement is most often not the most effective solution for saving energy or money. There are several other areas where energy can be conserved while still maintaining the historic character of a house.

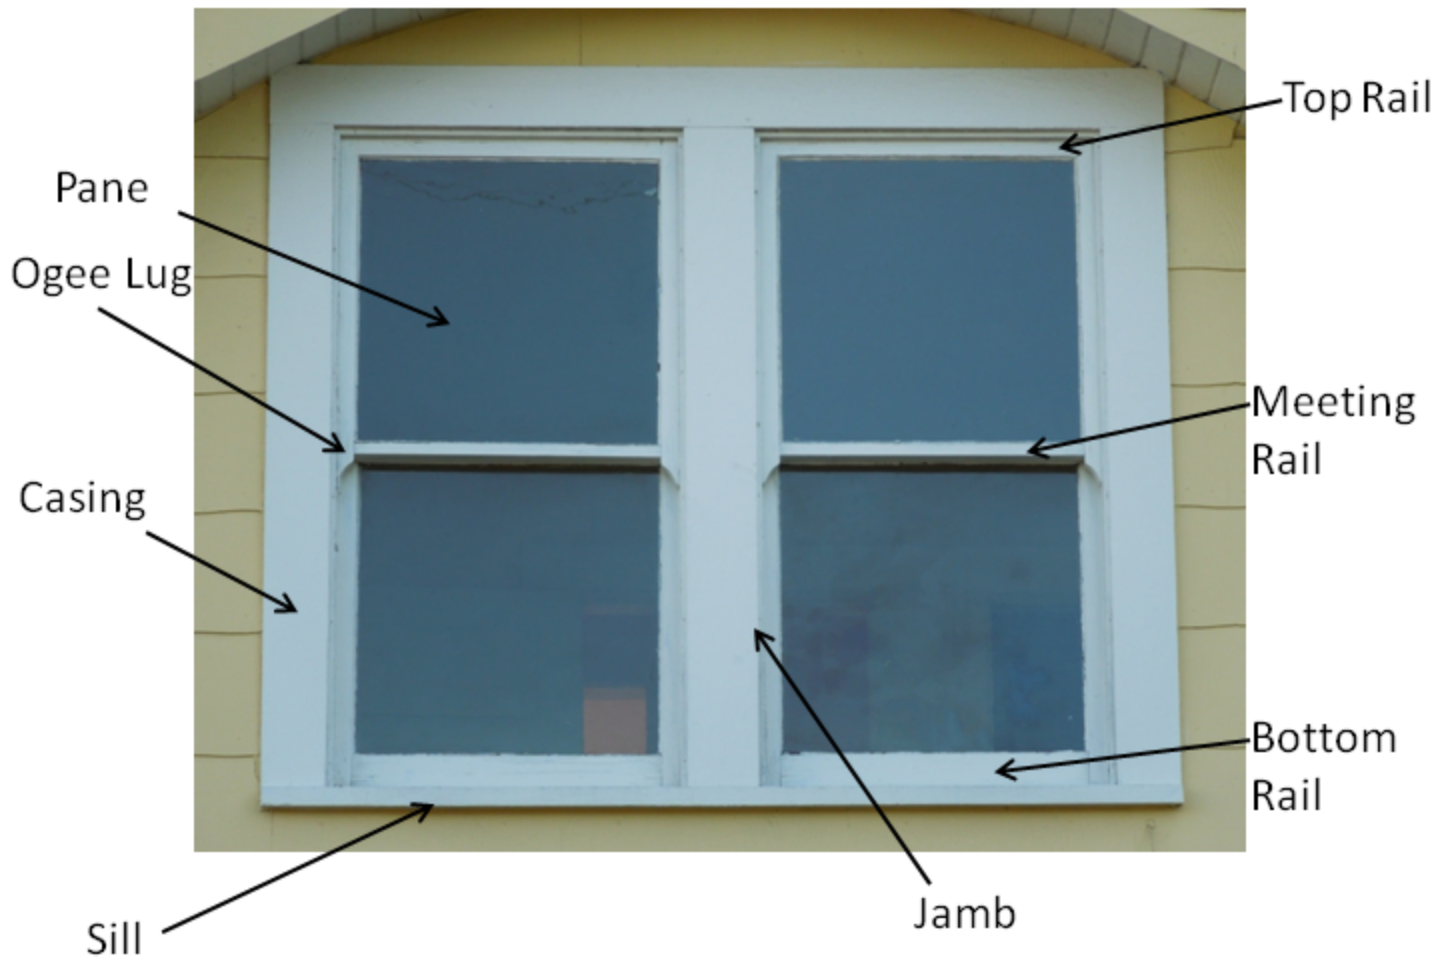
## Pair of Typical Double-Hung Wood Windows

Most historic homes in Portland have windows that fit into one of the following categories. Each window is made up of one or more *sashes* – the framework that holds the glass panes in place. Figure 2 identifies some of the common elements of a window and the areas in which weatherization measures can be most effective.

- *Double hung wood windows* are the most common type of window found in older and historic Portland area homes. They are meant to open from both the bottom and the top in order to provide proper ventilation.

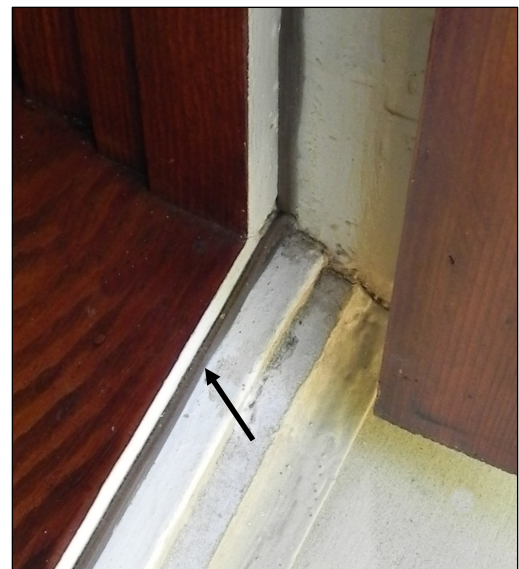
**Compression weather stripping on a wood casement window.**

- **Weather Stripping for Compression Applications**

"Compression application" means that the weather stripping is compressed when a window is closed. Foam and felt are the most common and inexpensive types of compression application weather stripping. These products are adhered to the surface on which they are used and are not for sliding applications. Foam and felt are therefore

most effective at the top and bottom of double hung windows or for use around casement windows. Keep in mind that foam and felt do not have a long lifespan as they can deteriorate when exposed to moisture. They are also usually visible when the window is open.

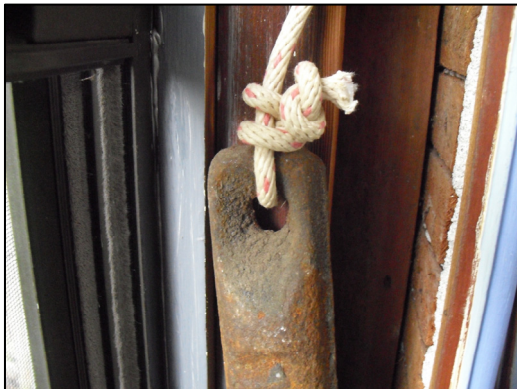
**Example of a properly knotted sash cord.**

One of the most common complaints against historic windows is that they won't open or close properly because the window ropes (sash cords) and weights are either broken or have detached. This is another affordable fix that can usually be completed by a homeowner or through a window repair professional.

In the Pacific Northwest, "double hung" windows are the most common type found in historic homes. This means that not only should the window open from the bottom, it should also open from the top as well. When operating properly, such windows can be used to provide natural ventilation throughout a home. When the window sash cords break or come untied, the sashes become out of balance, leading to opening/closing difficulties. In order to repair the sash cords and re-connect the weights, you must first gain access to the cavities where they are located. Many historic double hung wood windows have an access door cut into the window jambs. These doors are often screwed or nailed in place. Once removed, the weights and ropes should be able to be accessed without removing the interior window casings. Unfortunately, in some instances, there are no access doors and the interior casings must be removed in order to gain access to the weights and sash cords. In such cases you might consider screwing the casings back into place after you have made repairs, rather than nailing them, in order to make them easier to remove in the future.

Once you have access to the weights cavity you can install new sash cord (or chain) – available at most hardware stores. New sash cord will last for decades but you must make sure you tie the cord to the weights securely, so they do not fall off after you have put things back together. Never paint sash cords as it will only lead to additional problems opening and closing the windows.

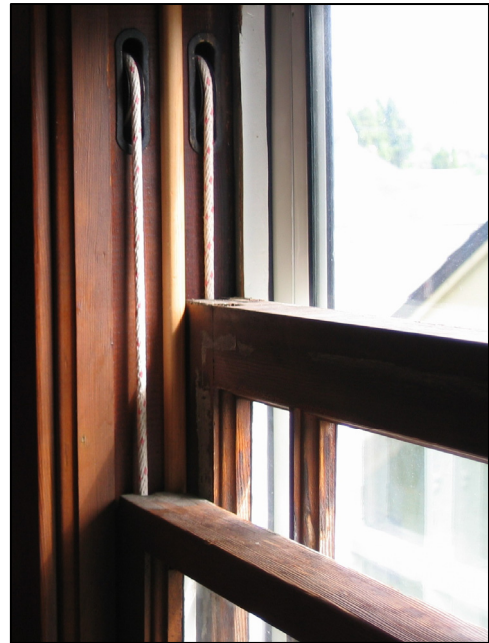
**Unpainted jambs decrease friction and allow window sashes to open and close more easily.**

Depending on where it is located, paint can be one of your historic windows' biggest enemies. Most window repair professionals do not recommend painting the sash jambs as that frequently leads to sticky windows. We've all heard of windows being "painted shut". That is because jambs were painted, along with the sash frames. In such instances, the first step in repairing sticky windows is to cut through the paint using a painter's tool. Paint can also be removed using chemical strippers or a heat gun, along with a paint scraping tool. Once paint is stripped from a window it can then be sealed with a high quality wood sealant or coated with a varnish that does not create the stickiness of paint and maintains the unpainted wood finish that was typically original to the house. You can also rub paraffin wax on the sides of the sash frames so that they will slide up and down more easily.

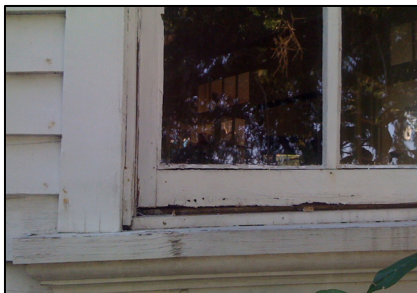
**Example of a window that will not close completely because it is racked**

## "Racked" Windows

Windows that won't open or close properly because they are no longer square are considered "racked." Racking is typically not a problem caused by the window itself – it is most often caused by the settling of a house over the course of many decades. Not only will a racked window need to be repaired in order to function properly, racked windows can also lead to a number of additional problems ranging from increased air and moisture infiltration to broken sash joints. The good

news is that historic windows can usually still be repaired, but you must also determine and address the root cause of the racking, or your repairs will be unsuccessful. Unless the original cause of the racking is addressed, replacing a racked window with a new replacement window will likely lead to the premature failure of the replacement.

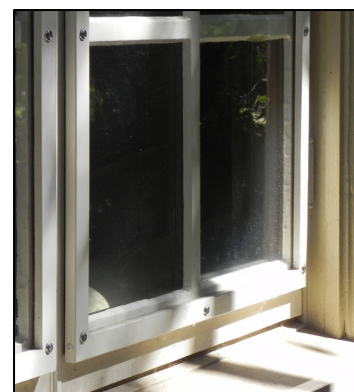
“Piggy-Back” casement style storm window  
Courtesy of Jim Heuer.

- **Casement Windows** – As mentioned above, most storm windows can be custom built to match your original historic windows. This includes casement style windows that swing out and away from the house when opened. On casement style windows, the type of storm window that is used most often is called a “piggy back” style because it actually mounts directly to the original sash frame. This allows the window to still be opened although the additional weight may make opening more difficult. In addition to storm windows, you can also install weather stripping in casement windows much the same as you would with double-hung windows. **Make sure that you use compression type weather stripping for casement window applications.**

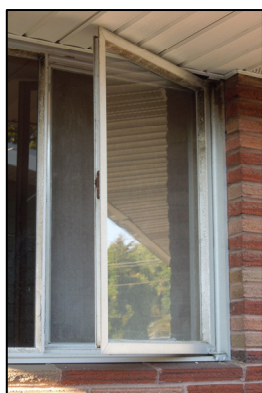
Aluminum casement style window.  
Courtesy of Val Ballestrem.

- **Metal Frame Windows** – Metal framed windows, typically steel or aluminum, present unique challenges for repair and weatherization that may be best addressed by a window repair professional. If the metal is corroded or bent, the window may have to be removed first in order to be properly cleaned and repaired. You can still install custom storm windows, but adding weatherstripping, especially along sliding surfaces can be difficult. You can (and should) still caulk around metal windows to prevent air infiltration just as you would with other types of windows. The National Park Service provides additional detail for repairing and weatherizing metal windows in their *Preservation Brief Number 13*, available online. The URL for this brief is located in the resource section of this booklet. In the event that your metal windows are beyond repair, there are companies throughout the United States that produce custom metal windows.

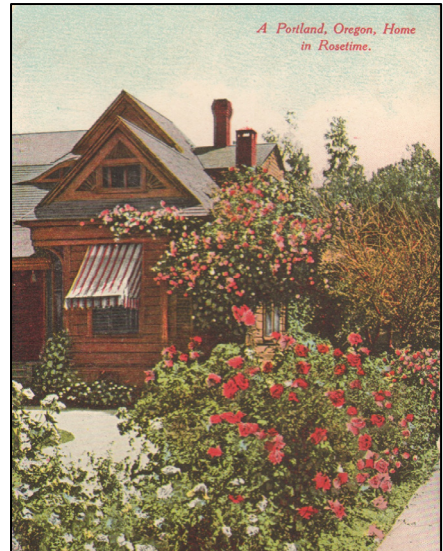
Early 20th century postcard depicting an awning on a Portland, OR home.  
*Courtesy of the Architectural Heritage Center.*

- **Awnings** – Awnings were commonplace on homes built from the late 19th through the mid-20th century and therefore if they are made of suitable materials can be considered historically appropriate. Installation of new awnings on historic homes in Portland, however, will require Historic Design Review. Given that they are used to shade the interior of a home from the sun, they are mostly effective in the summertime. They are often retractable too, so in the winter the sun can be allowed to heat the home’s interior.

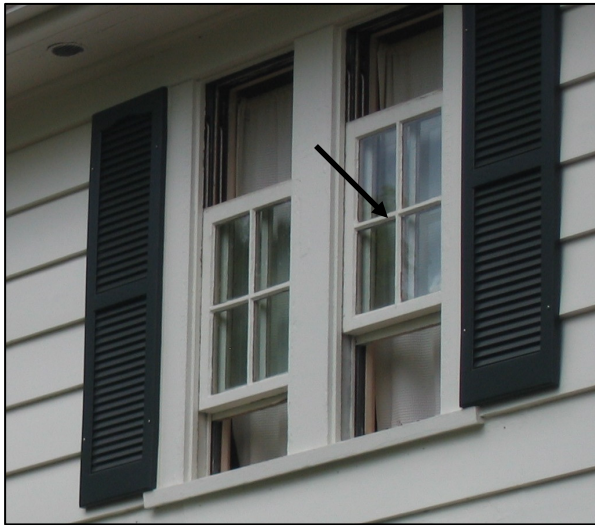
**Example of muntins on a pair of historic wood windows.**  
*Photo courtesy of Patty Spencer*

Most historic windows in the Pacific Northwest are constructed of wood and it is recommended that if windows must be replaced, that they are replaced in-kind (of same/similar material, style, and dimensions). Substitute materials, especially vinyl, are not appropriate for a historic home. Replacement windows often have different profiles than the original windows and lack key features of original windows such as the “ogee” lugs that extend from the bottom of the upper sash on the typical double hung windows found in our region. Many historic homes have windows with so-called “divided light sashes”, where the sash glass is divided into multiple sections by wooden dividers called *muntins*. If divided light windows are replaced, the replacements should
