ENGLISH HERITAGE

Traditional Windows: their care, repair and upgrading

Guidance and best practice on the understanding, conservation and thermal upgrading of traditional windows.

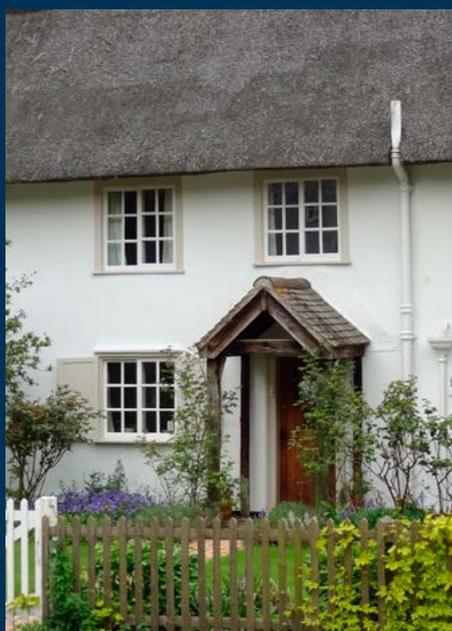
Top Left: Surviving historic fenestration is an irreplaceable resource which should be conserved and repaired whenever possible.

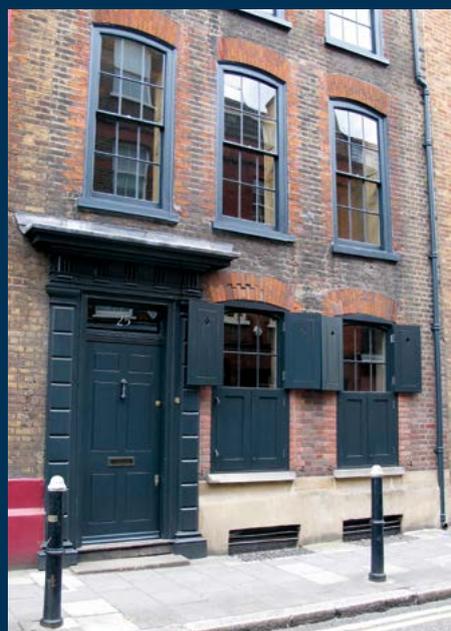
Top Centre: External shutters from the 18th – century divided into upper and lower leaves to give greater flexibility in balancing requirements for light, ventilation and security.

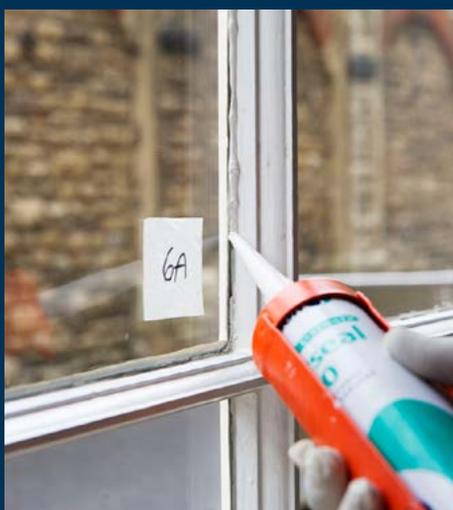
Bottom Left: The addition of precision cut acrylic glazing to small paned windows allows the existing glazing to remain in place. The edges need to be carefully sealed to prevent moisture entering the cavity. This is backed up with a specially developed dessicant material inserted in the cavity to prevent condensation.

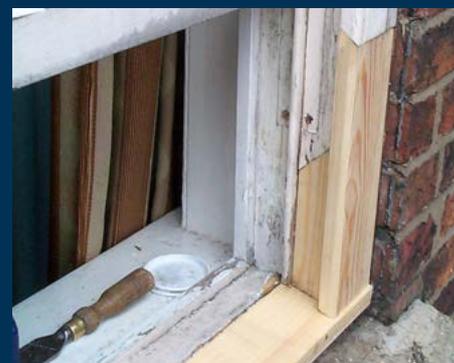
Bottom Right: Decayed timber at the base of the pulley stile, the outer lining and the exterior of the cill has been cut out and new timber inserts have been pieced in.

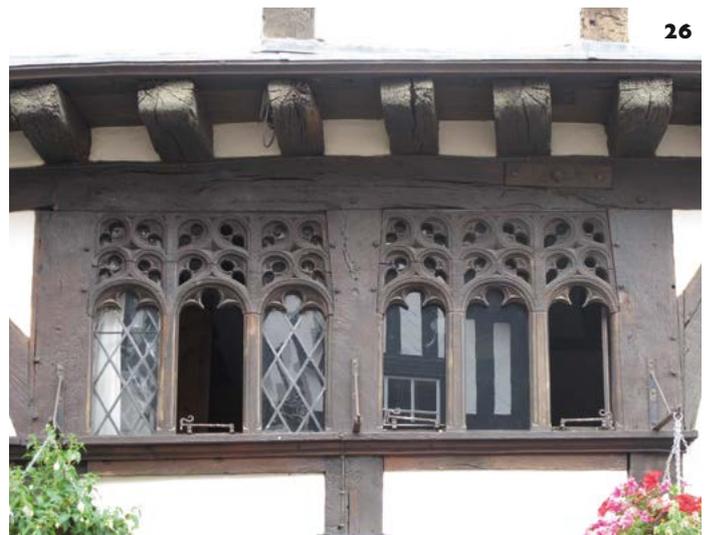
26

26: Late 15th-century mullioned window (with 19th- and 20th-century glazing). The mullions and traceried heads are integral with the timber frame.

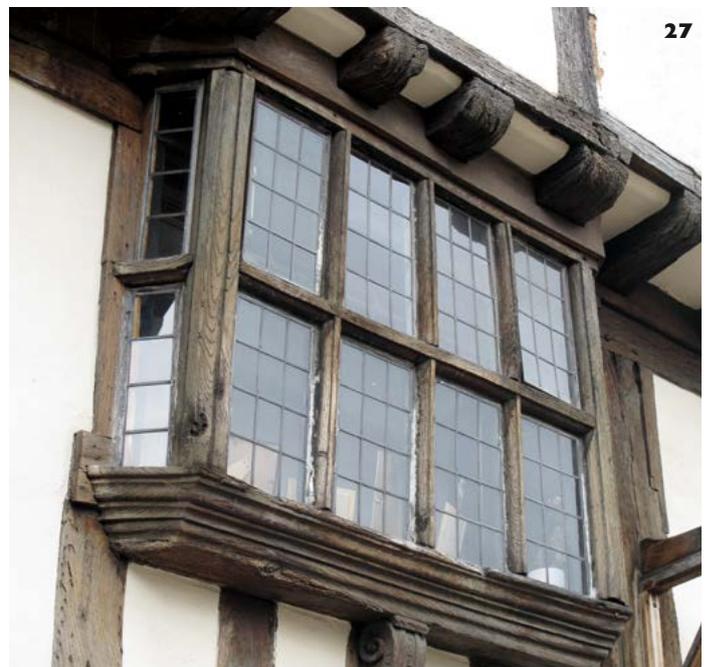
27

27: A 17th-century mullion and transom window planted onto the structural frame and secured by pegs.

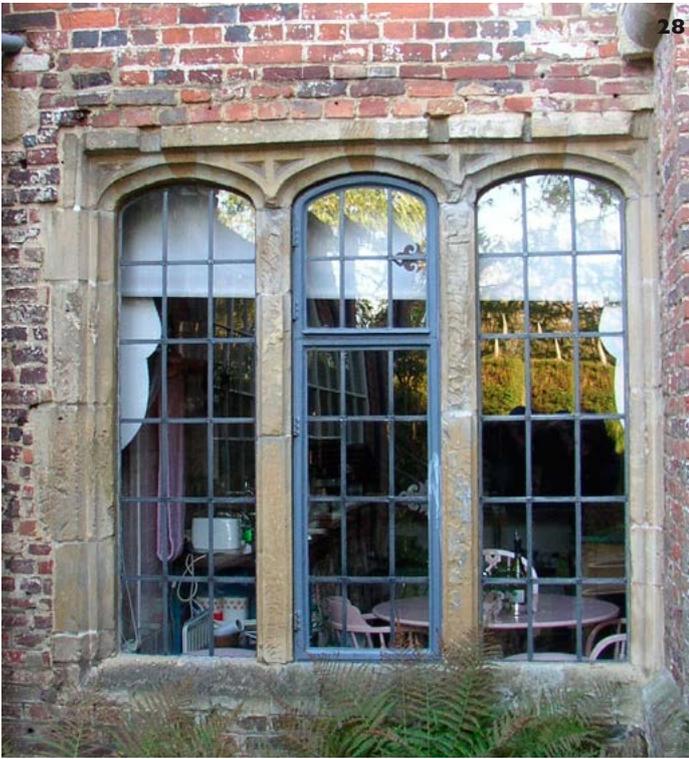
28: Leaded glazing set within stone mullions with a later steel casement to the central bay.

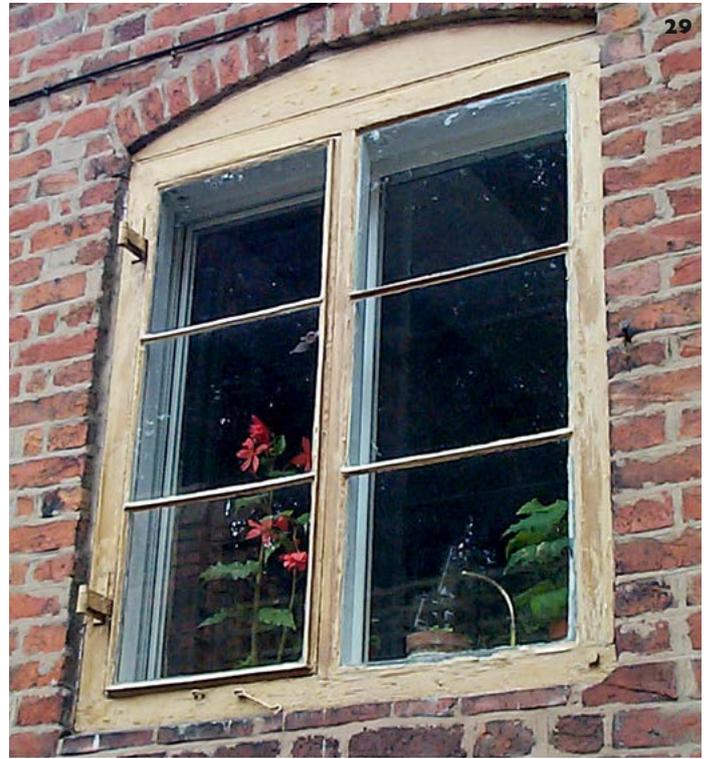
29: Late 17th or early 18th –century oak framed window with an opening side hung iron casement.

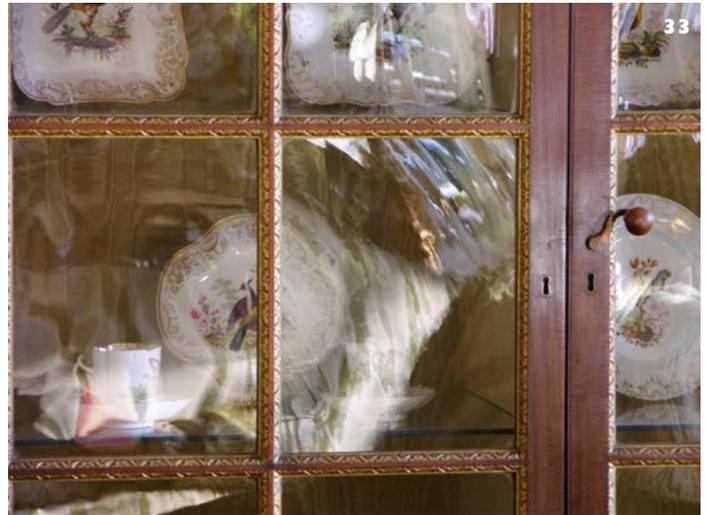
33: An example of crown glass which is now very rare but was widely used for windows until the mid 19th-century.

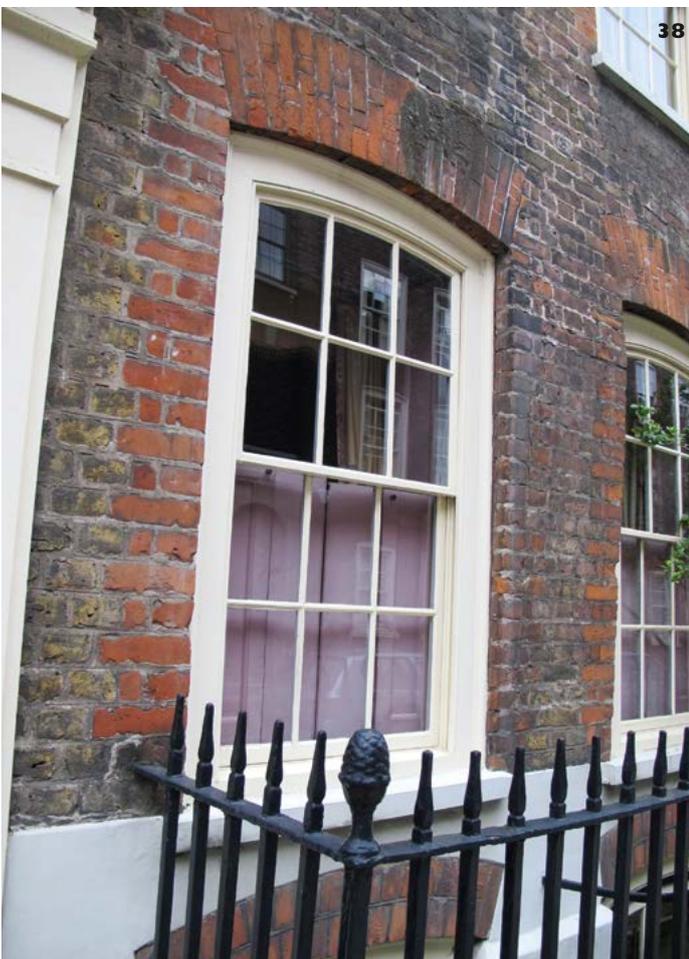
38: In the cities of London and Westminster, legislation came into force in 1709 which required window frames to be set back from behind the wall face.

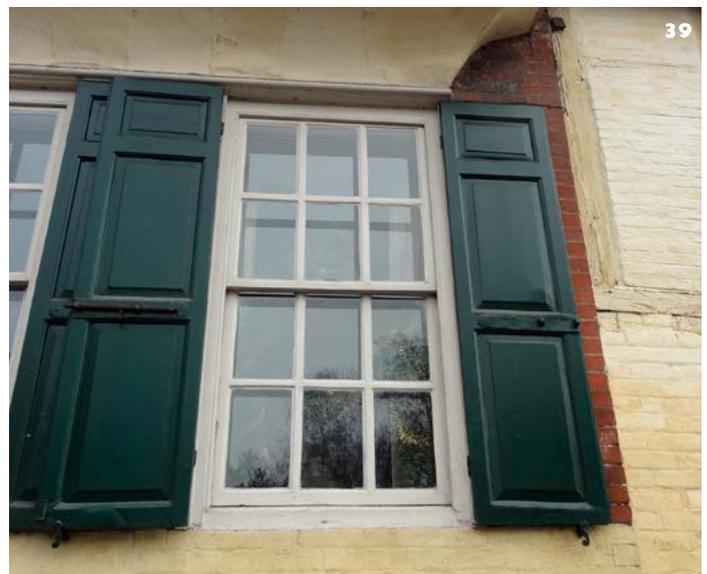
39: Late 17th to early 18th century glazing bars were considerably thicker than later profiles.

Early glazing bars were thick and robust, usually made of native oak or a similar hardwood. They were often almost 40mm thick to support and protect the fragile glass. However, the increasing use of oak for shipbuilding coincided with the growing availability of cheaper softwoods from Scotland, the Baltic states and Scandinavia. Most late 17th and early 18th-century glazing bars were based on the ovolo, or quarter-circle moulding and used 'deal', a generic term for pine or fir softwood. Crown glass was used for glazing; being lighter it lent itself to larger sashes. Thinner, finer glazing bars, with pointed (gothic) and lamb's tongue mouldings also became very popular. By 1820 some glazing bars were only 12mm wide (although, to provide lateral strength, they could be up to 38mm deep). Venetian windows which have round-headed windows as part of the design are often found in the late 18th and early 19th centuries. These were partly a response to the window tax, a property tax based on the number of windows in a house that was introduced at the end of the 17th century and eventually repealed in 1851. This often resulted in *trompe l'oeil* fake painted sashes or plain masonry recesses where windows had been blocked up. However, not all blocked windows can be attributed to the window tax.

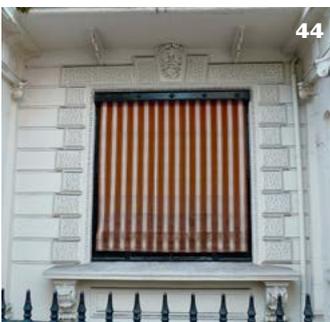
44

44: A rare surviving awning.

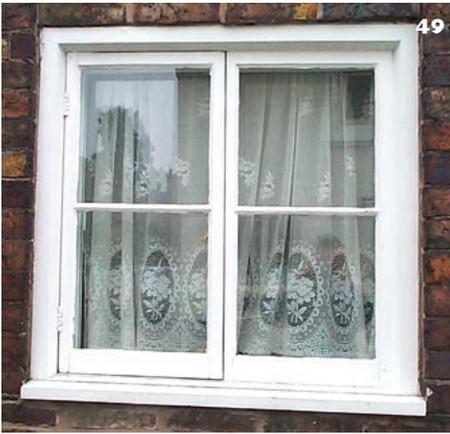
49

49: A simple 19th-century timber side-hung casement window. The uniformity of the frame proportions is maintained by the split mullion.

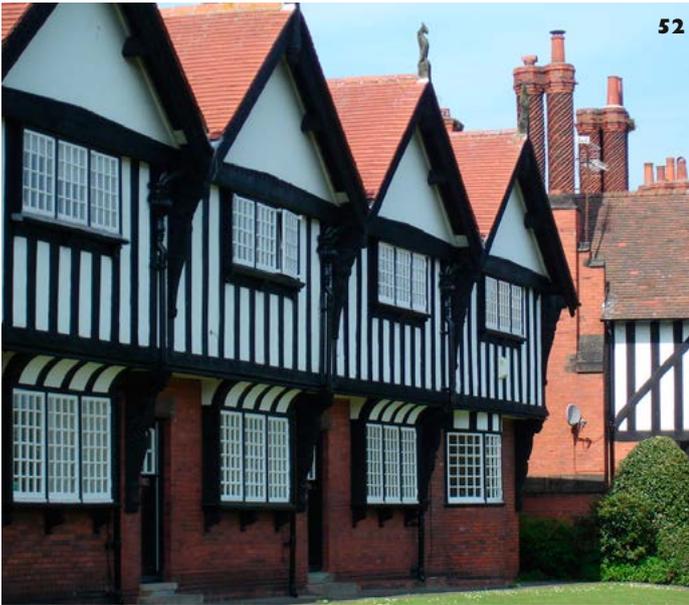
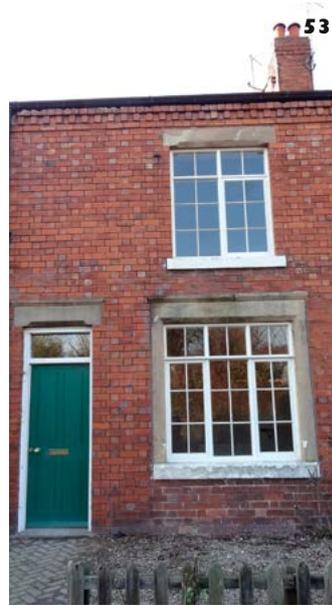
52

52-53: Small pane cottage windows became popular towards the end of the 19th century for model workers housing as shown here at Port Sunlight and New Bolsover.

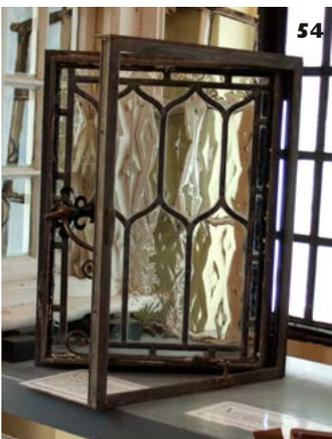
54

54: Early 20th-century Crittall window dating from 1904 (from the Brooking Collection).

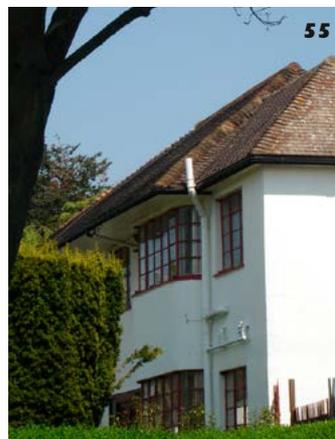
55

55: Steel windows became a feature of inter-war suburbia.

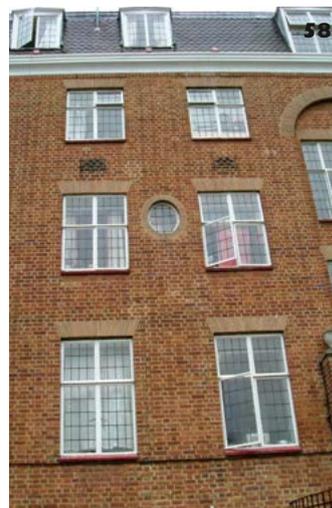
58

58: Steel windows combined with leaded lights in a block of 1930s flats.

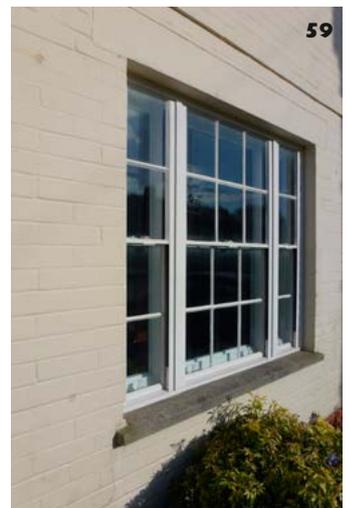
59

59: A rare three light steel sliding sash window dating from the early 1950s.

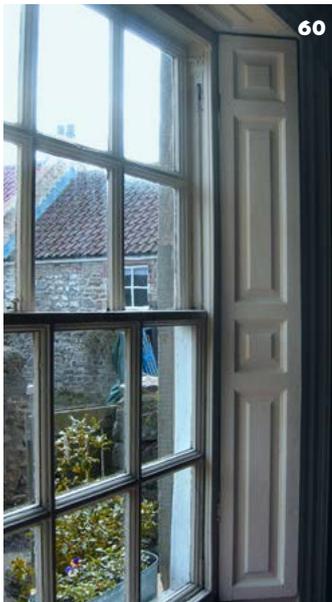
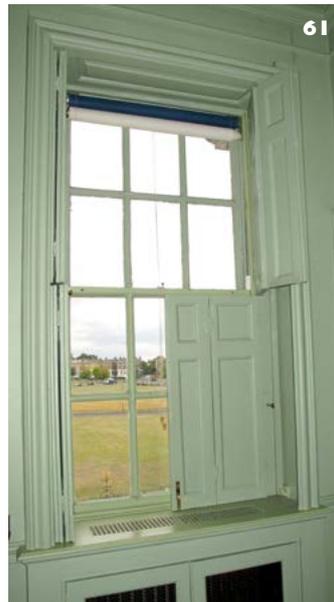
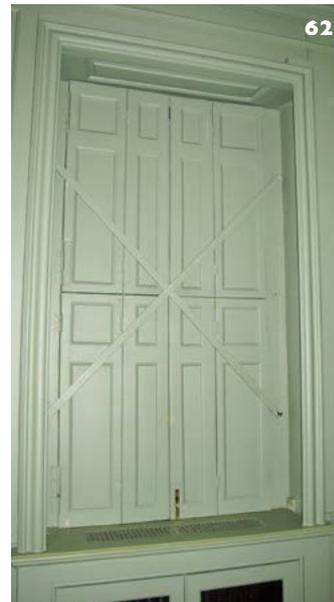
60–62: Double hung sash windows with internal shutters which fold into recesses on each side of the window. When fully closed the shutters are secured tightly with iron shutter bars.

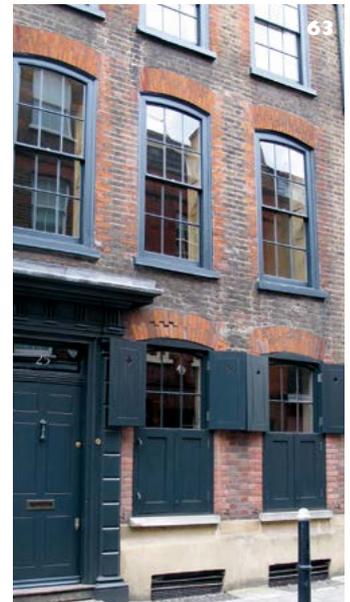
63: External shutters from the 18th –century divided into upper and lower leaves to give greater flexibility in balancing requirements for light, ventilation and security.

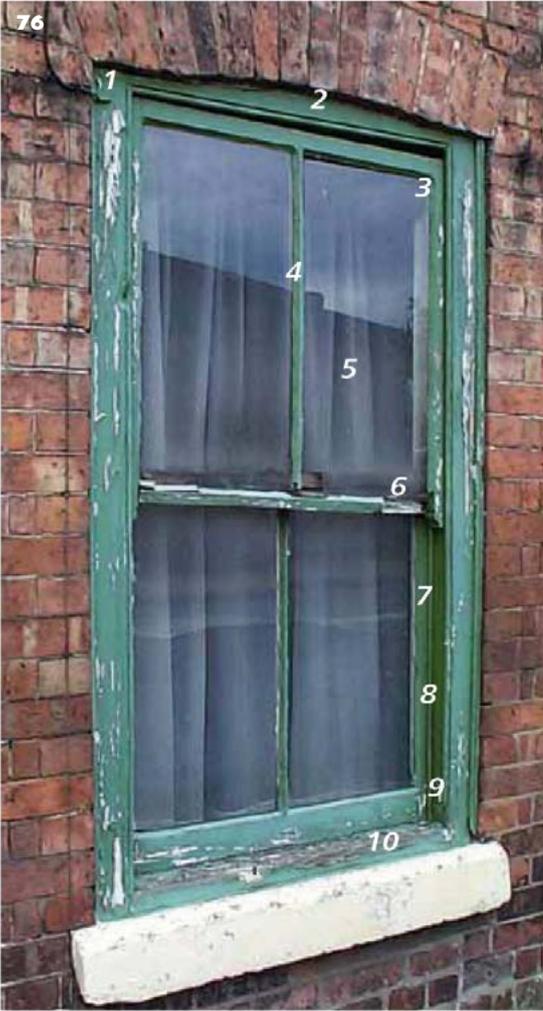
1. Holes drilled in frame for cable entry may admit water and cause decay
2. Deformation of window caused by structural movement in wall; sashes no longer fit or slide properly
3. Broken sash cords
4. Breakdown of paint and putty caused by lack of regular maintenance; this allows water to penetrate and become trapped, causing decay
5. Glass displaced or broken due to deformation of sash
6. Failure of joints, caused by timber decay due to water penetration
7. Opening parts of window jammed due to accumulation of paint
8. Worn or damaged beads, causing rattles and draughts
9. Decay of stile (or jamb) and outer lining at junction with sill due to water penetration
10. Decay of sill caused by water penetration after breakdown of paint. Water may also creep into the joint between the timber sill and the masonry sub-sill

76: Some of the problems to look out for when inspecting older windows.

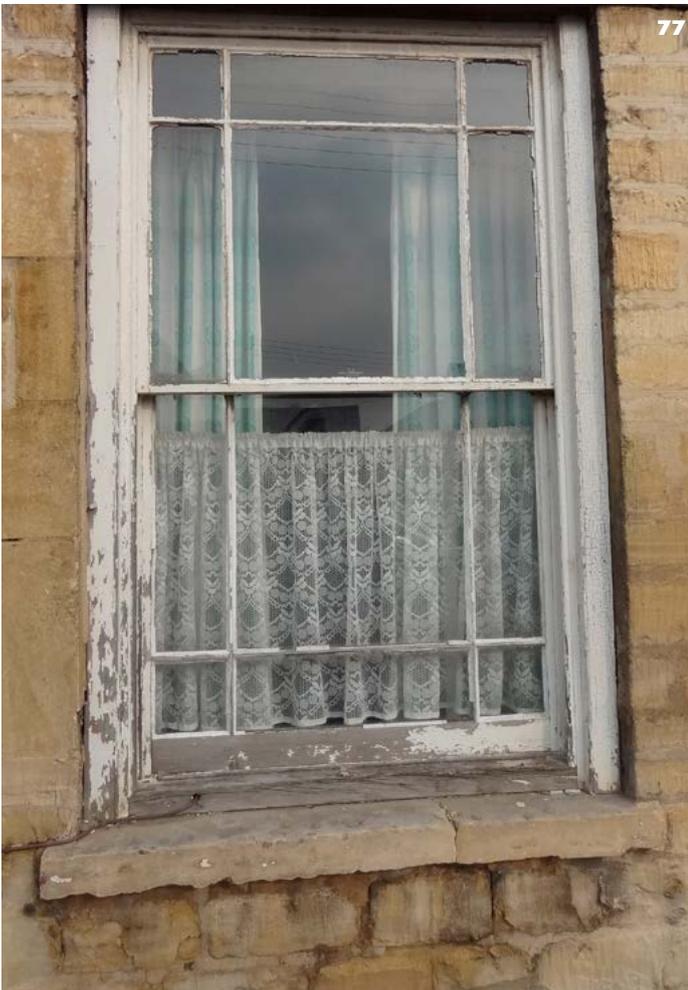
77

77: A double hung sash window lacking maintenance but still easily capable of being overhauled.

The purpose of overhauling timber windows is to correct defects caused by general wear and tear. Typically works include:

- freeing jammed casements or sashes and removing build-ups of paint which interfere with their effective operation
- replacing broken sash cords
- lubricating pulleys and hinges
- replacing broken glass and defective putties
- cleaning and repairing ironmongery and replacing missing or broken items
- easing sticking sashes and casements
- adjusting/packing hinges
- replacing missing or worn beads
- preparation and redecoration of previously painted surfaces (5–8 year cycle).

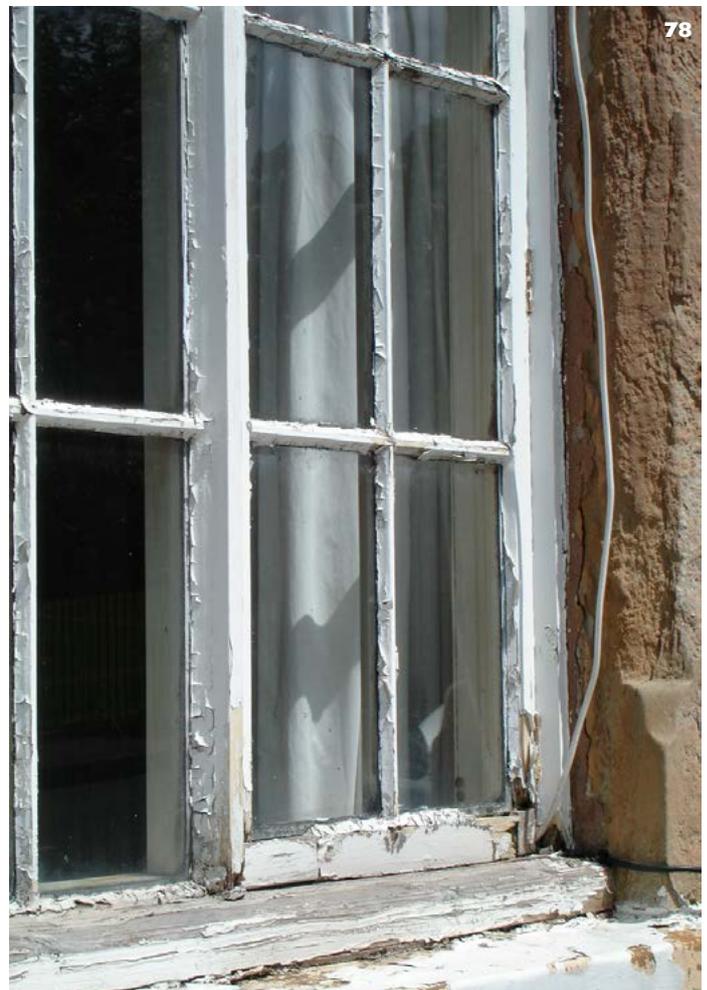
78

78: Lack of maintenance has resulted in lost putties to glazing and rot at the base of the window frames all capable of repair: Cables fed through the base of the frame have allowed water to enter and contribute to the rot.

If the timber has been affected by rot, the underlying surface will be soft and fibrous. Vulnerable areas should be probed with the point of a sharp knife or bradawl. It is easy for an experienced carpenter to repair affected areas by cutting out the rotting wood and replacing it with a piece of sound, treated timber. Epoxy resins are sometimes used as a substitute for treated wood in these patch repairs. However, it is important to paint over the repaired area as soon as possible, as resin degrades in ultra-violet light (see Section 4, Repairing Windows, for more detail on epoxy resin repairs).

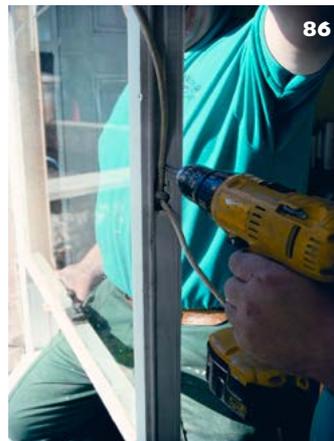
86

86: Fixing the cords to the grooves in the sides of the sash.

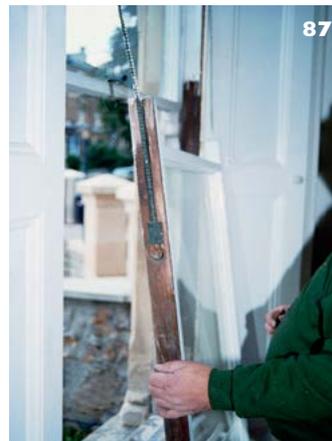
87

87: Chains are replaced in much the same way being screwed into the special fitting in the sash.

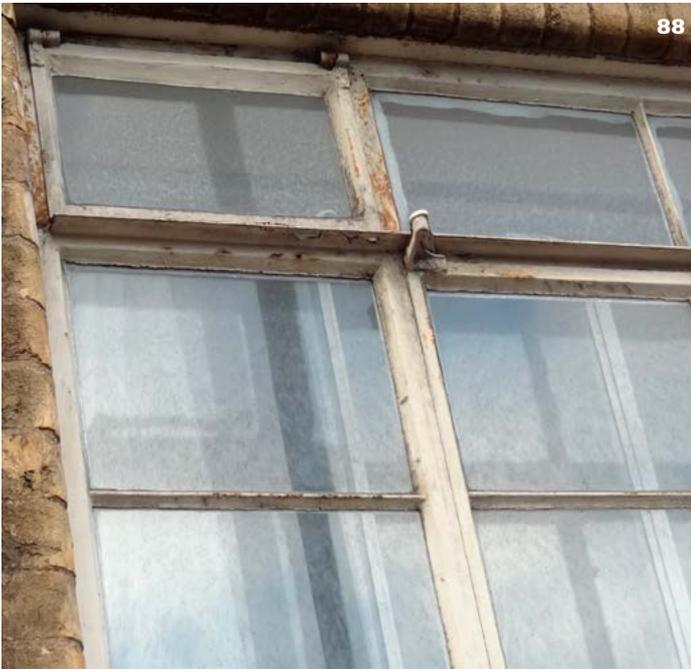
88: A steel window showing signs of corrosion with paint blistering.

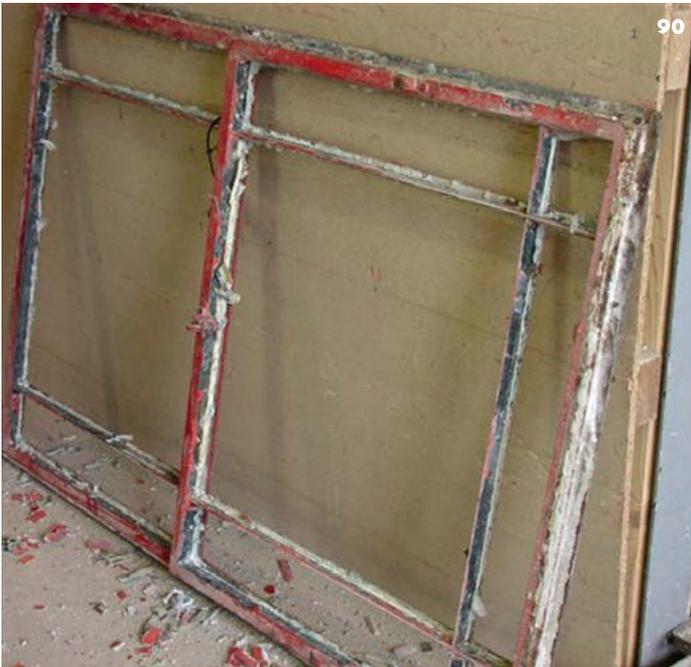
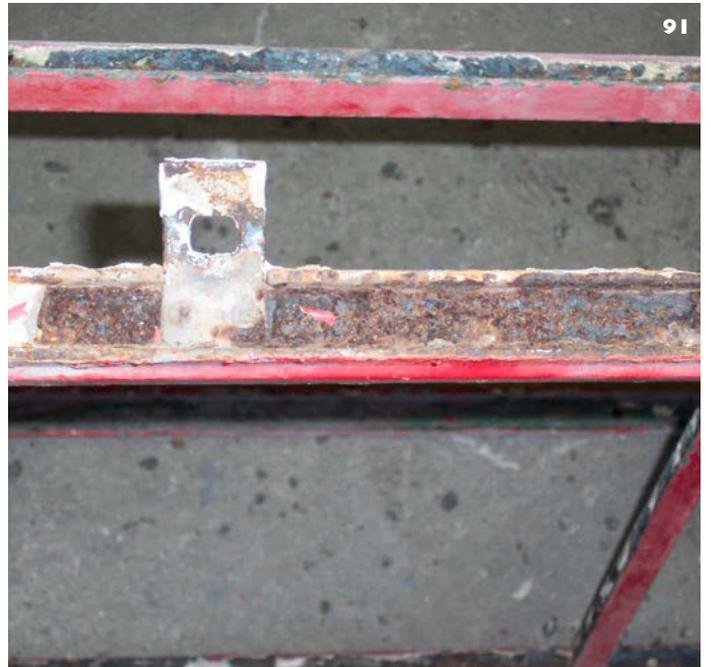
90–91: Preparation of a steel window for repainting- all loose paint must be removed along with any corrosion such as rust. Deep losses should be filled to stop water collecting leading to corrosion.

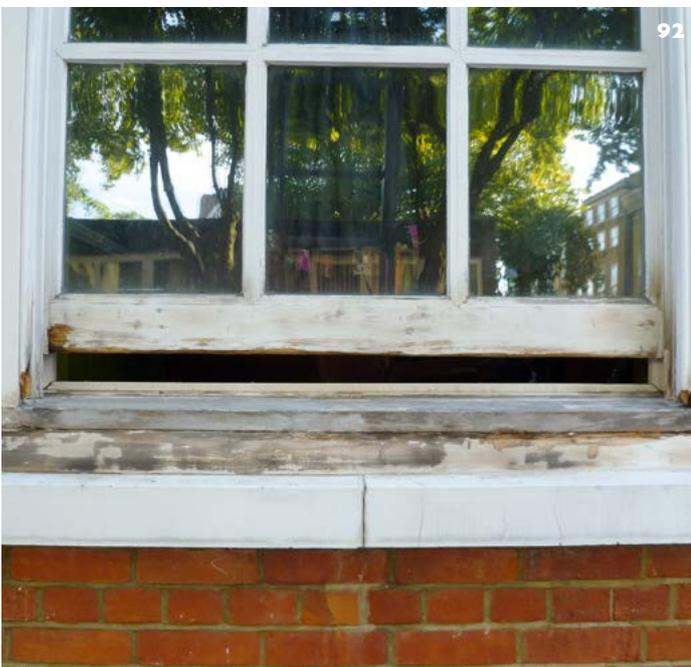
92: If paintwork is allowed to deteriorate on timber windows this can lead to decay of the timber as shown here to the lower more vulnerable parts of the window.

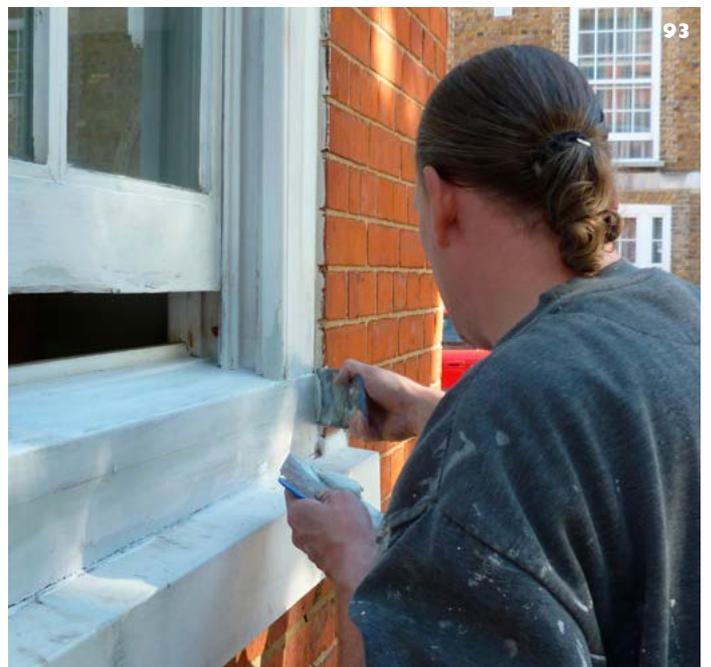
93: The decayed parts of the window being filled and primed ready for repainting.

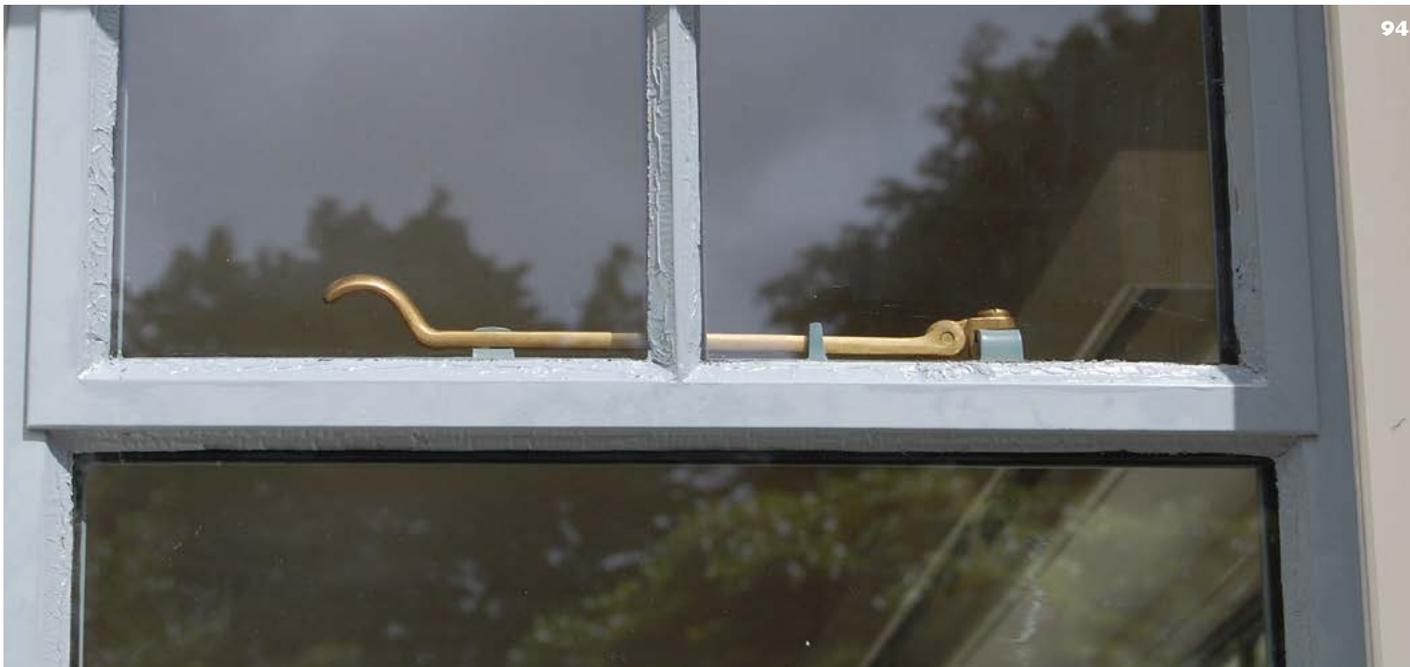
94: The new putty to this steel casement hasn't been allowed sufficient time to cure before being painted. Consequently the paint has blistered.

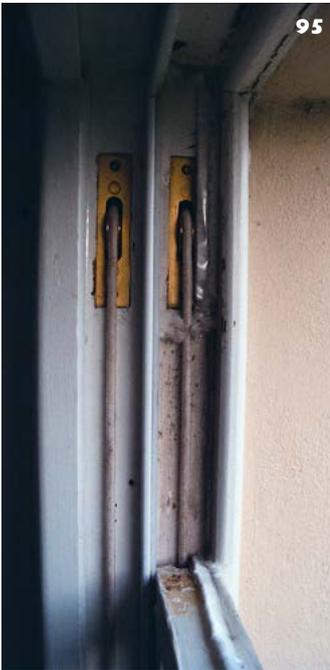
95: In a double hung sliding sash window each sash has its own pulley and cord. The parting bead separates the sashes and holds them in position. The cord and pulley need to be kept in good working order.

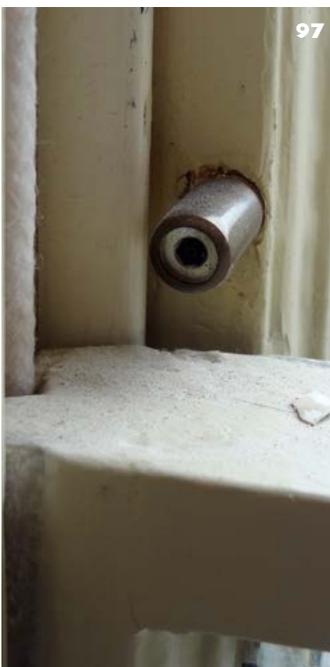
97: Height restrainers allow a degree of ventilation without compromising security.

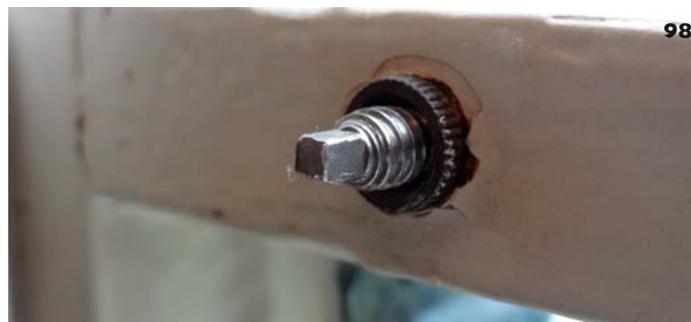
98: Bolts inserted into the meeting rails of a sash window keep the two sashes firmly locked in place.

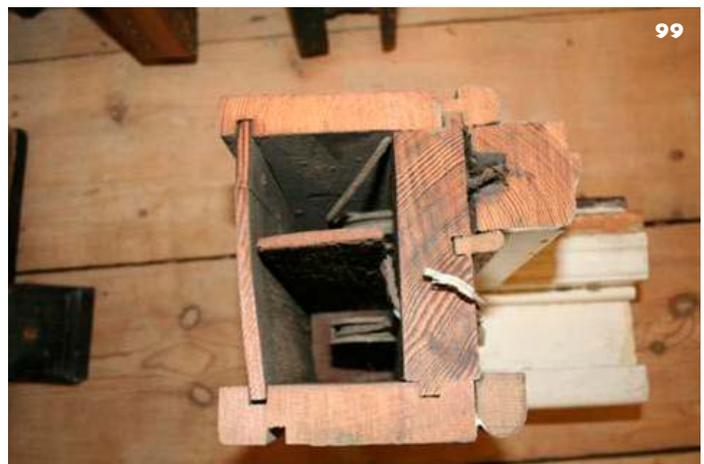
99: This section through a sash box shows the high quality of the timber used during the 19th century.

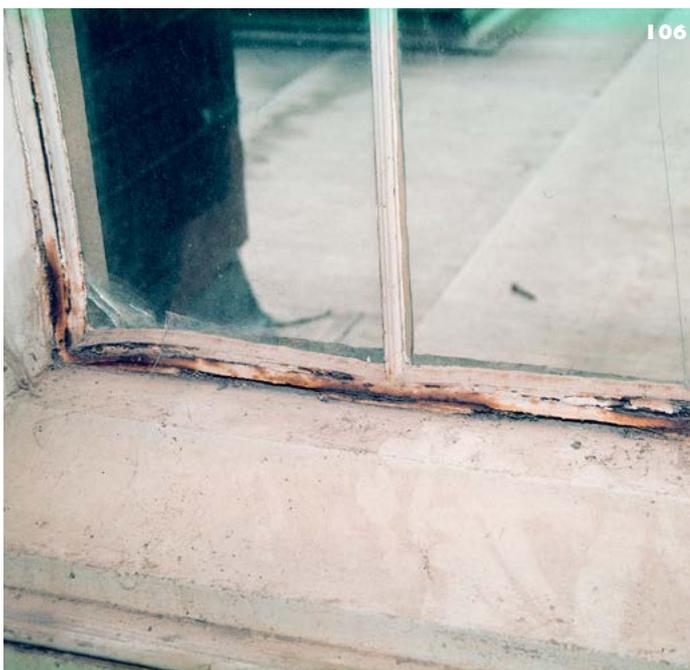
106: Steel window showing severe corrosion to the bottom rail of the frame and distortion from 'rust jacking' which has cracked the glass.

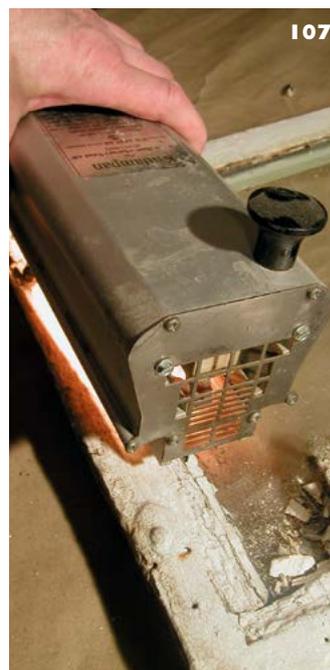
107: A putty lamp should be used where old putty needs to be renewed as this reduces the risk of cracking the glass.

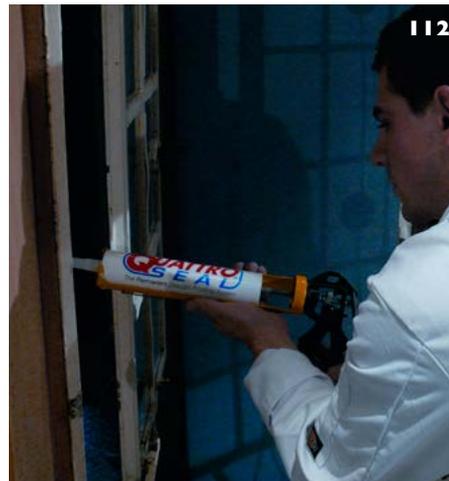
112: Silicone being injected into gaps between the frame and casement to exclude draughts. The casement is first painted with a releasing agent. The silicone is then left to cure with any excess trimmed back.

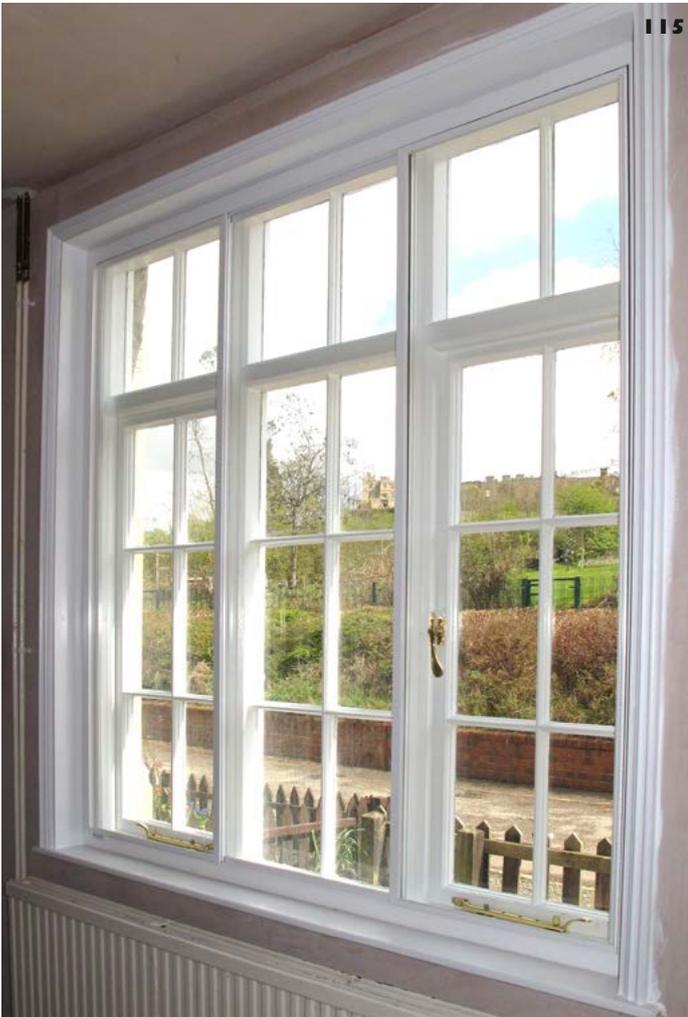
115

115: Failing plastic coated aluminium double glazed windows to this listed terrace house were replaced with single glazed timber casements to the correct historic pattern with secondary glazing incorporating Low E glazing giving a centre pane U-value of 1.6w/m²K.

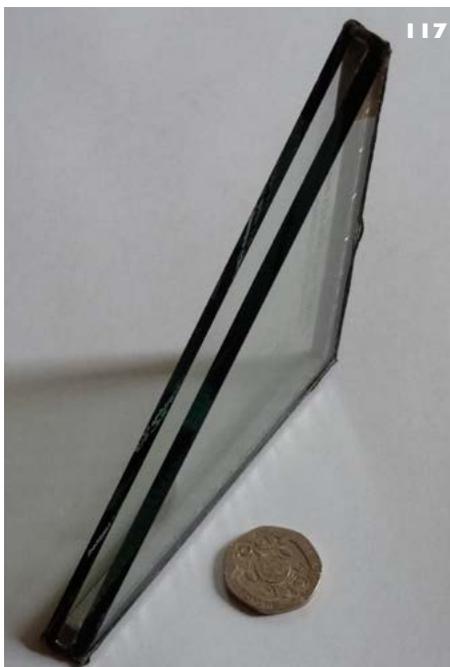
117: This slim profile IGU comprises 3mm outer glazing a 3mm gas filled cavity and 4mm Low-E inner glazing giving a total thickness of 10mm.

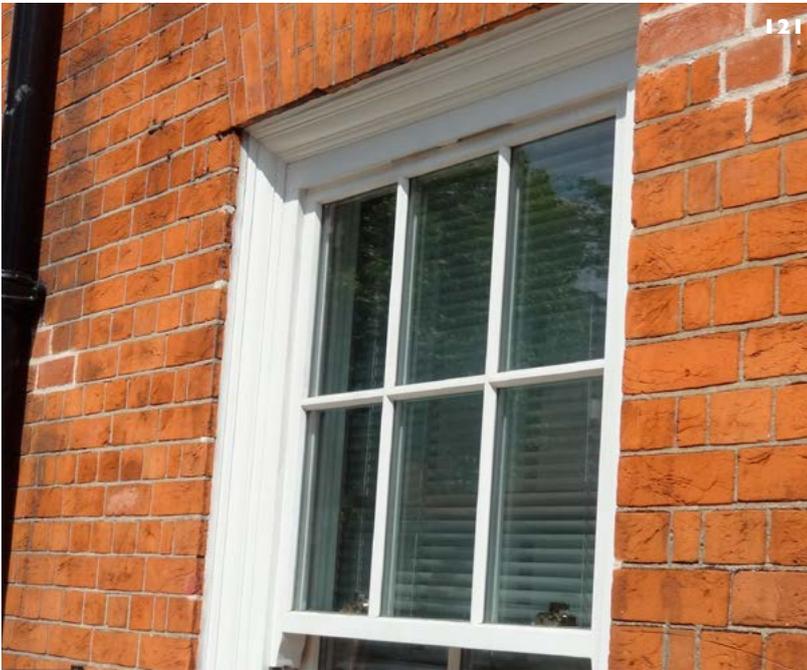
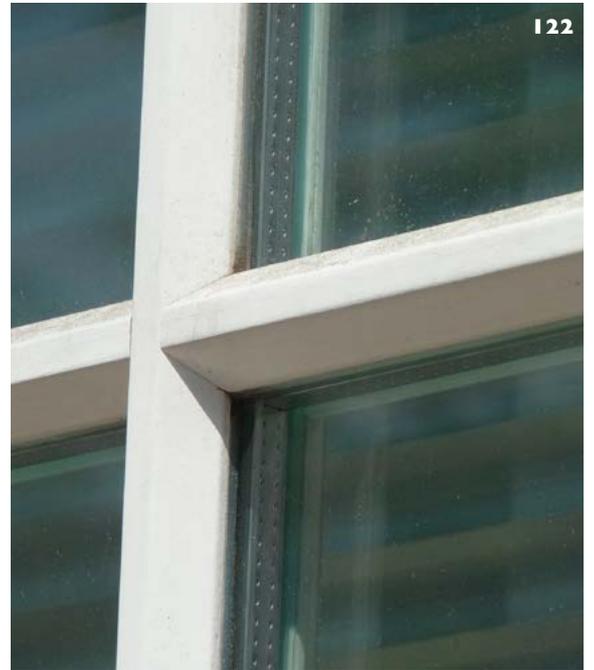
121–122: All the double hung sash windows to this Victorian tenement were completely renewed with replica sash windows incorporating IGUs. The timber glazing bars have been applied onto the IGU. Although the workmanship is of a good standard the overall appearance is rather flat and lifeless.

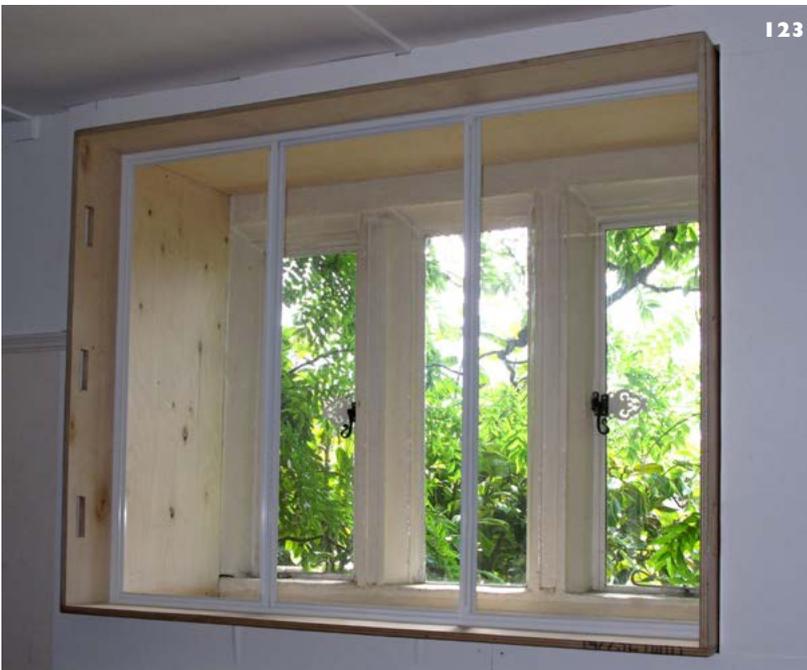
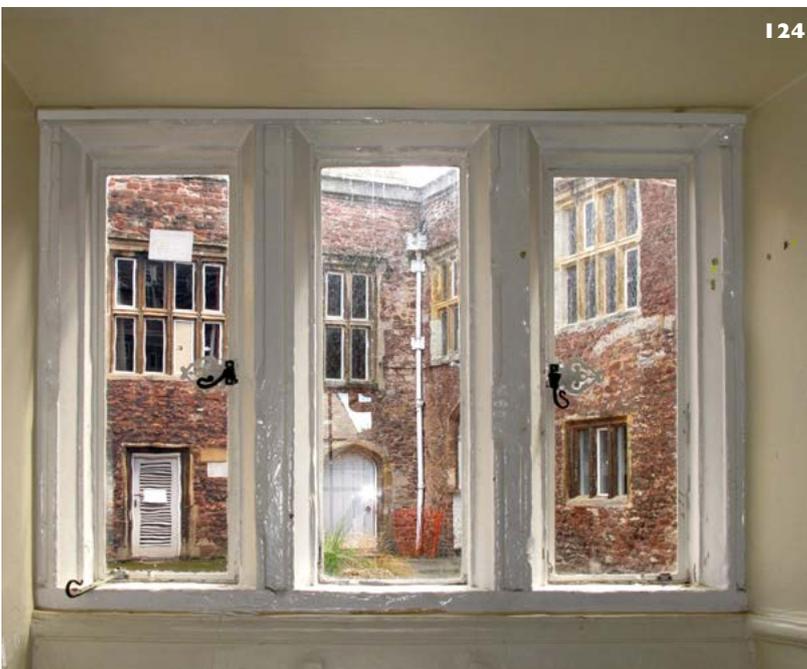
123–124: Following a mock up of secondary glazing units these steel windows were fitted with slim IGUs as this solution had less impact on the significance of the window. There was no historic glass and the steel sections were able to accommodate the thickness of the IGUs.

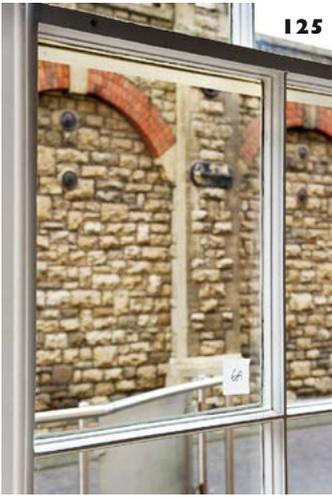
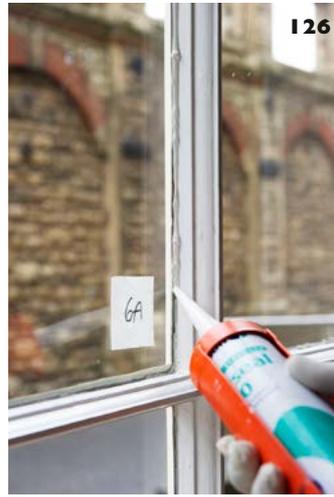
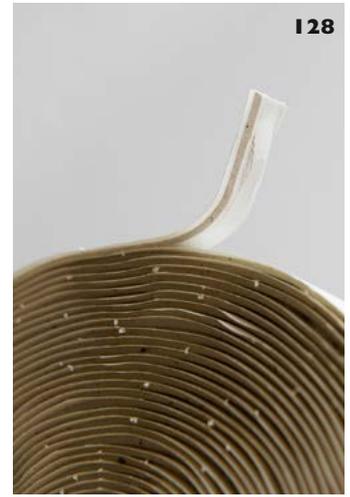
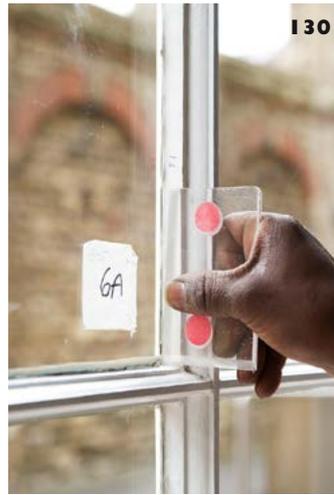
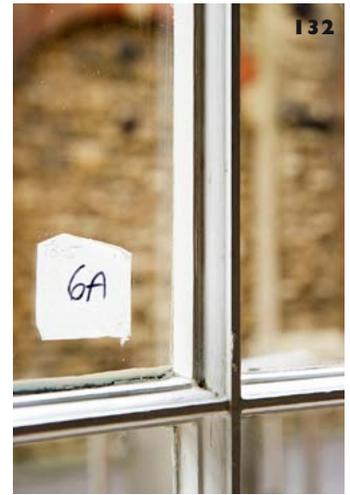
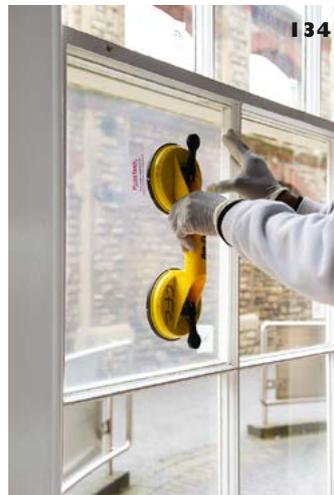
125–139: This sequence shows the addition of precision cut acrylic glazing to small paned windows. This allows the existing glazing to remain in place.

The edges need to be carefully sealed to prevent moisture entering the cavity. This is backed up with a specially developed dessicant material inserted in the cavity to prevent condensation.

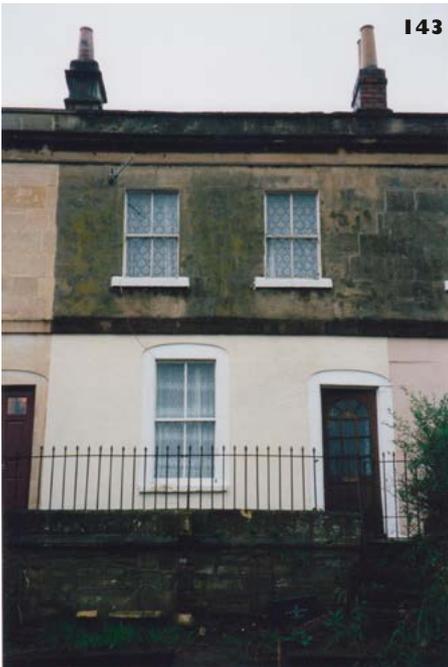
143

143–144: The repairs and restoration works to this listed terrace house have included the accurate reinstatement of the 6-over-6 glazing pattern but this has involved the removal of windows, albeit in poor repair, dating from the late 19th century. The justification for restorations such as this are often finely balanced between the desire to recover the scale and proportion of the historic design and the loss of later historic fabric. These judgements can only be made on a case-by-case basis as often many other issues need to be considered.
